Wolf Lodge Creek Watershed Assessment and Restoration Prioritization Plan

Near Coeur d'Alene, Idaho

Submitted To:
Idaho Department of Environmental Quality
2110 Ironwood Parkway
Coeur d'Alene, ID 83814

December 2016

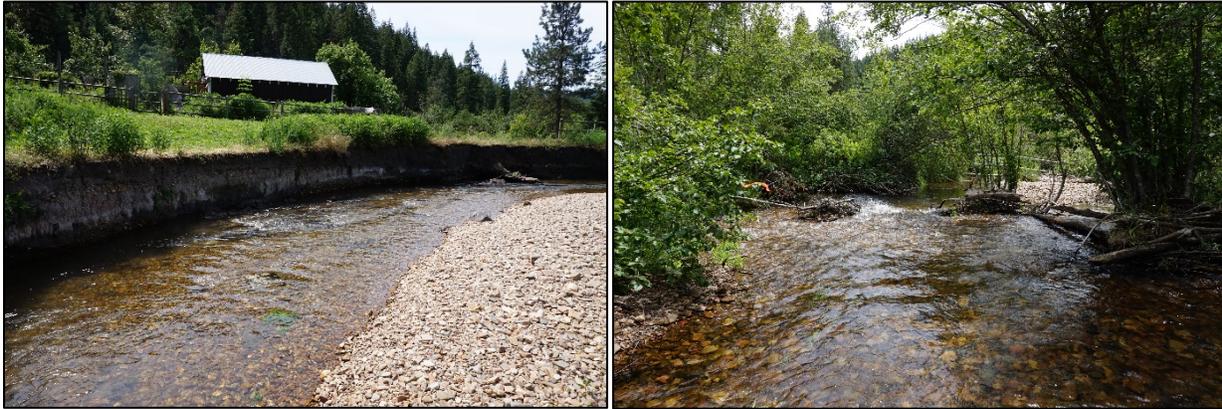
Figure B5-4. Extremely erodible meander bend (left). Upstream end of sub-reach failed beaver dam (right).

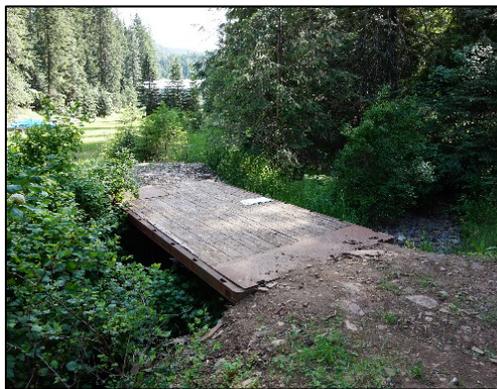
Bridge Deck

BRIDGE DATA	
Construction materials:	Wood deck, steel stringers, native approach grades
Deck condition:	Stable, wood
Stream channel constricted by bridge?	Yes

RISK ASSESSMENT	
Overtopping:	Possible
Mass Failure	Possible, fillslopes eroding at bridge inlet/outlet.
Erosion:	Medium, fillslopes eroding at bridge inlet/outlet.
Significance of problem:	Medium, fill is eroding and bridge is undersized.

RECOMMENDATIONS	
Talk with landowner about potential removal/replacement.

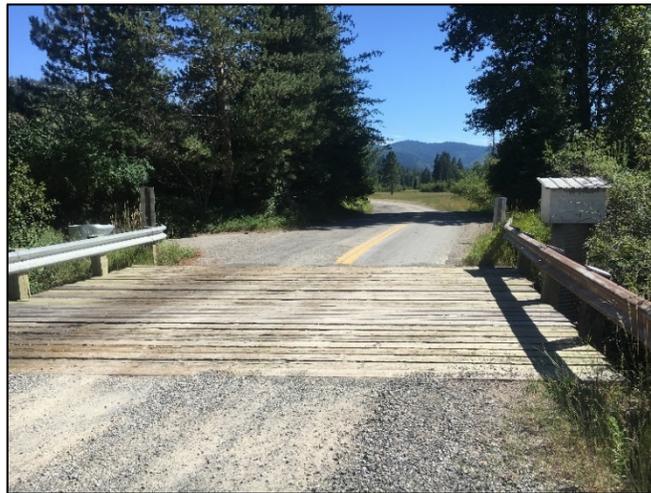
Wooden Deck

BRIDGE DATA	
Construction materials:	Concrete abutments, wooden deck.
Deck condition:	Good.
Stream channel constricted by bridge?	Yes.

RISK ASSESSMENT	
Overtopping:	Unlikely.
Mass Failure	Unlikely.
Erosion:	Low.
Significance of problem:	Low.

RECOMMENDATIONS	
Remove USFS stream gage and maintain deck.

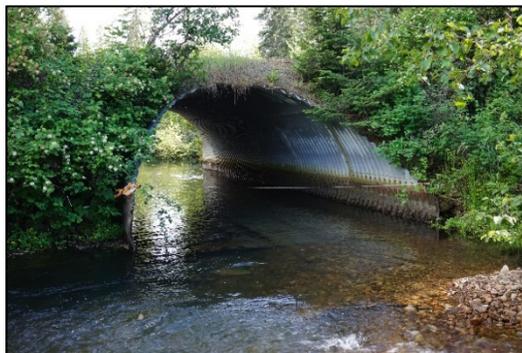
Inlet

CULVERT DATA	
Diameter:	14.5 ft.
Length:	35 ft.
Alignment with stream:	Adequate.
Culvert installation:	Culvert is countersunk below stream grade.
Energy dissipation at outlet:	Marginal, some erosion.
Armoring:	Yes.
Condition:	Good.

RECOMMENDATIONS
None, crossing is functioning.

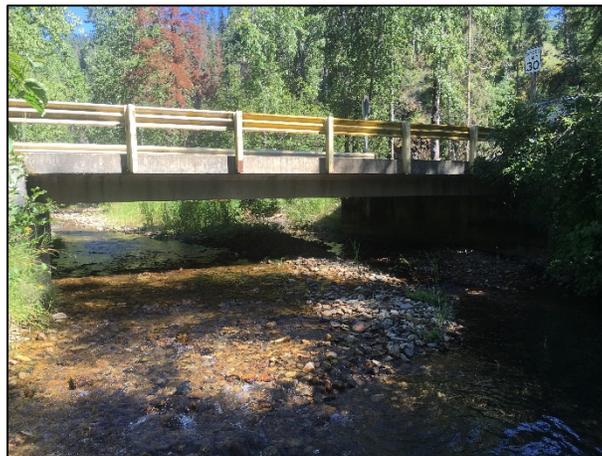
Downstream Bridge

RECOMMENDATIONS	
Gravel bar forming at bridge inlet. Recommend monitoring and removal as necessary.

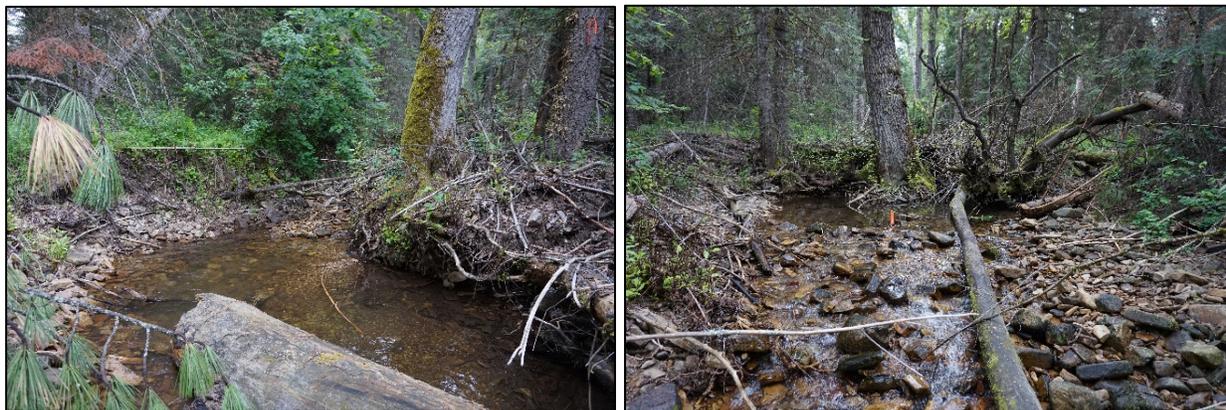
Despite channel incision, WLC1 maintains relatively low sediment yield because of large cobbles that protect the bank from erosion. The channel planform appears to be stable due to cobbles and woody vegetation root structures, and instream habitat diversity has been lowered with channel incision. This reach is not a high priority for restoration efforts, but future harvest activities should limit management activities that reduce large wood recruitment to the channel.

Figure 4-1. Typical channel and bank conditions of Reach WLC1.

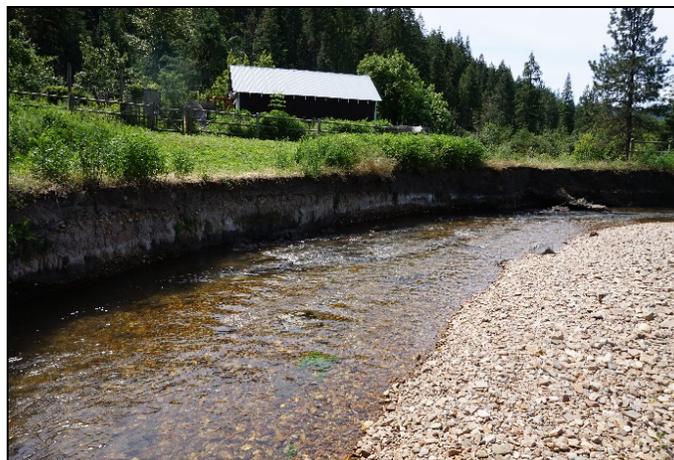
In summary, WLC3 is a reach that has been substantially altered from its historical condition by human actions including agriculture, riparian shrub and tree clearing, residential development, and timber harvesting. Channelization and hard bank stabilization projects have led to unfavorable channel geometry and increases in bank erosion rates. Efforts to stabilize the banks may prove effective in curbing erosion from a single site, but fails to address underlying causes of the problem. The proximity to home owners and the severity of bank erosion leads to a high restoration prioritization in this reach.

Figure 4-7. High priority restoration site on WLC3.

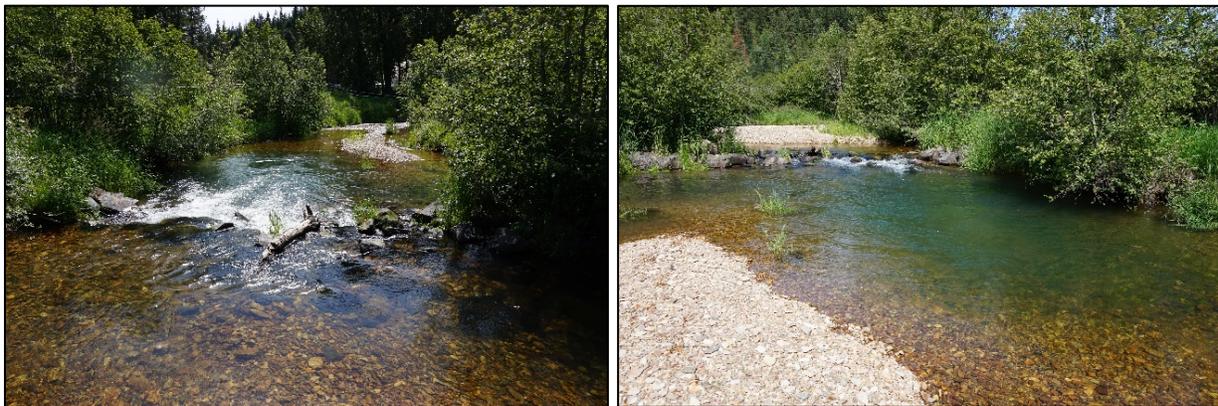
The large meander bend in the WLC3 sub-reach was the site of GeoMax a project designed to reduce bank migration with tree barbs and a small rock check feature upstream. Despite full implementation of these projects they have failed to reduce the rate of bank migration and this site is now a high priority for restoration efforts. The goal of the tree barbs were to decrease near bank stress, but they were inadequately spaced leading to secondary flow circulation (i.e. eddies) which have driven further bank erosion. This project has largely failed to address the goals identified in the GeoMax report (GeoMax 1990).

Figure 4-8. Typical channel conditions in Reach WLC3.

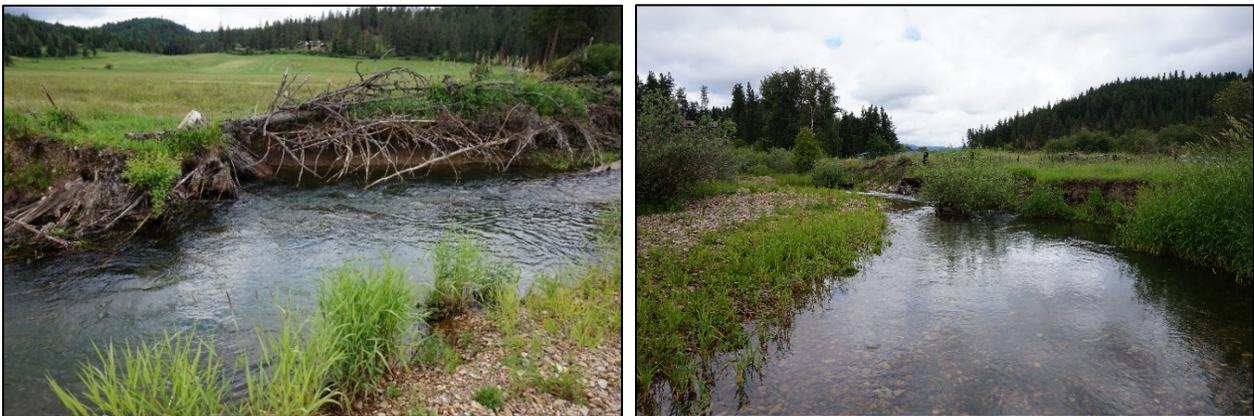
Reach-specific recommendations include limiting sediment removal from within the channel except at the upstream bridge sediment trap. WLC4 is a high priority restoration reach. Efforts will focus on creating an adequate inset floodplain for the channel to dissipate energy during high flow events without causing the large amounts of bank erosion observed currently. Restoration efforts will result in downstream landowners having a major reduction in property loss to bank erosion and a reduction to flooding of pasture land, while allowing the channel to support more natural geomorphic processes. The restoration concepts included in this report address the excessive bank erosion and loss of floodplain connection in this section of Wolf Lodge Creek.

Figure 4-12. Typical bank and channel conditions in Reach WLC4.

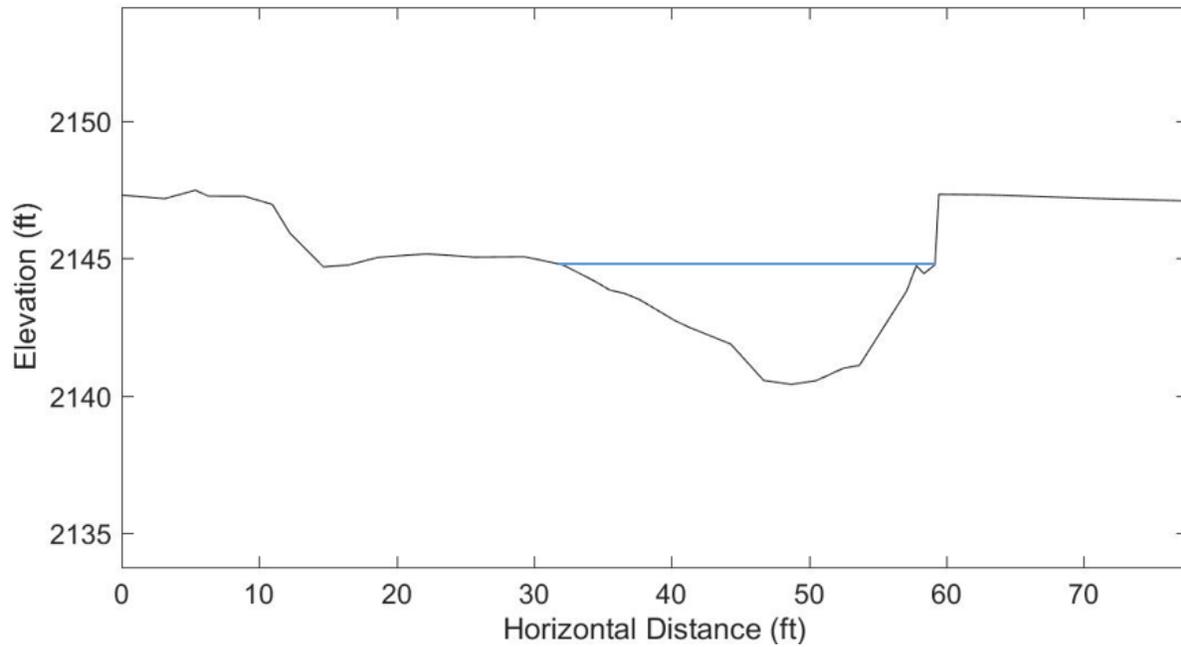
A geomorphic survey was completed at the upstream end of WLC4 just downstream of the Wolf Lodge Creek Road bridge. This reach is highly degraded due to historic dredging and channelization. In the sub-reach the channel is an F4 stream type, with high levels of entrenchment and moderate sinuosity. A 725 ft longitudinal channel profile, two riffle cross-sections, two pool cross-sections, pebble count for riffle and pool, large wood survey, and BEHI assessment were completed in the reach. The cross-sections were located in representative channel habitat features. The average bankfull slope was 0.002 ft/ft compared to a water surface slope of 0.002 ft/ft. Pool cross-section and descriptive statistics are included in Figure 4-14 and Table 4-12. The pool illustrated in the cross section is a location where historic sediment removal likely occurred. Width-to-depth ratios decreased when compared to WLC3. Large wood was not prevalent in the reach with the exception of large trees placed at the top of banks in efforts to increase bank stability. Many of these segments are now undermined by continued bank erosion. Overall, WLC4 is a highly impaired reach and has been identified as a high priority restoration site. Restoration concepts focus on increasing floodplain connectivity by constructing an inset floodplain, which will reduce bank erosion and allow for more natural geomorphic processes.

Figure 4-14. Cross section 3 on WLC4. The blue line represents bankfull stage. This cross section shows signs of dredging given the steep, actively eroding overhanging bank on river right.

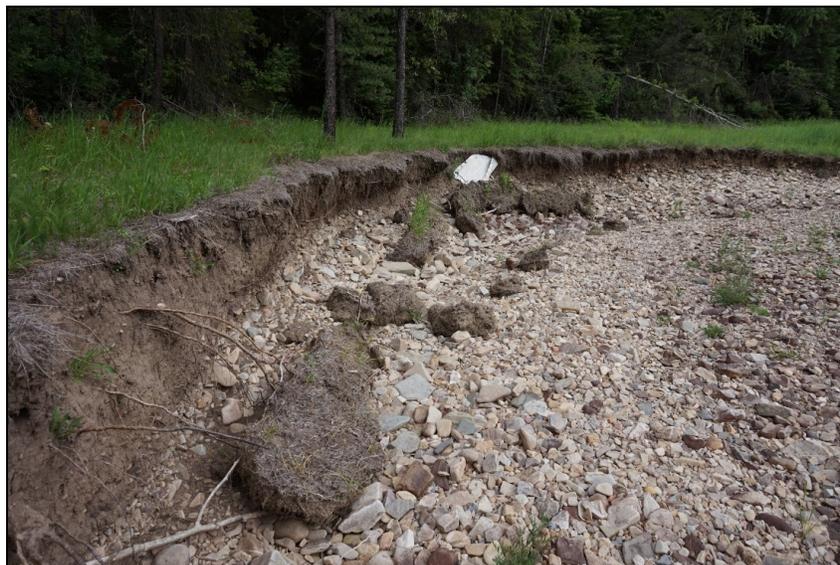
Soils in LC1 consist of Typic Udivitrands formed in broad stream bottoms, which have low surface erosion and low mass erosion potential, but have high sediment delivery potential (Table 2-7). Banks in this reach are highly erodible and are a large source of sediment downstream. Over-steepened banks with easily erodible topsoil characterize the upper bank, and underlying soils consist of fine to medium size alluvium. Large bank blocks calve off of the undermined banks, causing channel widening (Figure 4-19). BEHI analysis identified three bank conditions in the reach, two of which rated high with BEHI ratings of 31.9 and 26.8 (Table 4-17). These banks characterized a majority of the reach. Depositional bars that demonstrated low BEHI ratings represented 10% of the reach. Overall, LC1 contributes 191 tons/year of sediment through bank erosion, representing approximately 10% of the total contribution to the watershed. Section 5, Table 5-1 includes a description of the calculation of total sediment yield in tons/year.

Figure 4-19. Bank blocks from rapid bank erosion resulting from woody vegetation removal and channel entrenchment.

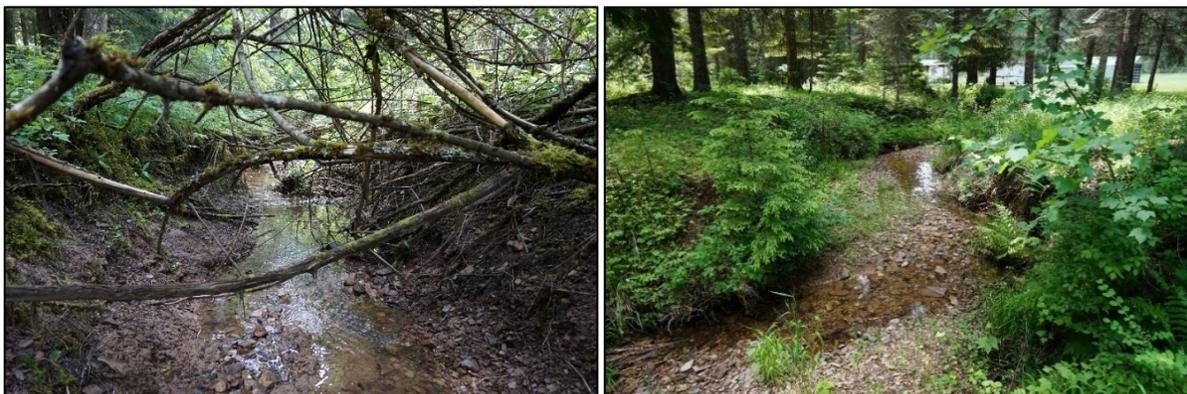
Westslope cutthroat juveniles were observed in a pool just below a knickpoint separating the upper forested section from the lower gradient reach of UN1. Recommendations for this reach include conservation of forested land and reducing conversion of forest to pasture on private property. This is important for reducing the amount of bank erosion and downstream sedimentation. More broadly, first and second order streams should be managed to reduce the amount of forest cover loss.

Figure 4-22. Incised channel above the knickpoint (left), and widened and incised channel with thinned riparian forest (right).

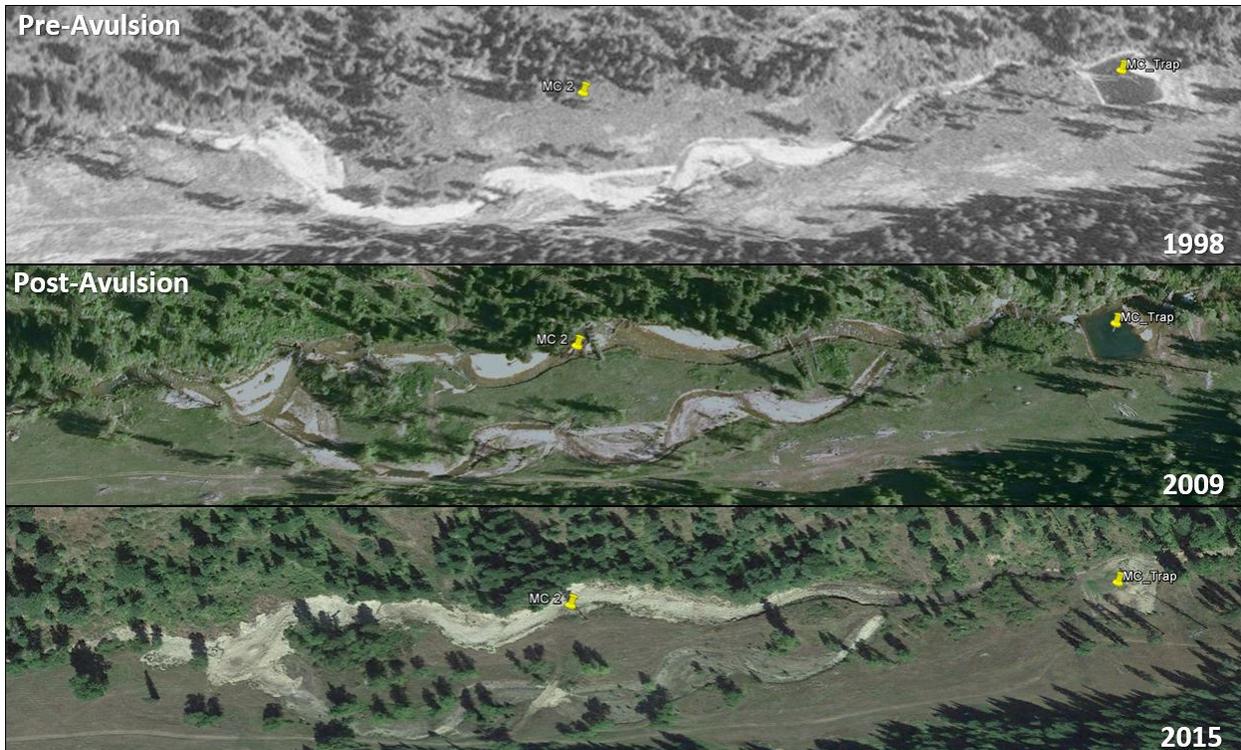
The Marie Creek valley floor in MC2 was cleared for logging, grazing, and other agricultural activities. Native riparian vegetation is limited to relict meander oxbows that were truncated and abandoned in the early 2000s as a result of a major channel avulsion. The avulsion was exacerbated by the lack of vegetation in the valley floor, which decreased channel boundary and floodplain roughness. After this avulsion, efforts were made to restore the channel and provide more diverse habitat, prevent flooding, and minimize bank erosion. Several structures installed are at risk of failure due to scour. A time series of imagery of the site is provided in Figure 4-29.

Figure 4-29. Time series of aerial photography highlighting the channel avulsion on MC2.

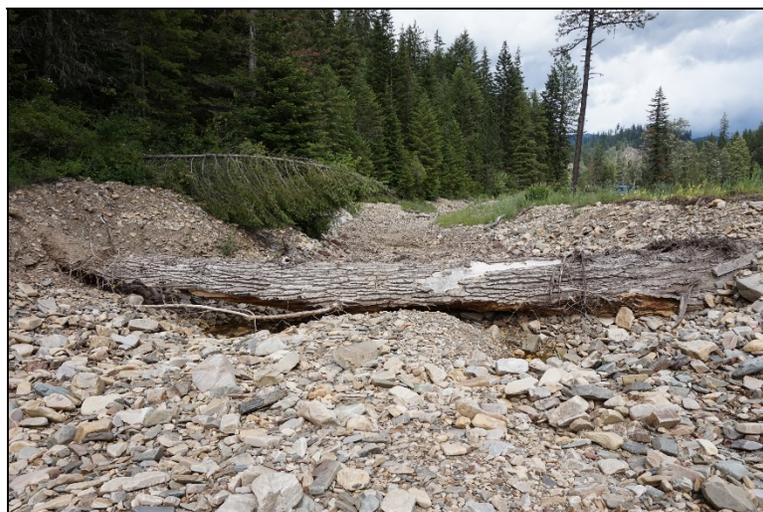
Several of the channel spanning wood features are susceptible to failure (Figure 4-30). The channel bed is scoured below the step features, and the structures are at risk of failure. An undersized bridge is located downstream of the restoration site and consists of a narrow span and mid-channel pier. Given the limited hydraulic capacity of the bridge opening, the bridge may be at risk of failure during a large flood event.

Figure 4-30. Example channel spanning log drop structure that is at risk of failure.

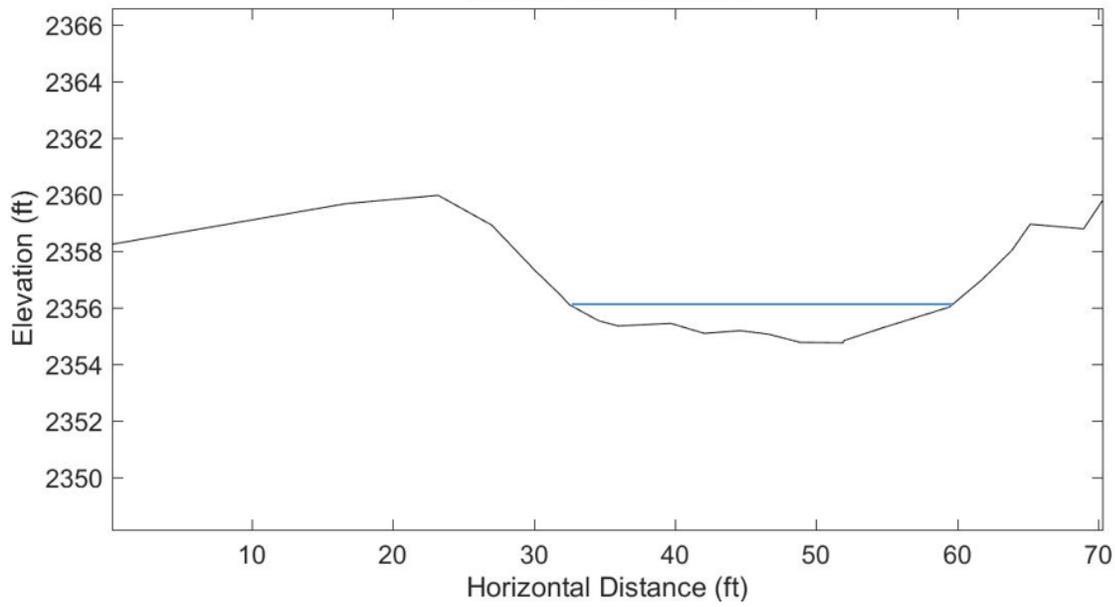
A geomorphic survey was completed at the upstream end of MC2 just downstream of the USFS sediment trap. This reach is highly degraded from a recent channel avulsion and mitigation efforts. In the sub-reach, the channel classified as a B4 stream type, with moderate sinuosity and limited floodplain connectivity. A 900 ft longitudinal channel profile, two riffle cross sections, two pool cross-sections, a pebble count, large wood survey, and BEHI assessment were completed in the reach. The cross sections were located in representative channel habitat features. The bed slope is 0.012 ft/ ft and the sinuosity of the channel is 1.23 ft/ft. Riffle cross-section and descriptive statistics are included in Figure 4-31 and Table 4-26. Width-to-depth ratios are outside of the range expected for a B4 stream type which is causing rapid channel widening. Large wood is not present in the reach with the exception of the channel spanning wood structures incorporated as part of the channel stabilization project described above. Uniform bed topography limits the development of aquatic habitat and is a result of channel widening and construction efforts. Additionally, the lack of large wood and riparian vegetation exacerbates the lack of habitat diversity.

Figure 4-31. Cross section 2 on MC2. The blue line represents bankfull stage. Leveed banks significantly disconnect the floodplain from the channel.

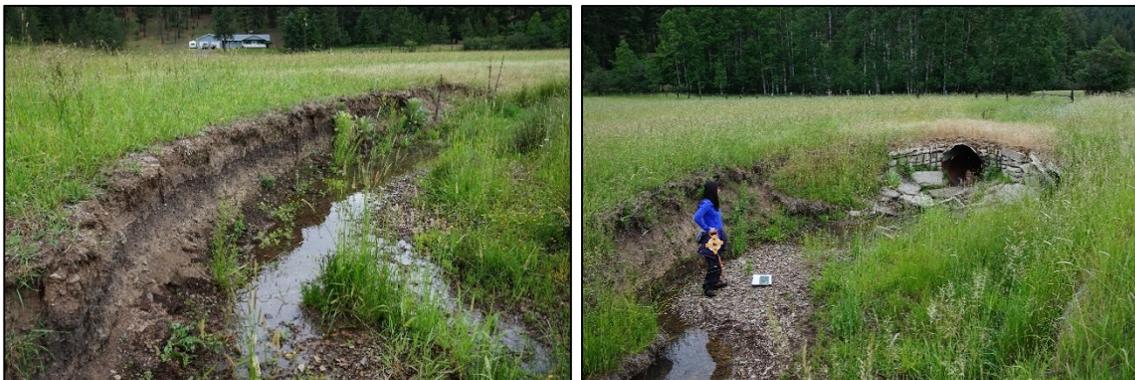
In summary, RG3 is prioritized for restoration actions that reduce sediment loading to the reach and Wolf Lodge Creek. Given the history of channelization and dredging of the channel, RG3 is identified as a reach with significant potential for restoration. Recommendations for short term management include ceasing in-channel dredging, and installing adequate energy dissipation at both culvert outlets. A conceptual restoration plan to address limiting factors in RG3 is presented in Attachment A.

Figure 4-36. Typical streambank conditions in Reach RG3 (left), and undersized culvert (RG3_Culvert) (right).

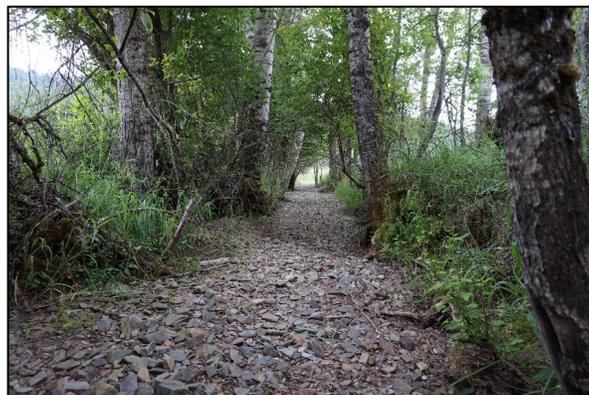
Figure 4-35. Straightened portion of RG3 and channel aggradation.

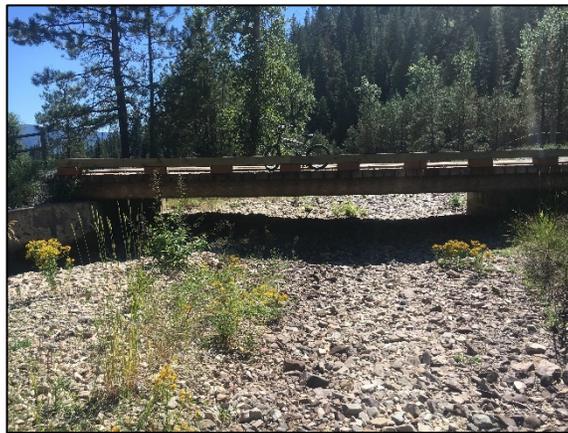
This bridge provides access to a private residence on Lonesome Creek. The bridge is located directly downstream of sub-reach LC1. The bridge is comprised of concrete abutments and a wooden deck with limited freeboard (Figure 6-2). The channel is constricted by the bridge and bedload is aggrading, reducing channel and bridge hydraulic capacities. Failure risk is considered moderate due to the reduced hydraulic capacity and potential to trap debris/bedload. Both approach grades are contributing sediment to the crossing.

Figure 6-2. LC1_Bridge stream crossing.

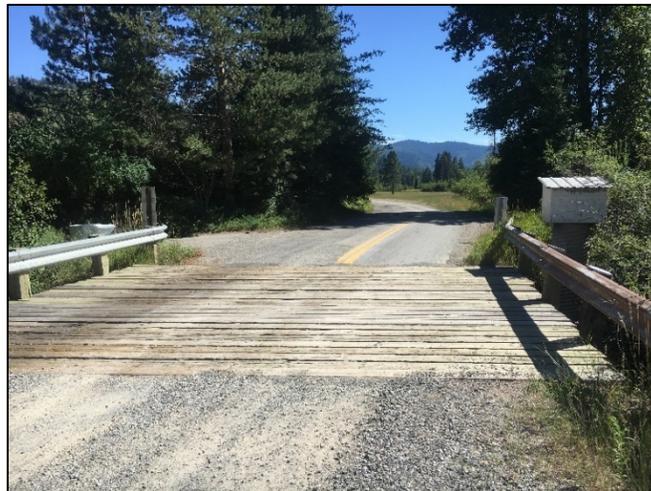
This public bridge provides access to the headwaters of Stella, Lonesome, and Phantom Creek. It spans Phantom Creek (WLC1) and is comprised of concrete abutments and a wooden deck (Figure 6-3). The bridge is in good condition. The channel is constricted by the bridge which has led to bedload aggradation upstream. Overtopping is unlikely. The constriction and subsequent aggradation may lead to further channel adjustment upstream (i.e. bank erosion and widening). A decommissioned USFS gauge structure is attached to the bridge and has been inactive for over 15 years. Channel morphology is stable upstream and downstream of the bridge inlet and outlet, respectively. While a bridge of greater span and hydraulic capacity is warranted, replacement is not considered a priority given the restoration priorities identified in this report.

Figure 6-3. WLC1_Bridge stream crossing.

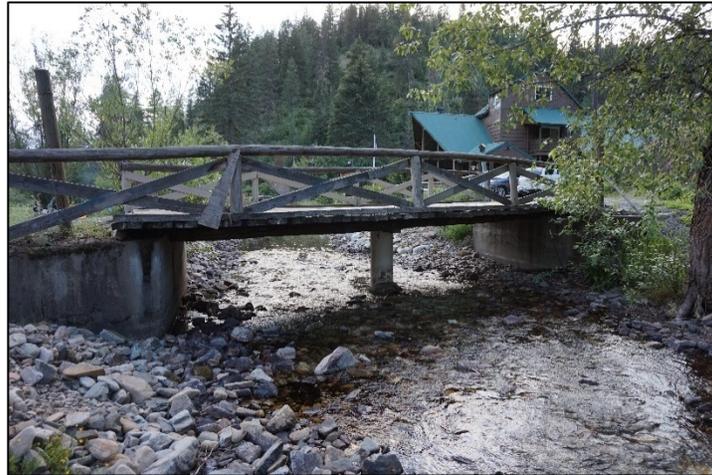
This private bridge provides landowner access to private property and USFS land located in the Marie Creek watershed, including the Marie Creek sediment trap. The bridge deck and stringers are structurally comprised. The abutments consist of cast-in-place concrete and are aligned streamwise with the channel. The wooden deck has deteriorated, and the main center pier support is comprised of a polyvinyl chloride tube filled with concrete (Figure 6-4). The mid-channel pier poses a risk to sediment/debris blockage. The bridge is a constraint to restoration efforts on MC2 and should be replaced concurrent with restoration actions.

Figure 6-4. MC2_Bridge stream crossing.

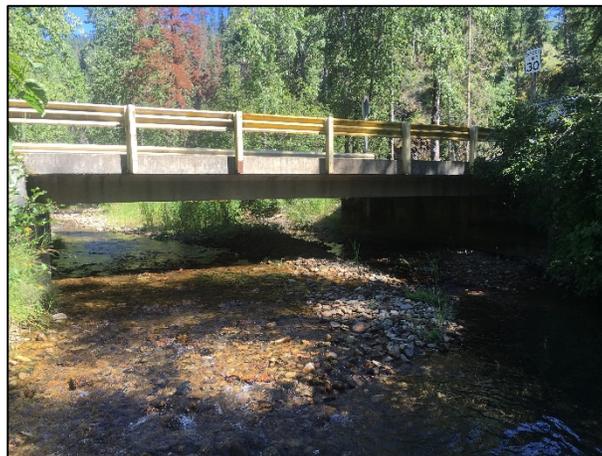
MC_Bridge is functioning and continued monitoring of the bridge and sediment deposition should be performed.

Figure 6-5. MC_Bridge stream crossing.
