**Reconnaissance-Level Investigation of Sediment  
Sources and Channel Morphology,  
and Recommendations for Management,  
Pine Creek, Shoshone County, Idaho**

**Bureau of Land Management  
1808 North 3rd Street  
Coeur d'Alene, Idaho 83814**

20 June 1996

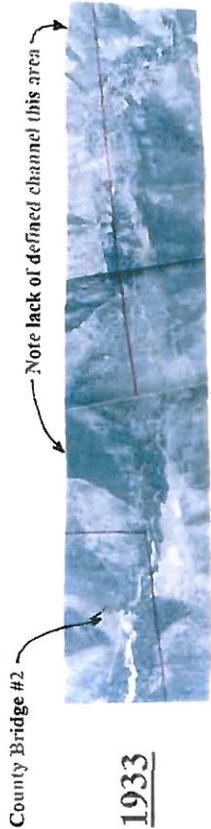
1933

Langlois Creek Confluence

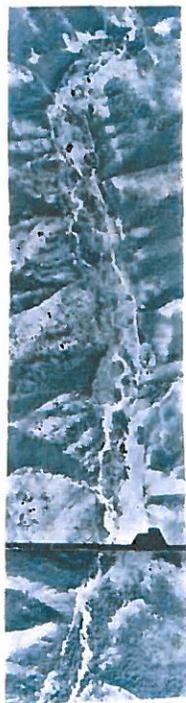
1956

Some channel widening, particularly downstream Langlois Creek confluence. Still lack of defined channel in most of the reach upstream of that point.

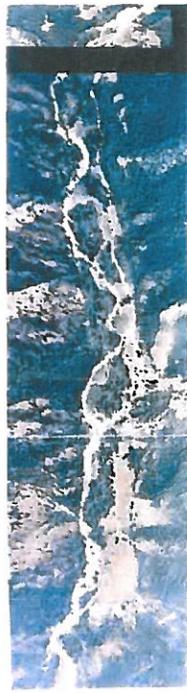
1984

Most flow appears to have returned to the right channel. Channel continues to widen in many places. New channel cut through riparian along right side of valley bottom upstream of Langlois Creek.

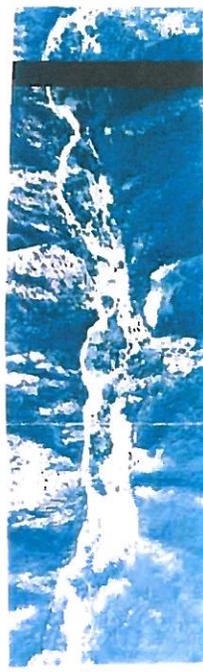
1991

Left channel now appears abandoned. Main channel continues to widen throughout reach.

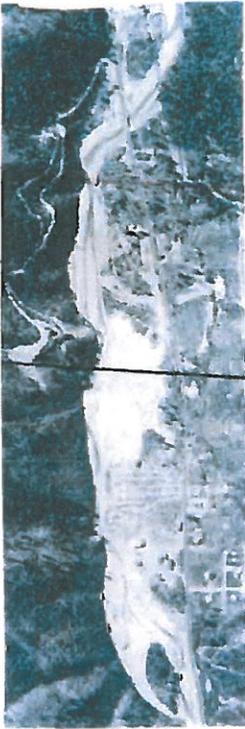
1968

Note much narrower channel upstream of Liberal King mine, compared to present conditions. Car junkyard occupies most of floodplain, including much of active channel. Channel at downstream island is directly against road riprap.

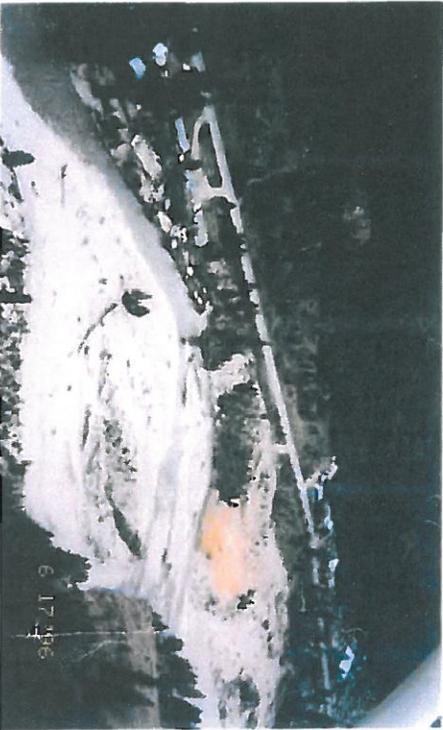
Channel has widened substantially upstream mine. Deposition of mid-channel bar is deflecting flows towards residence on left bank. Vegetation is beginning to establish on center of bar. Tailings protected by temporary riprap to prevent erosion at low to moderate flows. Downstream translation of meander will likely outflank tailings and riprap.

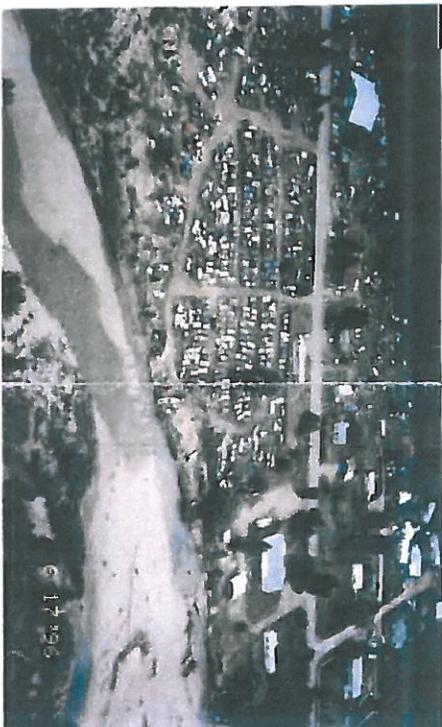
Erosion continues at junkyard. Entrained vehicles are visible on mid-channel bar downstream.

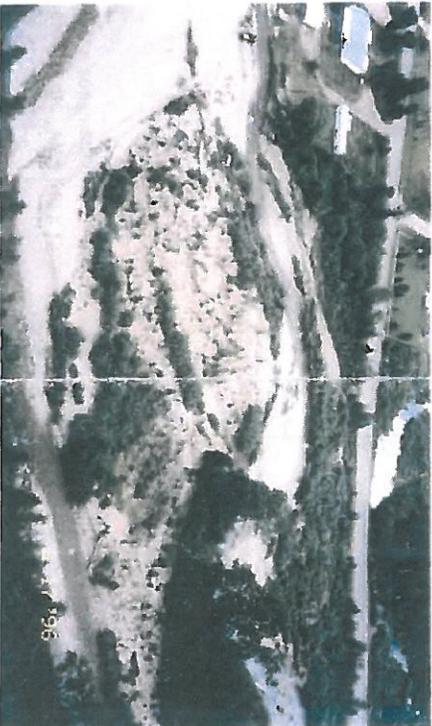
Vegetation becoming established on mid-channel bar, upstream of older island. Vegetation on 1968 channel adjacent to highway is being eroded as meander's translate downstream.

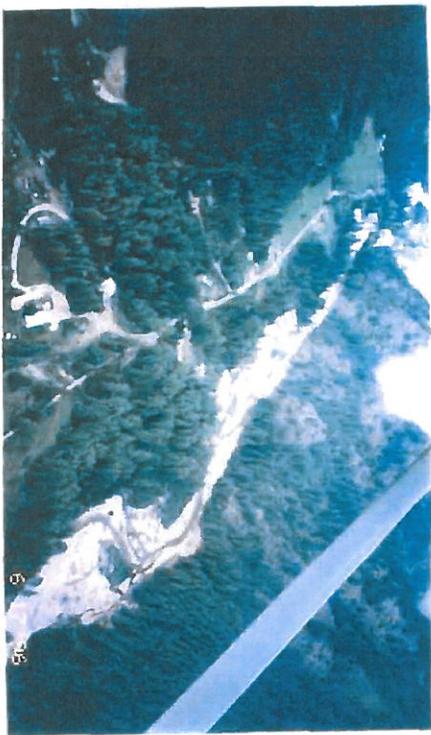
View downstream of the confluence of Langlois Creek and vicinity. Wide, shifting unstable channel occurs throughout this reach. One site of hillslope erosion is visible where channel impinges on right side of valley.

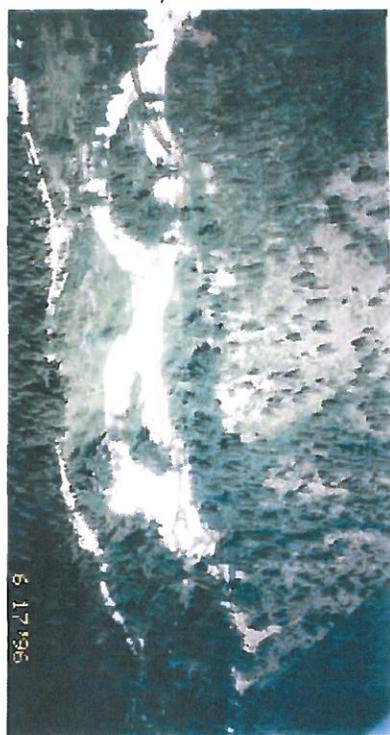
View of channel just upstream of Langlois Creek confluence. New channels were cut through riparian vegetation during floods of 1996.

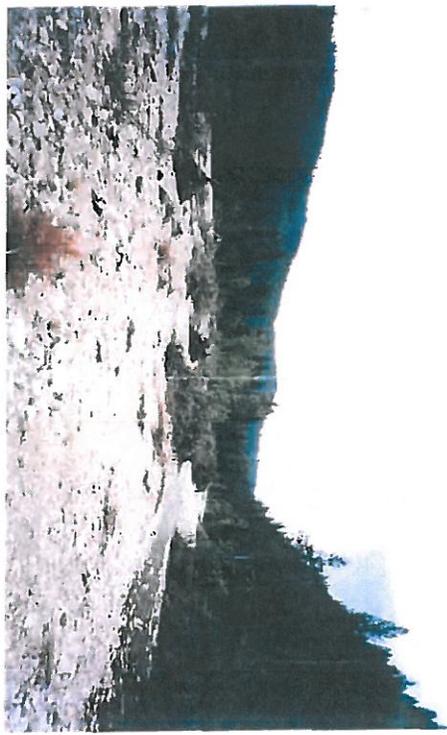
View downstream from confluence of Langlois Creek. Woody debris has been deposited on large gravel bars, assisting in creating blockages and diverting flow towards the streambanks.

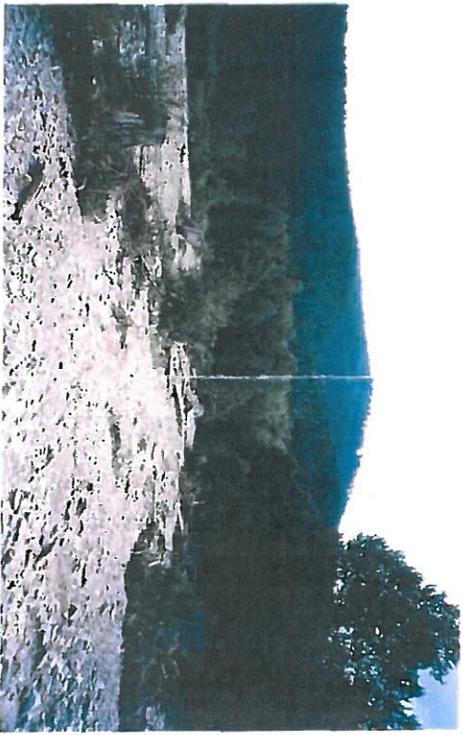
Typical view upstream of confluence of Langlois Creek. Large cedar stumps are being slowly eroded and floodplain material remobilized.

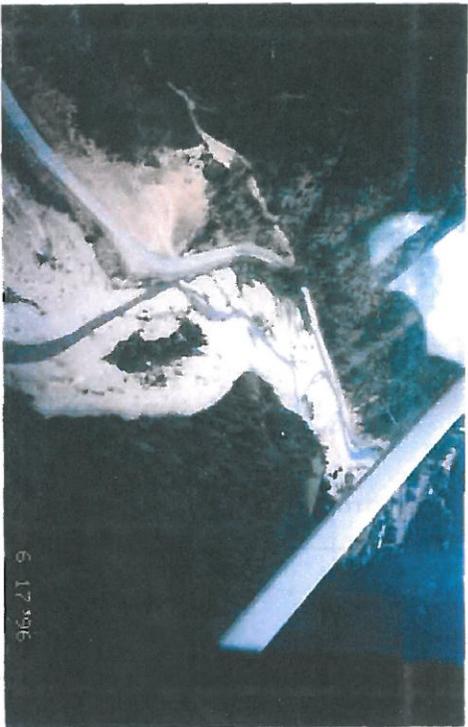
**View upstream along the East Fork to the confluence of Nabob Creek. Channel shifted across active floodplain during the three storm events in Water Year 1996. Remnants of riparian vegetation visible on islands and along margins of channel.**

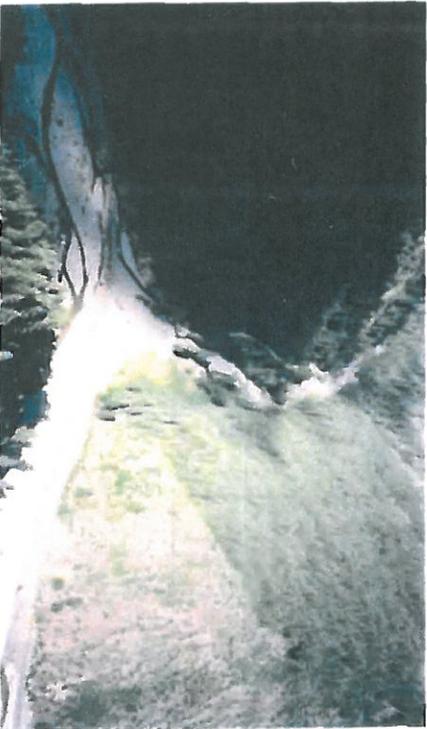
**View of Highland Creek confluence. County Road acted as debris dam after undersized culvert clogged. Creek finally washed out road. Note large amount of stored sediment in creek channel upstream.**

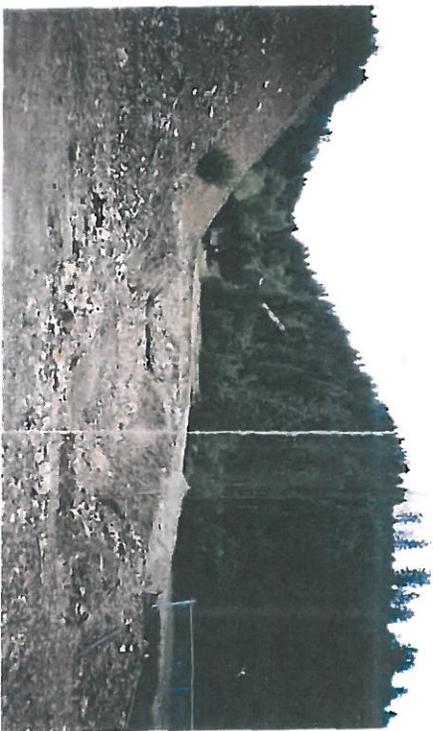
**View of sediment fan at confluence of Nabob Creek. Culvert was clogged by large influx of sediment, and overtopped road.**

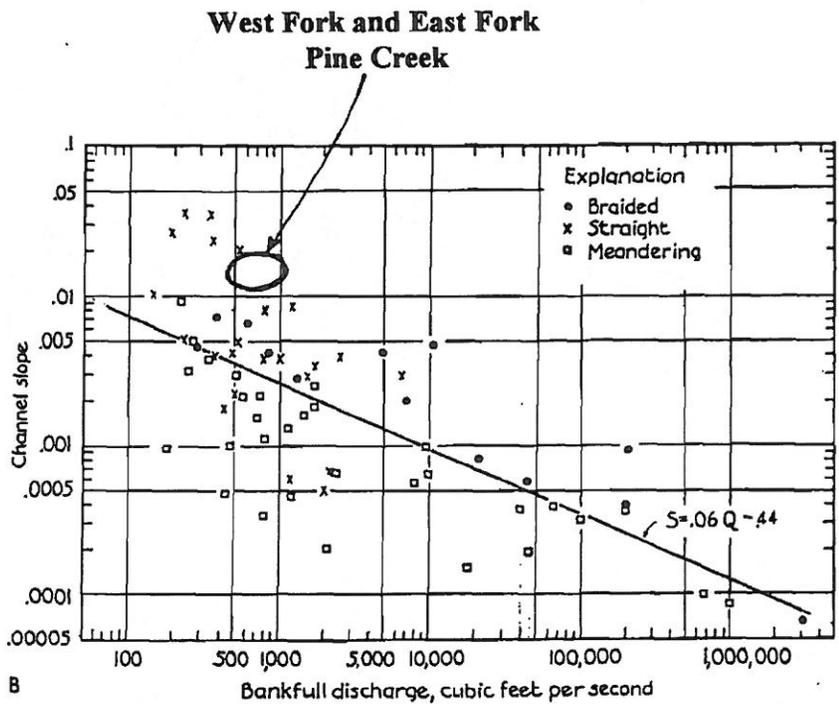
**FIGURE 7**  
**Comparison of Pine Creek with Braided/Meandering Planform Relationship**  
**to Bankfull Discharge after Leopold et al. (1964)**

The gradient of West Fork Pine Creek in its alluvial reach is .015, while the gradient of the East Fork Pine Creek is .017. Although the bankfull discharge is not known, the U.S. Army Corps of Engineers, as reported by HUD (1979), computed the 10-year storm flow for the West Fork as 2255 cfs. Bankfull discharge is commonly found to have a recurrence interval of from 1.5 to 5 years. Based on the COE calculations, bankfull discharge would likely be in the range of 500-1000 cfs. This area is shown on the channel slope versus bankfull discharge from Leopold et al. (1964) above. The West and East Forks plot well into the braided field, indicating that in the absence of bank stabilizing factors such as a dense riparian forest, these channels would likely have a braided pattern.
