Bloomington Canyon Mine Preliminary Assessment Report

Bear Lake County
State of Idaho

Department of Environmental Quality

October 2007

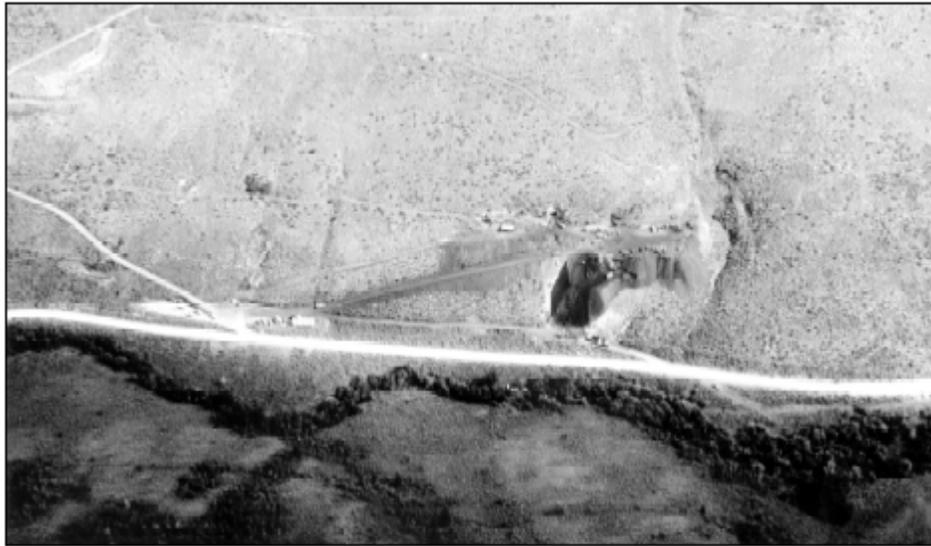
Figure 4. Bloomington Canyon Mine, August 12, 1975, showing 1974 and 1975 tunnels.

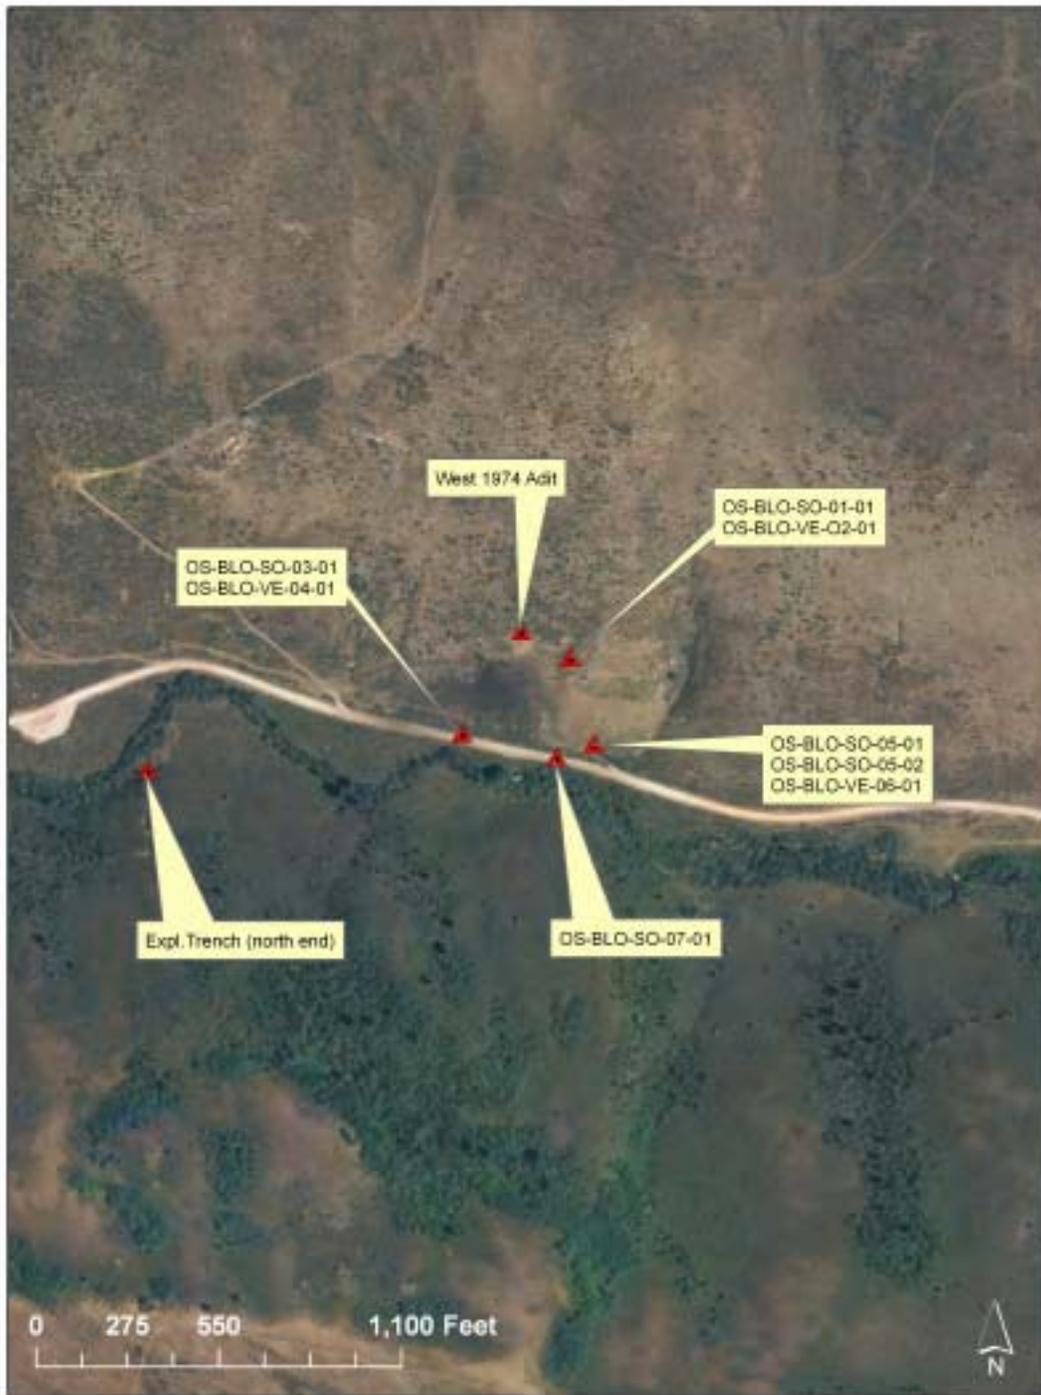
Figure 7, sampling locations at the Bloomington Canyon Mine.

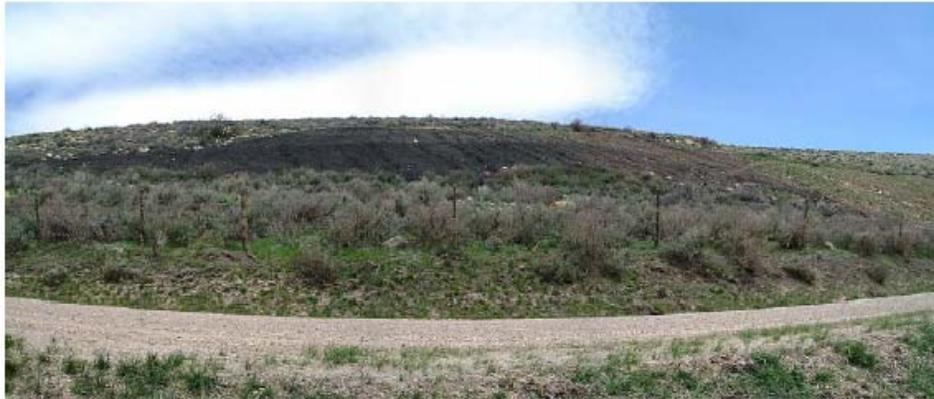
Visual observations from the interagency site inspection in 2002 indicate that the Bloomington Mine was solely an underground operation, consisting mainly of two open declines about 200 feet apart, one large contoured waste dump, and a reclaimed road. Bloomington Creek flows easterly within 200 feet of the waste dump.

The waste dump is large; several hundred feet from east to west and approximately 200 feet north to south. Volume of the waste pile would be approximately 22,000 cubic yards, according to field measurements and approximate measurements from a Google Earth photo. The thickness was estimated to be relatively thin, less than 15 feet deep. The waste dump and access road from the west has been contoured to the slope. The eastern half of the waste dump is moderately vegetated and composed of a mixture of Phosphoria Formation lithologies. The west half of the dump has almost no vegetation and is composed of mainly black shale.

Photo 11.1
Bloomington Canyon Mine. View to north.

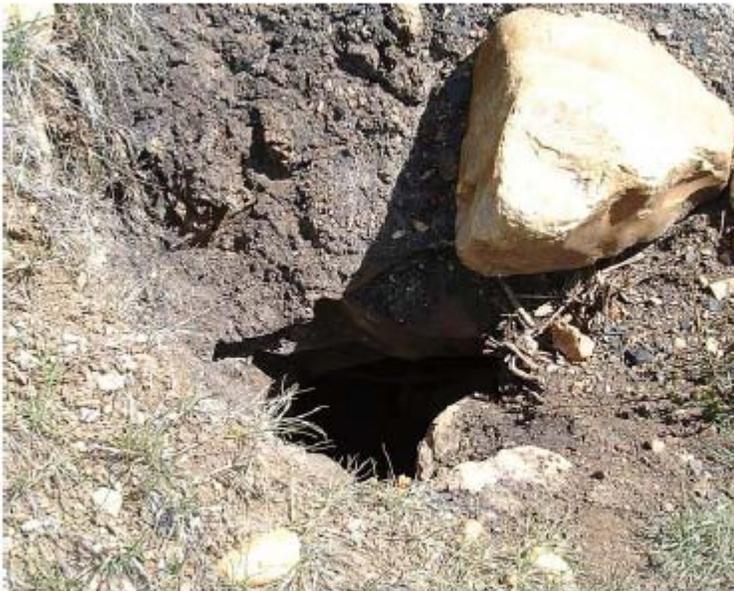
There are three declines at the mine: the centrally located T14S vanadium tunnel, the 1974 tunnel, and the 1975 tunnel. The T14S tunnel has been dozed closed and is no longer evident. At one time, both the 1974 and 1975 tunnels appear to have been closed, however, both tunnels are currently open enough for human entry (DEQ 2002). The openings at the 1974 and 1975 tunnels are approximately 2 feet and 4 feet in circumference respectively.

Photo 11.2
Bloomington Canyon Mine, 1974 Tunnel opening. View to north.

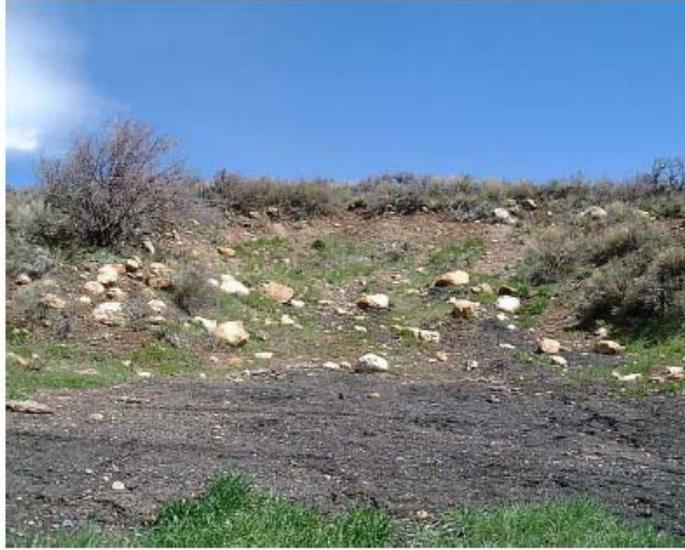
Photo 11.3
Bloomington Canyon Mine, T14S (Wyodak) Tunnel dozed closed. View to north.

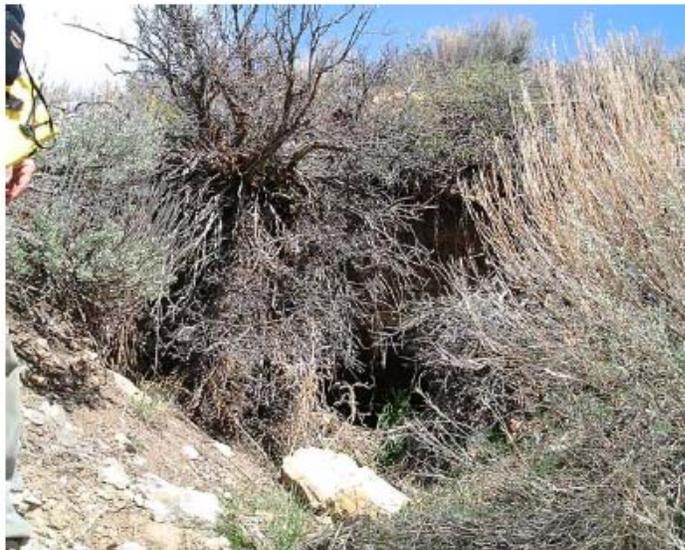
Photo 11.4
Bloomington Canyon Mine, 1975 Tunnel opening. View to north.

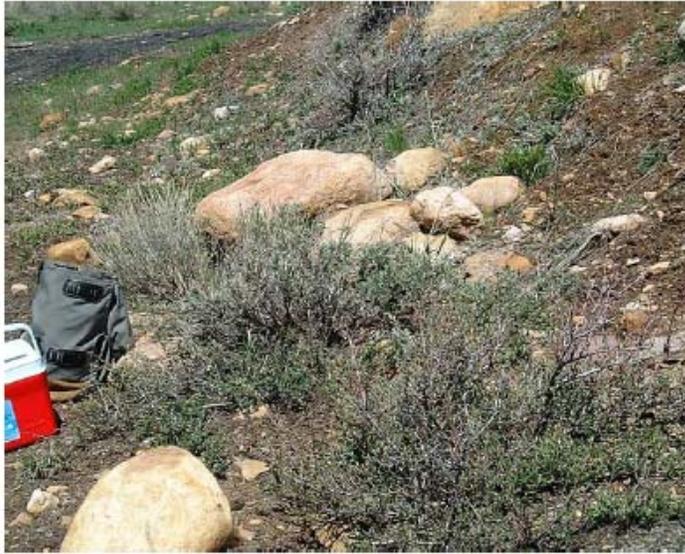
- The first sample, designated OS-BLO-SO-01-01 (Appendix Photo 10.5), was taken from the top of the dump. The sample was composed of about 70% black shale and 30% tan sandstone and limestone. The vegetation sample collected from the same location (OS-BLO-VE-02-01) was of bitterbrush.

Samples OS-BLO-SO-01-01(soil) and OS-BLO-VE 02-01 (vegetation) were collected for the top of the waste pile. The soil sample showed elevated concentrations of cadmium (Cd), chromium (Cr), nickel (Ni), selenium (Se), vanadium (V), and zinc (Zn). The vegetation sample consisting of Bitter Brush, which showed slightly elevated concentrations of Selenium.

Photo 11.5
Bloomington Canyon Mine, sample location for OS-BLO-SO-01-01 and OS-BLO-VE-01-01.
View to west.

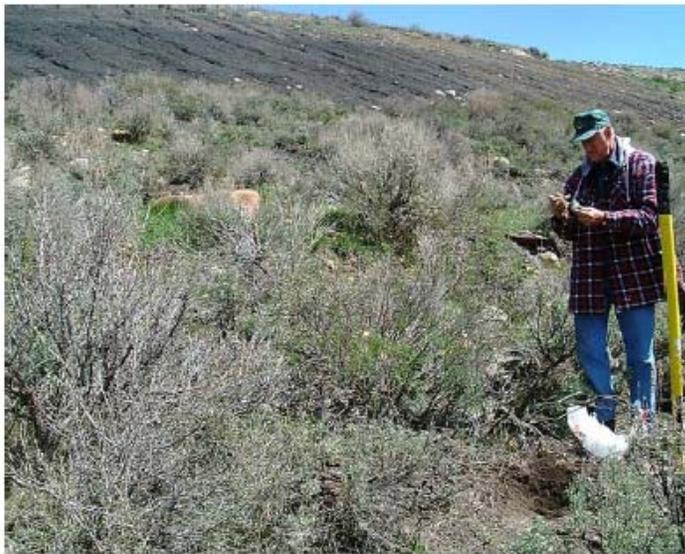
- Samples OS-BLO-SO-03-01 and OS-BLO-VE-04-01 were taken southwest of the dump, between the berm and Bloomington Canyon Road. The area was highly vegetated with sagebrush. The soil sample was composed of brown, dry “fluffy” , organic soil with about 10% rounded gravel. Western Yarrow was collected for the vegetation sample.

Samples OS-BLO-SO-03-01 and OS-BLE-VE-04-01 were collected southwest of the waste pile and between the berm and Bloomington Canyon Road. Analytical results from the soil samples show that all metal concentrations were below Area Wide Risk Criteria (AWRC). Metal concentrations in the vegetation sample (Western Yarrow) were also below AWRC.

Most of the area has been strongly eroded. A stone and earth berm separates the waste dump from the Bloomington Canyon Road. Erosion of black shale washing over the berm and onto the road is evident.

Photo 11.6
Bloomington Canyon Mine, sample location for OS-BLO-SO-03-01 and OS-BLO-VE-04-01.
Erosion of black shale at the top of photo. View to northeast

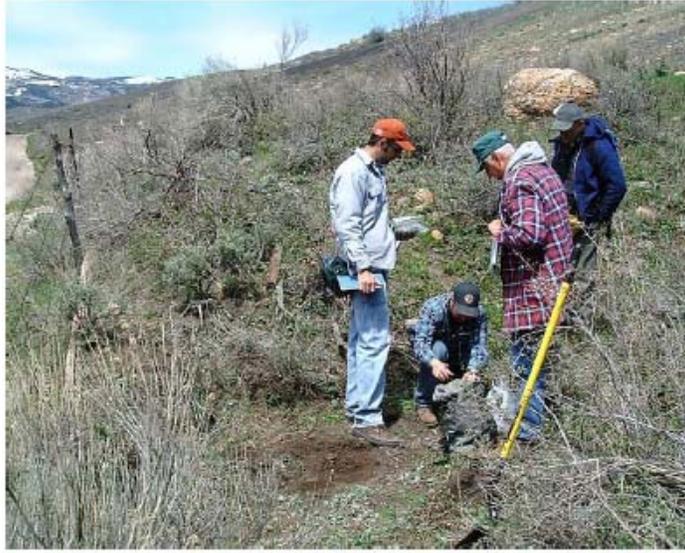
Photo 11.7

- The next two samples were collected in the drainage east of the waste dump and below the berm. The soil sample, OS-BLO-SO-05-01, was composed of 30% brown soil, 20% brown clay and 50% well rounded carbonate gravel. A duplicate sample, OS-BLO-SO-05-02, was also collected. Wild Geranium was collected as vegetation sample OS-BLO-SO-06-01.

Bloomington Canyon Mine, sample location for OS-BLO-SO-05-01 and OS-BLO-VE-06-01. Bloomington Canyon road on left side of photo. View to west.

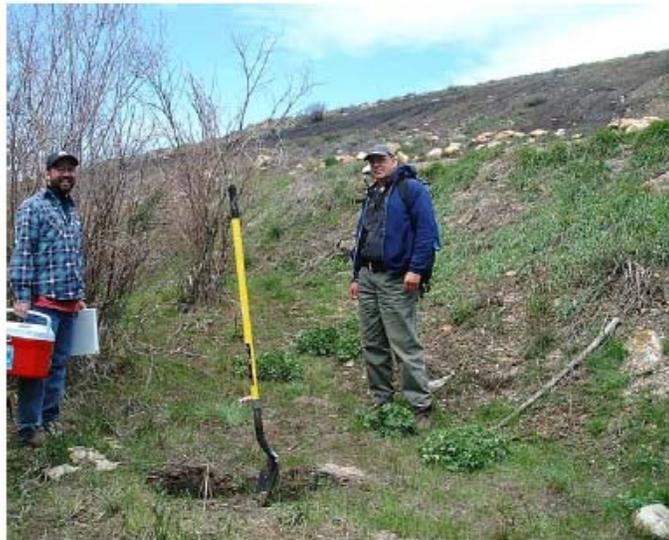
Photo 11.8

- The final sample was a soil sample taken from across the road at the mouth of the culvert approximately 30 feet north of the stream edge. The soil sample, OS-BLO-SO-07-01, was composed of dark brown to black, highly organic, clay rich soil. Analytical results are presented in Table 2.

Bloomington Canyon Mine, Sample location for OS-BLO-SO-07-01. Sample in Bloomington Creek flood plain. View to northwest.
