# **Star Mine Preliminary Assessment Report**

Blaine County  
State of Idaho

**Department of Environmental Quality**

December 2006

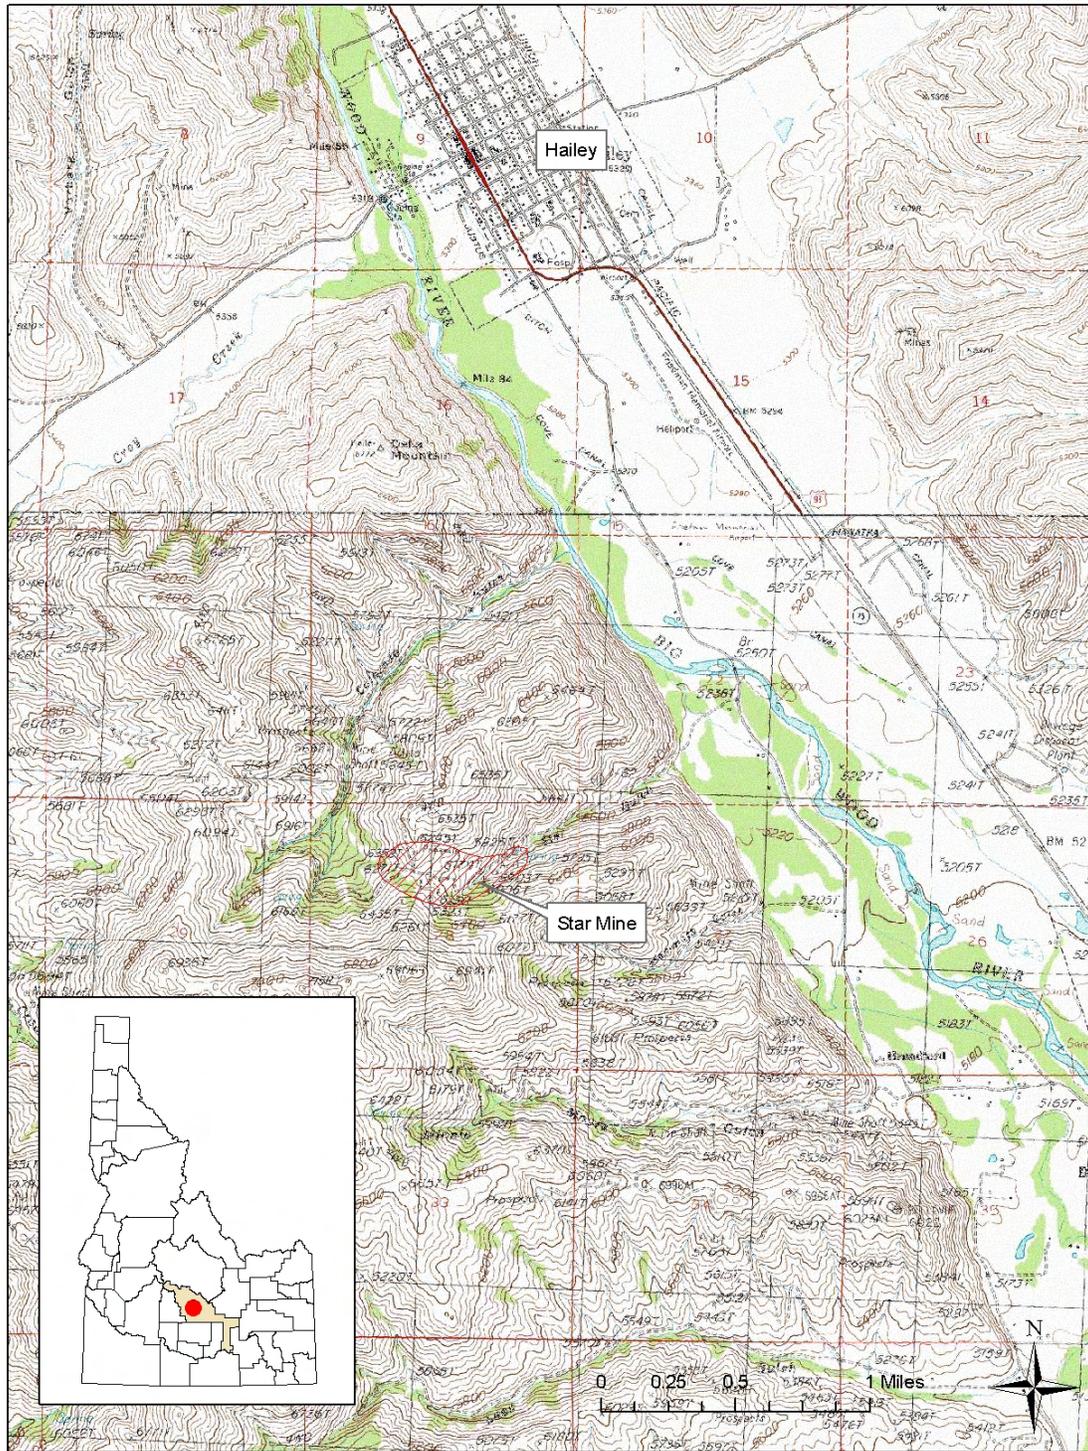
The general location of the mines is identified in Figure 1. The closest town to the mining site is Hailey, which is approximately two miles by air and four miles by road. Figure 2 shows the topography around the site, and Figure 3 presents an aerial view.

Figure 2. Topographic overview of the Star Mine area.

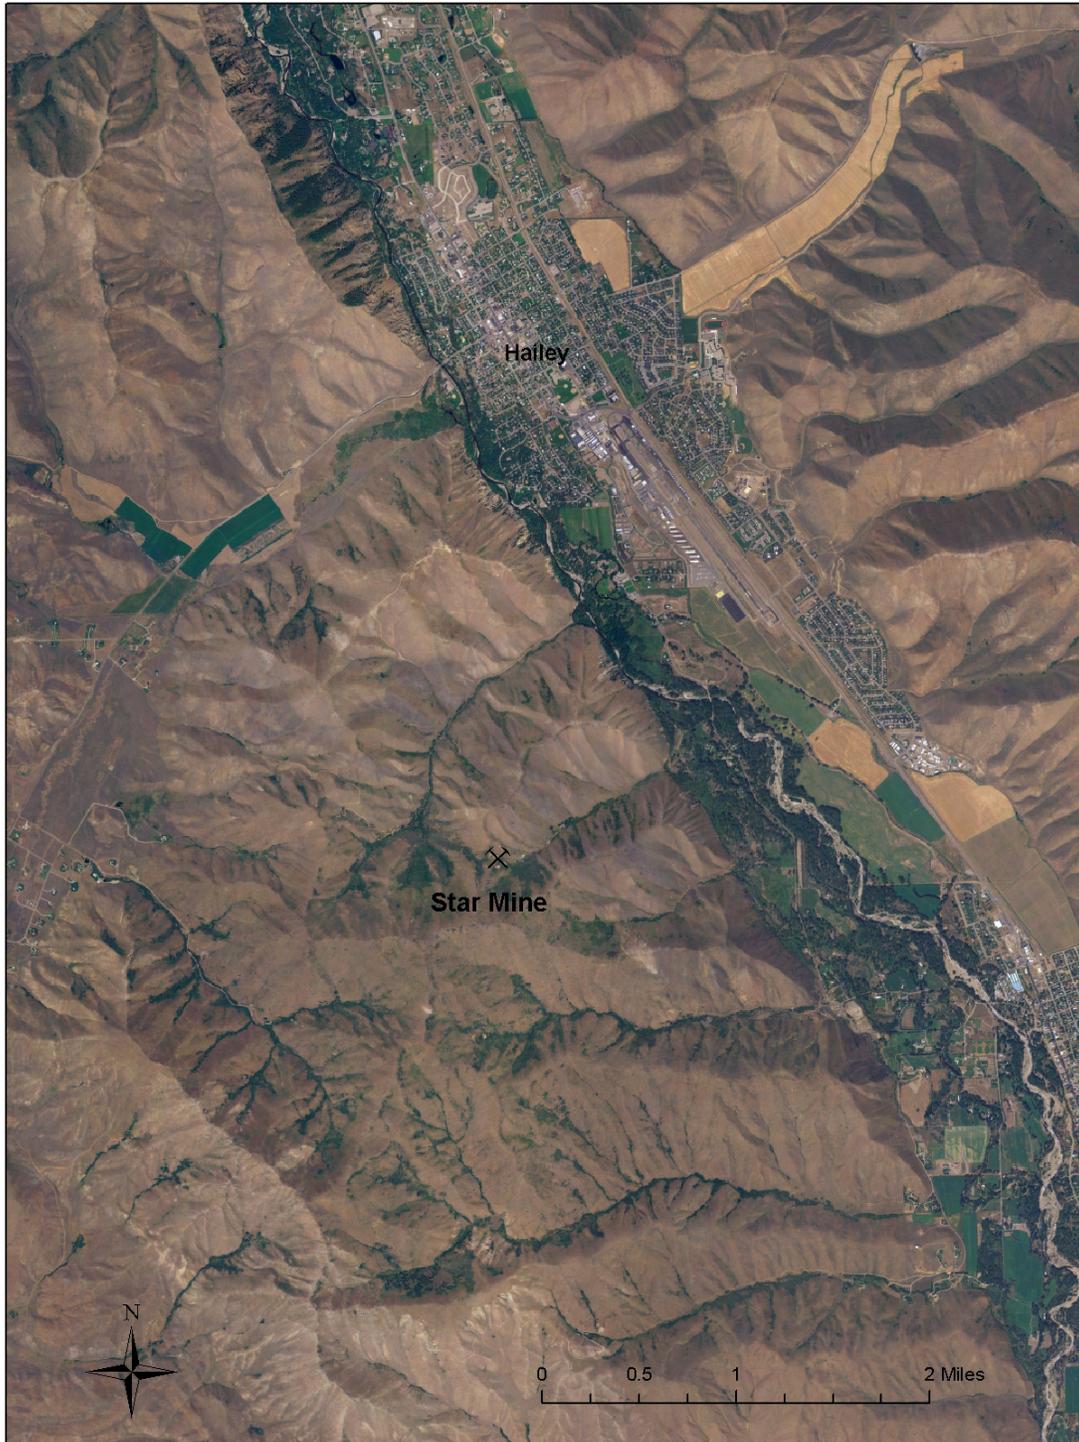
Figure 3. Aerial photograph of the Star Mine area.

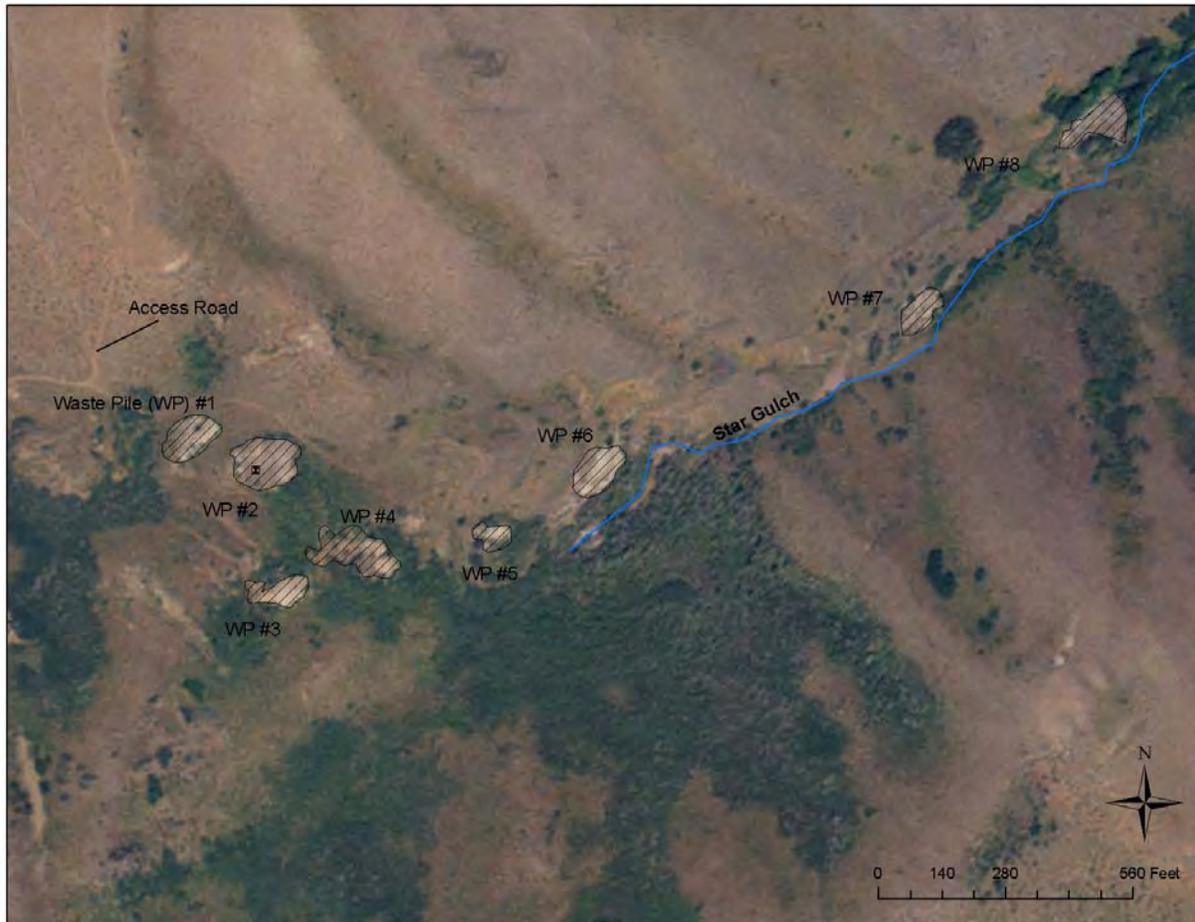
Figure 4. Aerial photograph of the Star Mine.

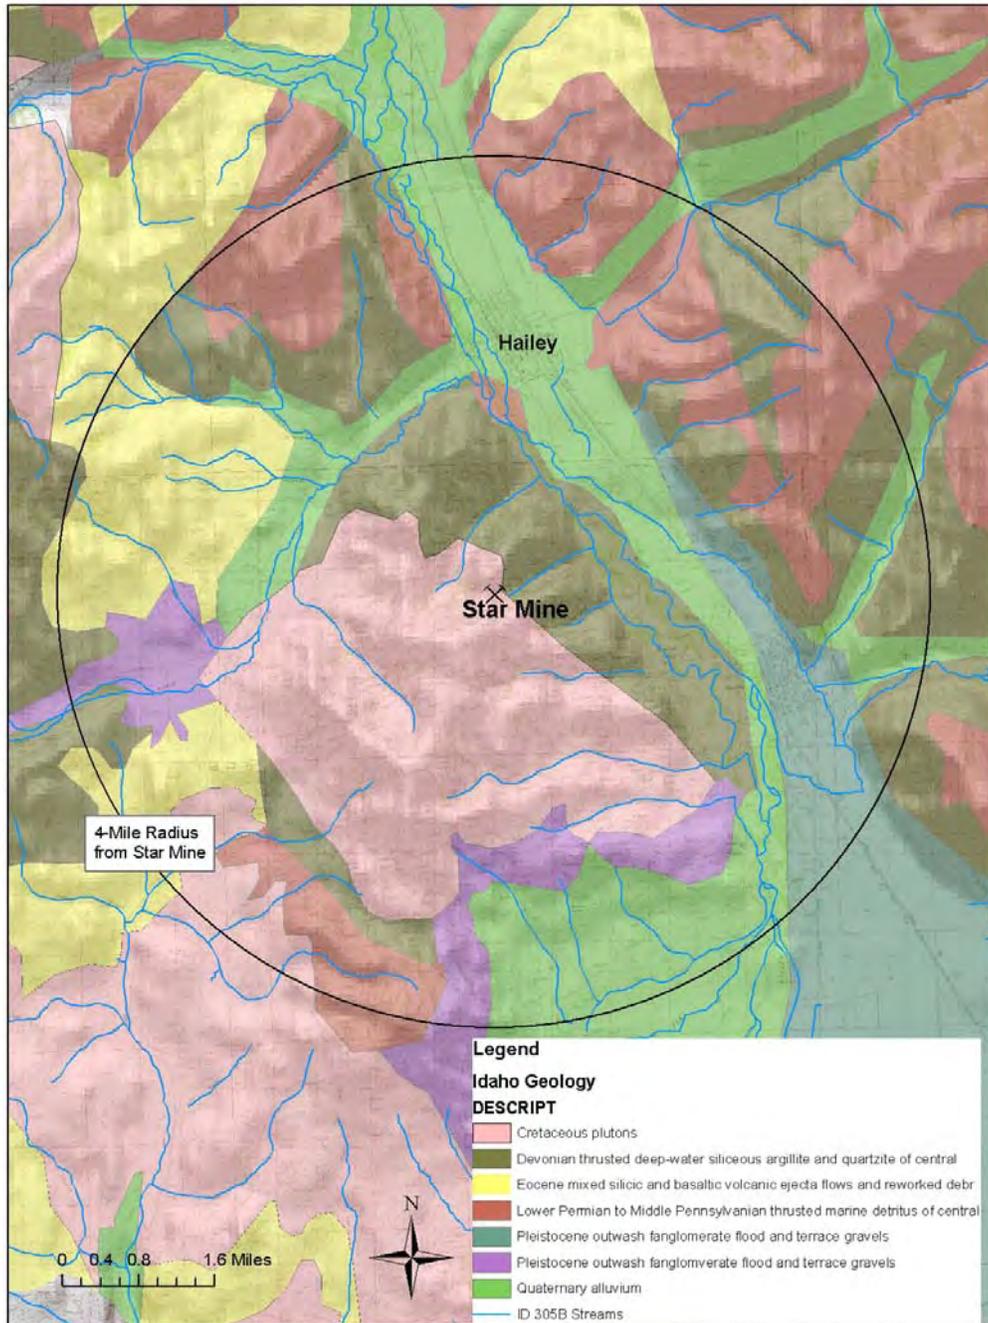
The general geology of the area, depicted in Figure 5, was described by Anderson (1950, p2) who described the geology of the site:

Figure 5. Geologic map of the Star Mine area.

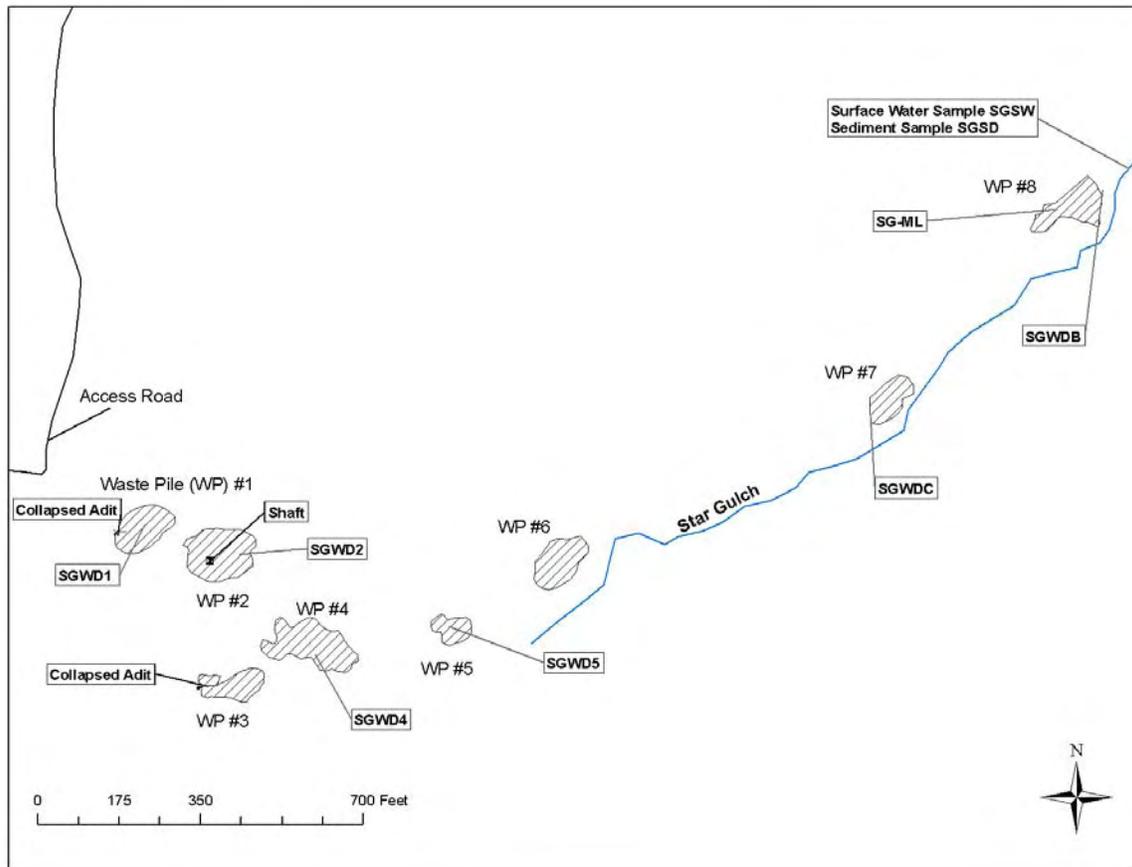
DEQ conducted a site visit on July 11, 2006, which included a visual inspection of the Star Mine and collection of one (1) water sample and eight (8) soil and sediment samples from the sampling locations shown in Figure 6. The samples were designated as shown.

Figure 6. Small scale sketch of the Star Mine and environmental sampling locations.

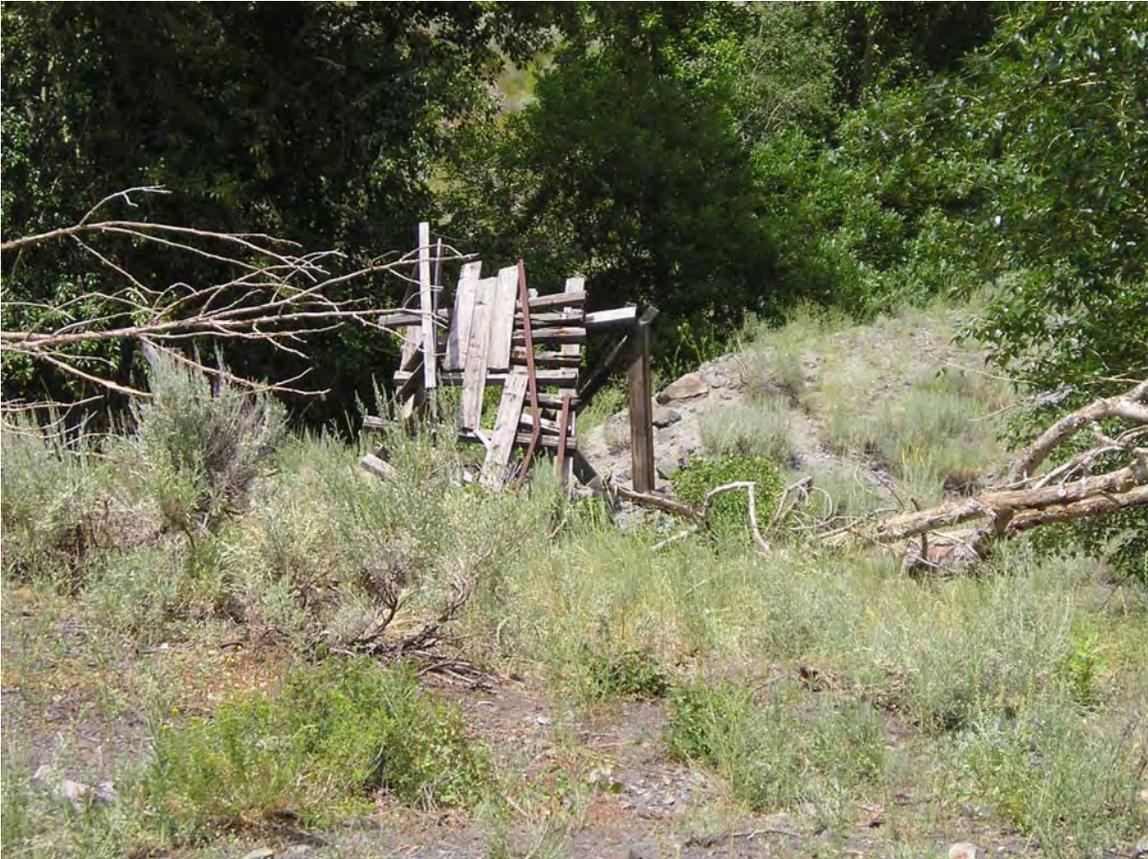
DEQ also mapped the volume of the mine waste piles within the Star Gulch drainage at approximately 50,000 cubic yards (cy). The Star Mine waste piles are located above the flowing portion of Star Creek. The mine operated on the northeast side of Star Creek, on mostly open south-facing slopes, which allowed DEQ personnel the ability to make good observations and assessments. Associated with the mine are significant waste piles that can be seen throughout the upper portions of the drainage. All former structures at the site have been reduced to scattered rubble (Photo 1).

**Photo 1. Remnants of a structure at the bottom of Star Gulch, looking east, down the drainage.**

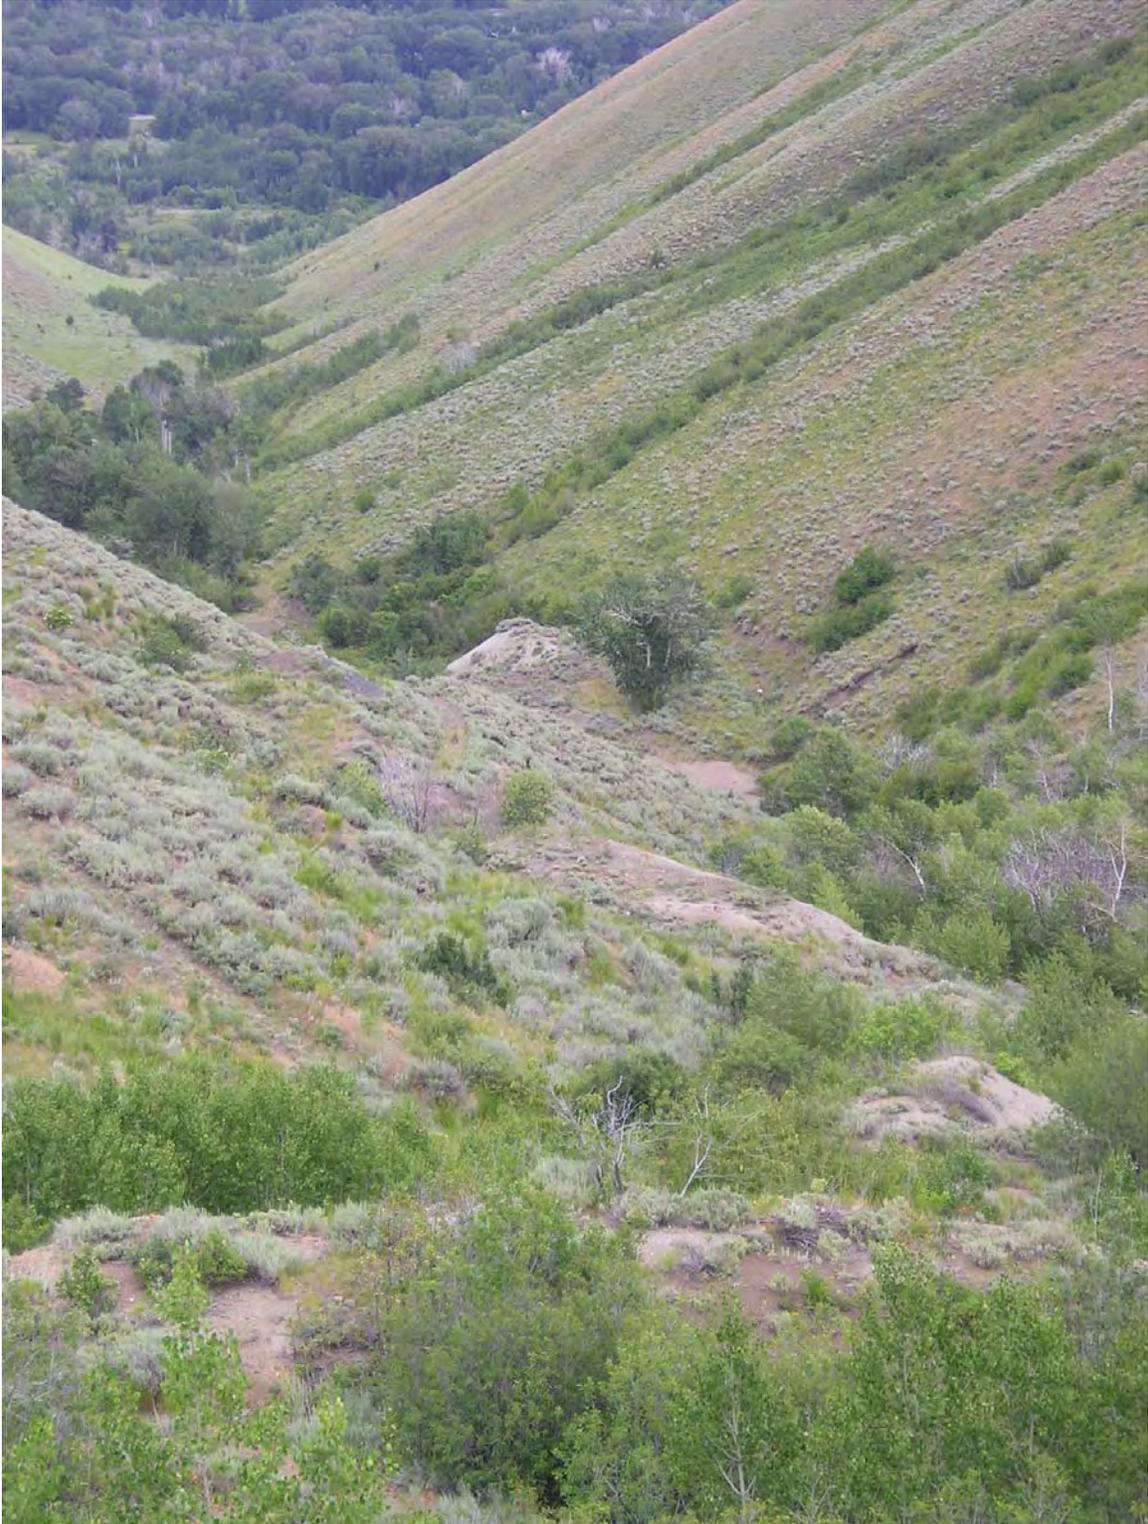
The Star Mine has eight significant waste piles that were inspected during the DEQ site visit (Photo 2). The waste piles were arbitrarily named Waste Pile #1 through Waste Pile #, 8 in the order in which they were mapped (Figure 6). The eight waste piles exist on steep slopes of approximately 15 percent.

**Photo 2. View looking east down Star Gulch. Multiple waste piles can be seen scattered throughout the drainage.**

The Waste piles are composed of variable-sized grains, ranging from 3-5 mm in diameter to large boulders, with the majority of the material having a fairly uniform grain size. The

waste pile materials have weathered from a light gray to a reddish brown. Almost no vegetation has reclaimed the site except the occasional bunches of grass and sagebrush (Photo 2 and Photo 3).

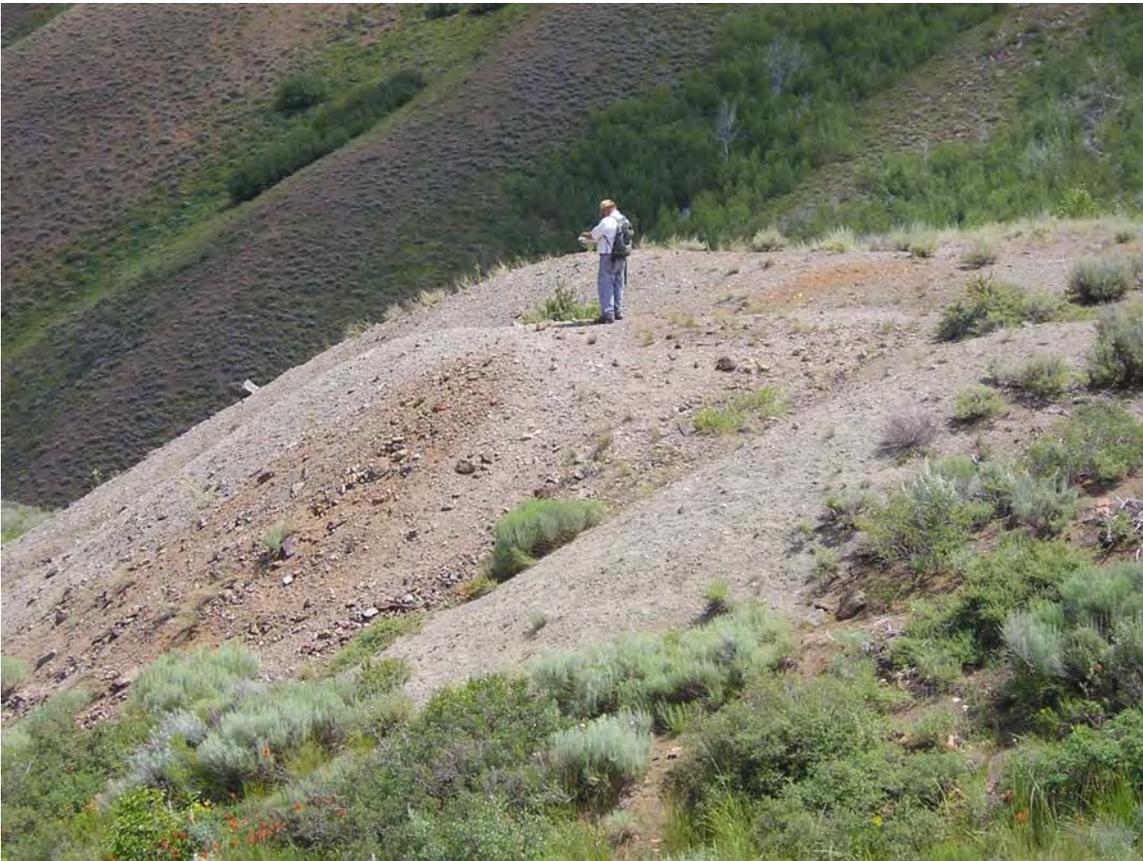
Waste Pile #2 is located to the southeast of Waste Pile #1 on the same south-facing hillslope. It measures approximately 60 feet long, 100 feet wide, and 30 feet thick (Photo 3). An old road has been cross-cut through the waste pile that joins Waste Pile #1. The remnants of a shaft were seen in the central portion of this pile.

**Photo 3. View of Waste Pile #2, looking south from Waste Pile #1.**

Soil sample SGWD2 was collected on the top of Waste Pile #2. The sampling technique used to collect the sample was similar to the one used for Waste Pile #1: a composite sample across the top of the dump approximately 2 inches below the surface. No surface water was observed to be flowing on or across Waste Pile #2 during the site visit. The composition and color of Waste Pile #2 was very similar to that of Waste Pile #1. In addition, Waste Pile #2 also has not yet been reclaimed by a healthy stand of native vegetation.

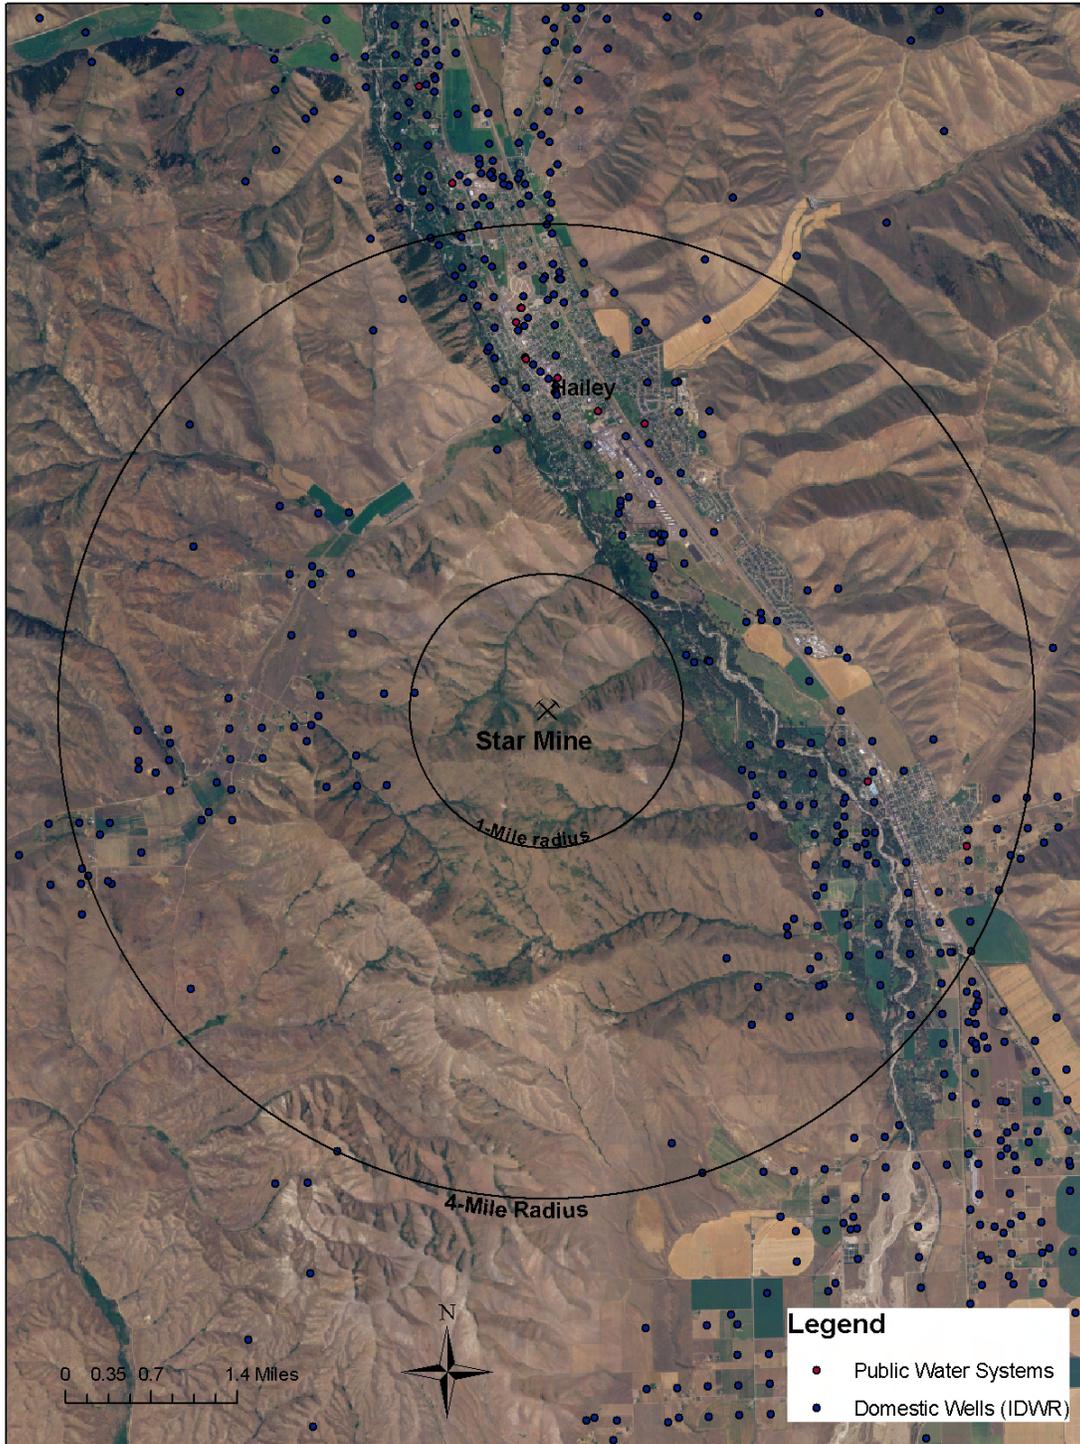
Figure 7. Domestic wells and Public Water System wells located with a four-mile radius of the Star Mine.

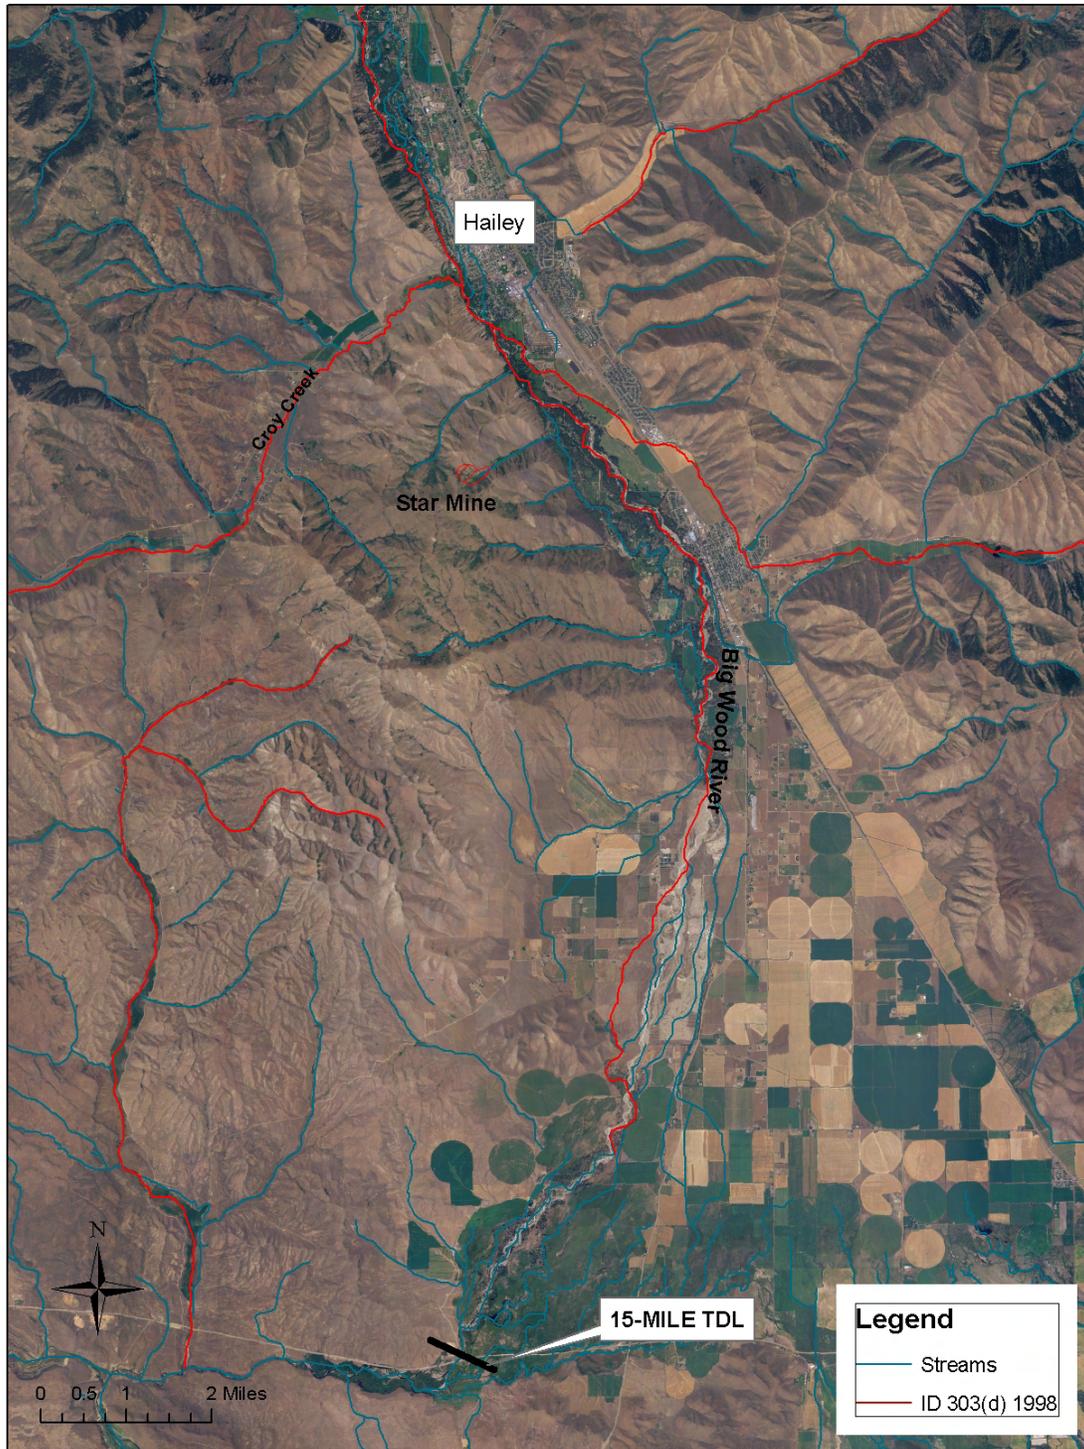
Figure 8 depicts the drainage patterns of these water bodies as well as the 15-mile downstream *Target Distance Limit* (TDL) located on the Big Wood River.

Figure 8. Surface water 15-mile Target Distance Limit from the Preliminary Assessment Site.
