Subject: Site Assessment of the Campbell Mine, Pierce Mining District,
Clearwater County, Idaho

ABBREVIATED PRELIMINARY ASSESSMENT

Site Name: Campbell Mine

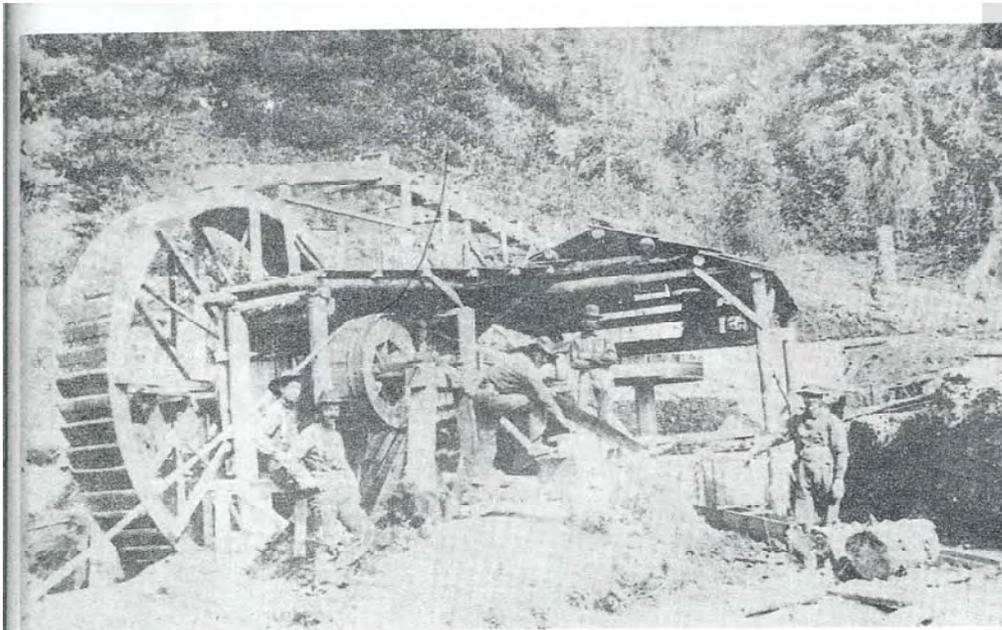
Arrastre for crushing ore; on Silver Creek near Pierce (Idaho Historical Society Photo)

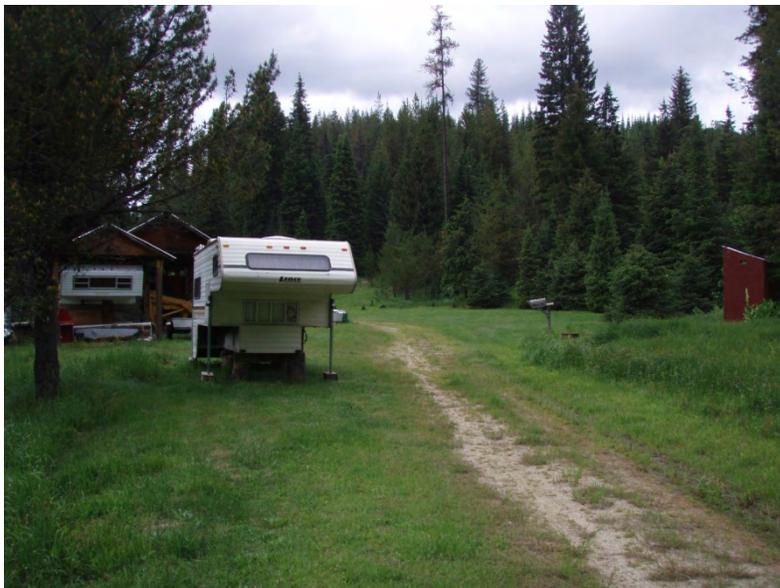
Photo 2. Campers, fifth wheel trailers, and house trailers under snow sheds.

Although there is little mining development at the Campbell Mine, a recreational home site area has been developed for part-time/seasonal residents of campers, fifth wheel trailers, and house trailers under snow sheds. The owners were supposed to join DEQ on the site visit, but were unavailable due to a family emergency.

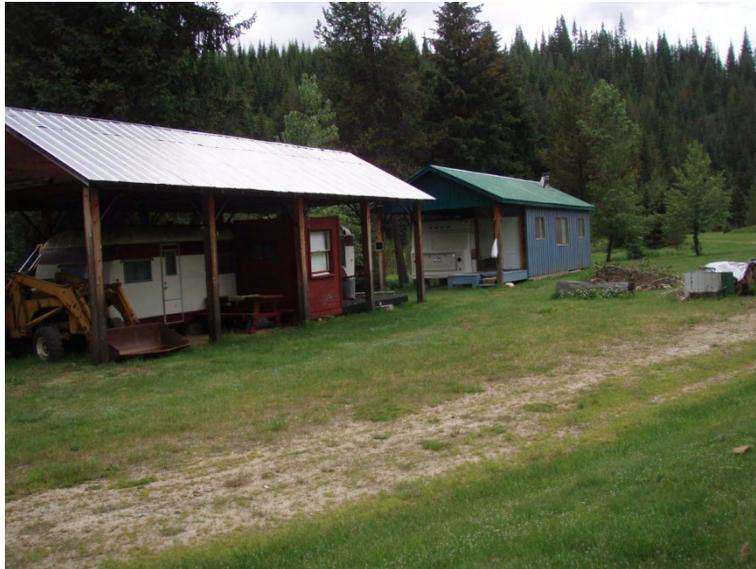
Photo 3. Trailer homes at Campbell Mine camp site.

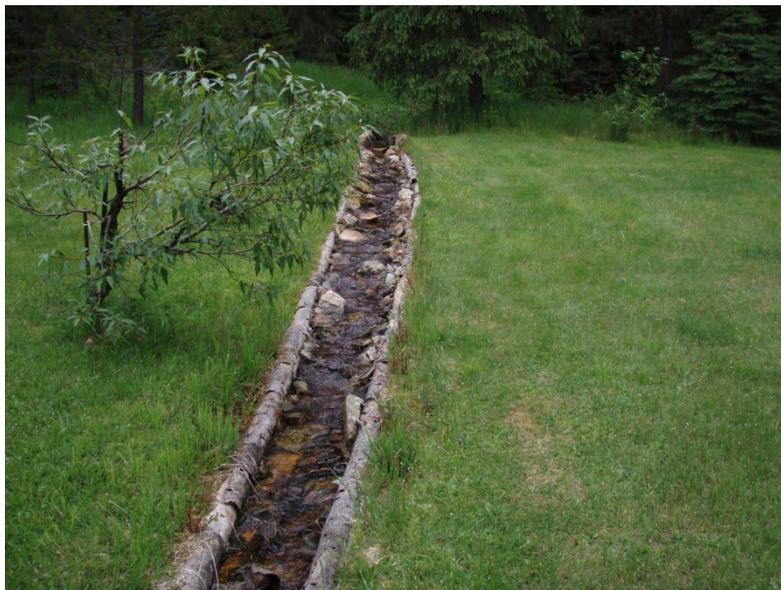
Photo 4. Aesthetic drain ditch at Campbell Camp site.

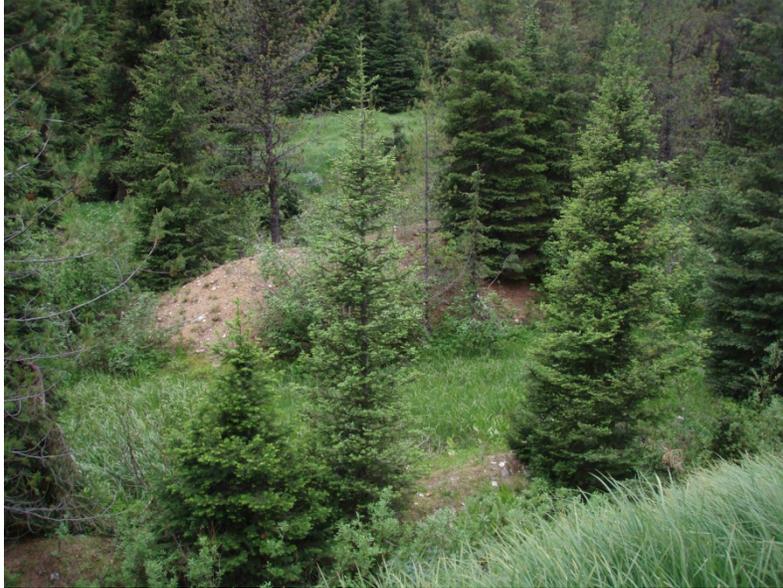
Photo 5. Historic placer piles at Campbell Mine downstream of the home sites along Silver Creek.

Only a couple hundred yards of placer tailings (gravels) were visible from the Silver Creek Road (private) although the morphology of the channel and surrounding ground suggests there may have been a lot more.

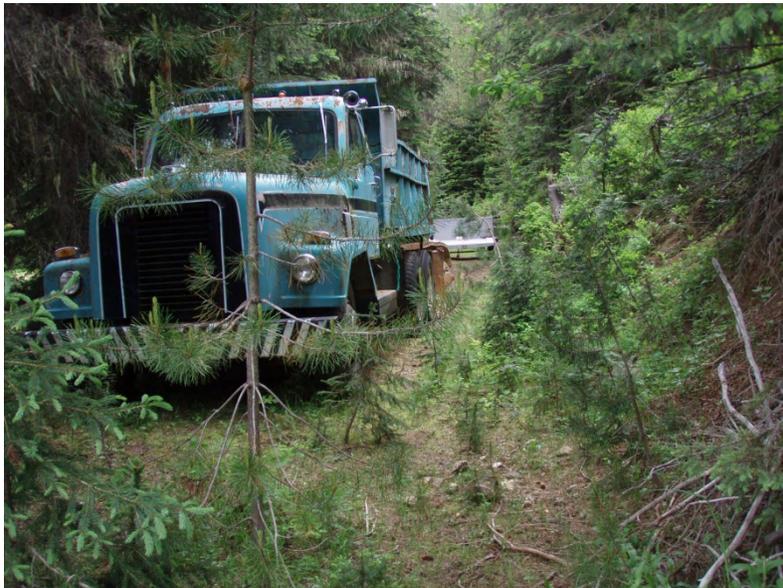
Photo 6. Campbell Mine equipment yard.

The Campbell Mine has a small bench or staging area with some equipment including a 12 yard dump truck, bull dozer, and equipment shed. Although the equipment and materials do not appear to have been used for some time, there was no evidence of petrochemical spills, hazardous waste, or other issues here.

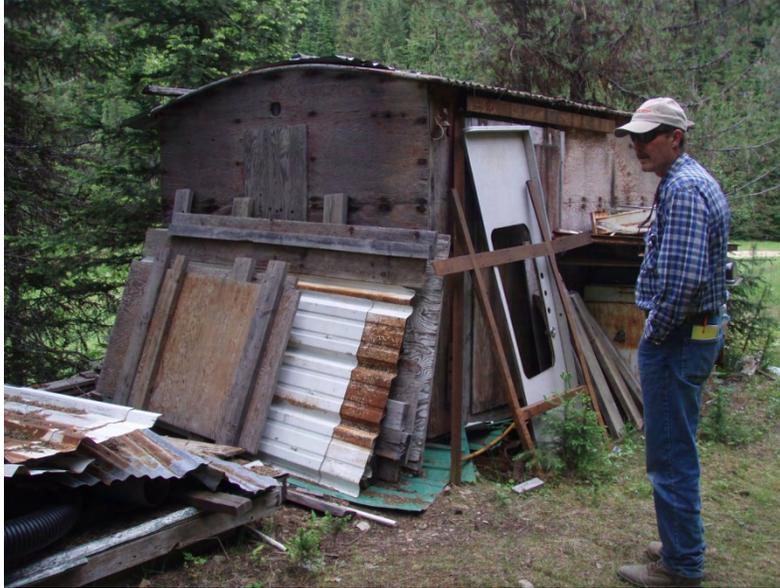
Photo 7. Campbell Mine equipment shed.

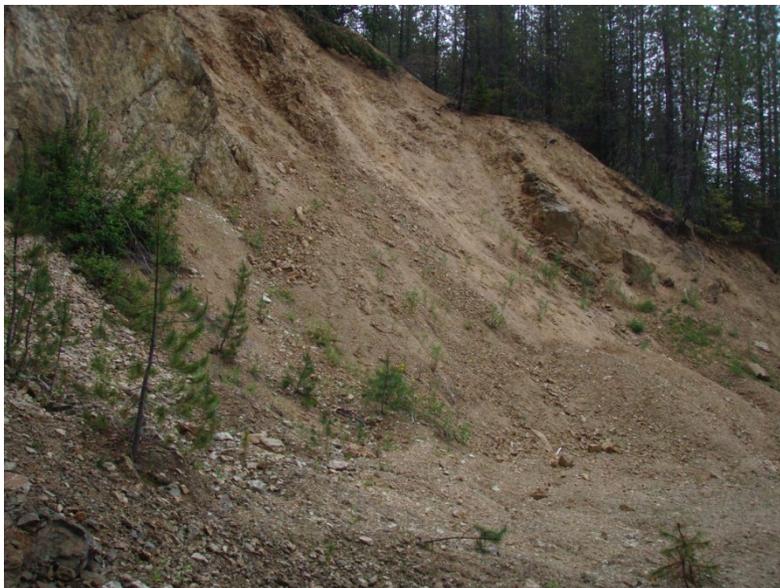
Photo 8. Campbell Mine Pit above camp on east side of creek. No pathways to Silver Creek are evident. Latitude 46.59275°N, Longitude -115.65160°W

There are two very small pits located at the Campbell Mine neither of which exceeds a 1,000 yards of production. Neither has a significant waste dump adjoining them. There are no indications of major erosional features or delivery of mine waste to the nearby Silver Creek. Most of the ore may have been removed for processing offsite. According to personal communication with Mrs. Cathy Halen, a shaft was on site but has been closed for many years.

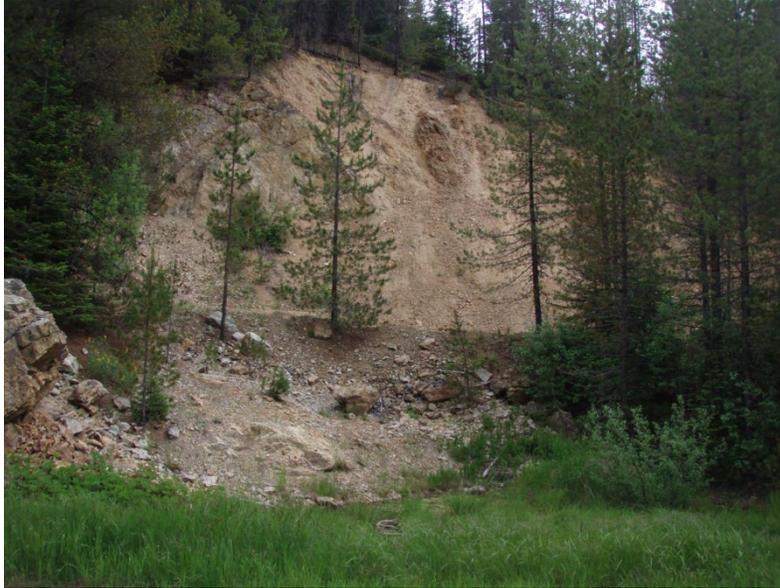
Photo 9. Campbell Mine Pit above camp and on the other side of the access road away from Silver Creek.

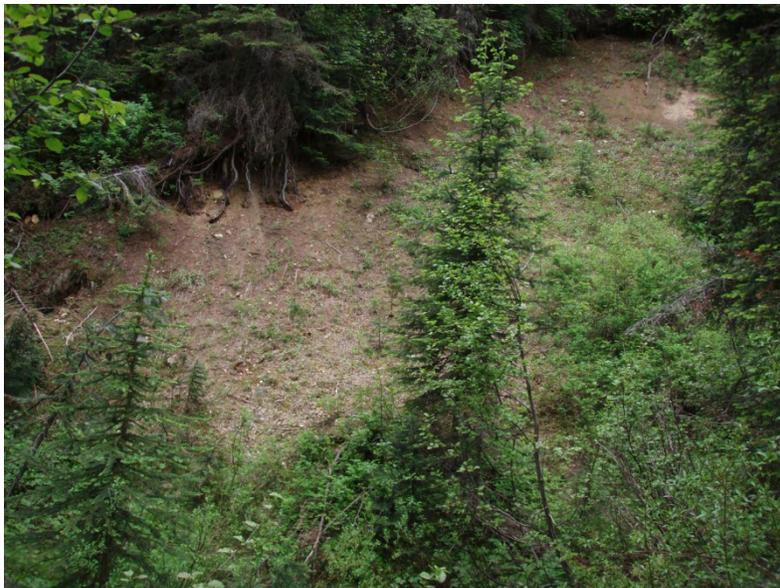
Photo 10. Upper Campbell Mine Pit on west side of creek (across creek). No pathways to Silver Creek are evident.
Latitude 46.59349°N, Longitude -115.6522°W

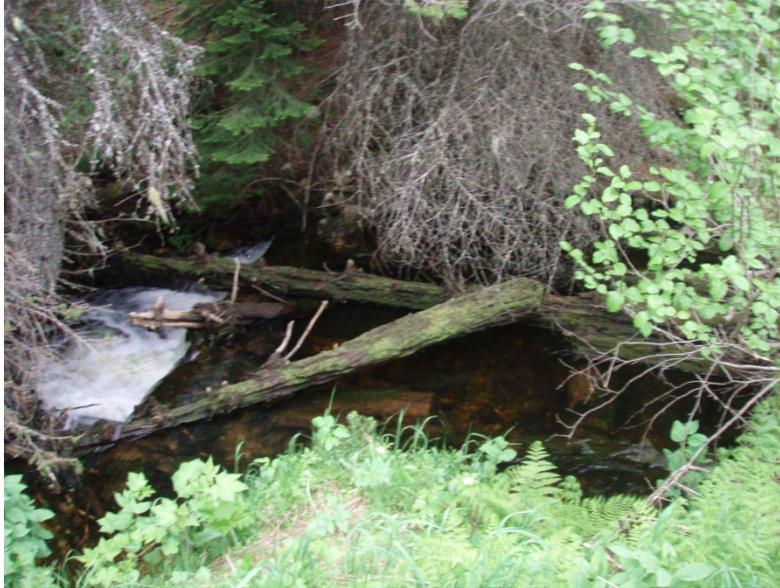
Photo 11. Campbell Mine; remnants of wooden dam or possibly of the Silver Creek arrastra.

From an historical perspective, the site may have significant interesting characteristics. While examining the stream channel for influences by or releases from the mine areas, DEQ located the remnants of a timbered dam. This is located above the mine site(s) on Silver Creek and most likely provided the hydraulics for placer operations below. On a personal note, the Campbell Family Trust property (Campbell Mine Site) is a very beautiful spot, extremely well maintained, and kept up.

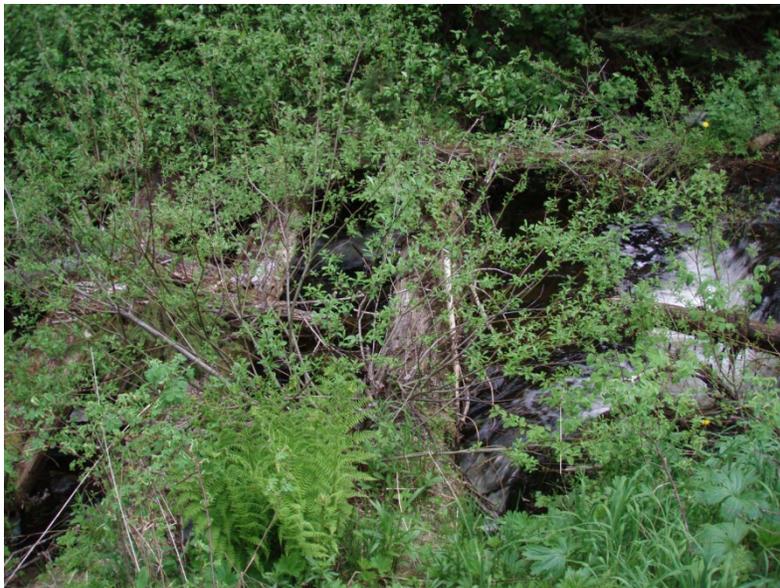
Photo 12. Campbell Mine Dam remnants or possibly of the Silver Creek arrastra.

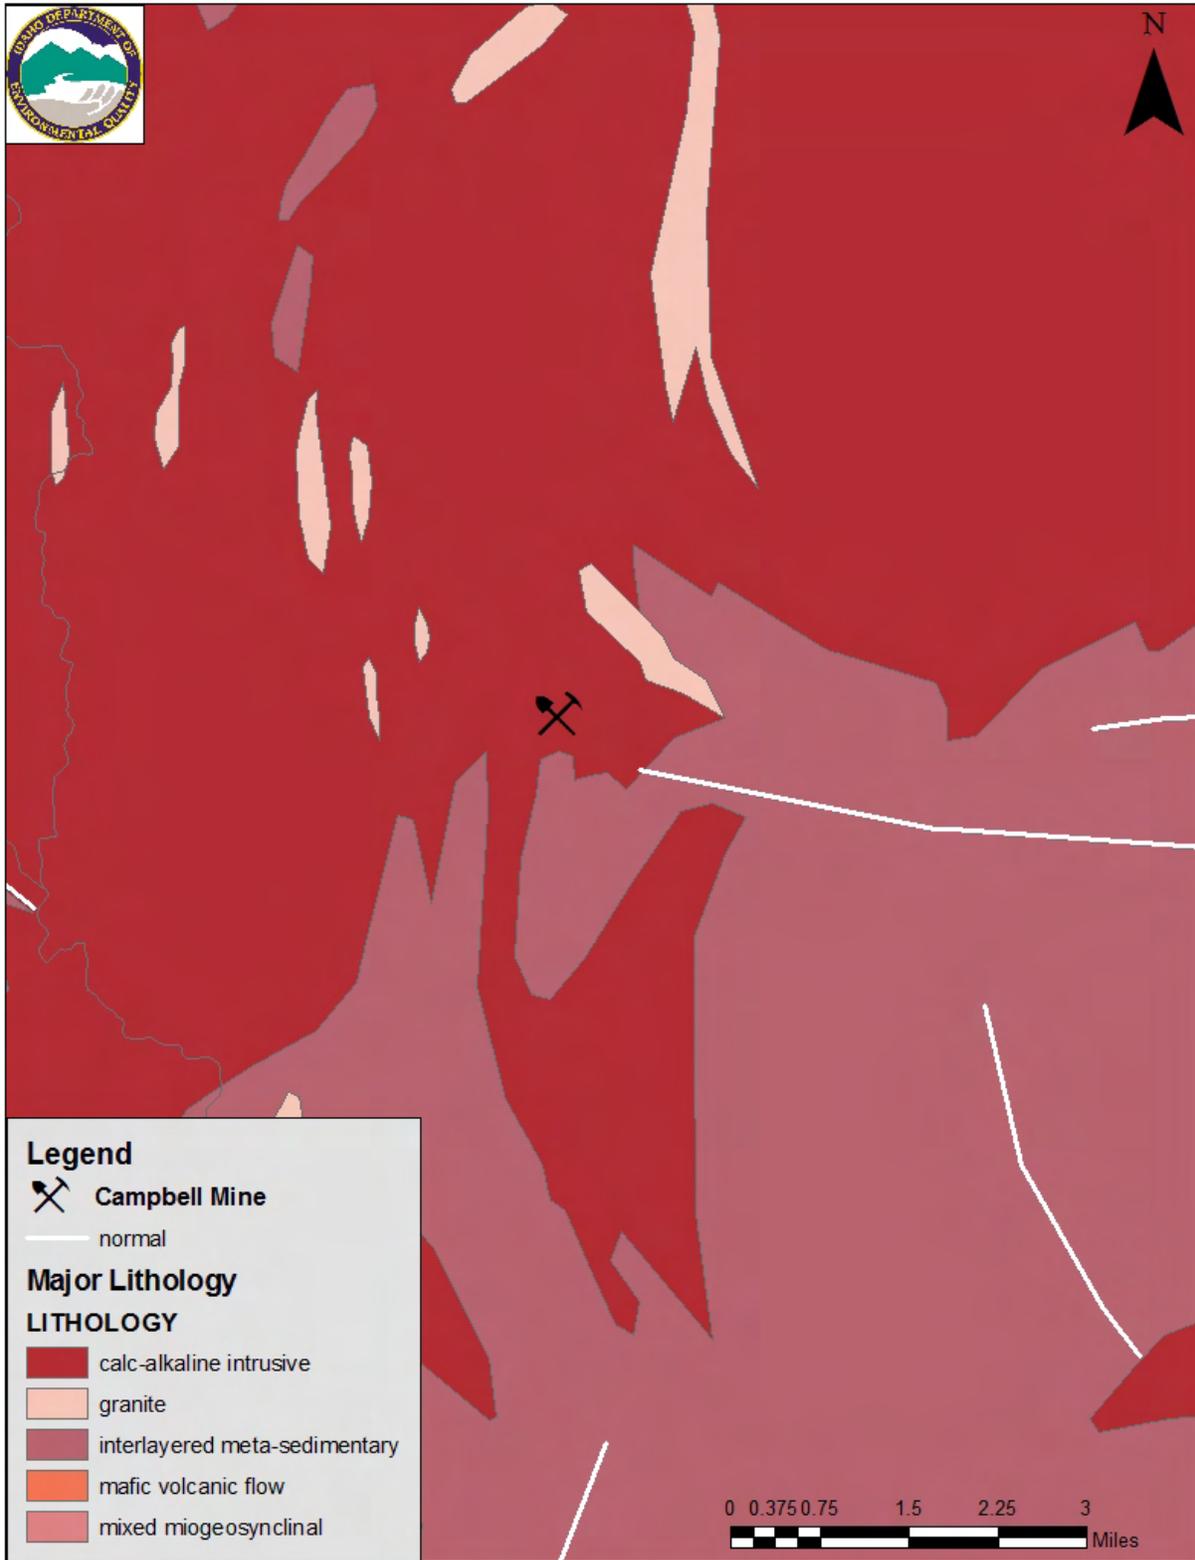
Figure 2. Major Lithology of the Campbell Mine and Surrounding Area
 (Map Sources: SDE Feature Class, USGS 1995; Idaho DEQ GIS ArcSDE 9.2 Geodatabase)

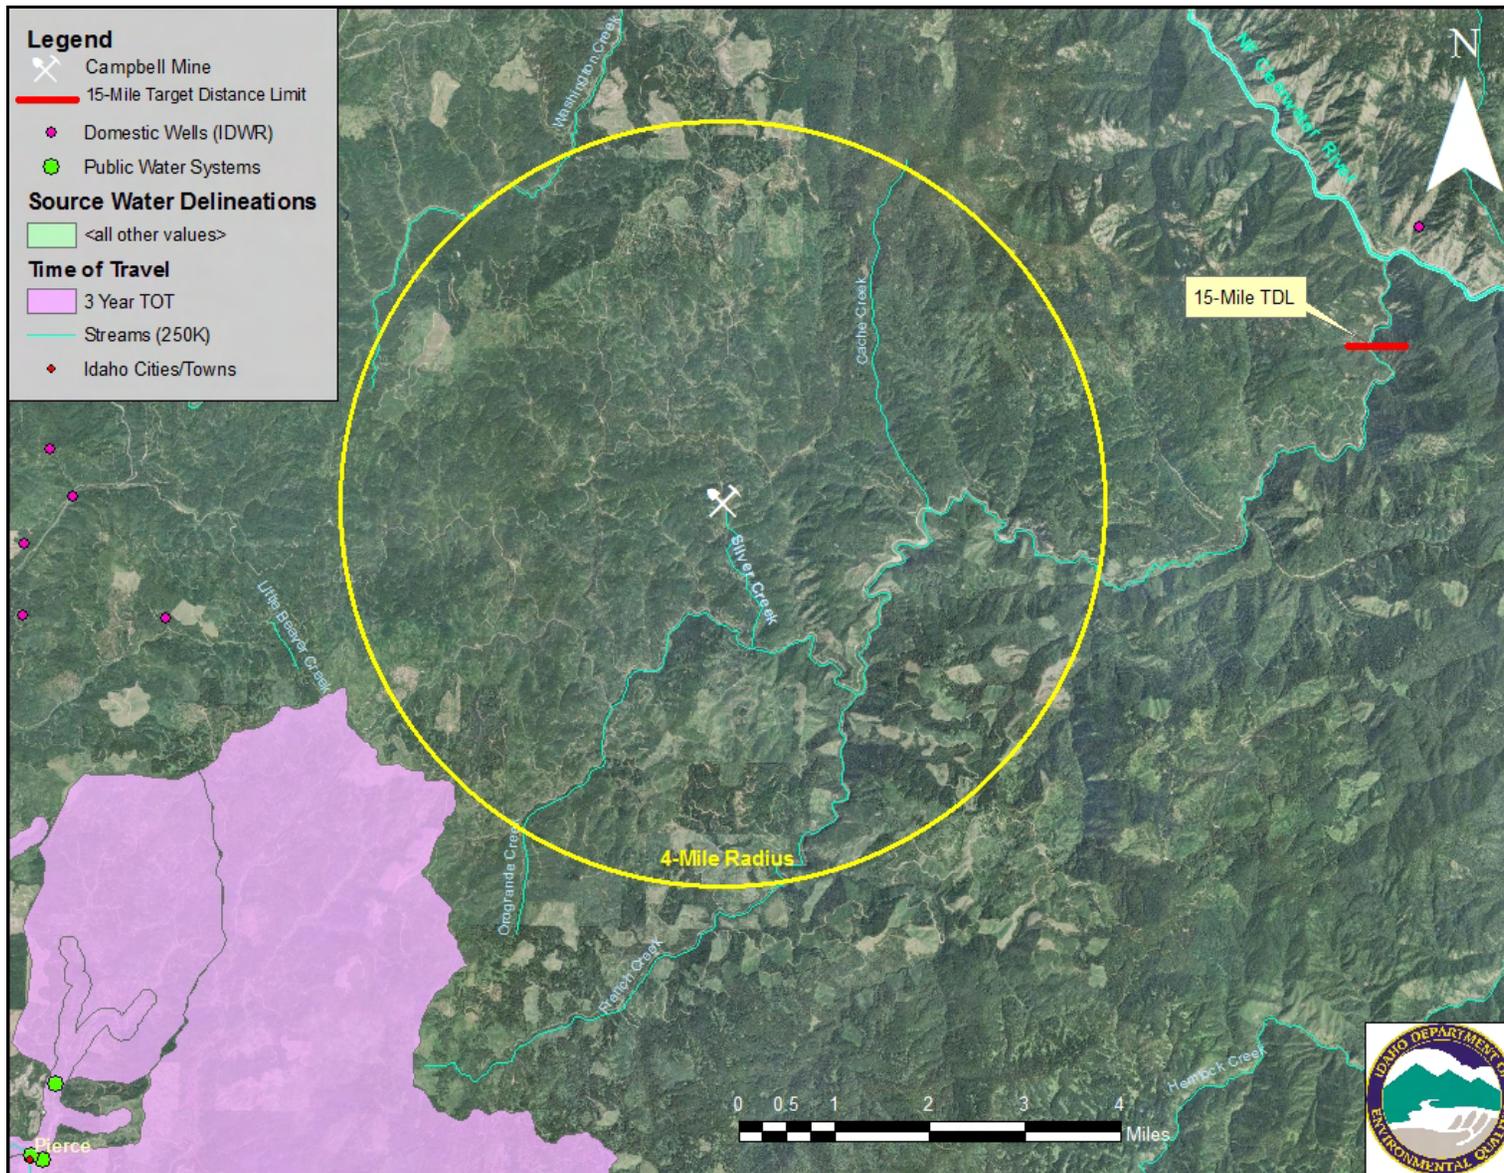
Figure 3. There are no domestic well locations or Public Water Systems within the four mile radius, 15 mile target distance limit (TDL). There are no significant wetlands within a two mile radius or in the general area. (Map Source: 2004 National Agriculture Imagery Program (NAIP))

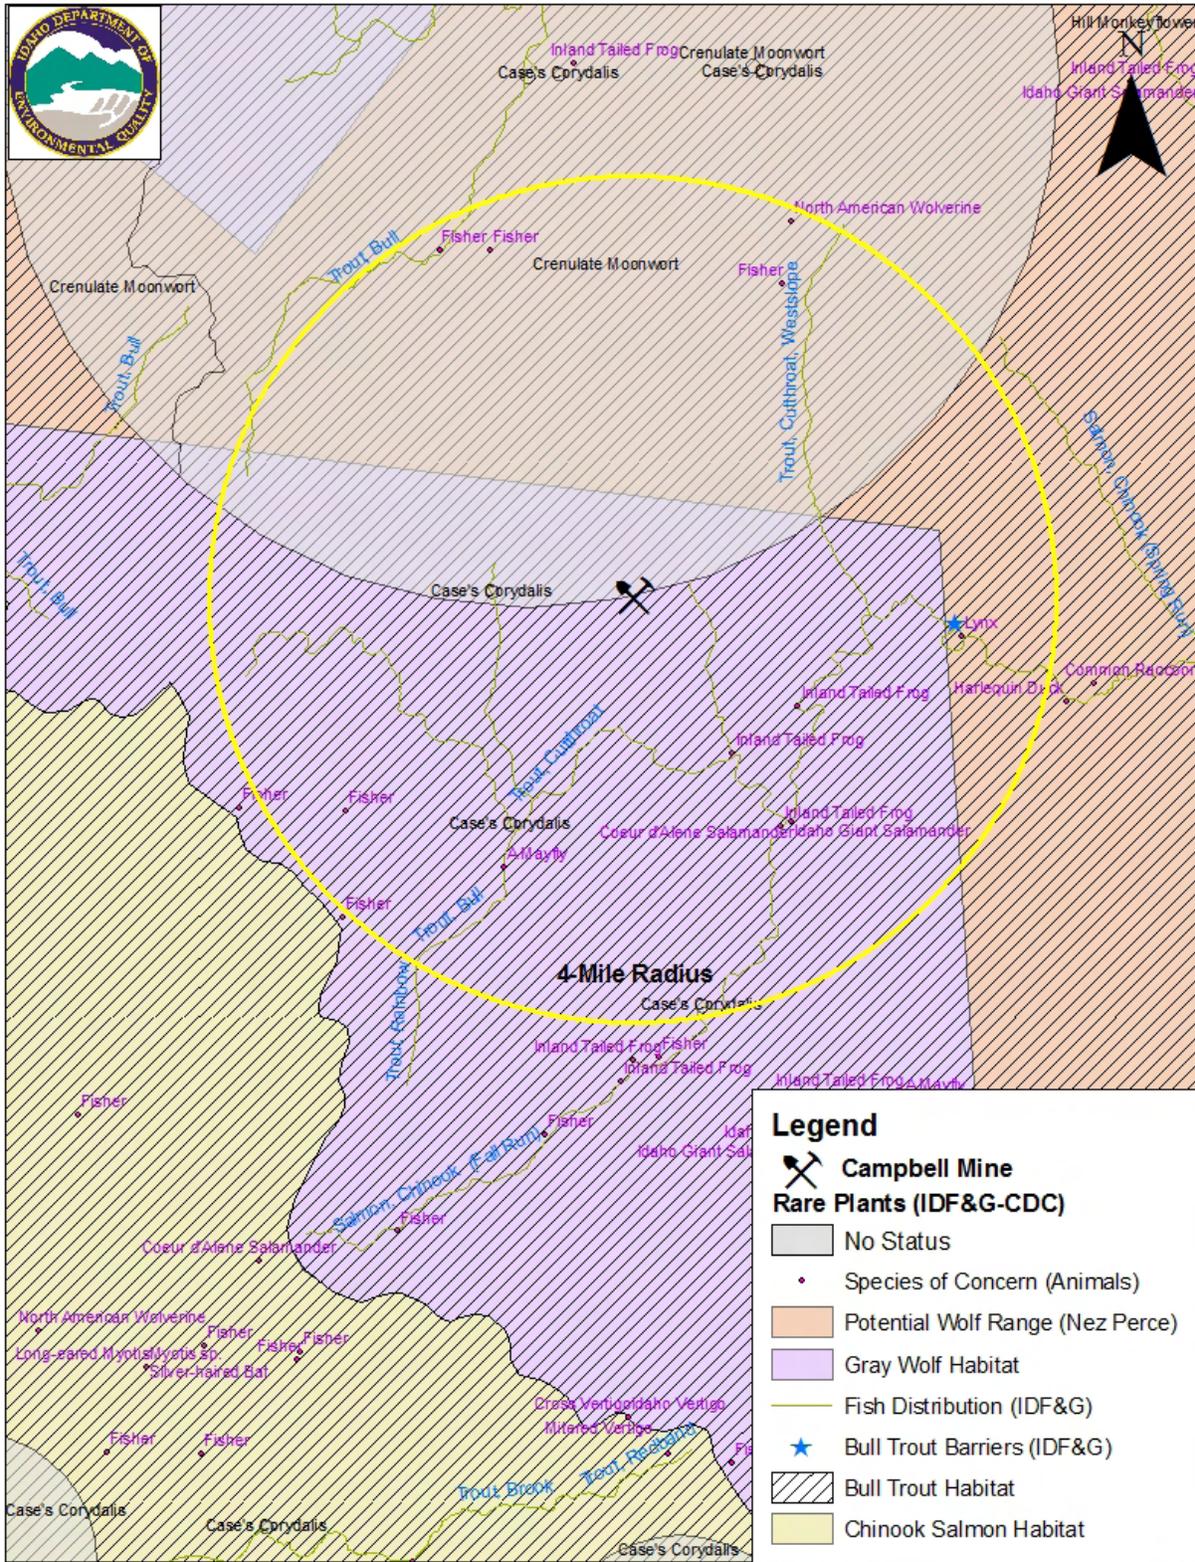
Figure 4. Sensitive species within four mile radius and surrounding area. Species of Concern: Non-Game Animals and Plants. Fisheries within four mile radius and surrounding area. (Map Source: SDE Feature Dataset, Animal Conservation Database. Idaho DEQ GIS ArcSDE 9.2 Geodatabase)

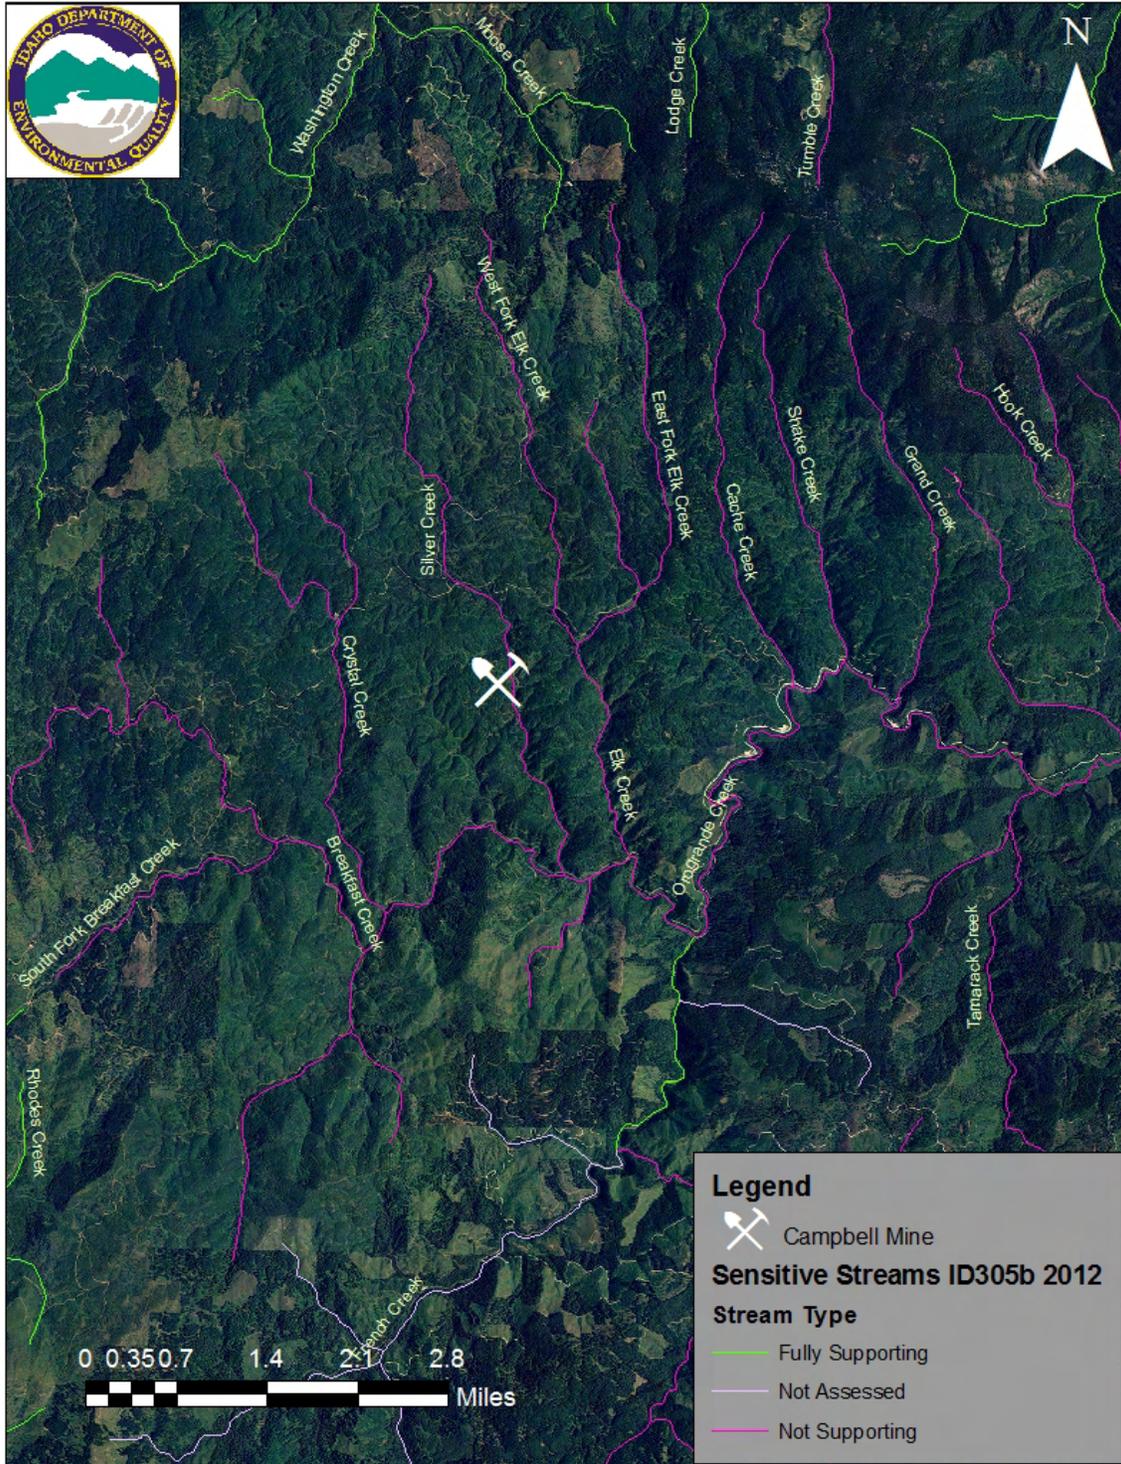
Figure 5. Sensitive Streams Located in the Vicinity of the Campbell Mine.
 (Map Source: IDEQ.GIS.ArcSDE 9.3 Geodatabase, NAIP 2004).

Silver Creek (Water body ID 17060307CL006_02) and Orogrande Creek (Water body ID17060307CL006_03) are listed on the State of Idaho 303(d) list for impaired waters. They are listed as not supporting salmonid spawning due to temperature. The Clean Water Act (CWA) requires the state to prepare a report, listing (a) the current conditions of all state waters and (b) those waters that are impaired and needing a TMDL (total maximum daily load). The first list is called the 305(b) list and the second is called the 303(d) list. Both lists are named in accordance with the sections of the CWA where they are defined; together they are known as the Integrated Report. Although they are maintained as separate lists and presented separately in the Integrated Report, impaired waters are just some of the state’s waters, so water on the 303(d) list is actually a subset of those on the 305(b) list.
