# Monitoring Update: USGS Monitoring Efforts 2009 - 2014

U.S. Department of the Interior  
U.S. Geological Survey

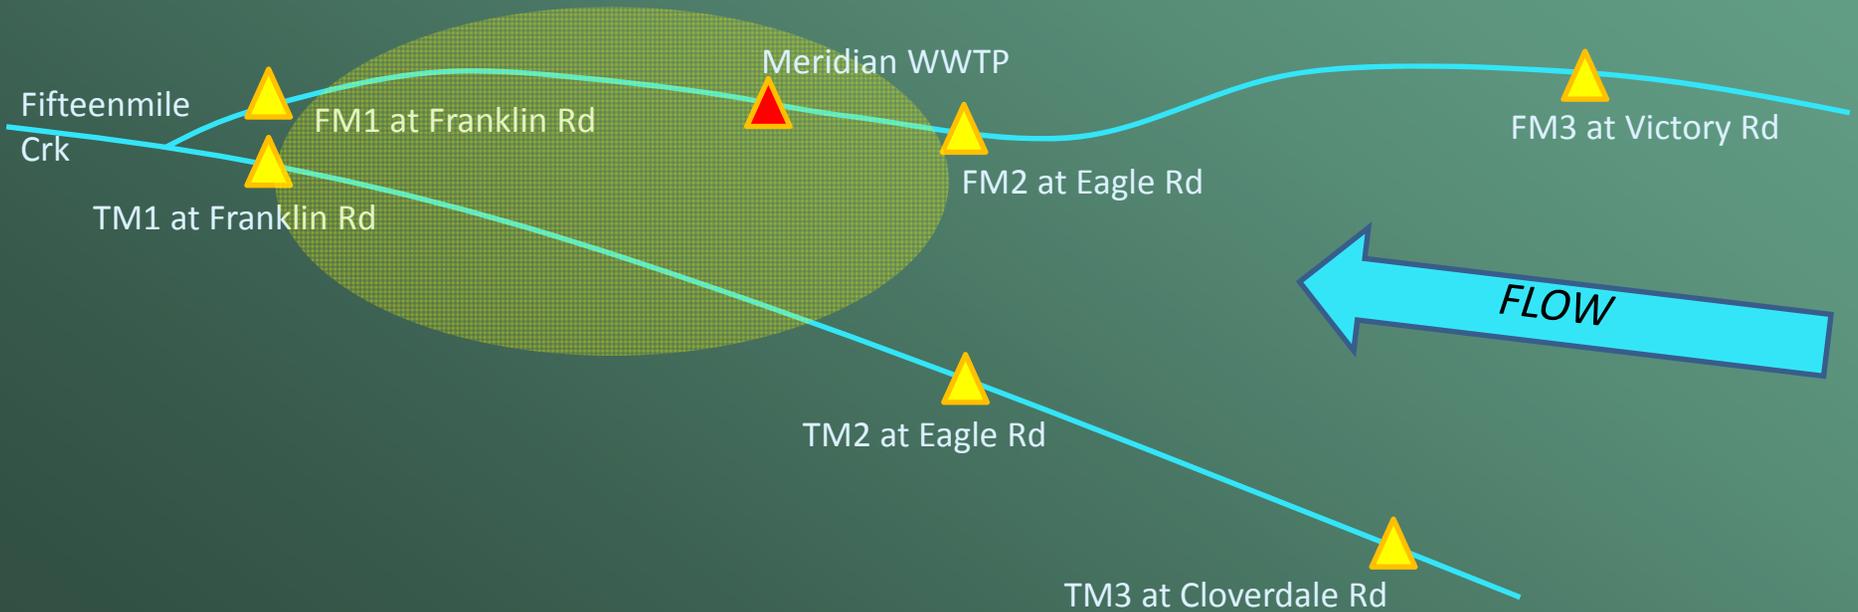
## Spatial Loading

### *Fivemile and Tenmile Creeks*

>90% TP, Sed, TN loads,  
every event

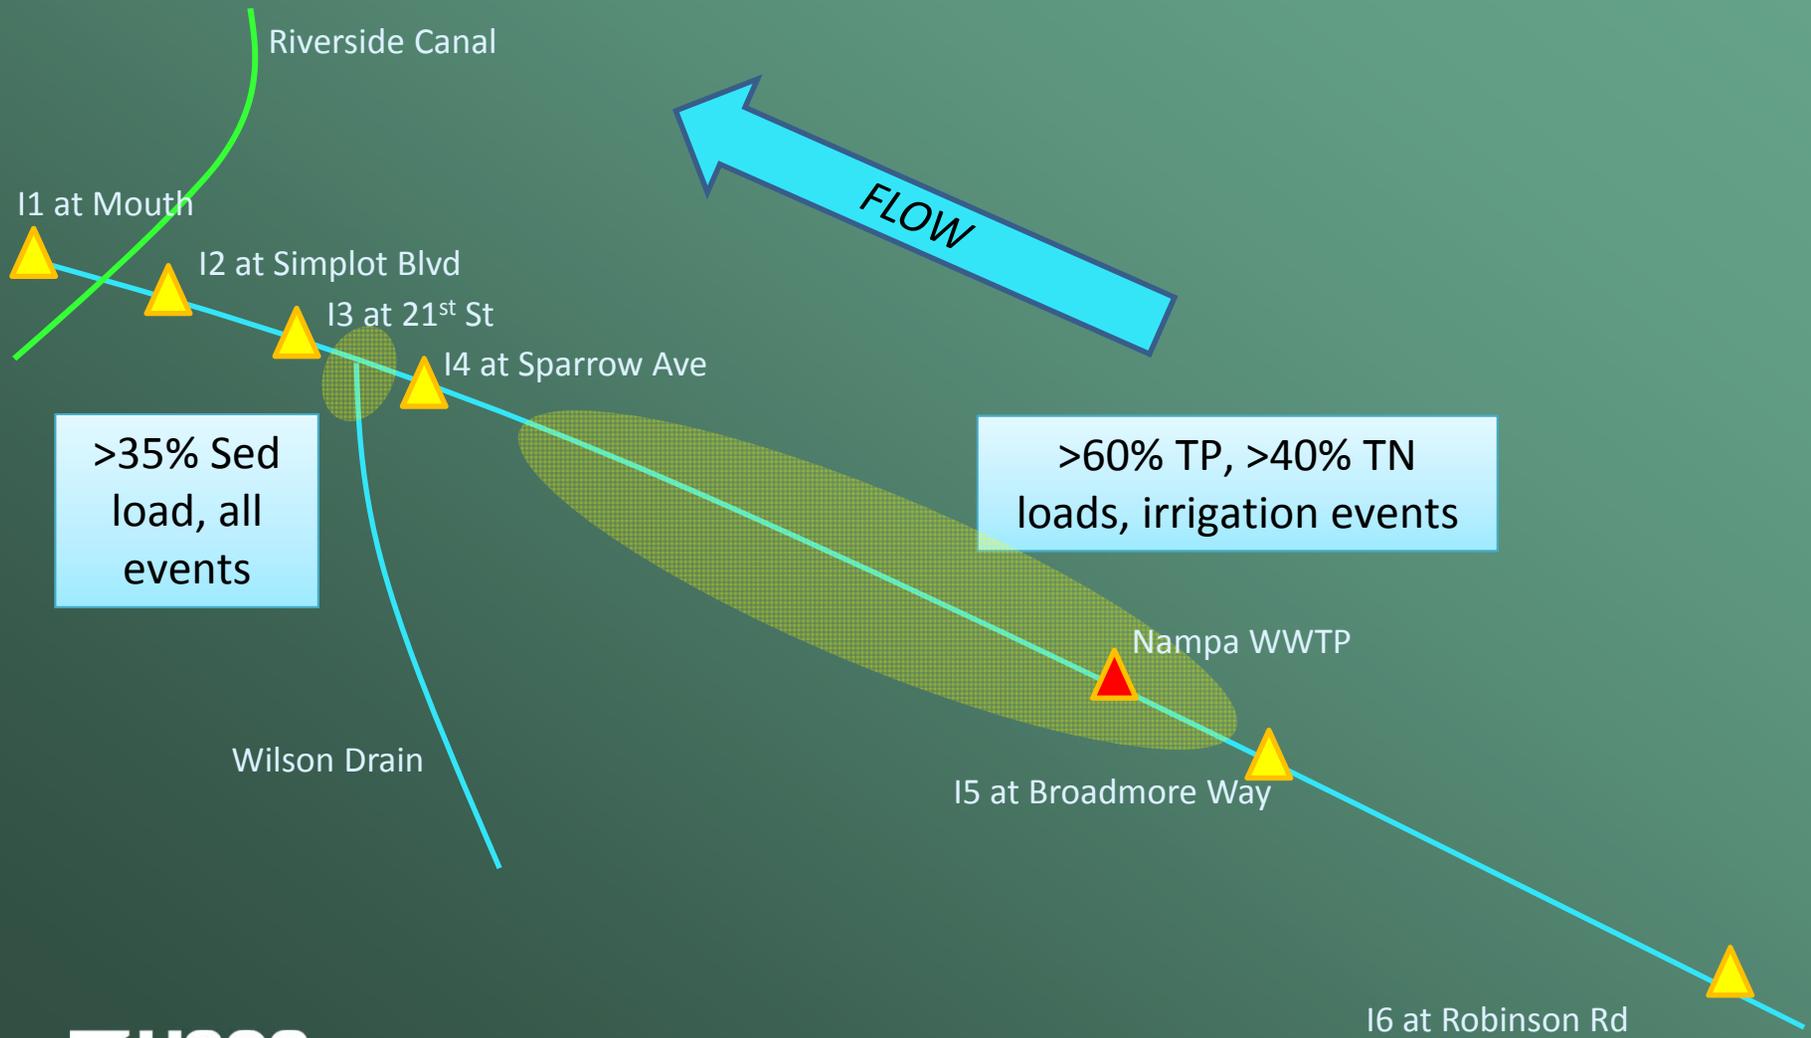
# Spatial Loading

## Indian Creek

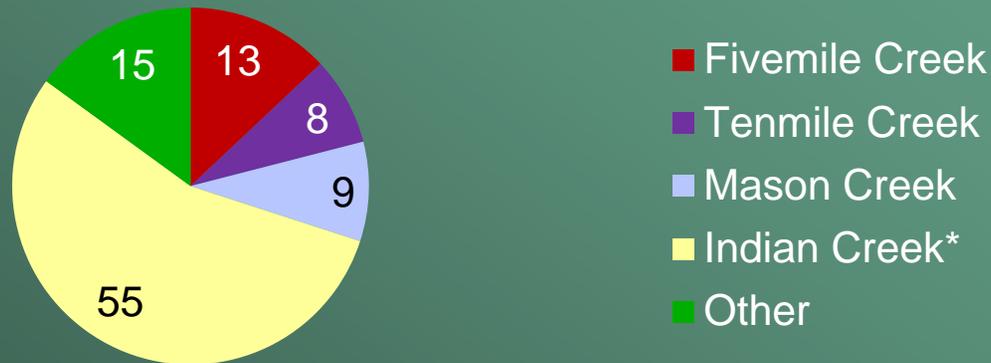
# Instantaneous Loads: Contributions to the Boise River near Parma

## Total Phosphorus – Mid-Irrigation Event

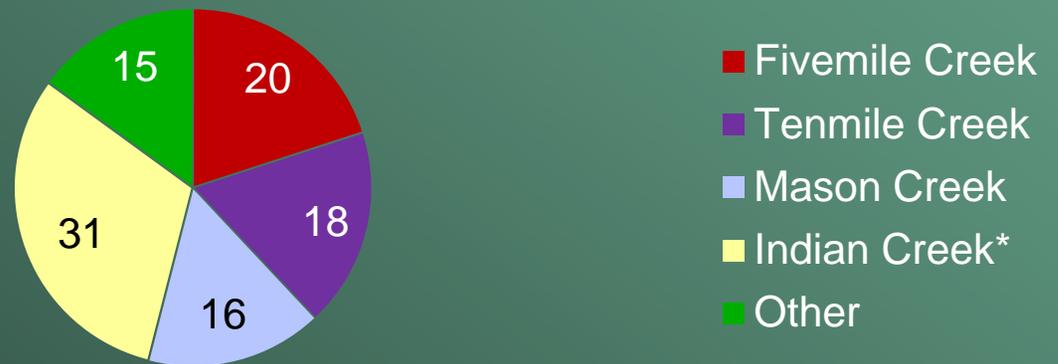
## Suspended Sediment – Mid-irrigation Event

**\*Results shown for  
Indian Creek at  
Simplot Blvd (I2)**

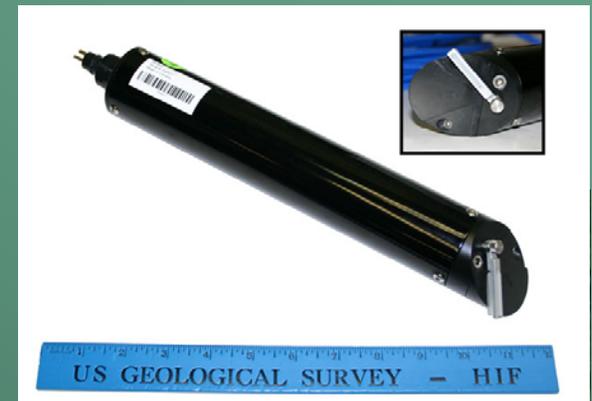
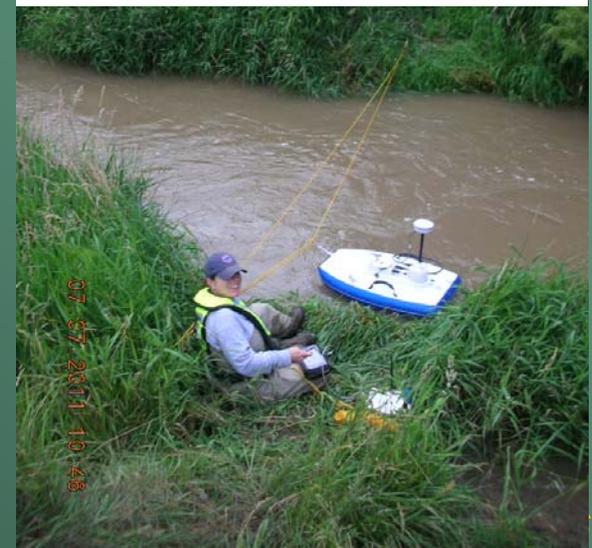
# Mason Creek Expanded Monitoring and Models

- Streamgage + Continuous Turbidity & Temp
  - Regression models (surrogates)
    - 15-minute estimates
      - Loads
        - Mass/time/ac, mass/time
      - Concentrations
    - Potential for real-time estimates

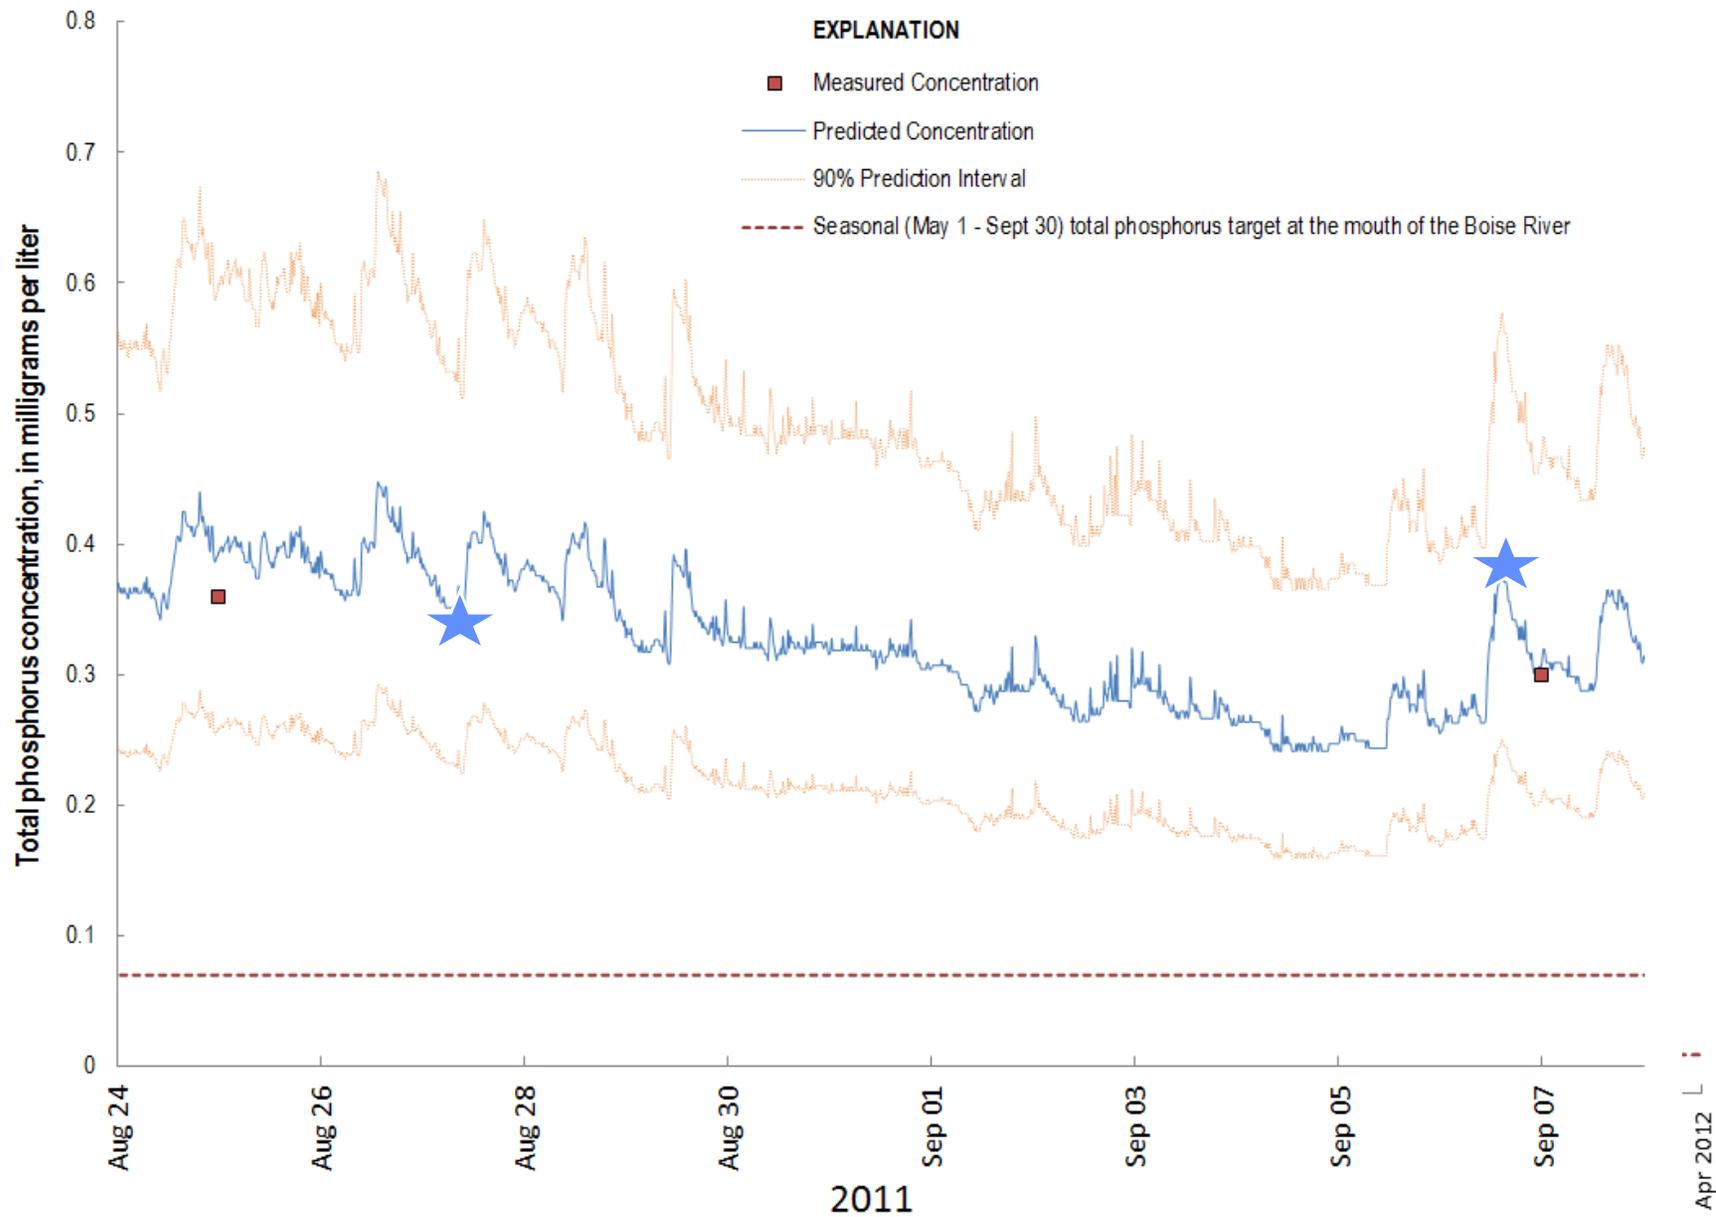
# Phosphorus Surrogate

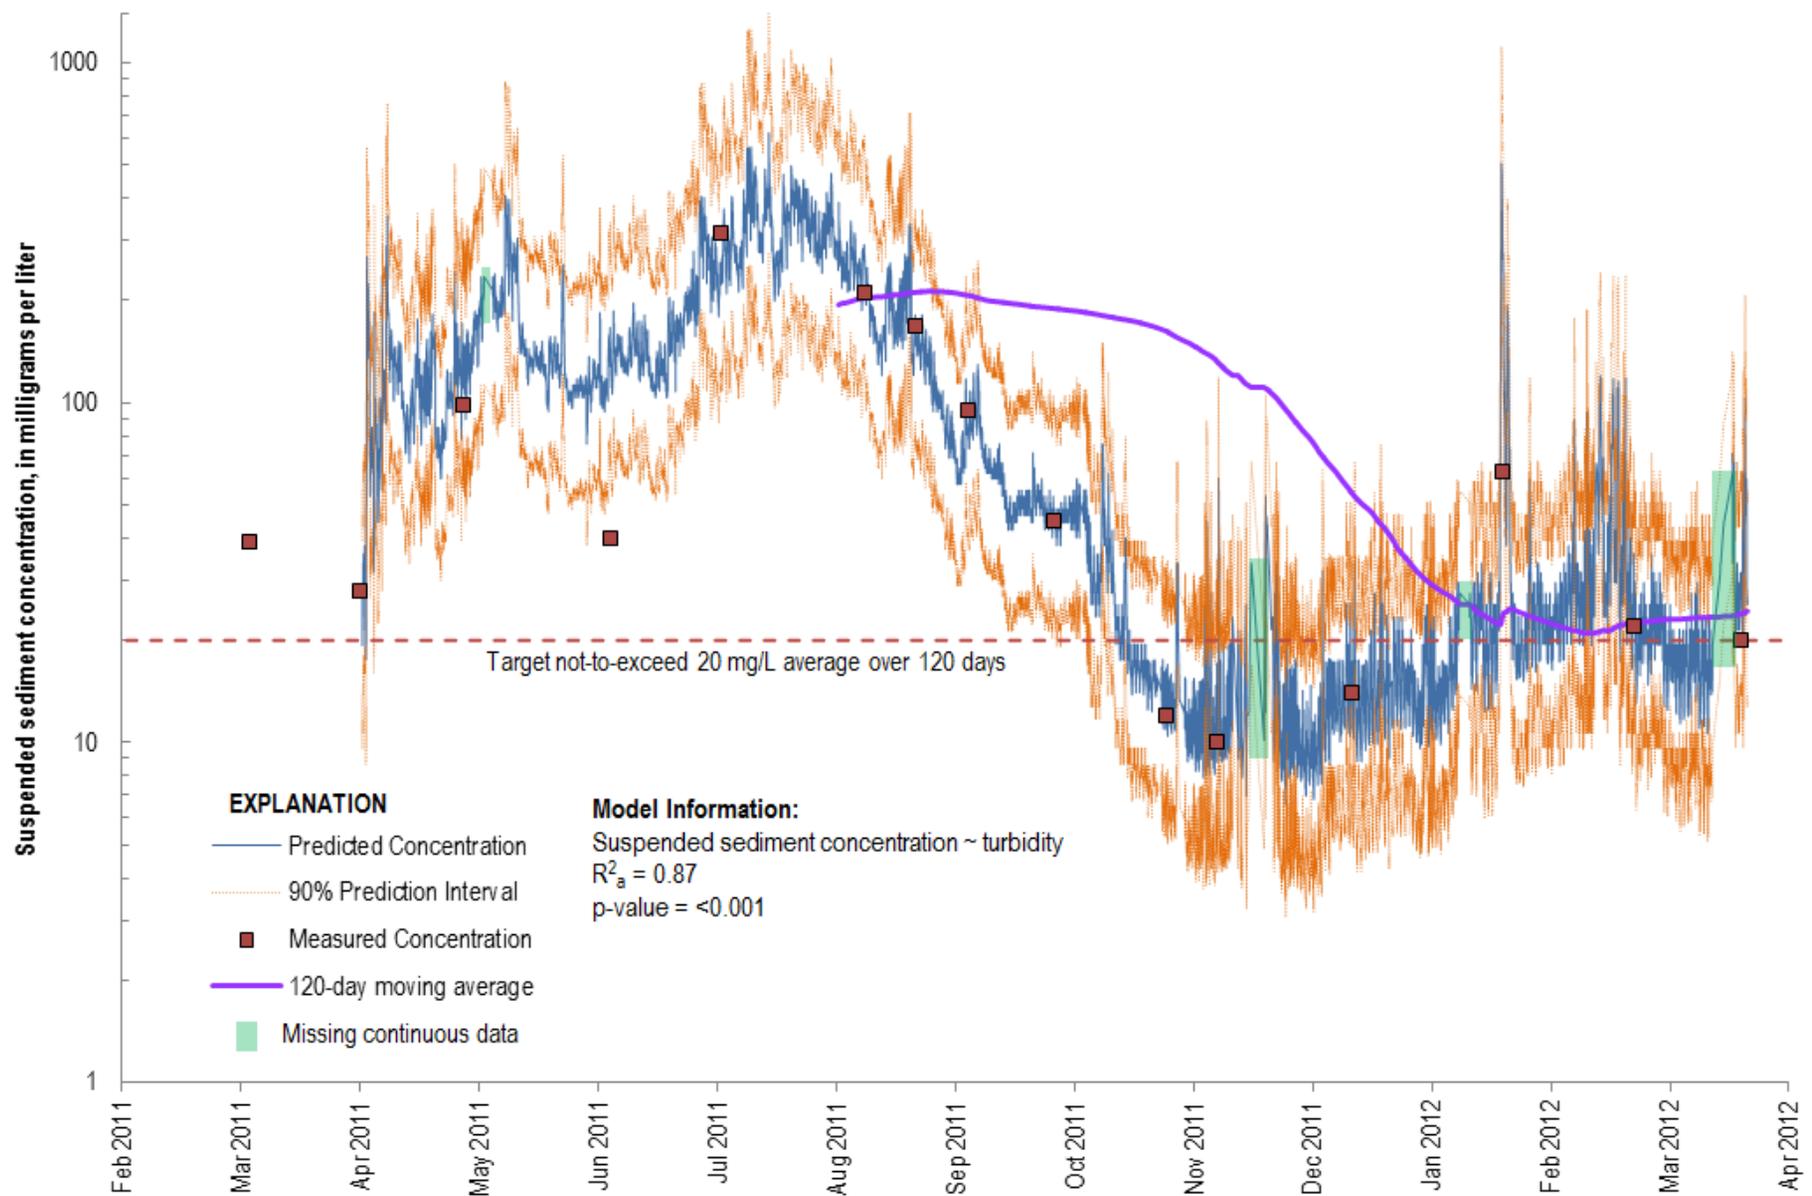
# Sediment Surrogate

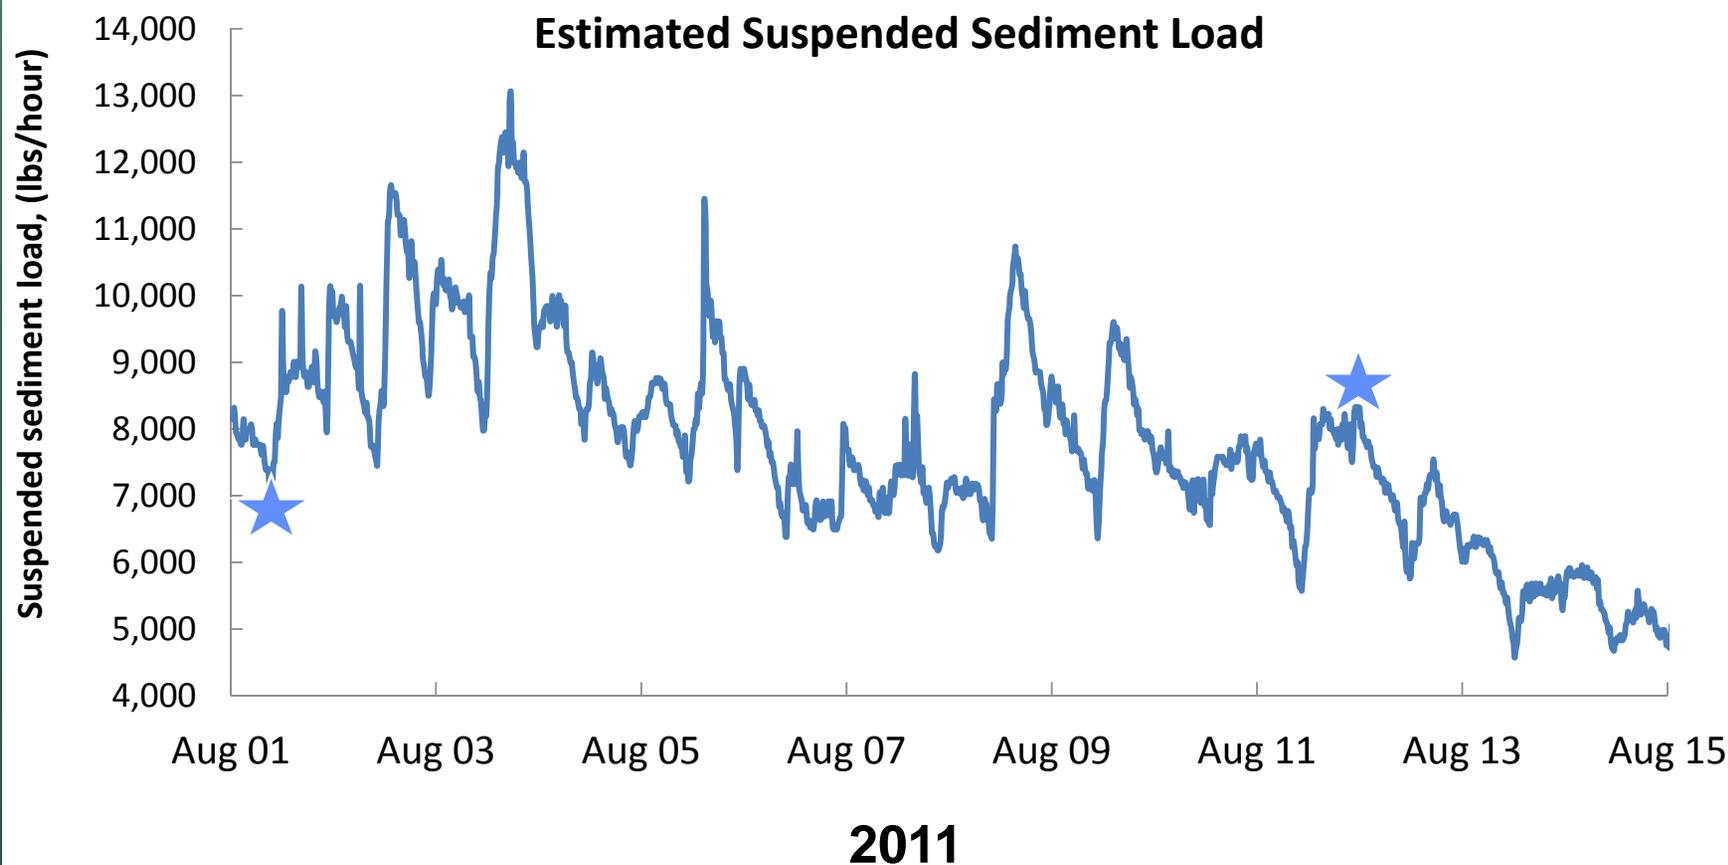
# Application of Surrogate

- Estimate 12,100 ton/yr sediment load
  - ~23,180 ac in crop in watershed
  - 1,044 lb/ac sediment runoff
    - Assuming all runoff from irr. land
- Estimate 31 ton/yr TP load
  - 2.67 lb/ac TP runoff

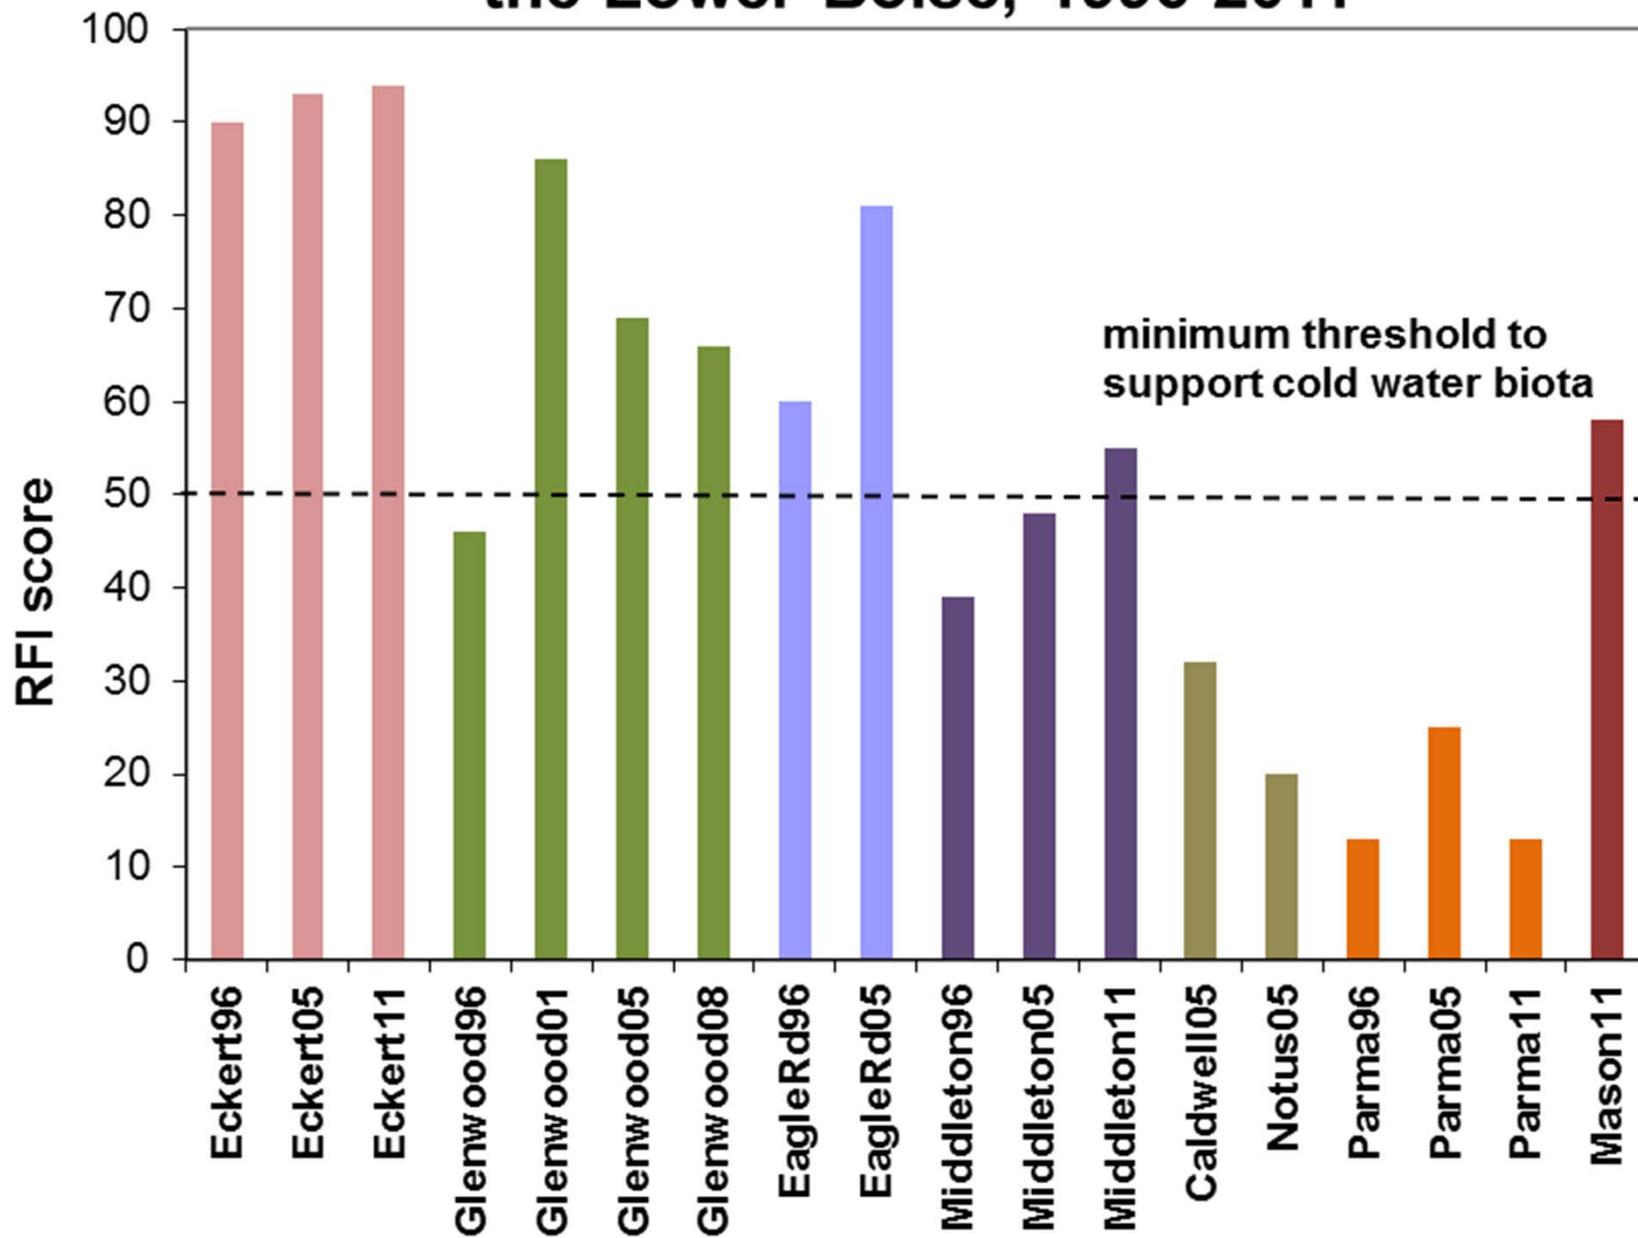
## Idaho State river fish index (RFI) for sites on the Lower Boise, 1996-2011
