# **VIENNA MINING DISTRICT**

## **PRELIMINARY ASSESSMENT AND SITE INSPECTION REPORT**

Blaine and Camas Counties  
State of Idaho

November 2010

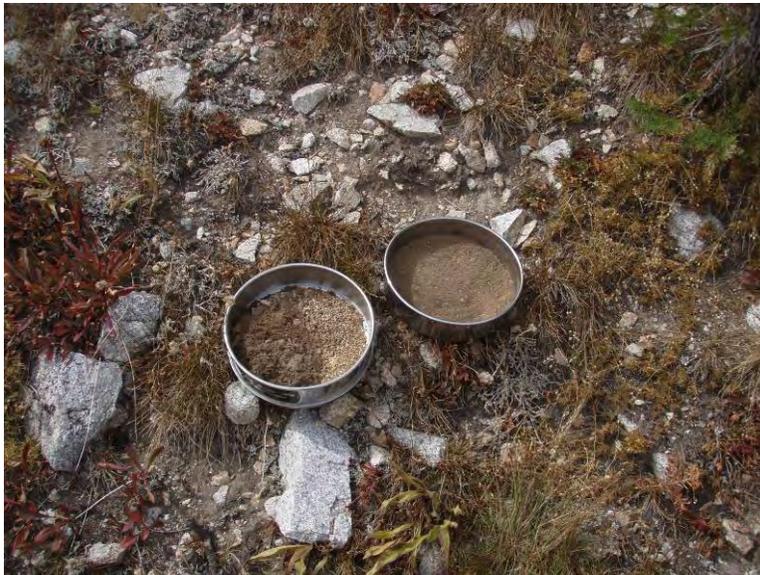
*Photo 7. Soil sample SMCBGSS1 was collected at approximately Lat. 43.80418°N, Long. 114.84769°W. Note the high volume of organic materials not normally found in the area's soils. (Photo by Schuld 9/14/10)*

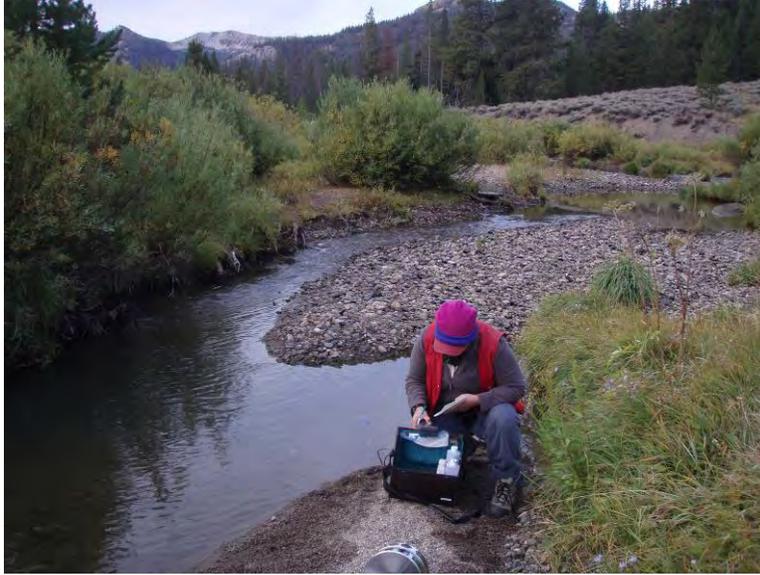
*Photo 10. Tina Elayer collecting field parameters on Smiley Creek (sample SMCSW1) approximately 1/2 mile below Vienna mines; Lat. 43.84101° N, Long. 114.81689° W. (Photo by Schuld 9/14/10)*

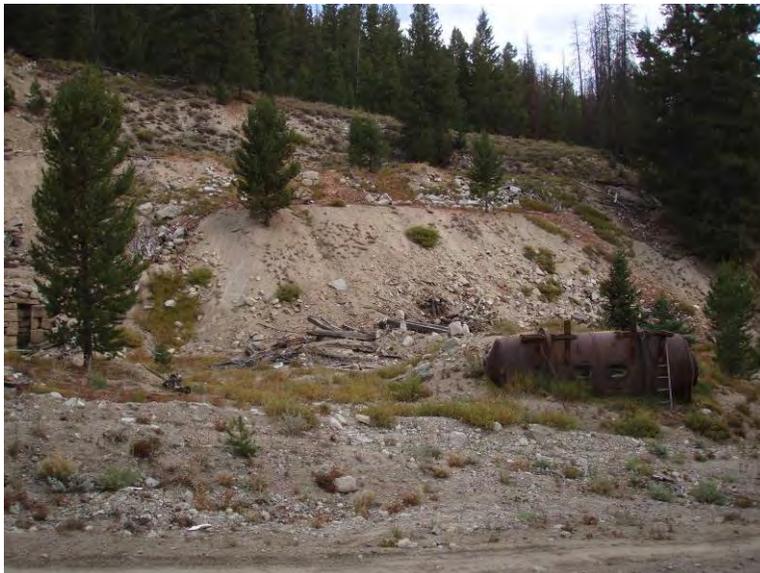
The Wisconsin Mill Site, which is overlain by the Rhine Lode and Mill Site claims, contains the remnants of mill foundations, refractory brick, and an old boiler used as foundation for a loading ramp, and less than 100 cubic yards of mine or mill wastes. Although the morphology of the site suggests the vast majority of mine and mill wastes previously stockpiled at the site have been removed, alteration minerals, refractory materials, erosional features, and a direct connection between the site and delivery to Smiley Creek led DEQ to collect waste samples at the site.

*Photo 13. Wisconsin Mill Site lower foundations and loading ramp (soil sample WMSSS1). (Photo by Schuld 9/14/10)*

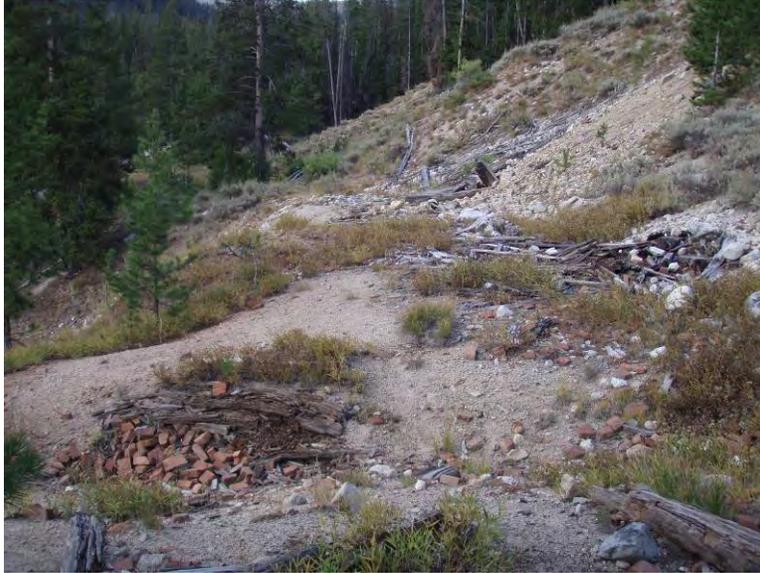
The amount of brick at the site did not look like refractory brick until it was observed that many “fines” located with the brick appeared to be oxidized ore. Although this is only a guess, DEQ thought perhaps some attempt was made to roast sulfide ores prior to running them through a concentrator.

*Photo 14. Above the lower foundations of the Wisconsin Mill Site is a large amount of refractory brick which may have been used to roast crushed sulfide ores prior to gravity separation (soil sample WMSSS2).  
(Photo by Schuld 9/14/10)*

A waste sample (WMSSS2) was collected in the fines surrounding the bricks on the middle level of the mill site (Lat. 43.71667°N, Long. 114.83260°W).

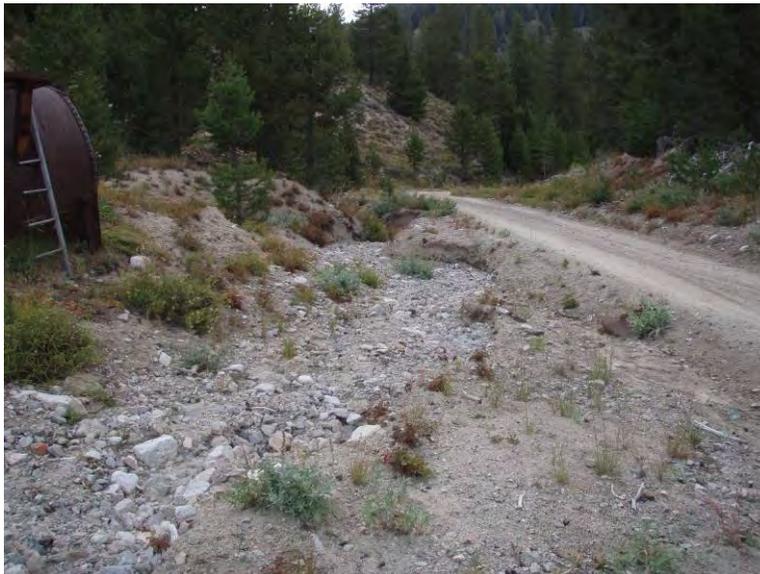
*Photo 15. Surface runoff from the USDA-Forest Service (USFS) public roadway is down cutting deep gullies at the base of the Wisconsin Mill Site.  
(Photo by Schuld 9/14/10)*

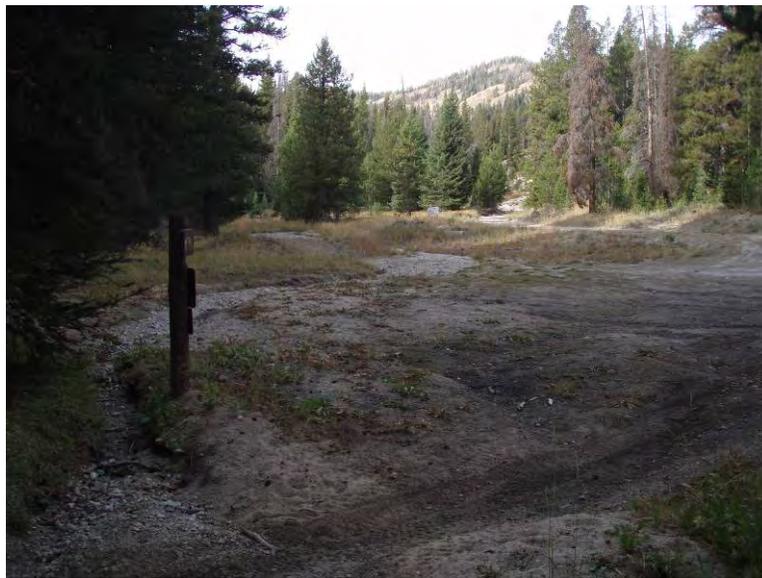
*Photo 16. Surface runoff from the USFS public roadway is down cutting deep gullies at the base of the Wisconsin Mill Site and delivering it to Smiley Creek near the “old” trail head for the Centennial Motorcycle Trail.  
(Photo by Schuld 9/14/10)*

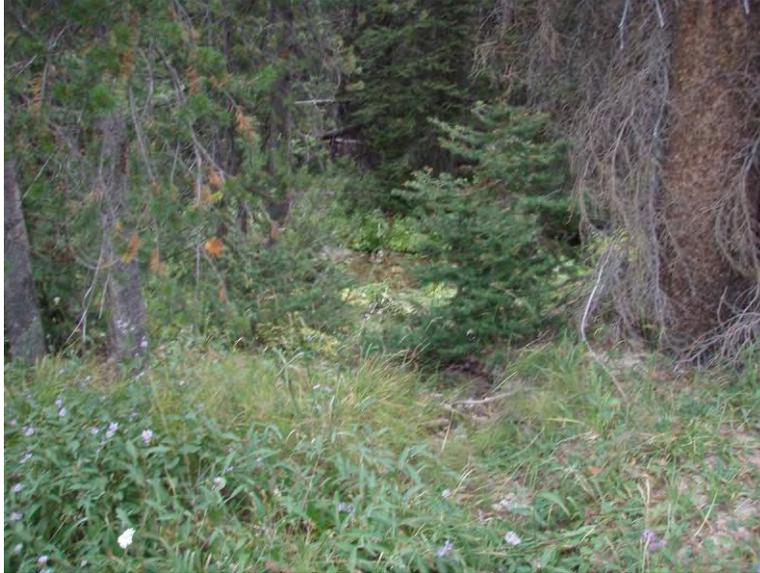
*Photo 17. Surface runoff from the Wisconsin Mill Site enters Smiley Creek (surface water sample WMPPEW1). (Photo by Schuld 9/14/10)*

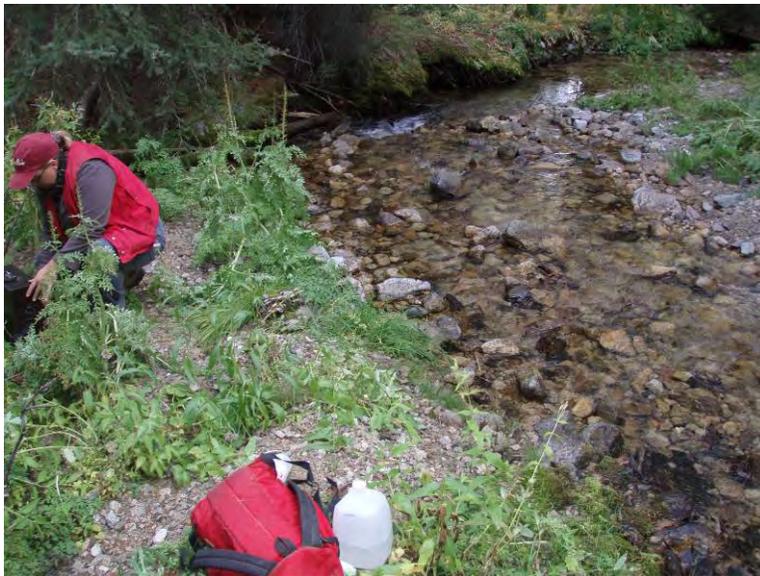
*Photo 18. Wisconsin Mill Site/Smiley Creek Probable Point of Entry (PPE). Sample WMPPEW1 collected at Lat. 43.81758°N, Long. 114.82915° W. (Photo by Schuld 9/14/10)*

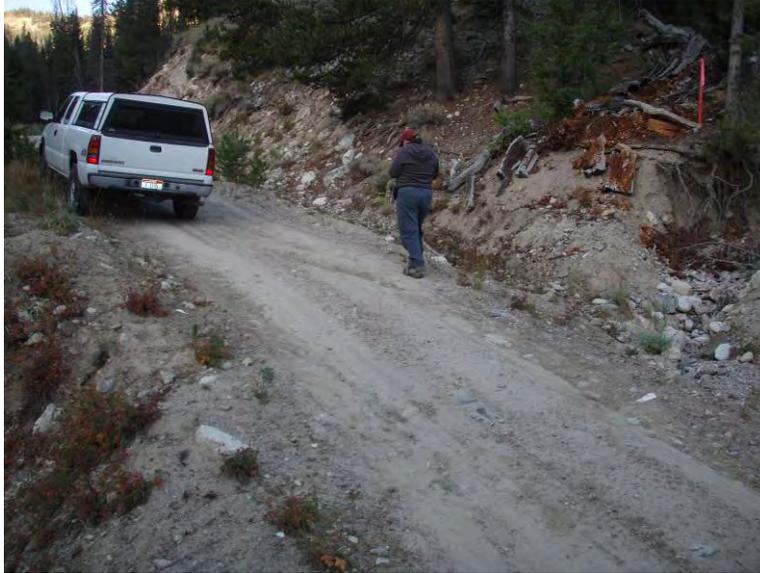
*Photo 19. Replacement of the culvert at this location on the roadway (above the Wisconsin Mill Site) would likely divert surface runoff from the erosional situation found at the mill site. (Photo by Schuld 9/15/10)*

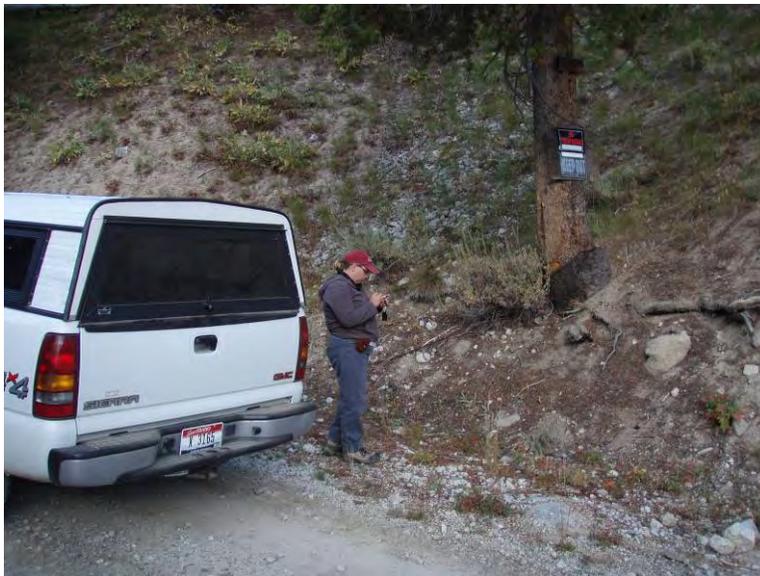
*Photo 20. A second culvert installed approximately 300 feet further up the road on the Rhine Lode claim would effectively reduce surface runoff velocities, and decrease the challenges of operation and maintenance on the first culvert. (Photo Schuld 9/15/10)*

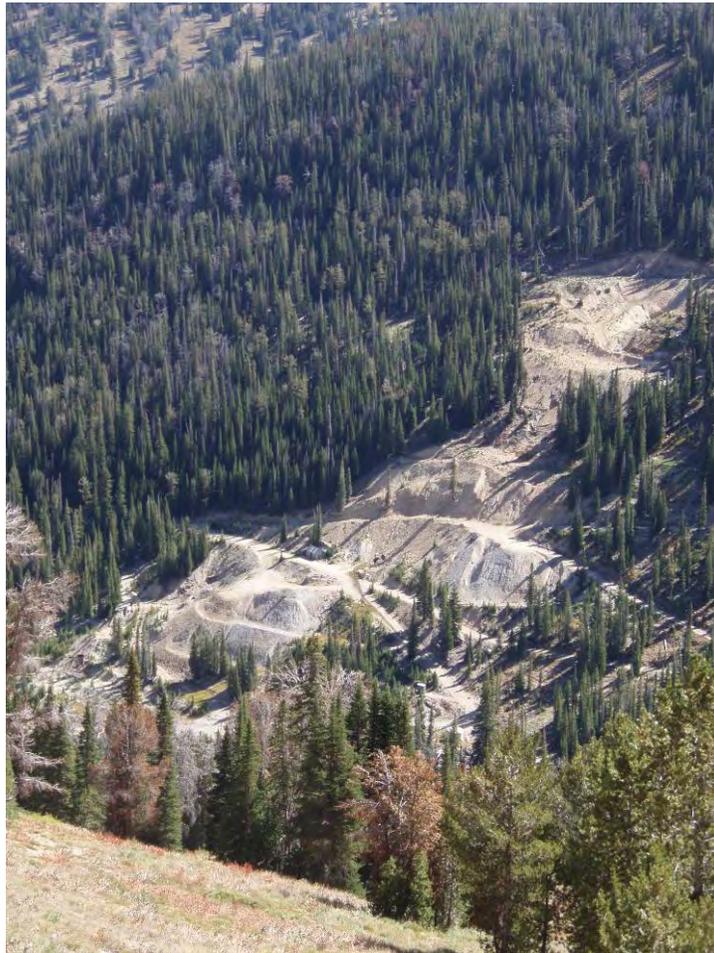
*Photo 21. The Webfoot Mine and Mill Site has at least five main levels of mine workings and a mill facility that processed at least 2600 tons of ore. (Photo by Schuld 9/15/10)*

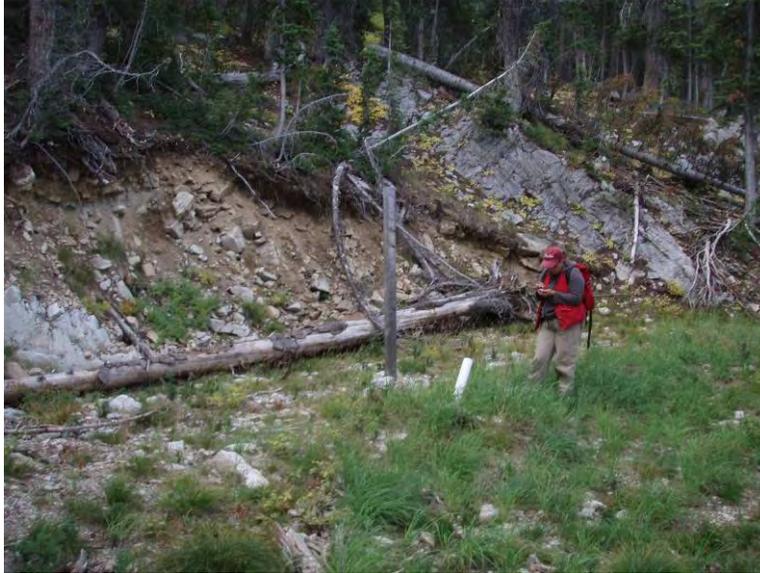
*Photo 22. At the very top of the Webfoot workings is a bench that has apparently been developed for a diamond drill hole site.  
(Photo by Schuld 9/16/10)*

Diamond drill hole WFDDH1 on the upper Webfoot bench at Lat. 43.80501°N, Long. 114.84241°W has been located and mapped for references sake.

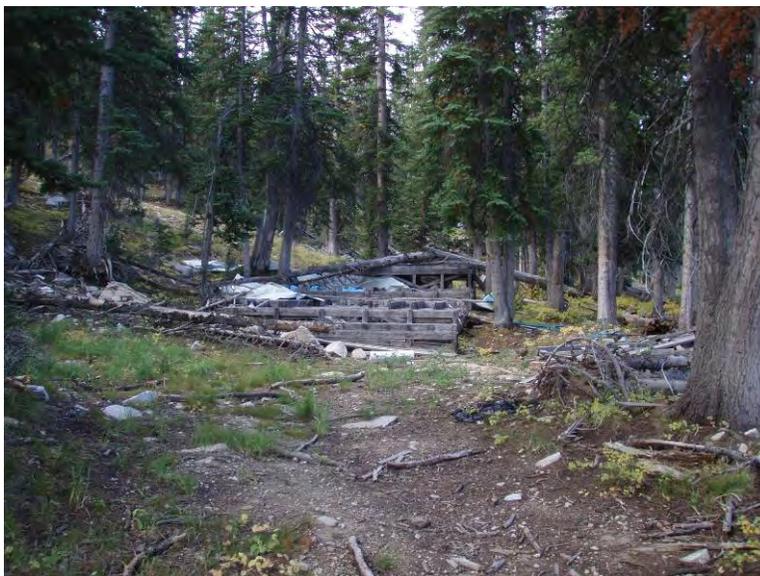
*Photo 23. Adjacent to the upper Webfoot Mine bench is a recent wooden foundation that was perhaps used as a core shed or center of exploration activities. (Photo by Schuld 9/16/10)*

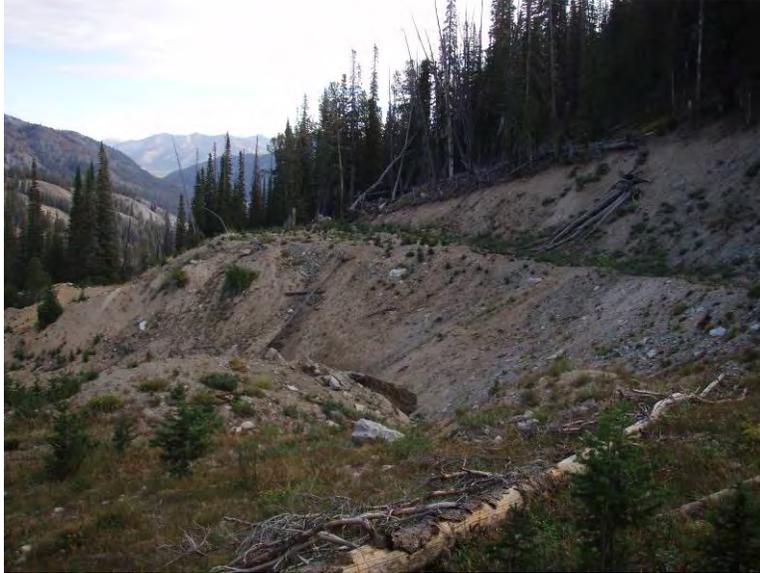
*Photo 24. Beneath the Upper Webfoot bench is the uppermost underground developments or 200' Level Adit and Waste Dump. (Photo by Schuld 9/16/10)*

This area around the upper Webfoot Mine, henceforth 200' Level Adit, looks more like an open pit than an underground working since it was blasted away during the filming of the hydraulic mining sequence in Clint Eastwood's and Warner Brothers' Productions 1985 movie "Pale Rider." The site was leased to Warner Brothers Production by a mine investment conglomerate called NAFCO that owned the property during the 1980's and early 1990's. No information has been researched regarding this lease or the previous owner.

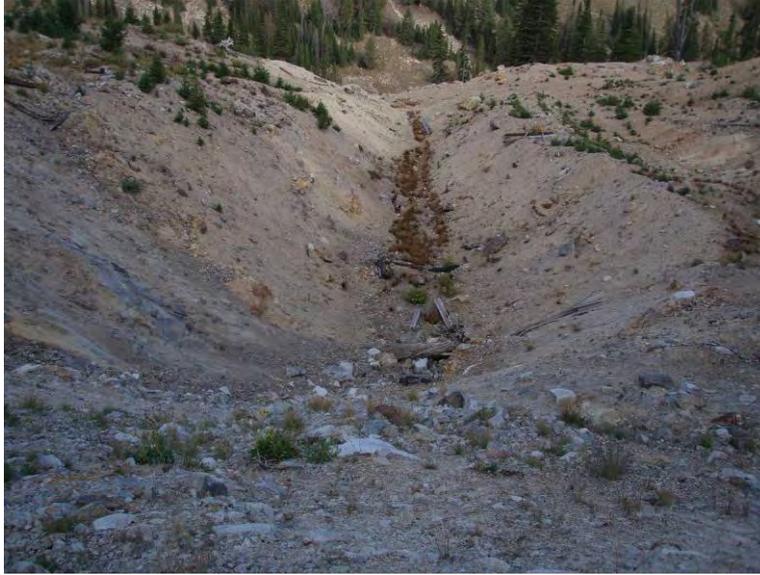
*Photo 25. Looking down into the exposed 200' Level Adit. Vegetation (sedges) and some iron staining down the length of the gully indicates seasonal discharge from the workings. (Photo by Schuld 9/16/10)*

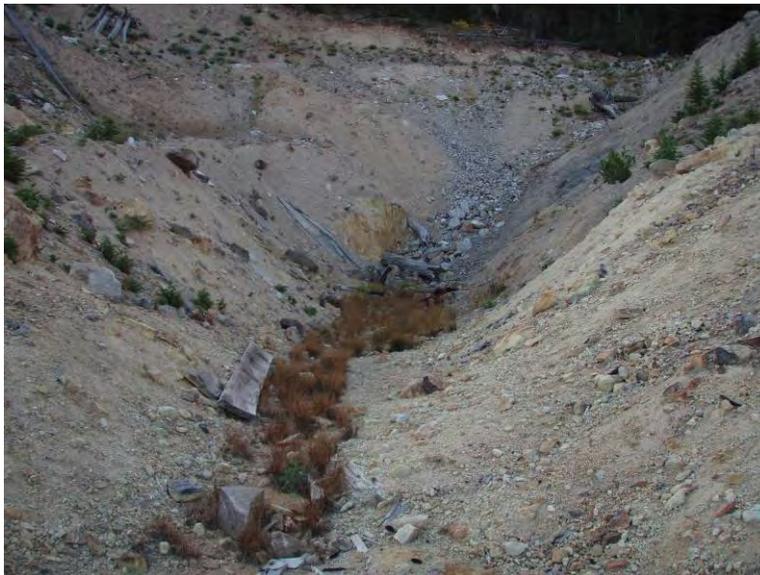
*Photo 26. Looking into the caved 200' Level Adit. (Photo by Schuld 9/16/10)*

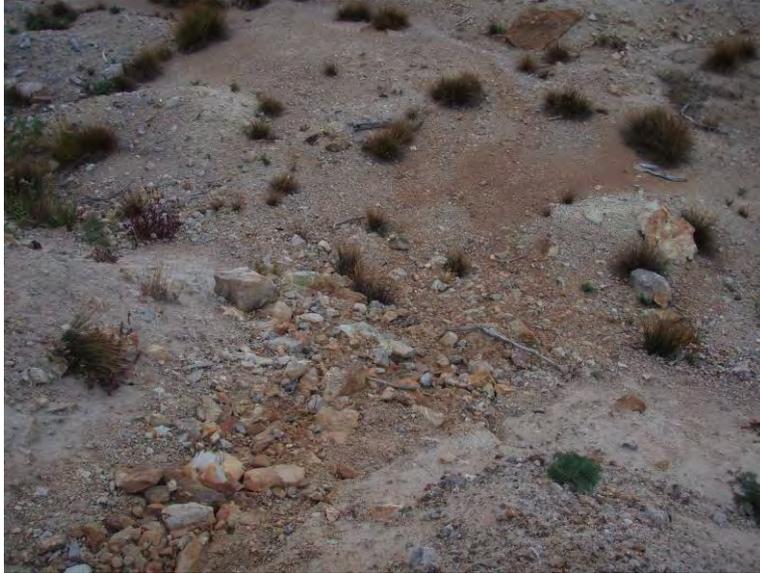
*Photo 27. Iron staining down the length of the 200' Level Adit.  
(Photo by Schuld 9/16/10)*

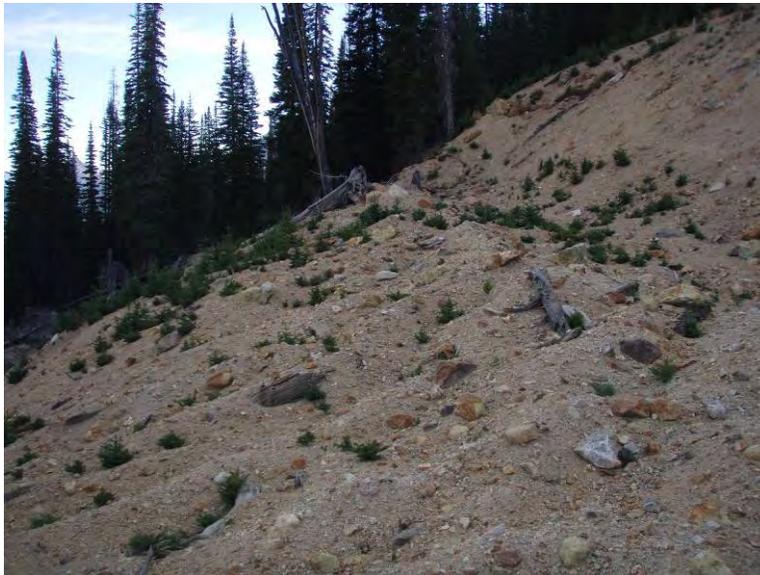
*Photo 28. The 200' Level Waste Dump appears to be modified by reclamation work. (Photo by Schuld 9/16/10)*

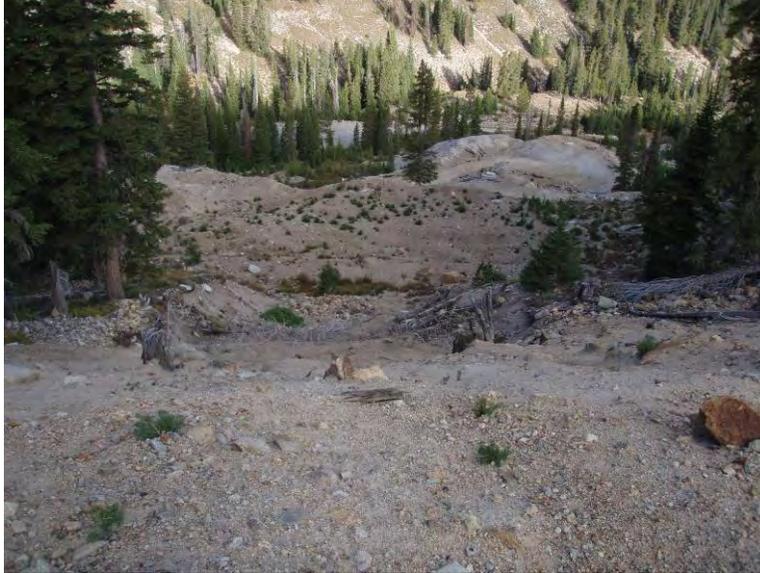
*Photo 29. Although they are not very evident in this photo, looking down this slope pilings, were noted in the face of the waste dump, presumably to provide some internal stability. (Photo by Schuld 9/16/10)*

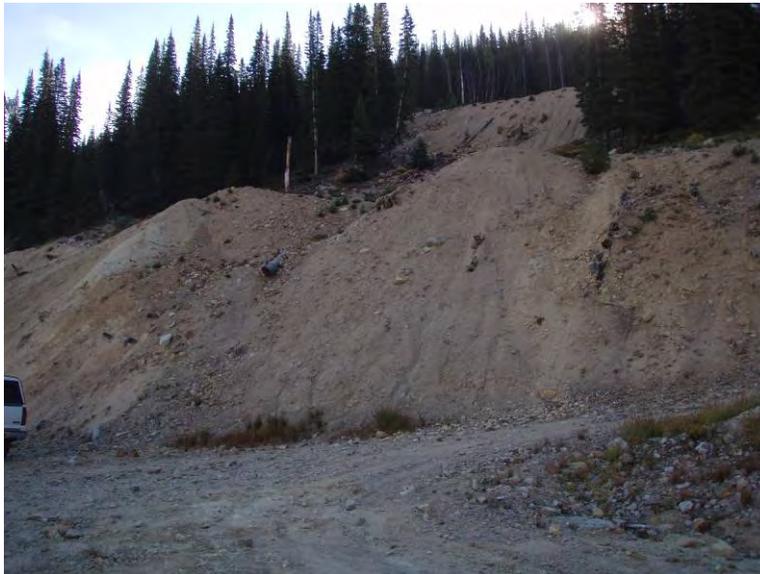
*Photo 30. At approximately 100 feet in elevation below the 200' Level Adit is the buried 300' Level Adit. (Photo by Schuld 9/16/10)*

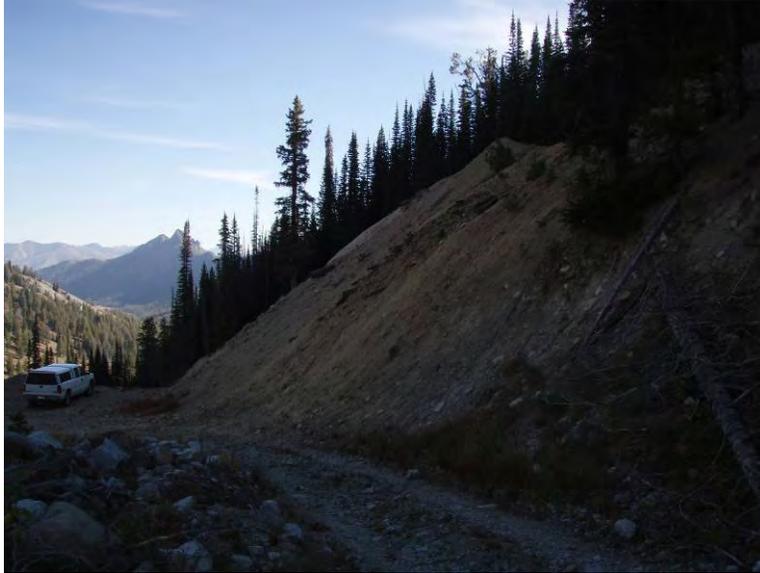
*Photo 31. This is the toe of the 200' Level Waste Dump at the 300' Level Landing and Adit. (Photo by Schuld 9/16/10)*

The Webfoot 300' Level Adit and Waste Dump are located at Lat. 43.80631°N, Long. 114.84325°W. As mentioned, the adit is buried and/or collapsed, and there is vegetation growing in the seep area which is proximate to where the adit should be. Similar to the 200' Level Waste Dump, waste volumes (1,000 to 2,000 cubic yards) and indications of intermittent mine drainage led to the decision to collect soil sample WF300LVLAD. Inspection of the area leads to the conclusion that erosion is problematic, but there is no evidence at this level that delivery occurs to surface waters or wetlands.

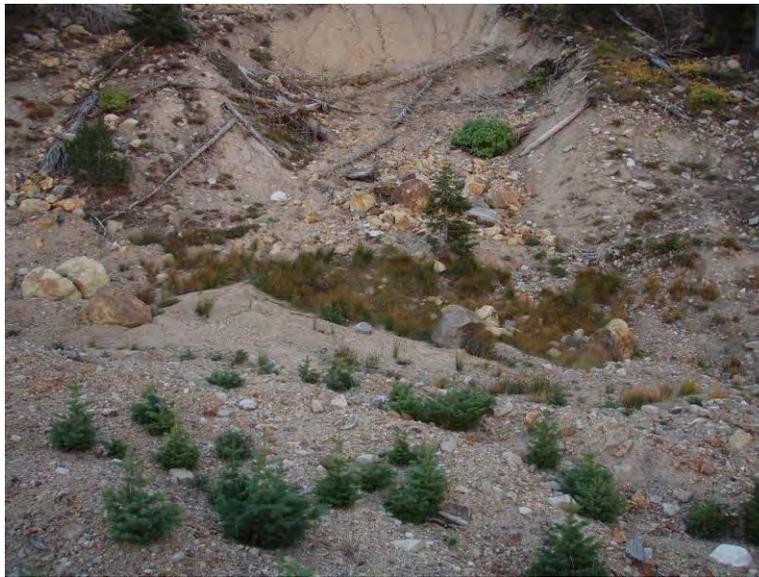
Unlike the 200' Level Waste Dump, the face of the 300' Level Waste Dump appears to be slightly more stable and conducive to the re-establishment of floral communities, particularly trees.

*Photo 32. Trees growing on the Webfoot 300' Level Waste Dump. (Photo by Schuld 9/16/10)*

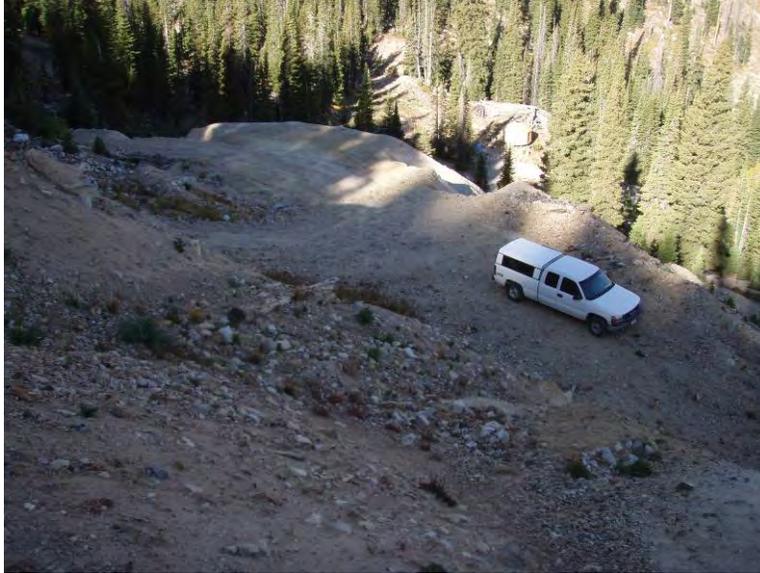
*Photo 33. Looking down on the Webfoot 300' Level bench.  
(Photo by Schuld 9/16/10)*

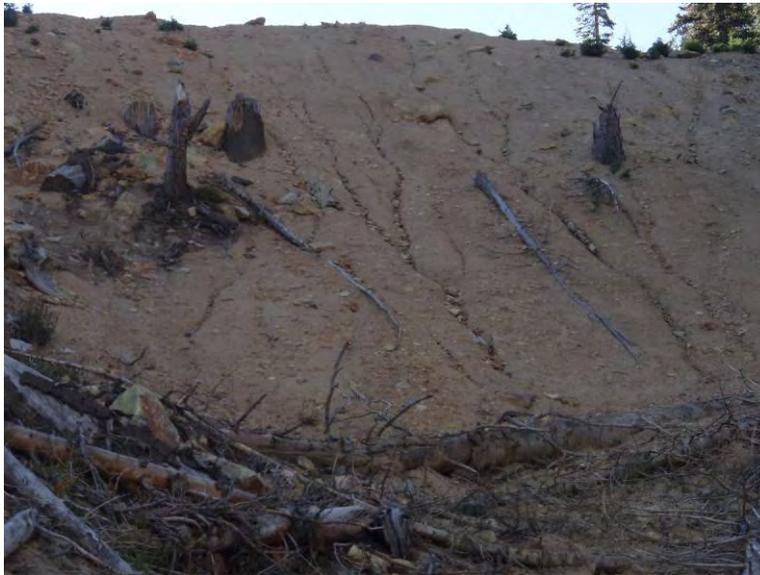
*Photo 34. Looking up the Webfoot 200' Level Waste Dump, it is pretty obvious  
the dump face continues to erode. (Photo by Schuld 9/16/10)*

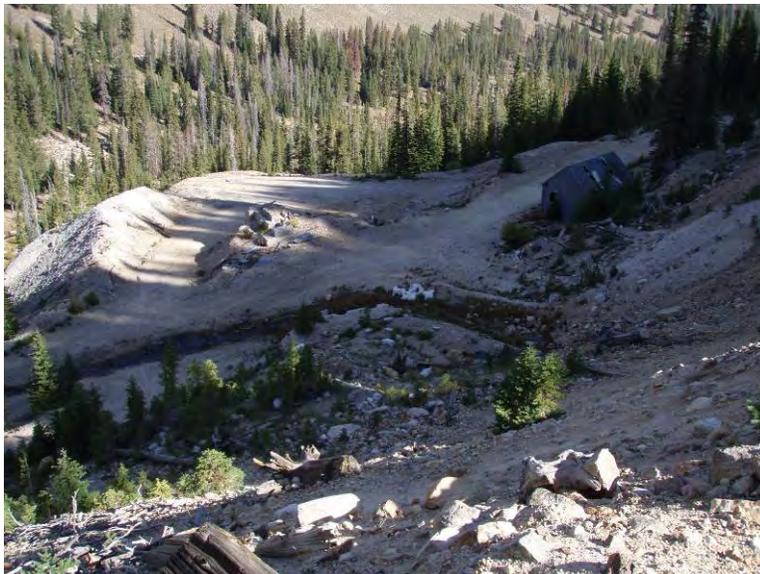
*Photo 36. Looking down on the Webfoot 400' Level Adit, Waste Dump, and mill foundations. (Photo by Schuld 9/16/10)*

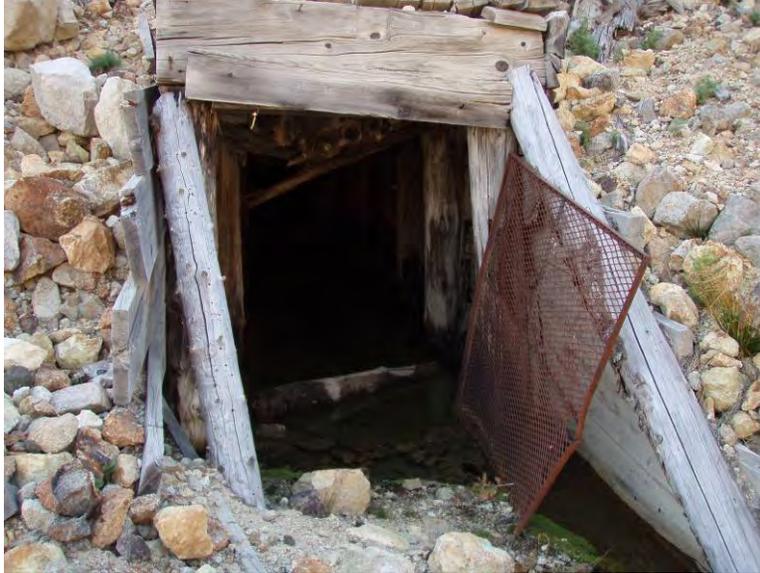
*Photo 37. Webfoot 400' Level Adit is open and has discharge draining from it (sample WF400LVSW1), Lat. 43.80683°N, Long. 114.84358°W. (Photo by Schuld 9/16/10)*

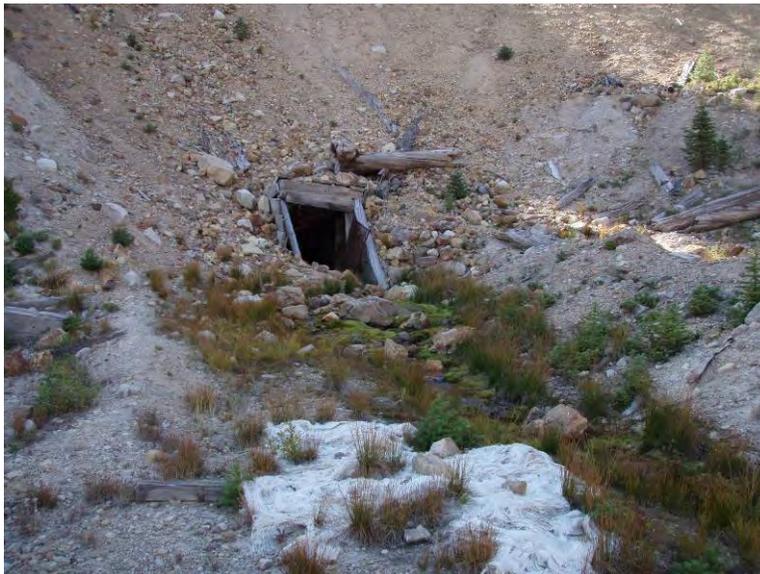
*Photo 38. Webfoot 400' Level Adit. (Photo by Schuld 9/16/10)*

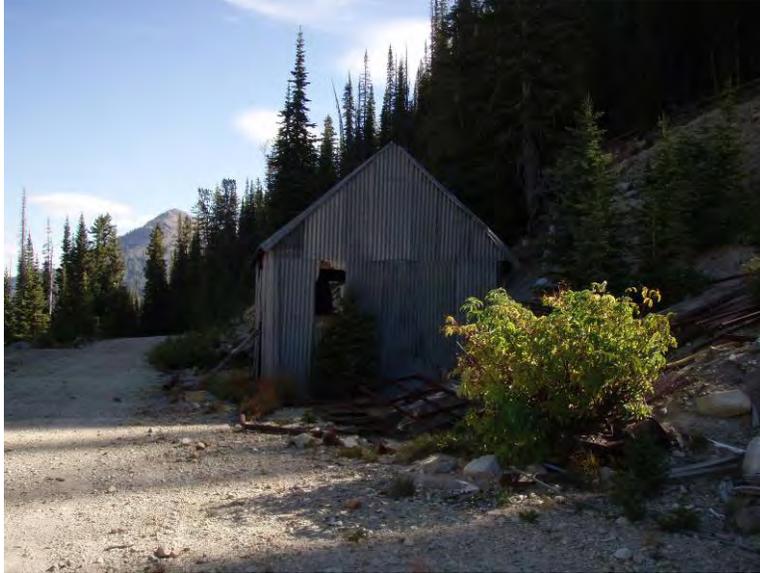
*Photo 39. Compressor shed at Webfoot 400' Level Adit.  
(Photo by Schuld 9/16/10)*

Although very little RCRA regulated hazardous wastes or deleterious materials was found throughout the Vienna District, there are some residual solid and petrochemical wastes. They do not pose a substantial risk to water quality, but those wastes and containers in the 400' Level Adit compressor shed should be properly disposed of by the lessee or owner of the Webfoot Mine.

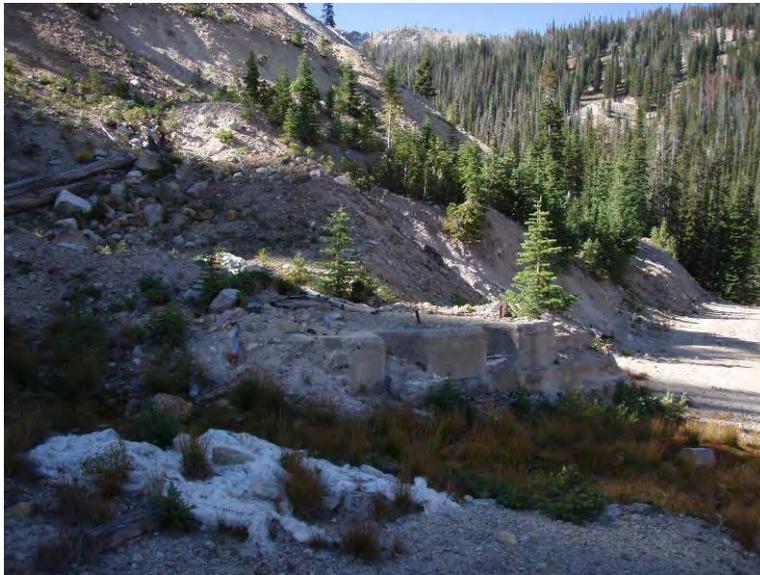
*Photo 40. Concrete foundation adjacent to the Webfoot 400' Level Adit.  
(Photo by Schuld 9/16/10)*

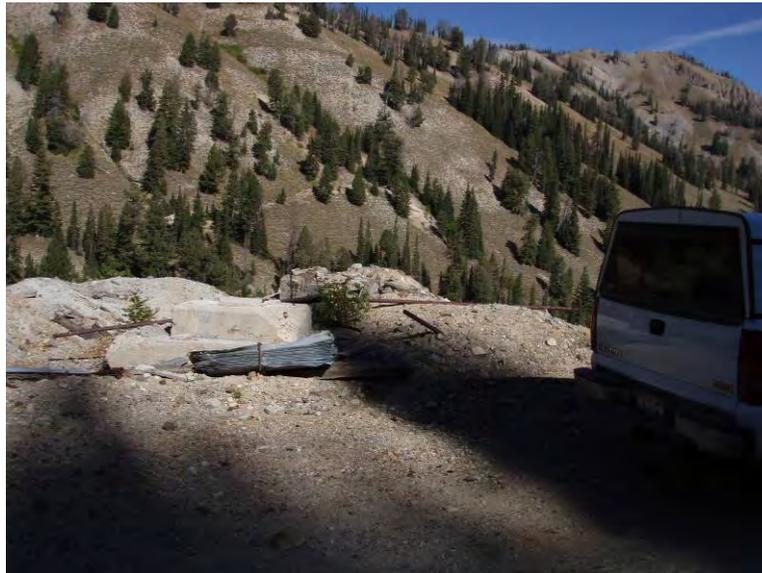
Between the Webfoot Mine Levels 400', 500', and 600' there are remnants of mill foundations from which approximately 2600 tons of ore were run through a "chlorination" mill system, presumably the Mountain King Mill. Although there is evidence of several hundred tons of mine waste left, very few tailings are present left. Most of the concentrates have been shipped off site and tailings have likely been buried under mine wastes or washed down Smiley Creek. The current lessee/partner of Terrawiggly has indicated an interest in reopening the Webfoot 400' Level and reconnection of the 600' Level via raises for ventilation and escape. If the rehabilitation is successful, it is likely most of the 400' Level water may report these tailings. However this is speculation.

*Photo 41. Mill foundations (Crusher?) on 400' Level Waste Dump.  
(Photo by Schuld 9/16/10)*

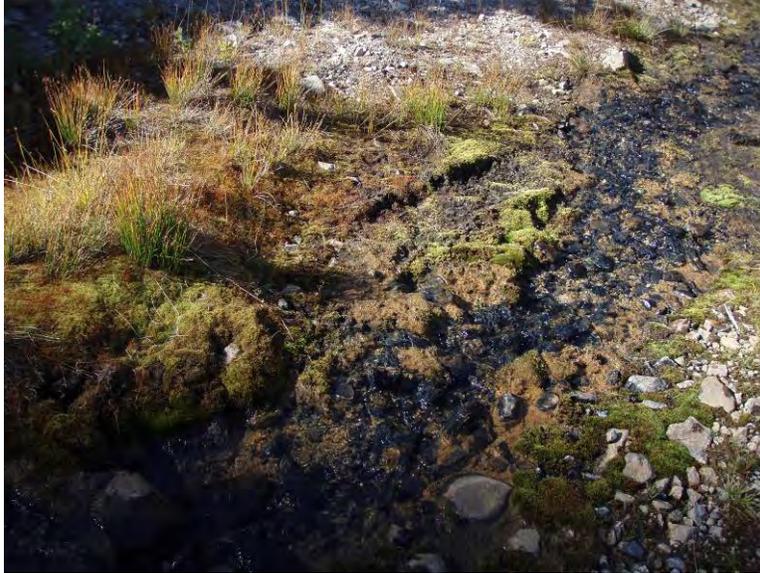
*Photo 42. Mine drainage from Webfoot 400' Level Adit.  
(Photo by Schuld 9/16/10)*

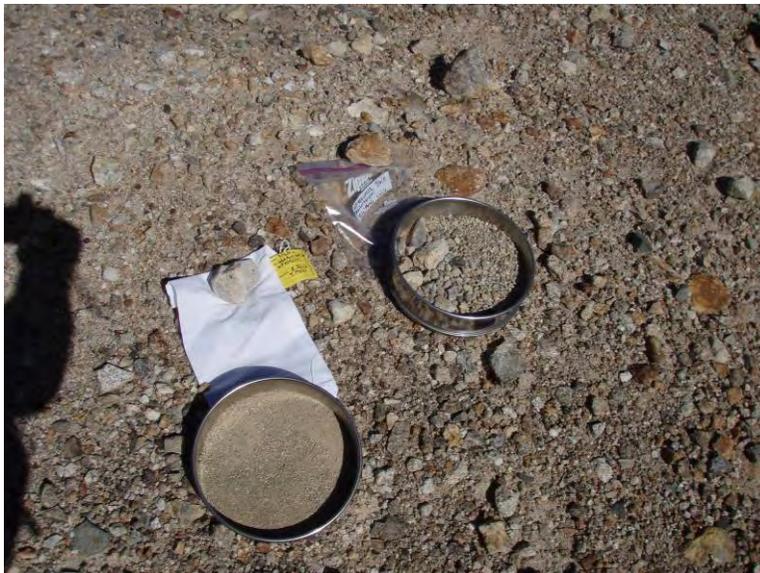
Because of the drainage, presence of sulfide bearing wastes and the size of the Webfoot 400' Level Waste Dump soil sample WF400LVSS1 was collected at Lat. 43.80709°N, Long. 114.84386° W.

*Photo 43. The Webfoot 400' Level Waste Dump was sampled (sample  
WF400LVWDSS1). (Photo by Schuld 9/16/10)*

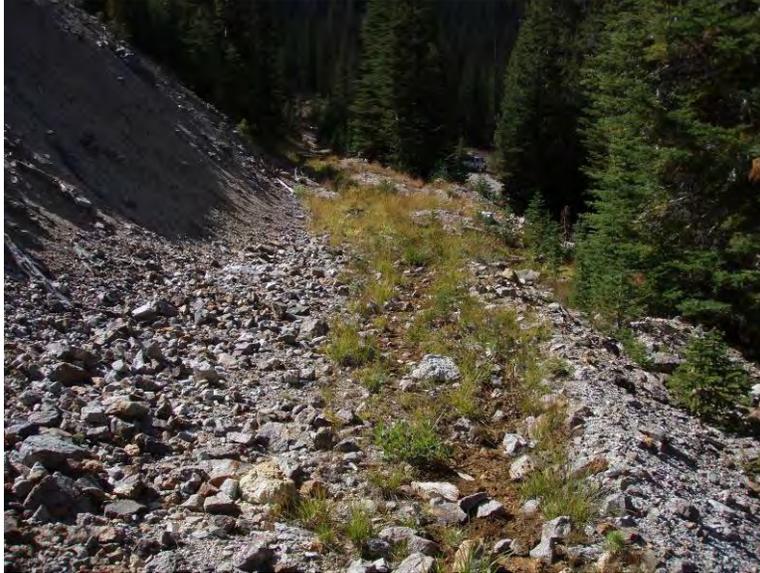
*Photo 44. The area between the Webfoot 400' and 500' Levels is dissected by a series of benches which were presumably constructed to provide for construction and operations of the mill. (Photo by Schuld 9/16/10)*

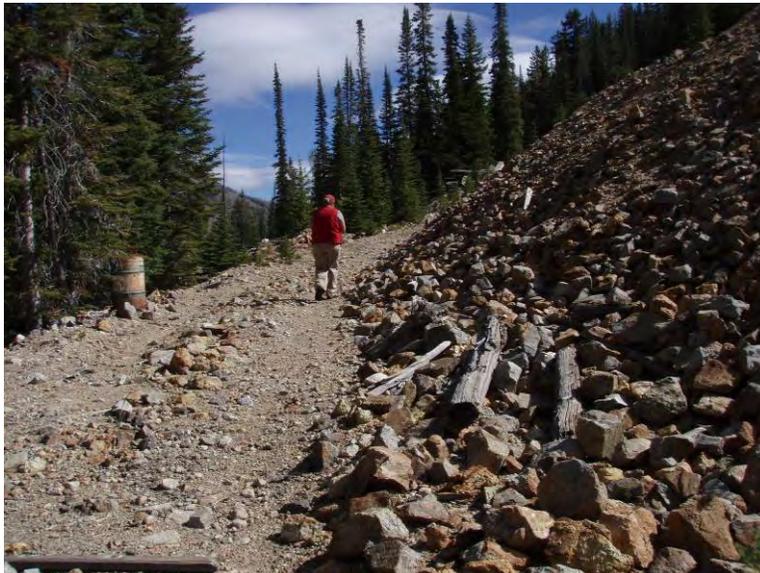
*Photo 45. Road out to the lower mill site and Webfoot 500' Level Adit. (Photo by Schuld 9/16/10)*

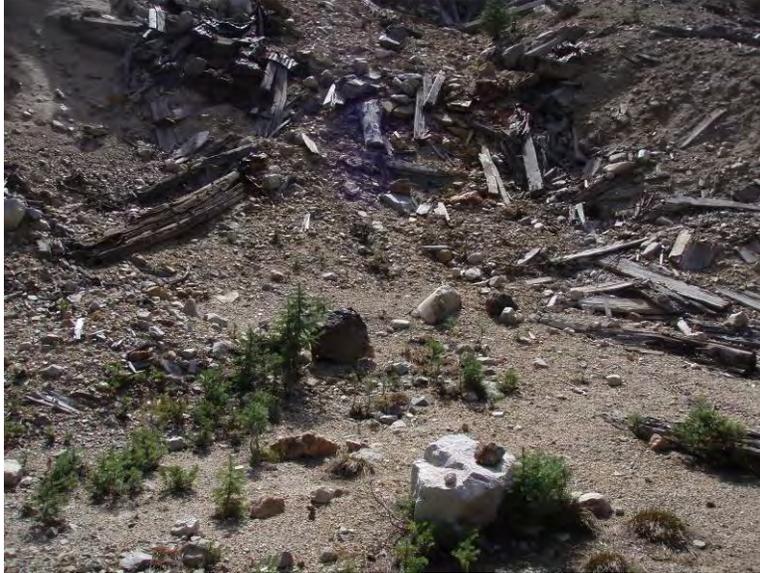
*Photo 46. Although the details are rather obscured, this appears to be the location of an adit, presumed to be a 500' Level Adit.  
(Photo by Schuld 9/16/10)*

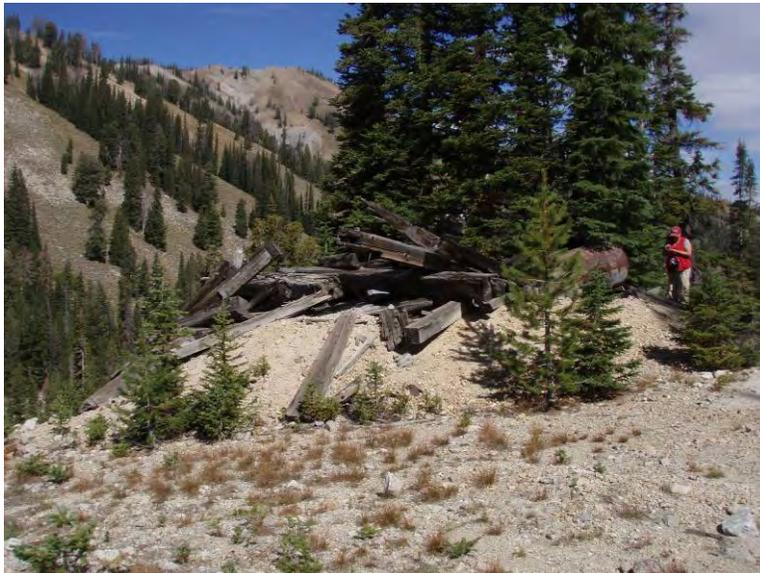
*Photo 47. This pile of timbers, just outside of the 500' Level Adit appear to have been part of the main Mountain King Mill building because of the remnants of tanks and plumbing material in the pile. (Photo by Schuld 9/16/10)*

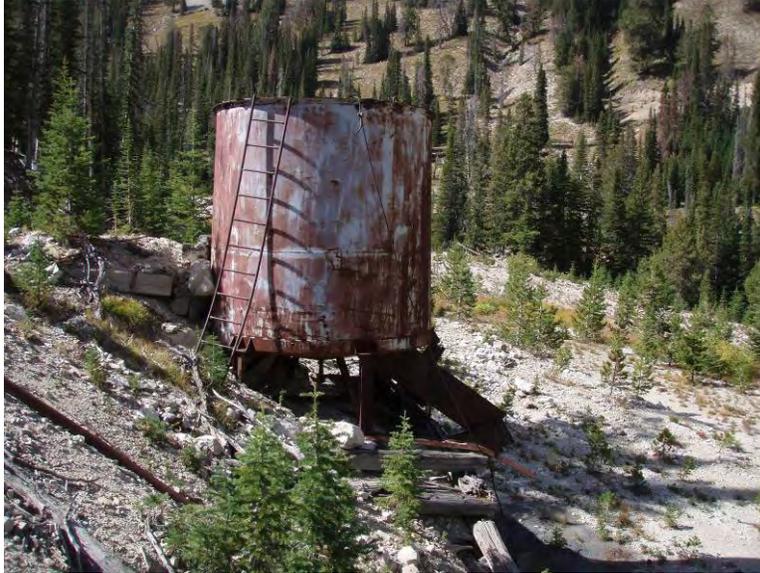
*Photo 48. Processing tank for Mountain King Mill.  
(Photo by Schuld 9/16/10)*

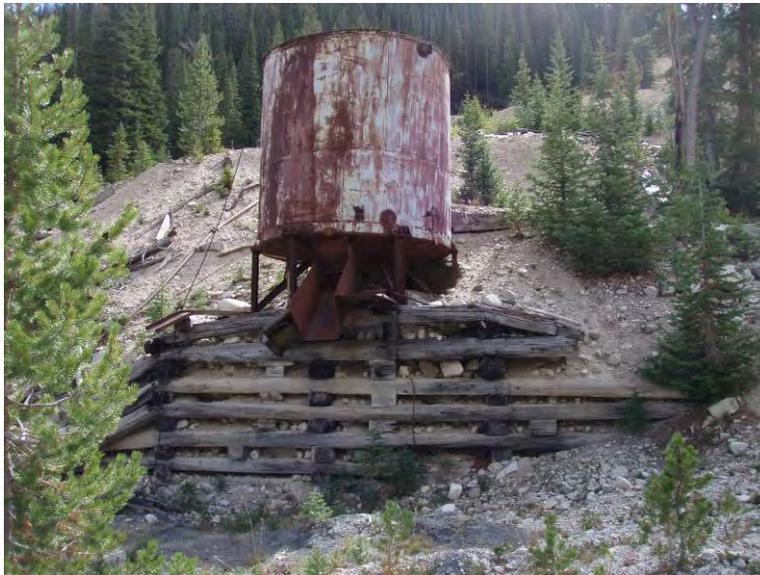
*Photo 49. Processing tank for Mountain King Mill.  
(Photo by Schuld 9/16/10)*

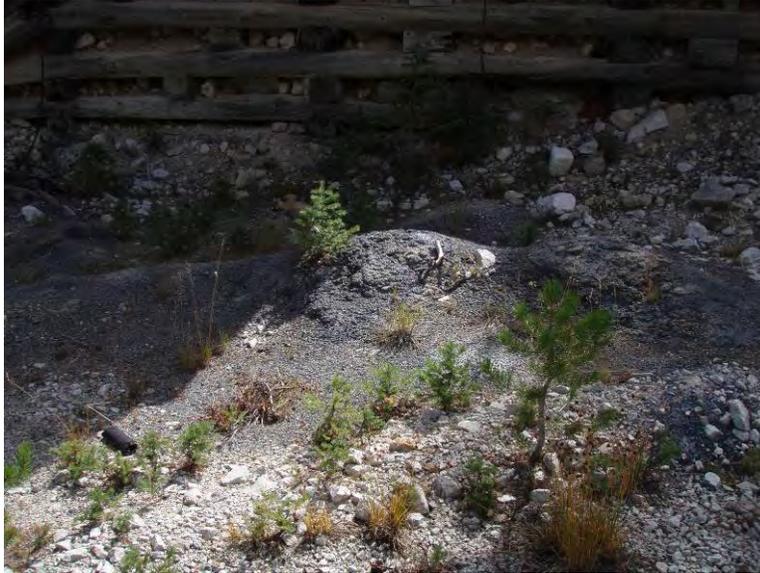
*Photo 50. Unidentified mill waste found at base of process tank.  
(Photo by Schuld 9/16/10)*

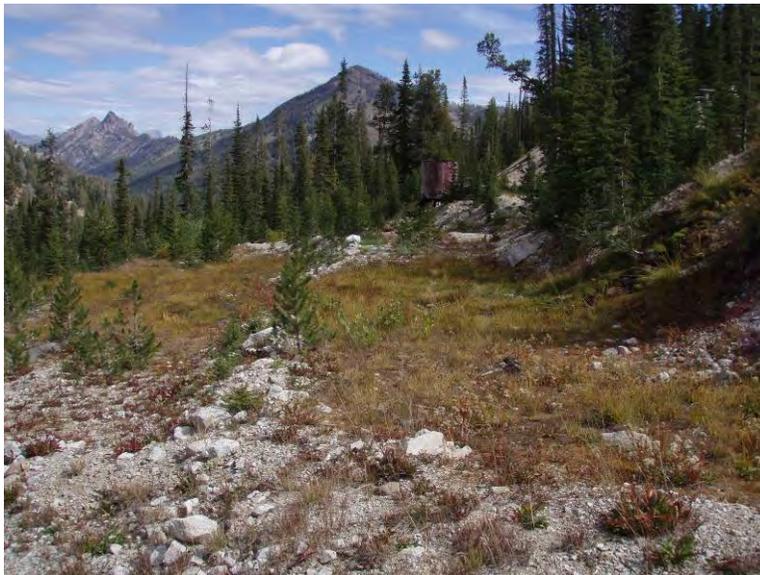
*Photo 51. Lower benches at Mountain King Mill Site.  
(Photo by Schuld 9/16/10)*

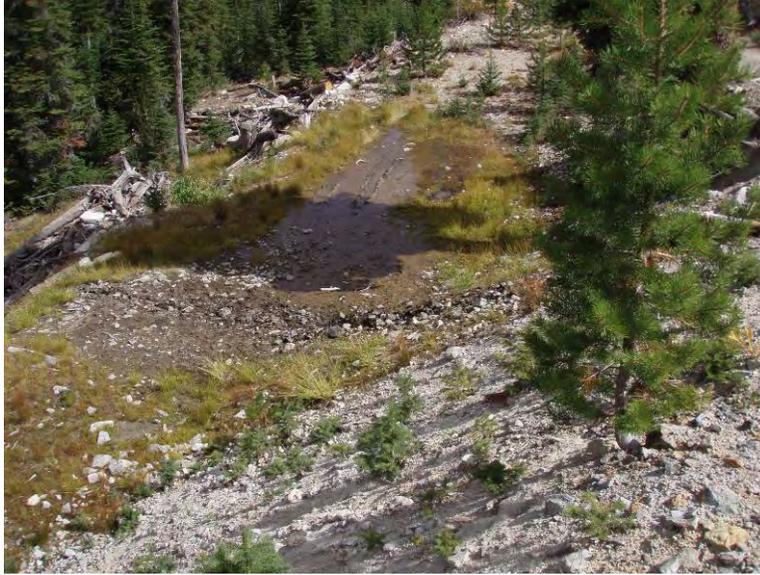
*Photo 52. Adit water crossing the lower benches at Mountain King Mill Site.  
(Photo by Schuld 9/16/10)*

The water course has been tracked from the Webfoot 400' Level Adit across the 400' and 500' Level waste dumps to Smiley Creek. Because the waste dumps represent additional sources for contamination, wastes and water at the toe of the dump was sampled on September 13, 2010 during a tour of the property with the owners (samples WFWD2SS1 and WFWD2SW1). It should be noted that until the Webfoot was surveyed in greater detail, the sample designation was for a Waste Dump #2 (WD2) instead of the more proper designation 500' Level Waste Dump (500LV) as used with other samples collected on September 16, 2010.

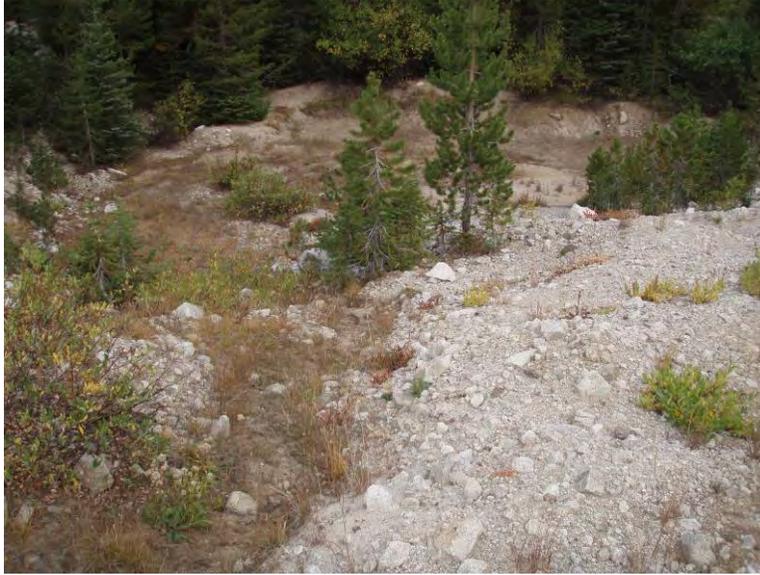
*Photo 53. A tailings impoundment below Webfoot 500' Level Waste Dump and Mill Site may be effective at times as a sediment pond, but the drainage to Smiley Creek has since been short circuited around this sump (sample WFMSSS1). (Photo by Schuld 9/14/10)*

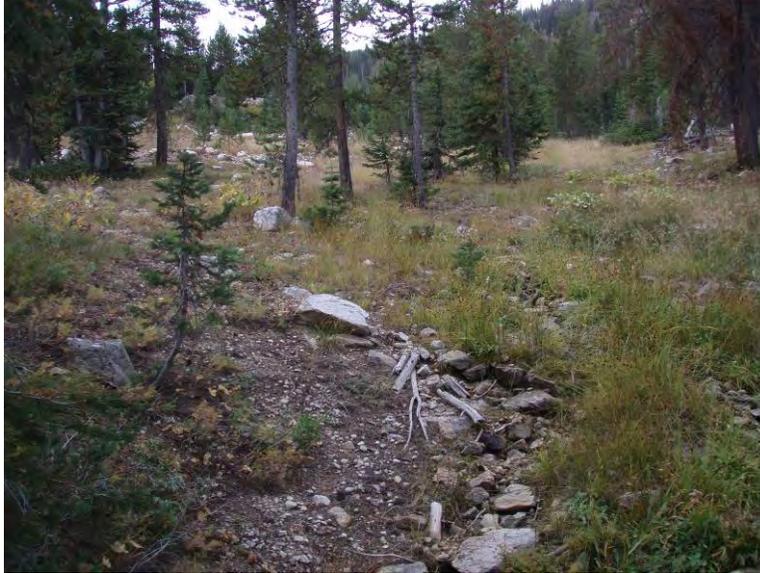
*Photo 54. Approximately 200 feet west of the 600' Level Waste Dump is a gully that constantly carries drainage from the 400' Level Waste Dump to Smiley Creek. (Photo by Schuld 9/14/10).*

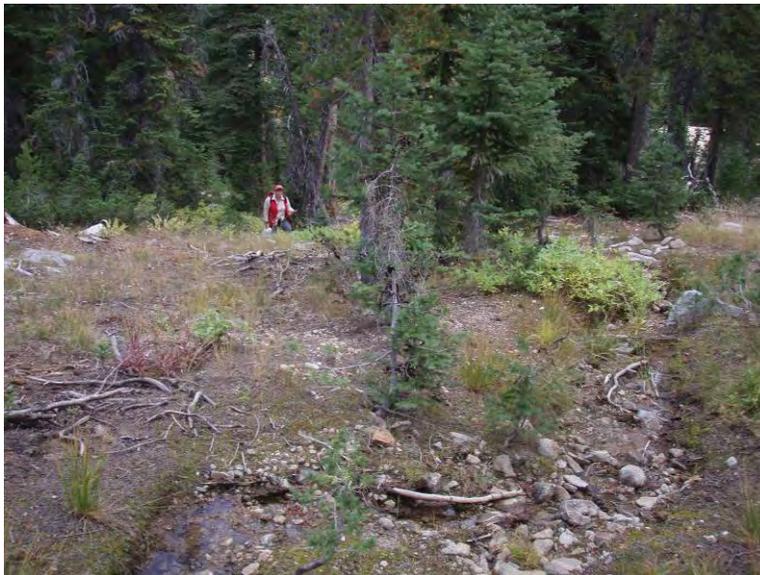
*Photo 55. Approximately 200 feet west of the 600' Level Waste Dump is a gully that constantly carries drainage from the 400' Level Waste Dump to Smiley Creek. Coincidentally, this photo shows a small stand of trees surrounding several patented claim corners for the California, Flagstaff, and Alturas lodes. (Photo by Schuld 9/14/10)*

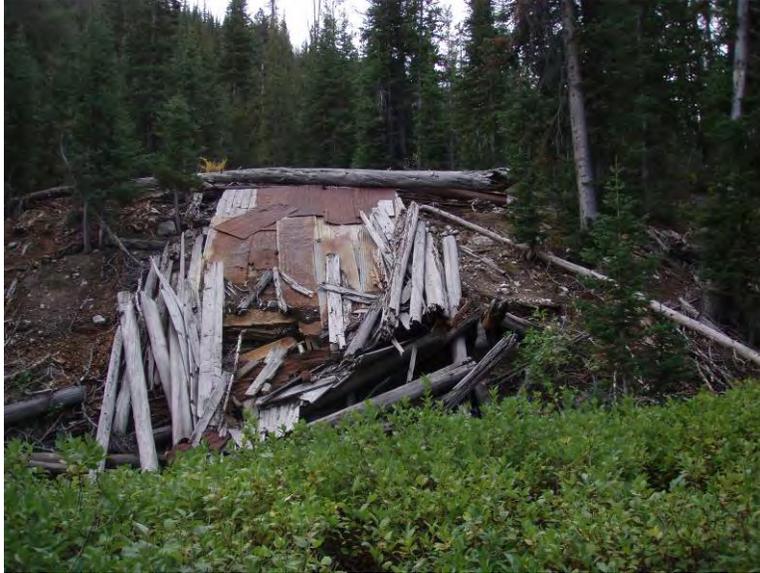
*Photo 56. Old ore chute on west side of Webfoot 600' Level Waste Dump.  
(Photo by Schuld 9/14/10)*
