# **VIENNA MINING DISTRICT**

## **PRELIMINARY ASSESSMENT AND SITE INSPECTION REPORT**

Blaine and Camas Counties  
State of Idaho

November 2010

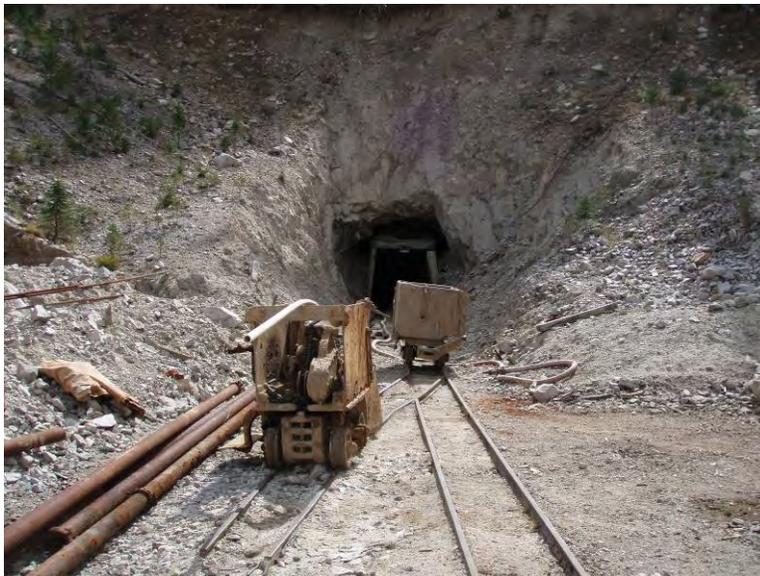
*Photo 57. Webfoot 600' Level Adit. (Photo by Schuld 9/16/10)*

The Webfoot 600' Level Adit and Waste Dump facilities are being redeveloped for new underground production. Underground workings are being rehabilitated, and there is an intention to reconnect the 600' and 400' levels for safety and other operational purposes. A new muck pile has been developed adjacent to the adit while the "old" waste dump is being excavated and redeveloped for more appropriate storage of wastes and loading of ores for shipment. The 600' Level Adit discharge at the time of DEQ's visit is approximately 20 gpm. The effluent was sampled (sample WF600LVS1) at Lat. 43.80853° N, Long. 114.84258°W.

Regarding the drainage, DEQ has recommended some thought be given to creating a French drain and infiltration gallery parallel to the access road to discharge mine water. The waste rock

dump can then be extended eastward over the french drain allowing mine waters to infiltrate the gallery without contacting mine waste rock.

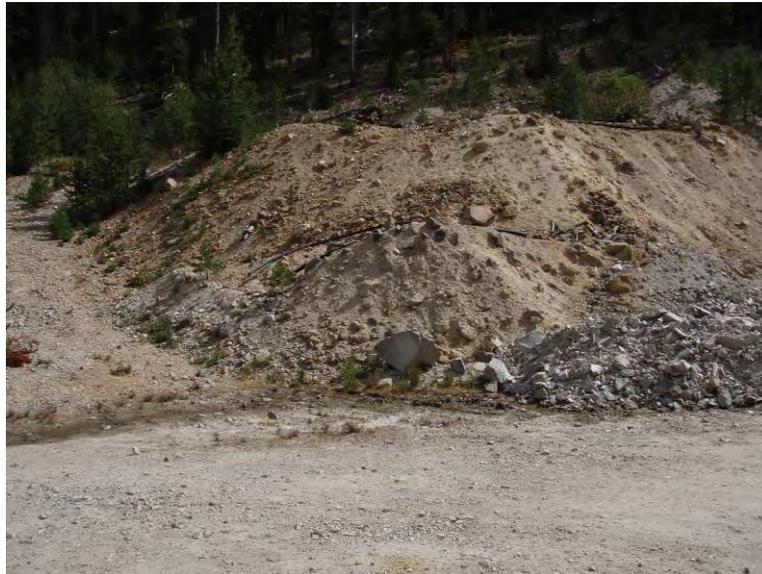
*Photo 58. Muck pile adjacent to Webfoot 600' Level Adit.  
(Photo by Schuld 9/16/10)*

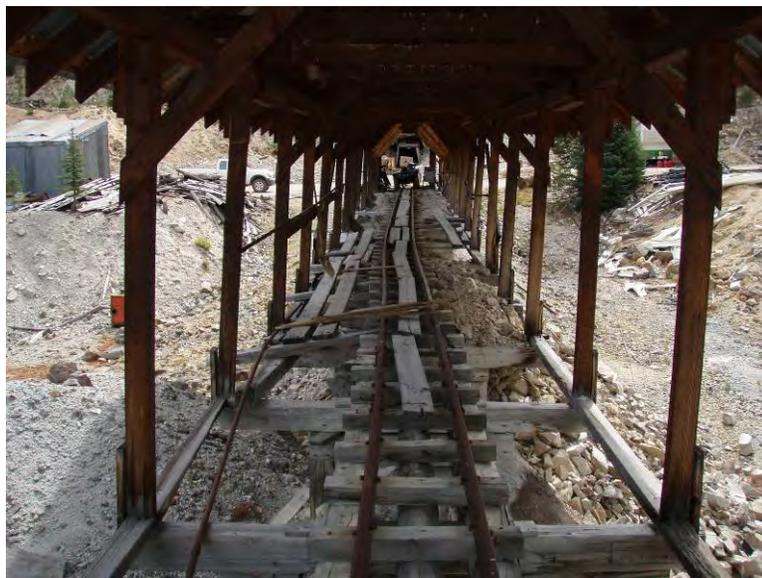
*Photo 59. Covered trestle over Webfoot 600' Level Waste Dump.  
(Photo by Schuld 9/16/10)*

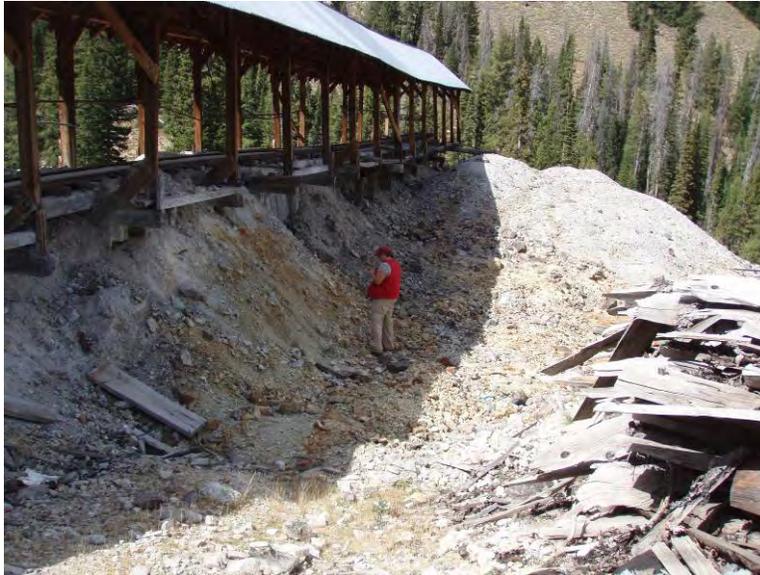
*Photo 60. The Webfoot 600' Level Waste Dump location (sample WF600LVWDSS1). (Photo by Schuld 9/16/10)*

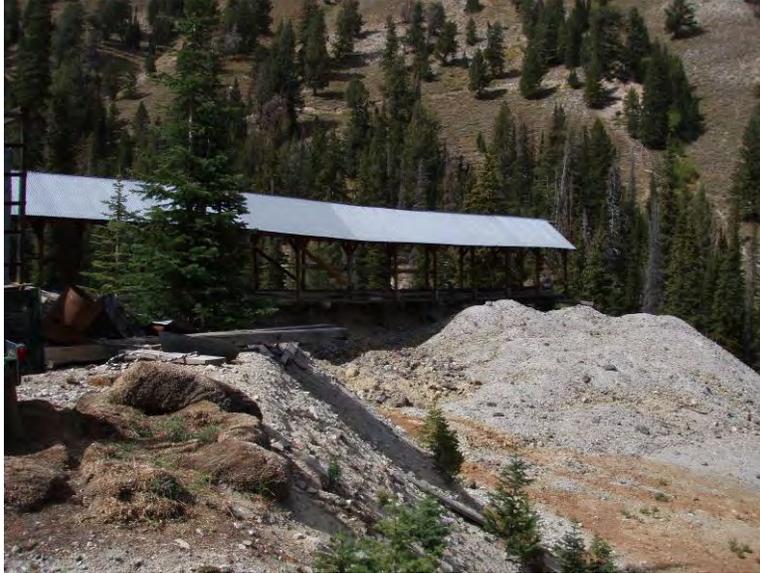
*Photo 62. Covered Webfoot 600' Level trestle and waste dump.  
(Photo by Schuld 9/16/10)*

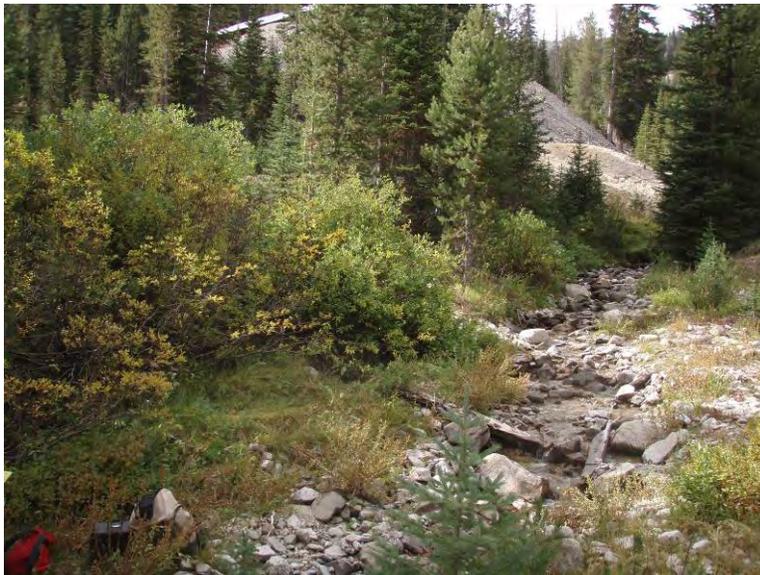
*Photo 63. The Lower Webfoot Mine and Mill Site has both mine wastes and tailings eroding into and possibly leaching into Smiley Creek below the site.  
(Photo by Schuld 9/14/10)*

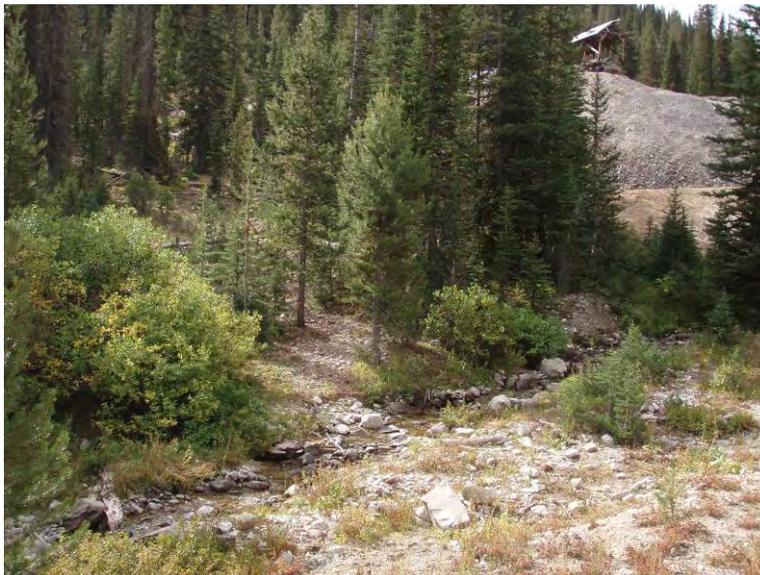
*Photo 65. Webfoot 600' Level Mine Waste Dump and PPE on Smiley Creek. (Photo by Schuld 9/14/10)*

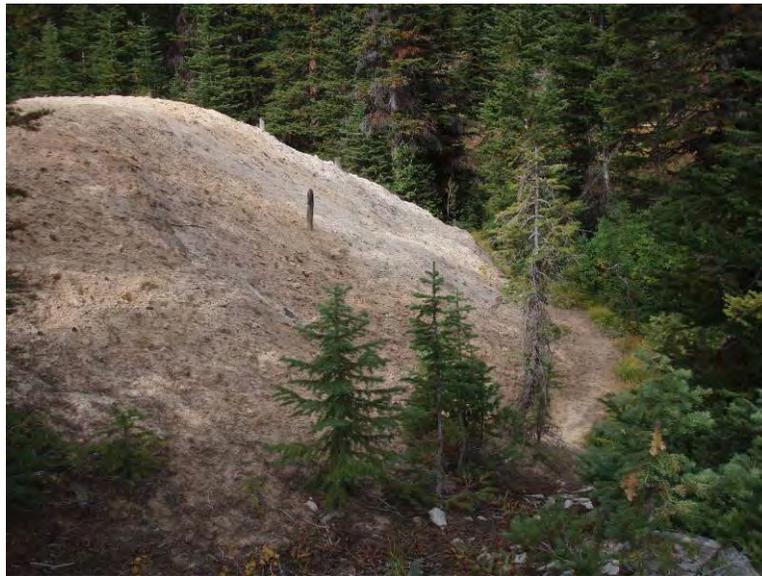
*Photo 66. Mountain King Mill tailings were found in two distinct piles below the Webfoot 600' Level Waste Dump. (Photo by Schuld 9/14/10)*

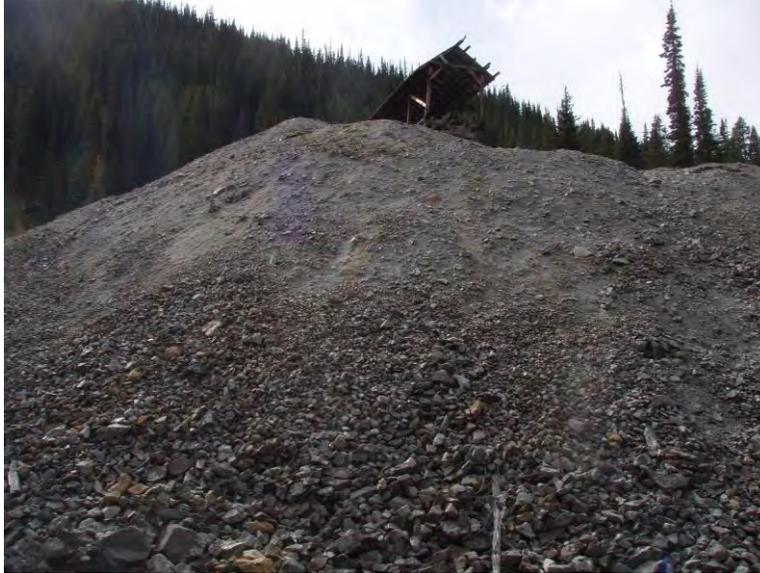
*Photo 67. Looking up the Webfoot 600' Level Waste Dump from the mill tailings pile. (Photo by Schuld 9/14/10)*

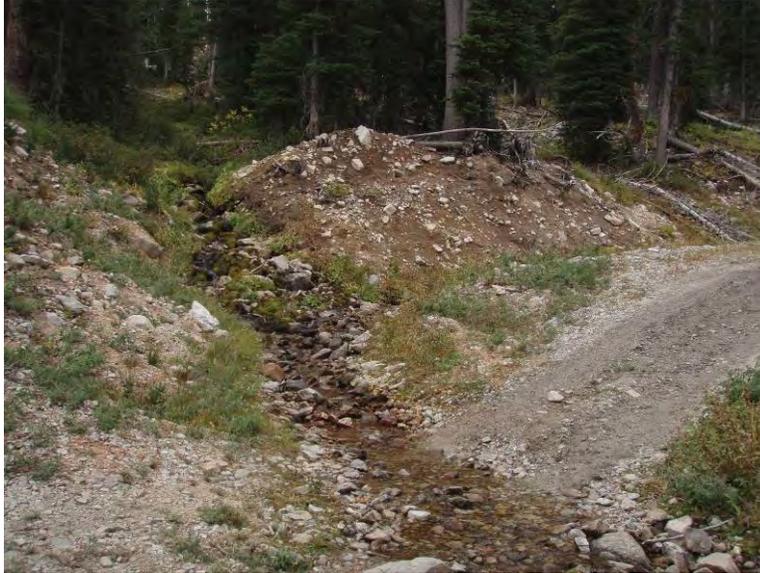
*Photo 70. Confluence of Smiley Creek and drainage from the Numa (possible Vienna East Ext.) Tunnel. Water sample SMCSW4 was collected at Lat. 43.80228°N, Long. 114.84666°W. (Photo by Schuld 9/14/10)*

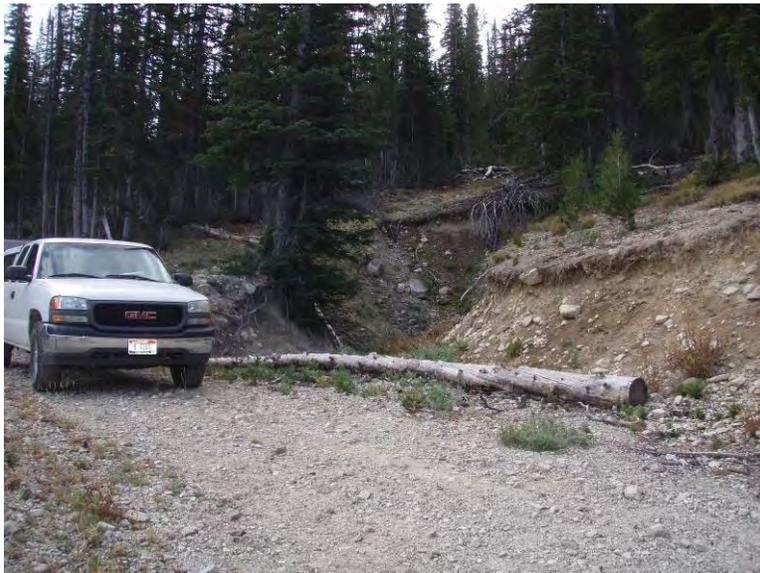
*Photo 71. The Numa Tunnel's adit is a collapsed feature along the main road to the Vienna and Solace mines. (Photo by Schuld 9/14/10)*

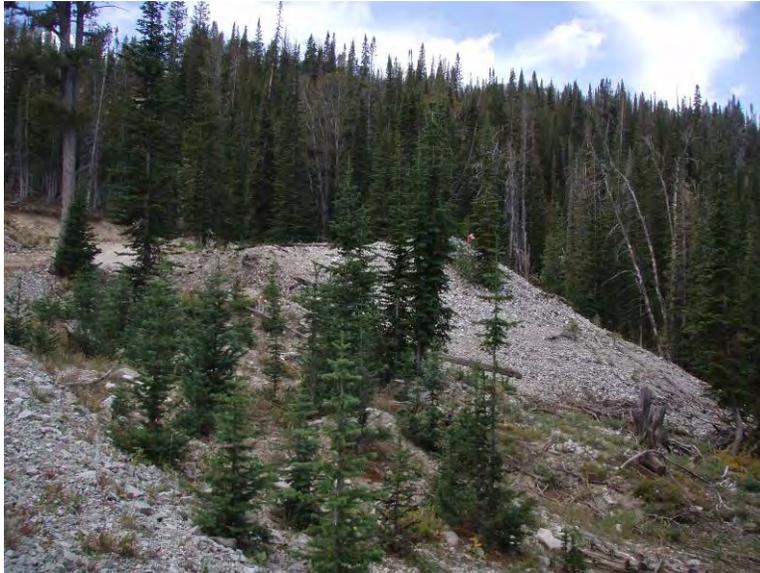
The Numa Tunnel was found at a collapsed structure at Lat. 43.80228°N, Long. 114.84666°W. Its waste dump contains approximately 1,000 cubic yards. Drainage from the collapsed adit is less than 20 gallons per minute (sample NTADSW1). The waste rock found on the dump appears to be only slightly altered granodiorite with very little evidence of sulfide or oxide minerals. The waste rock was not sampled.

*Photo 72. Numa Waste Dump. (Photo by Schuld 9/14/10)*

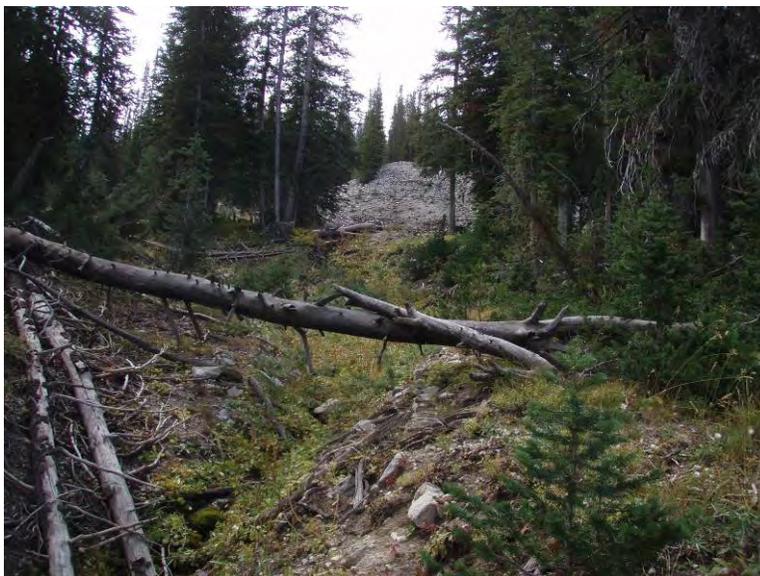
*Photo 73. Most of the drainage from the Numa Adit flows towards the confluence with Smiley Creek as discussed previously, but some seeps through the waste dump and was sampled at Lat. 47.79975°N, Long. 114.84652°W (Sample NTWDSW1). (Photo by Schuld 9/14/10)*

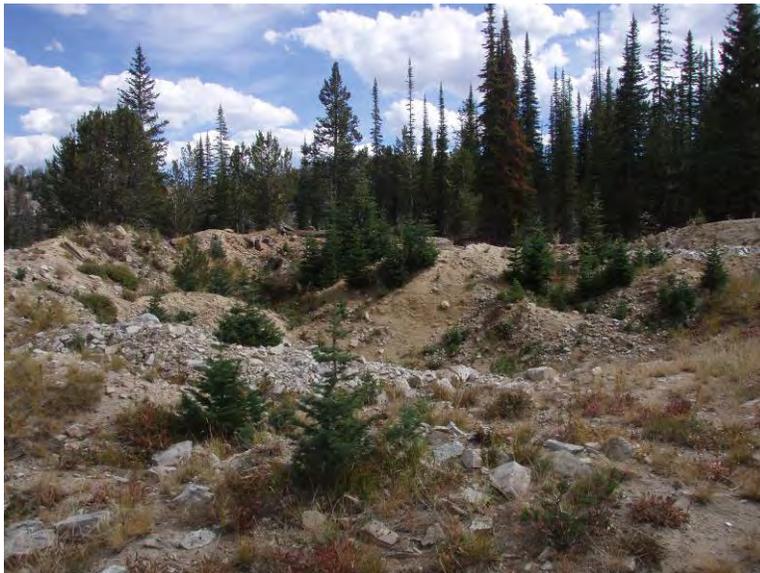
*Photo 77. The lowest waste dump, Vienna Waste Dump #1, has been dramatically altered by dozer exploration and probably sampling. (Photo by Schuld 9/13/10)*

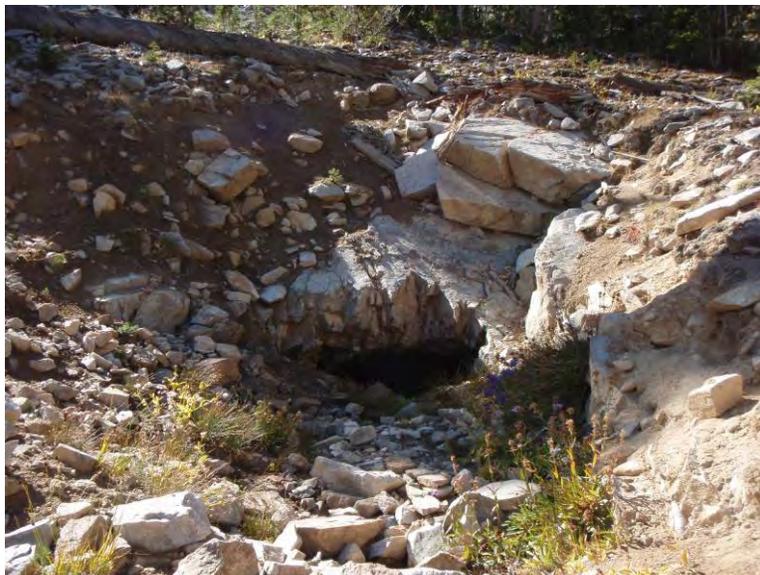
Vienna Adit #1 is an open adit with no visible signs of drainage. Although access to the property is restricted this is a dangerous physical hazard. The adit is located at Lat. 43.80403°N, Long. 114.85198°W.

*Photo 79. Vienna Adit #1. Open adit. No sign of water coming from adit. No  
apparent connection to a surface water pathway. Lat. 43.79401°N,  
Long. 114.84397°W. (Photo by Elayer 9/15/10)*

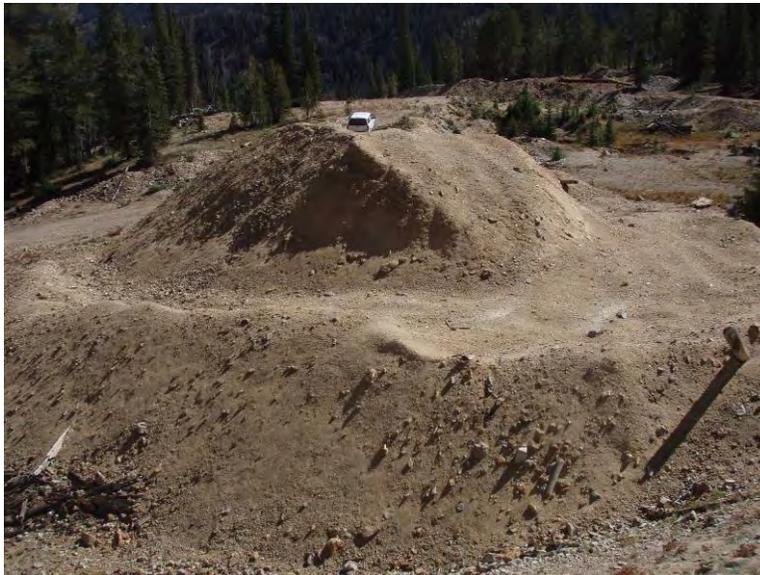
*Photo 81. Looking down on one of the lobes of Vienna Waste Dump #2 from the collapsed Vienna Adit #2. The dump was sampled (Sample VWD2SS1). (Photo by Schuld 9/15/10)*

Waste Dump #2, located at Lat. 43.80452°N, Long. 114.85287°W, has two separate lobes each of which exceeds 1,000 cubic yards of wastes. The waste dump(s) which are dominated by highly altered granodiorite, quartz stock work vein material, chlorite, and both sulfides and oxides was sampled. Sample VWD2SS1 is a composite of 60 samples, each approximately four cubic inches, of wastes collected approximately every 10 feet around the base of the two lobes of the waste dump. The sample was screened through a 9 mesh sieve, bagged, and tumbled to blend the various portions making up the composite.

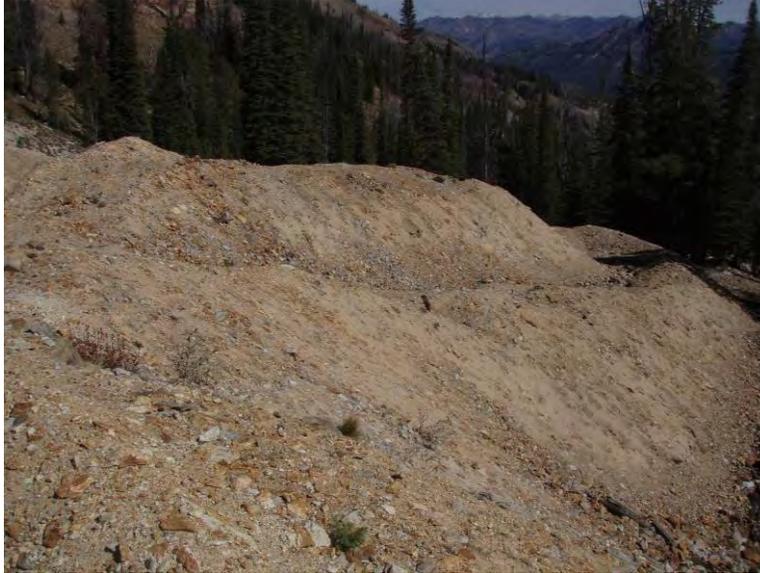
*Photo 82. The second lobe of Vienna Waste Dump #2 is just slightly north of the first lobe. (Photo by Schuld 9/15/10)*

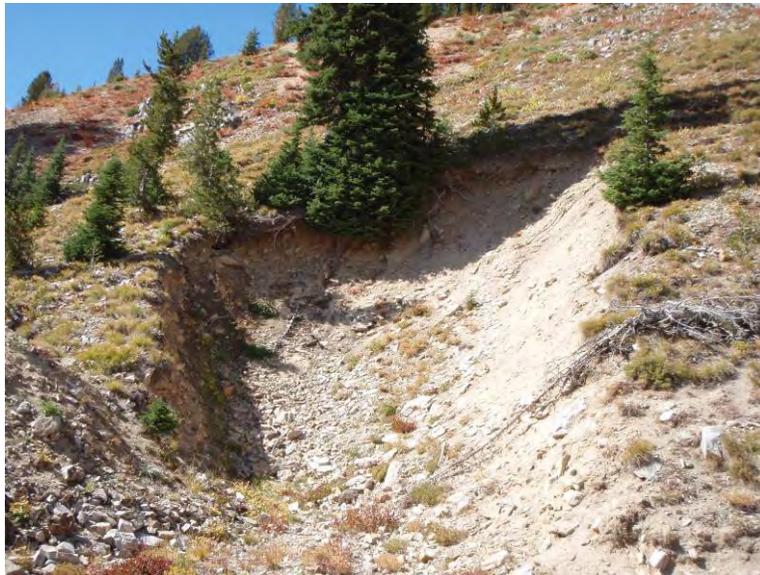
*Photo 83. Caved Vienna Adit #2. (Photo by Schuld 9/15/10)*

There are no signs of discharge from the caved Vienna Adit #2.

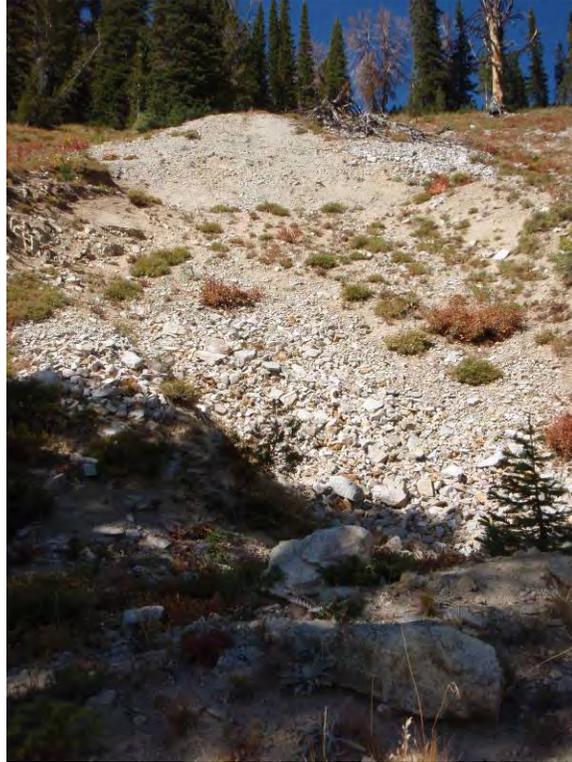
*Photo 84. Caved Vienna Adit #3 is located at Lat. 43.80547°N, Long. 114.85312°W. (Photo by Elayer 9/15/10)*

There is no apparent discharges of water from Vienna Adit #3 and no apparent connection of the waste dump to surface waters. Vienna Waste Dump #3 contains less than 1,000 cubic yards and is located at Lat. 43.80542°N, Long. 114.85294°W. The waste rock is dominated by altered granodiorite and vein materials. The dump was not sampled.

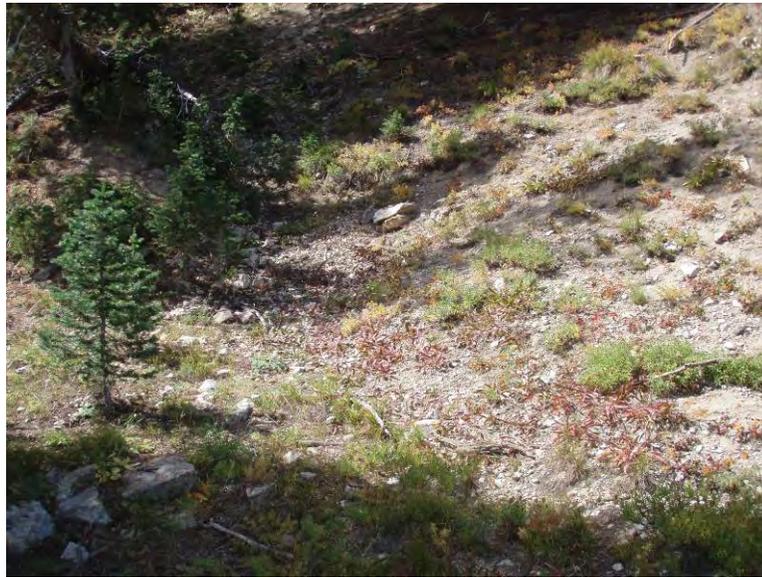
*Photo 86. Caved Vienna Adit #4 and waste dump.  
(Photo by Schuld 9/15/10)*

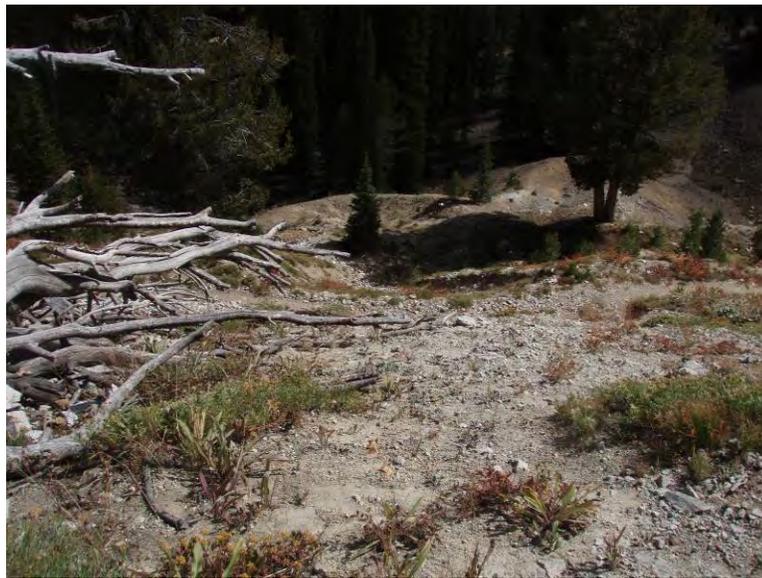
*Photo 88. Cat cut above the Vienna Mine along the ridgeline.  
(Photo by Schuld 9/15/10)*

On the ridge line above the Vienna and Nellie extension, a very long cat cut was excavated by bulldozer. The cat cut is marked in the distance on the Nellie extension Claim by the separation of the tree lines which looks similar to that seen along power line trails.

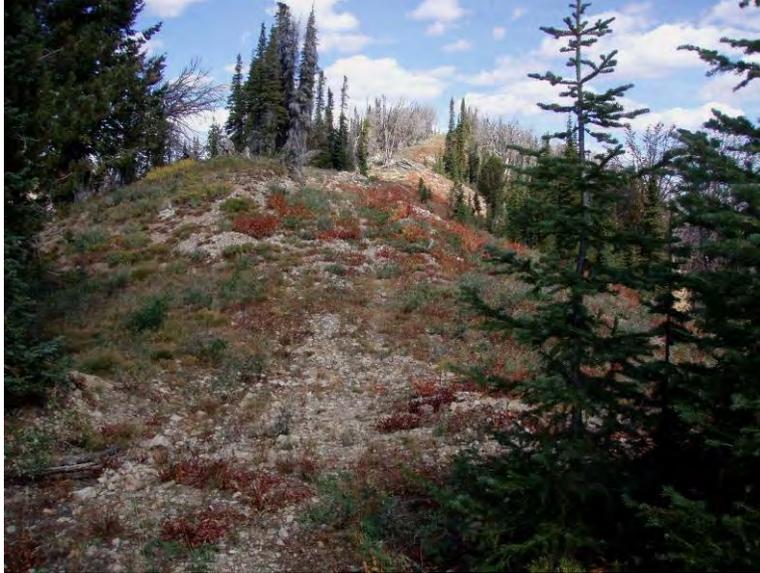
*Photo 89. The cat cutting above the Vienna workings has exposed a rather dramatic view of the Vienna Vein. (Photo by Schuld 9/15/10)*

The Vienna Vein outcrop exposed by the cat cut is located at Lat. 43.80499°N, Long.114.85445°W. The outcrop contains large altered fragments of granodiorite, quartz stringers, and massive sulfides. A portion of this area that may have been used as a drilling station has been regraded and seeded. In a conversation with Allen Jones, Allen said the man who did a lot of the cat work was a local resident by the name of Earl Waite.

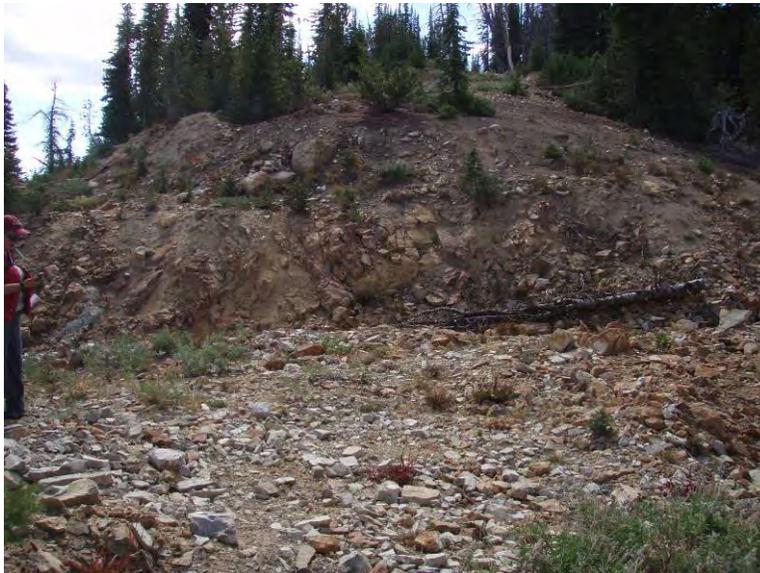
Vienna Adit #5 located at Lat. 43.80161°N, Long. 114.85430°W is not much more than a “dog hole” with less than 50 cubic yards of wastes on the dump.

*Photo 90. The cat cutting on the Vienna Vein has completely buried the uppermost Vienna Adit #5. The waste dump, upon which the photographer is standing, is still visible. (Photo by Schuld 9/15/10)*

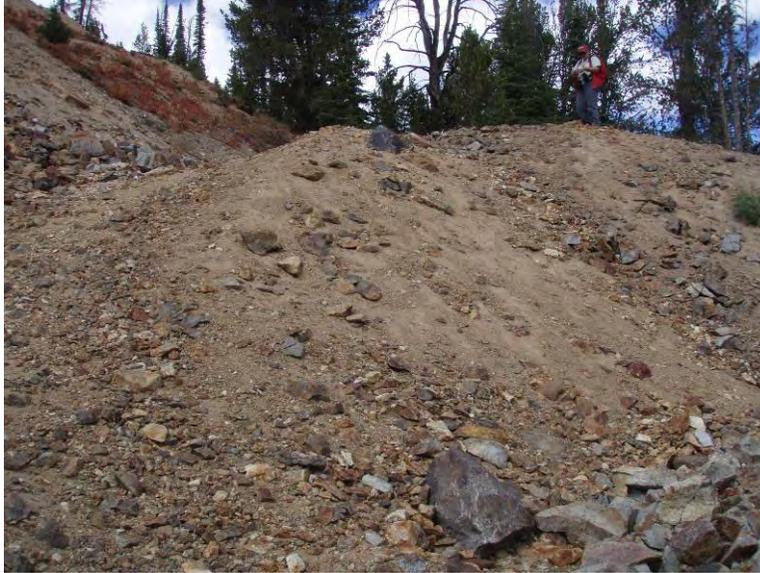
*Photo 91. Looking down past the buried Vienna Adit #6 to the Vienna Adit #7. Both of these adits are collapsed. Also notable is Waste Dump #6 and Waste Dump #7. (Photo by Schuld 9/15/10)*

Vienna Adit #6 located at Lat. 43.80408°N, Long. 114.85354°W is not much more than a “dog hole” with less than 100 cubic yards of wastes on the dump.

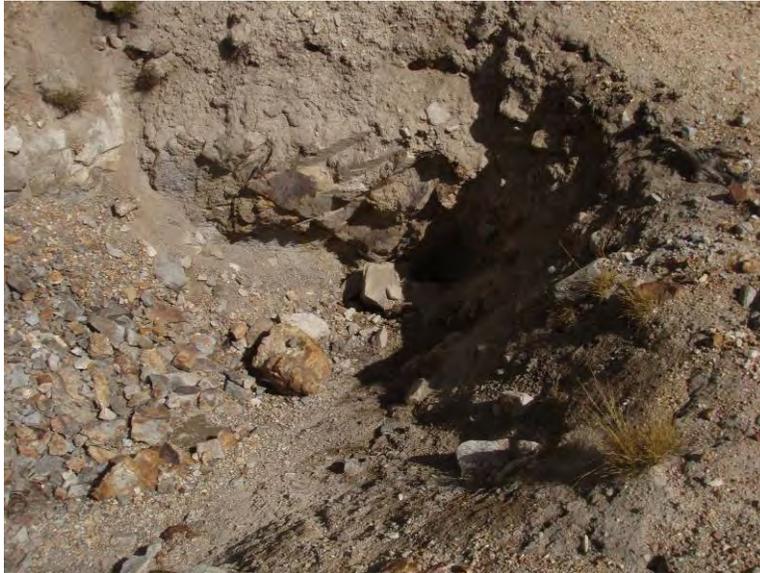
*Photo 92. Adjacent to the toe of Vienna Waste Dump #8 is an open raise presumably driven up from Vienna Adit #1. The opening is partially blocked but could be a significant physical hazard. (Photo by Schuld 9/15/10)*

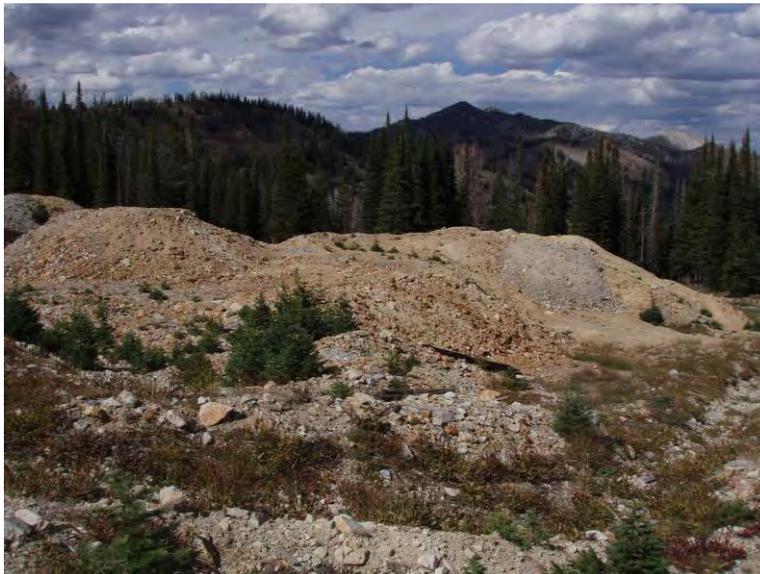
*Photo 95. Solace Mine waste rock. (Photo by Schuld 9/14/10)*

The stockpiled ore contains in excess of 2,000 cubic yards of highly altered granodiorite, stockwork, drusy quartz, and vein material with massive sulfides presumably containing argentite, tetrahedrite, proussite, sphalerite, and galena. Although localized staining indicates that some acid generation is occurring, it also appears, from the colors, localized buffering contains any migration of heavy metals from the stockpile or workings.

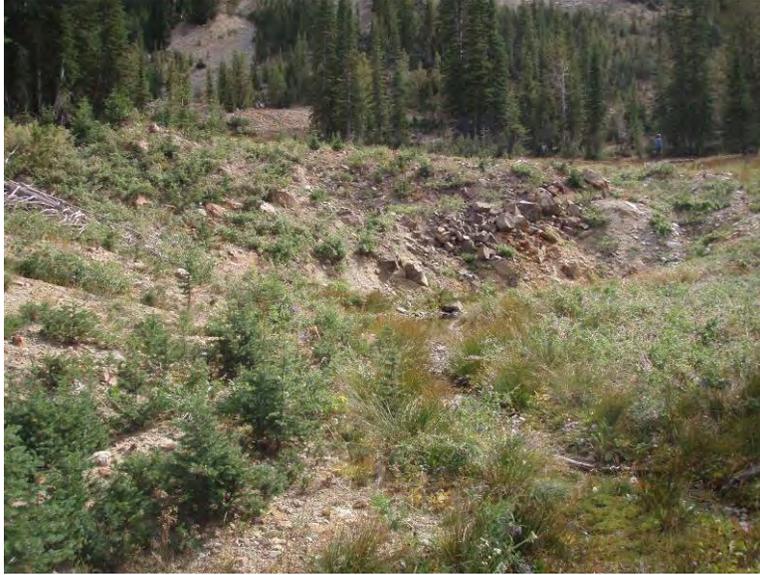
*Photo 97. Between the Emma and the Solace adits is an “unnamed adit” that produced less than 500 cubic yards of waste and is producing some water which was sampled at Lat 43.79837°N, Long. 114.84537°W (sample UKADSW1).  
(Photo by Schuld 9/14/10)*

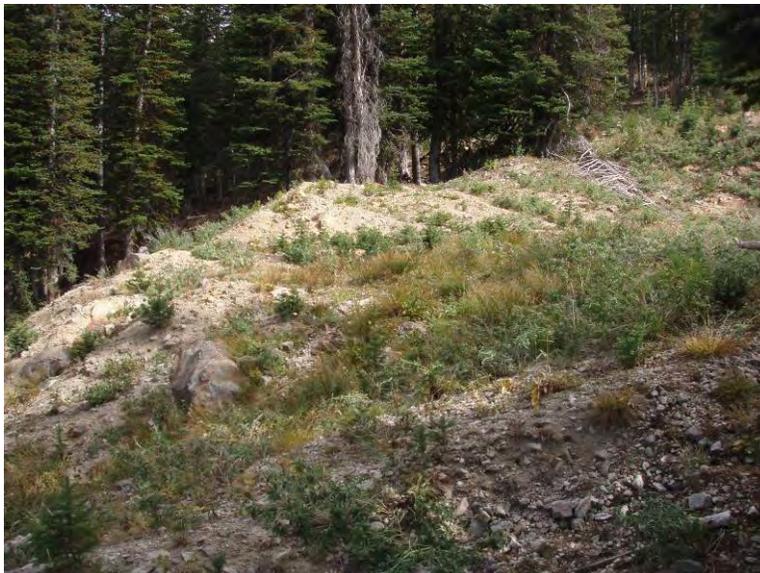
The Emma Tunnel Adit (ETAD) apparently produced at least 2,000 cubic yards of sulfide bearing waste. This is a very rough estimate as the waste dump has been spread over a large area of ground, possibly two acres in size, by a bulldozer.

The vast majority of the waste rock is moderately altered granodiorite bearing massive sulfides.

*Photo 99. Looking towards the collapsed Emma Tunnel Adit.  
(Photo by Schuld 9/15/10)*

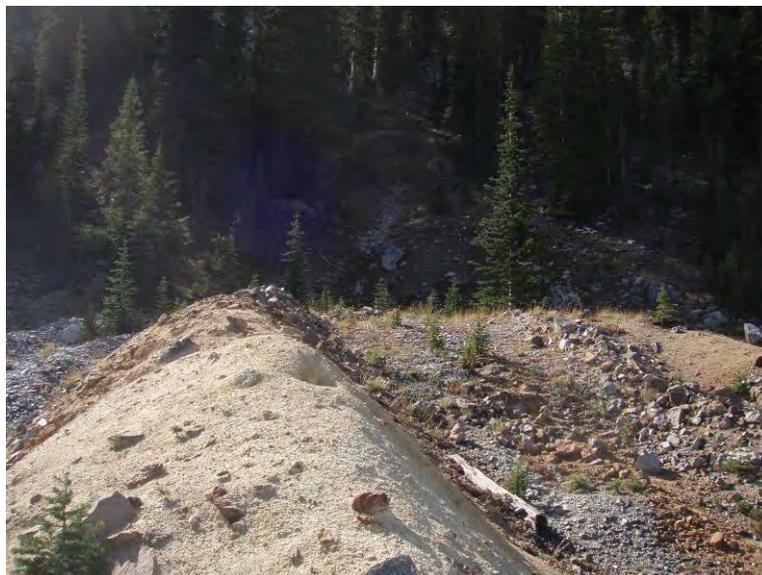
*Photo 100. Looking up the length of the remaining Emma Waste Dump #2  
towards the collapsed Emma Adit #2. (Photo by Schuld 9/15/10)*

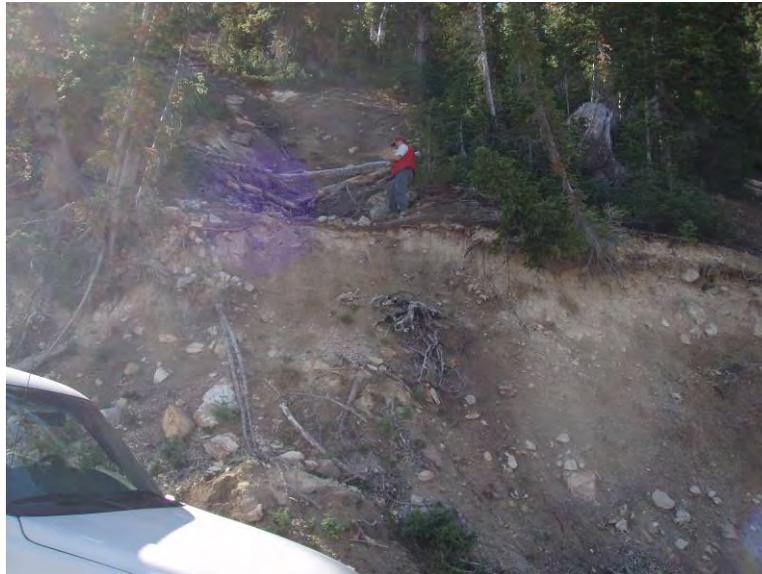
The DEQ designated Emma Adit #3 is located at Lat. 43.79707°N and Long. 114.84425°W. It was later determined to most likely be the Emma Decline Shaft discussed in historical reports and on the Emma Plat map. The 80 feet of reported workings probably produced less than 200 cubic yards of waste. The dump has been obliterated by the main mine road to the east side of Smiley Canyon. The caved collar of the Emma Decline Shaft is just above the roadway.

*Photo 101. The collapsed Emma Decline Shaft.  
(Photo by Schuld 9/15/10)*

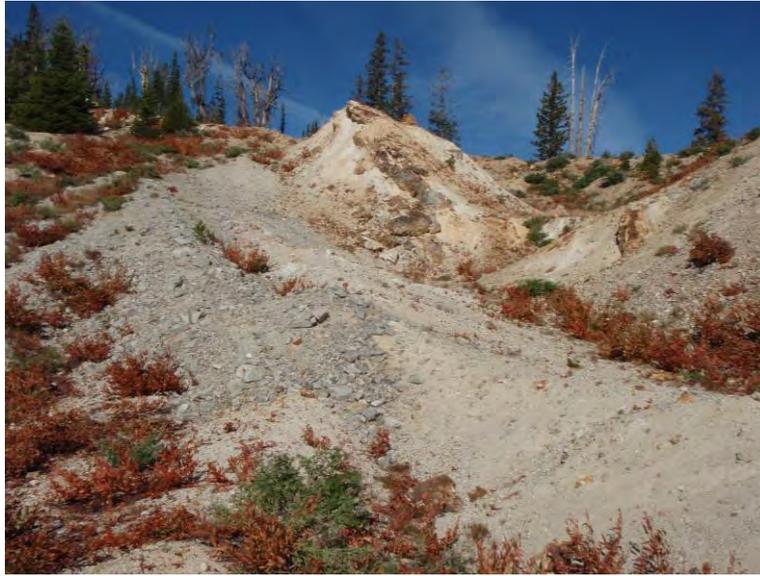
*Photo 103. Emma Adit #4. Waste Dump contains less than 200 cubic yards of waste. There is no evidence of water in adit. Lat. 43.79622°N, Long.114.84341°W (Photo by Elayer 9/15/10)*

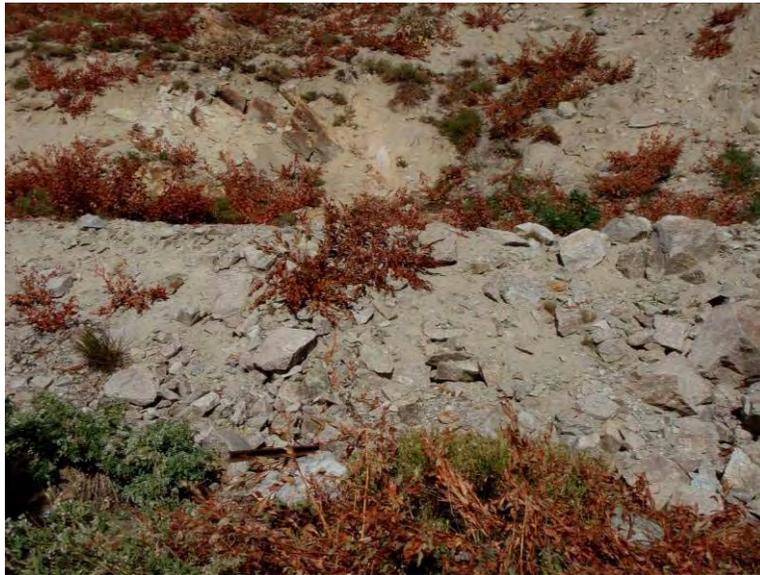
*Photo 105. Below Emma Adit #5 is a small bench and possibly where a loading platform was constructed. Perhaps the attempts to drive over to the Emma vein from this side of the mountain were partially successful.  
(Photo by Schuld 9/15/10)*

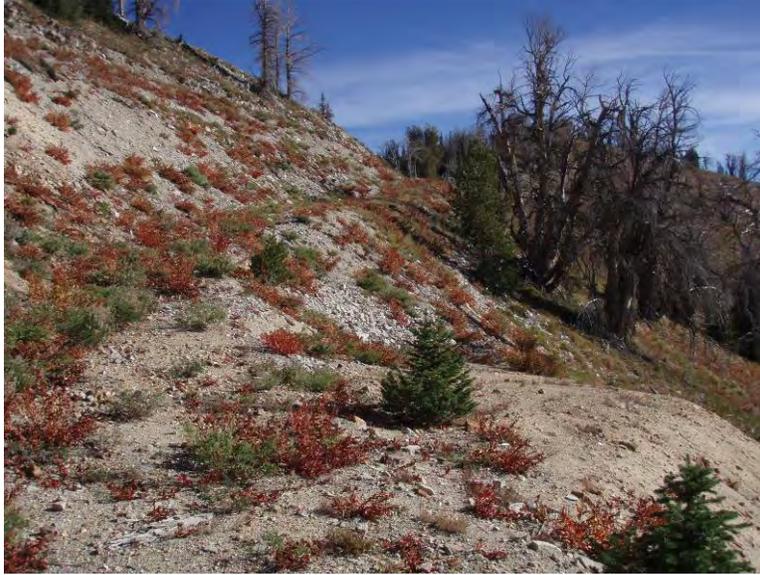
*Photo 106. Collapsed Emma Adit #5. (Photo by Schuld 9/15/10)*

The Emma adits and waste dumps #4 through #6 are located on the west side of the claim and face of the ridge dividing the claim roughly in two. The adits were presumably driven as an attempt to intersect the Emma Vein (?) from the south. All three are small collapsed features with less than 500 cubic yards of waste on all of the waste dumps combined.

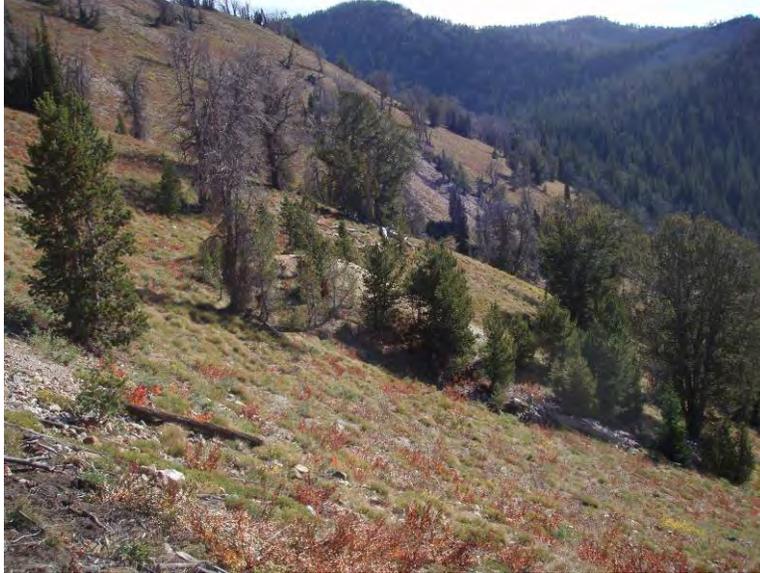
*Photo 108. Collapsed Emma Adit #6. (Photo by Schuld 9/15/10)*

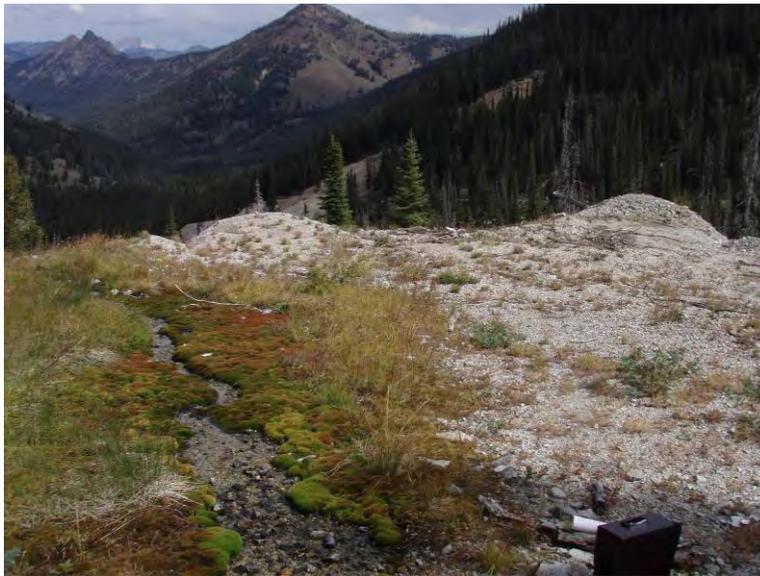
Regardless of the designation, the tunnel and waste dump were evaluated because of their adit discharge, waste volume, and connectivity to Smiley Creek. Because of the potential significance of the drainage, both through and around the dump to Smiley Creek, DEQ assessed the workings.

*Photo 109. The Coleman Waste Dump contains significantly less than 1,000 cubic yards of waste rock dominated by slightly altered granodiorite. (Photo by Schuld 9/14/10)*

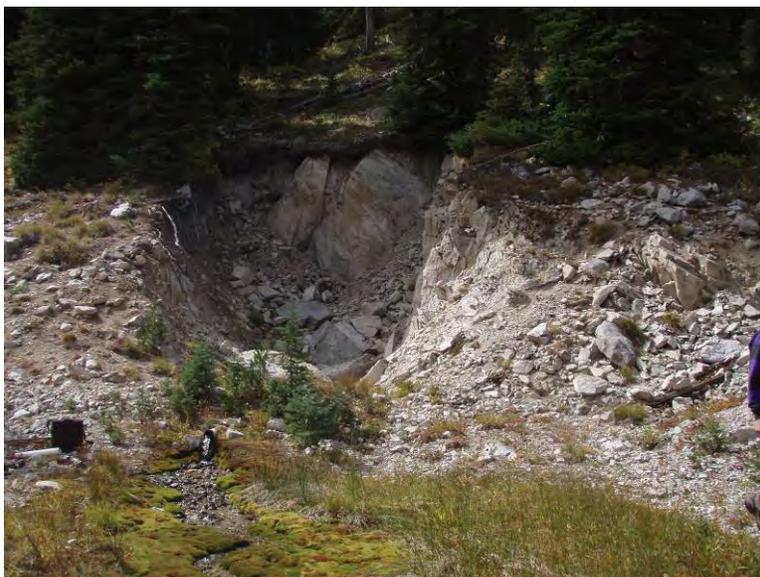
*Photo 110. Coleman Tunnel. (Photo by Schuld 9/15/10)*

The Coleman Tunnel may have been an attempt to locate deep intercepts of either the Emma or Vienna veins. It appears from the waste rock that Ross's interpretation of the tunnels located on the Numa, Coleman, and Rebellion may be correct in that they may have been intended to provide a route for dewatering the production levels.

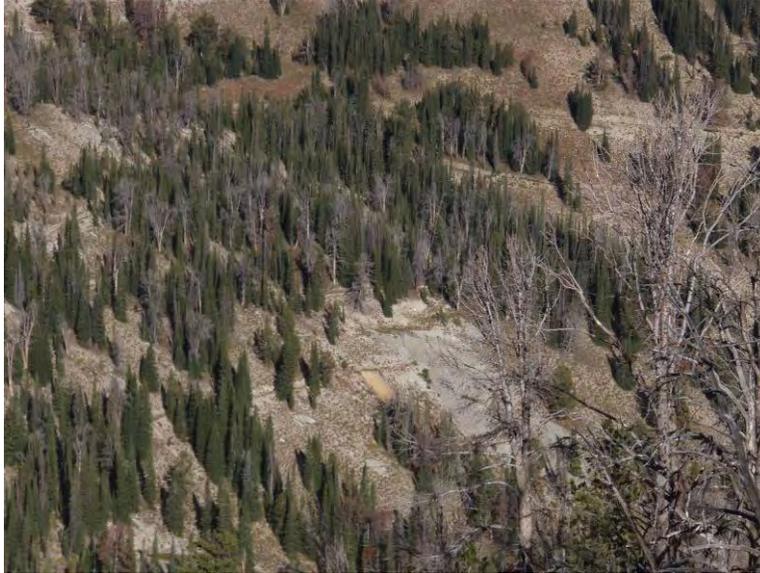
*Photo 111. Rebellion Tunnel and Waste Dump viewed from the upper Emma Mine site. (Photo by Schuld 9/15/10)*

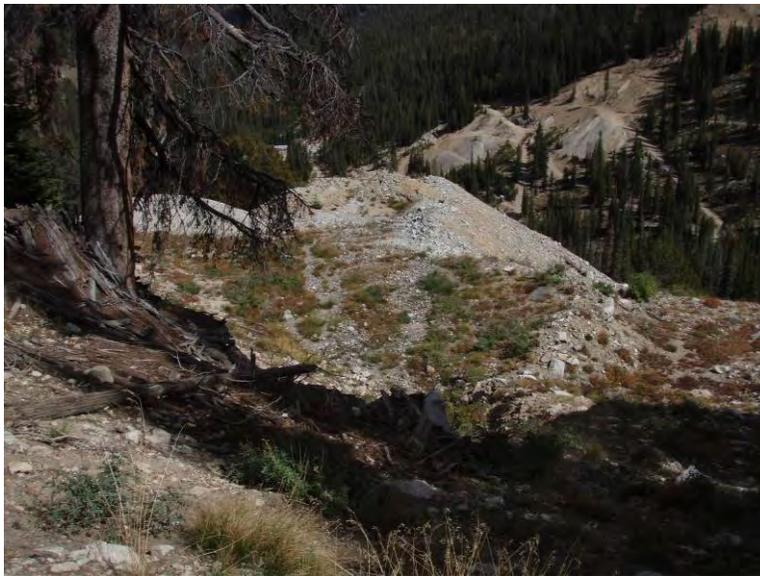
*Photo 112. Looking down on the Rebellion Waste Dump from the access road. (Photo by Schuld 9/15/10)*

The Rebellion Waste Dump contains approximately 3,000 cubic yards of material. The majority of the waste appears to be slightly altered granodiorite with few signs of alteration or sulfide minerals. A very small waste dump to the south has highly altered granodiorite and massive sulfides. The particles in this waste are well sorted and may have been run through a jig.

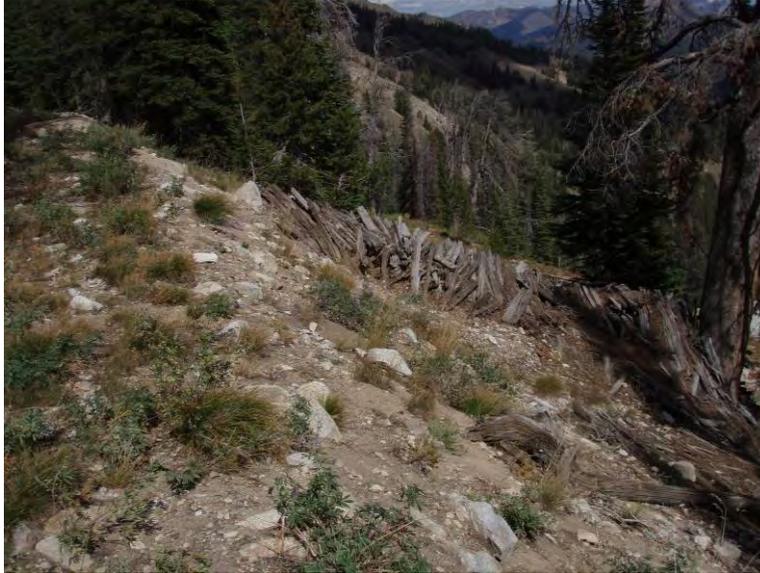
*Photo 113. Cord wood stacked above the Rebellion Adit.  
(Photo by Schuld 9/15/10)*

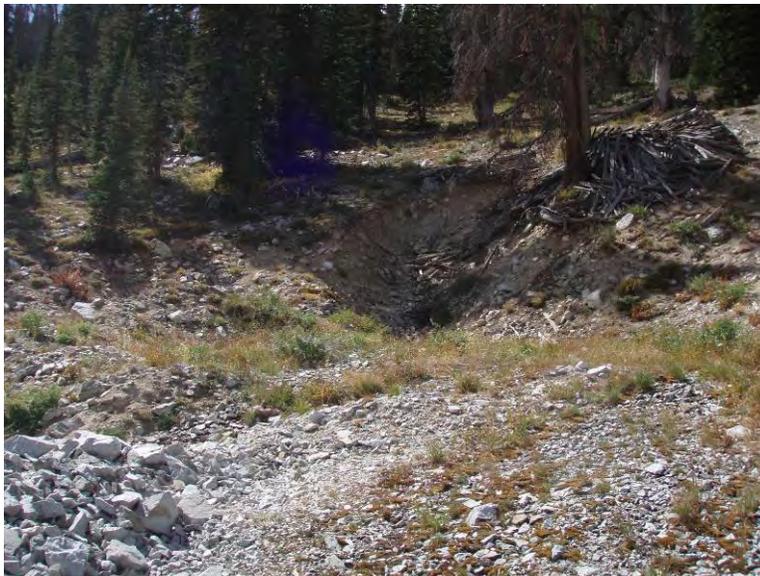
*Photo 114. Collapsed Rebellion Adit. (Photo by Schuld 9/15/10)*

The Rebellion Tunnel has a collapsed adit located at Lat. 43.80541°N, and Long. 114.84924°W. Although dry at the time of the investigation, there was evidence of an intermittent surface water pathway. Vegetation (sedges) is growing along the surface water pathway.

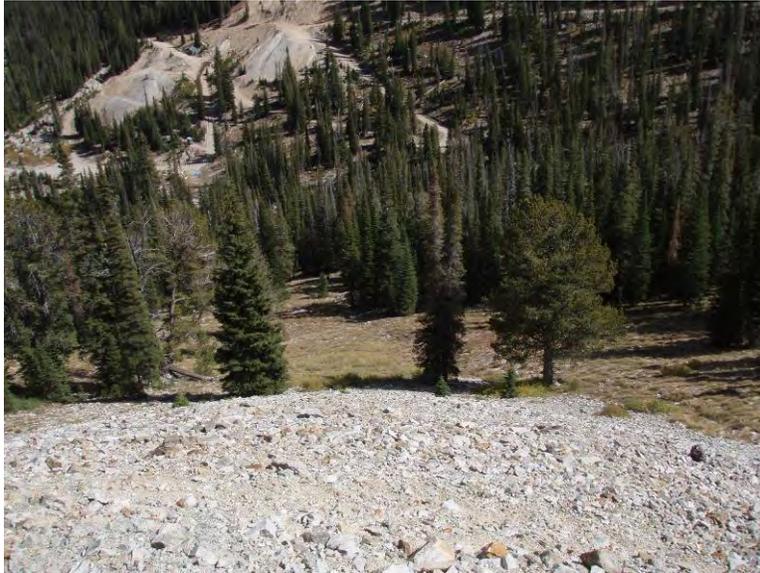
*Photo 115. Looking down the Rebellion Waste Dump towards the Webfoot Mine. (Photo by Schuld 9/15/10)*

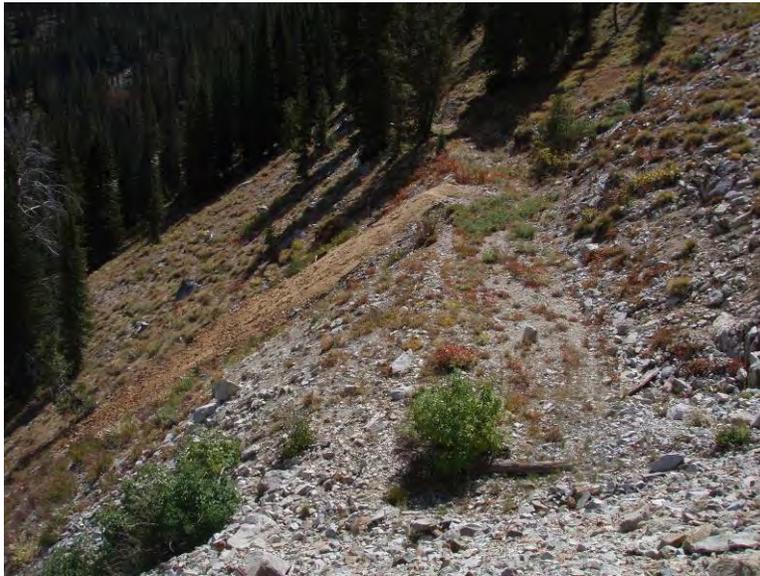
*Photo 116. Adjacent to the main Rebellion Waste Dump is approximately 5 cubic yards of what appear to be jig tailings. (Photo by Schuld 9/15/10)*

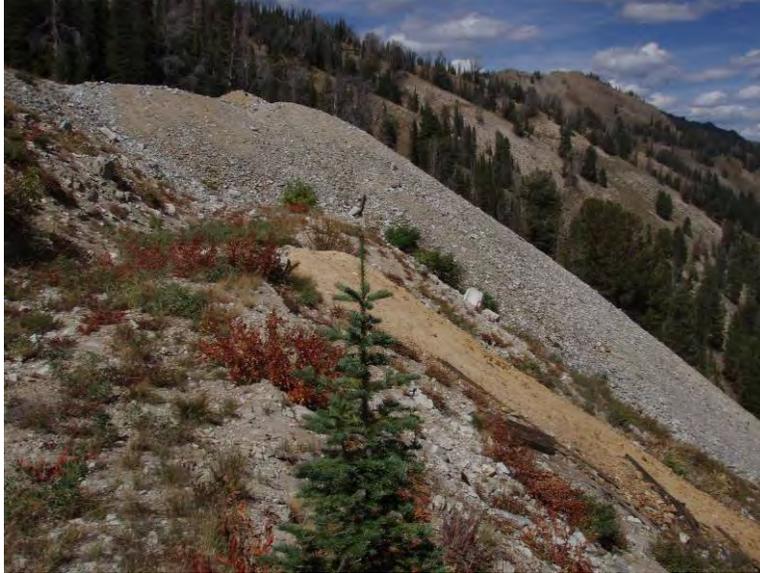
*Photo 117. Adjacent to the main Rebellion Waste Dump is approximately 5 cubic yards of what appear to be jig tailings.  
(Photo by Schuld 9/15/10)*

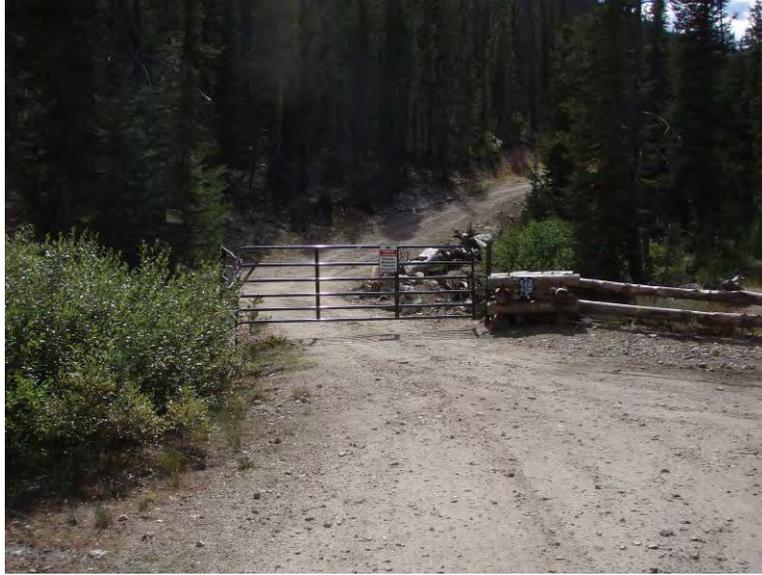
*Photo 118. Locked gate on Cargill Mill Site between the Wisconsin Mill Site and Webfoot Mine. (Photo by Schuld 9/13/10)*
