# **VIENNA MINING DISTRICT**

## **PRELIMINARY ASSESSMENT AND SITE INSPECTION REPORT**

Blaine and Camas Counties  
State of Idaho

November 2010

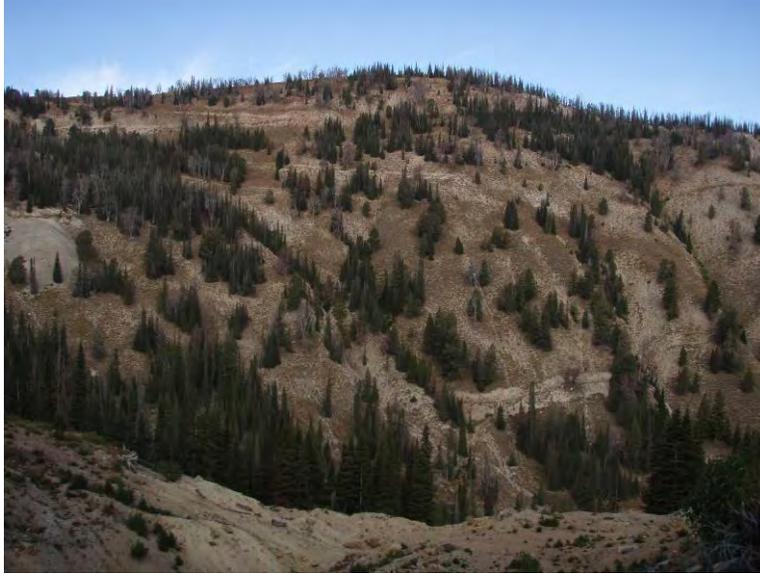
Although there is little historical discussions of developments on the Alturas claim, the view from the Upper Webfoot workings indicated there are at least some significant cat trenches cutting across the claim but no major mine dumps

*Photo 119. View (left to right) of Rebellion, Flagstaff, Alturas, and California claims. (Photo by Schuld 9/17/10)*

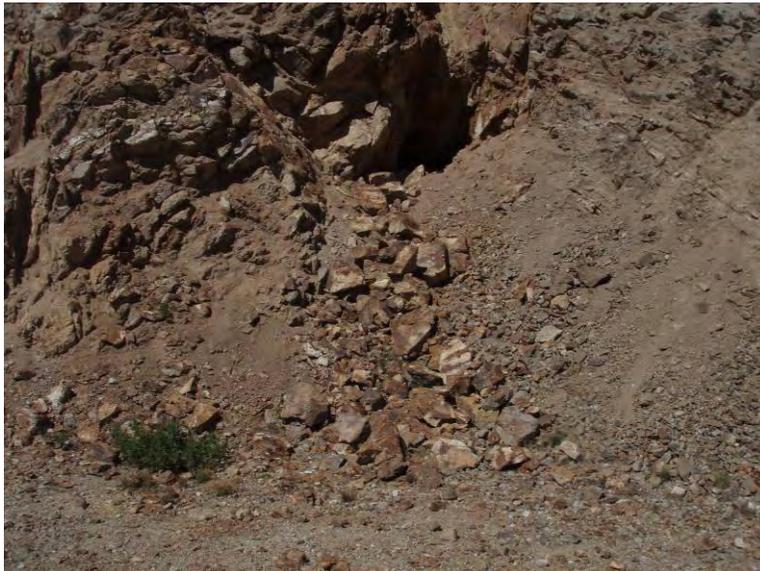
*Photo 120. The Nellie Extension Tunnel is a hazardous physical opening and access should be restricted or prevented. (Photo by Schuld 9/15/10)*

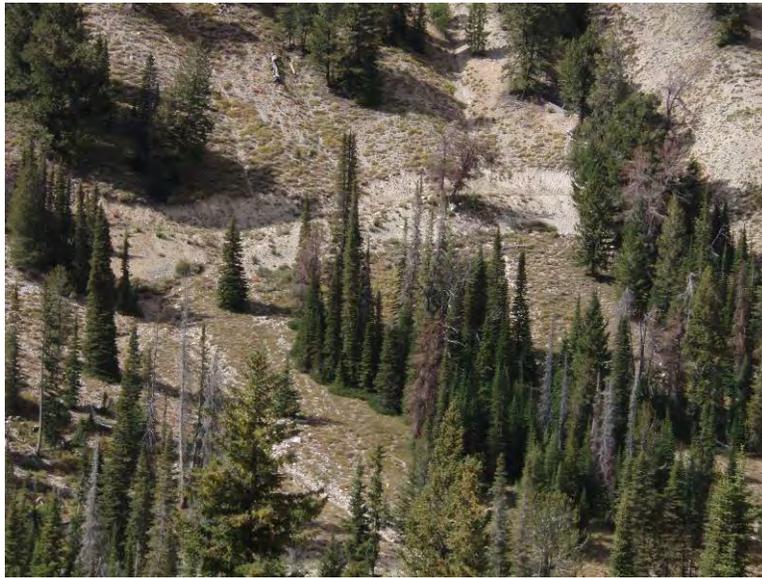
Although access was granted to the Alturas claim by Mr. Allen Jones (Terrawiggly LLC), DEQ did not receive permission from Terrawiggly's co-owners. DEQ did not enter this claim, but was able to make sufficient observations of the claim from the Webfoot Mine's upper workings. Although historical records indicate at least two significant mine tunnels were located on the Alturas and adjacent Nellie patented claims, there are no apparent significant waste dumps. Typical of older developments throughout the Vienna Mining District, the claims have been dissected with extensive cat cuts, presumably to expose and explore outcrops for extensions of the Vienna vein system.

*Photo 121. The Alturas claim has minor workings on it that seem to be dominated by the cat cuts seen above. (Photo by Schuld 9/15/10)*

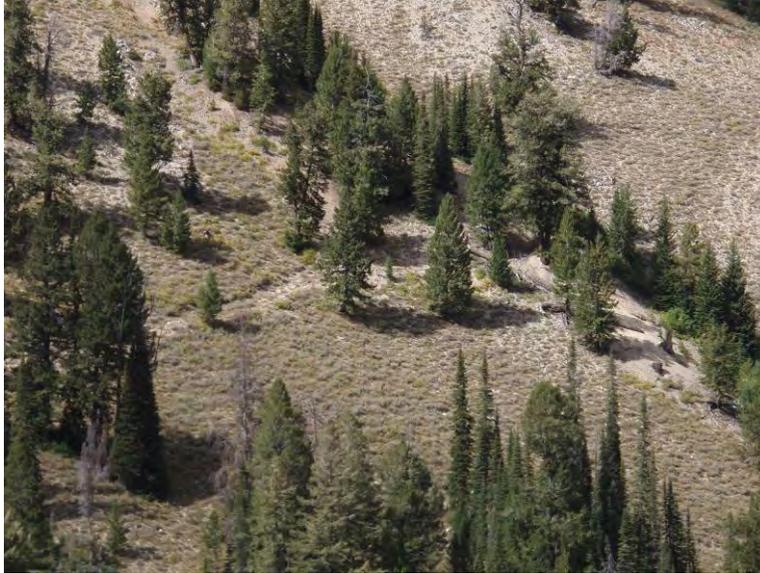
*Photo 122. The Nellie Claim has minor workings on it that seem to be dominated by the cat cuts seen above. (Photo by Schuld 9/15/10)*

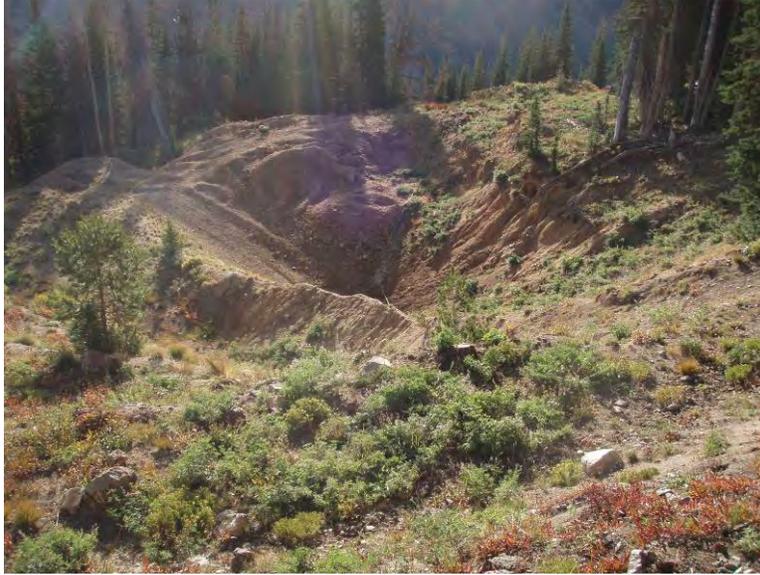
Near the western boundary of the Hidden Treasure claim (Lat. 43.80425°N, Long. 114.83765°W) is a substantial exploration development on splays of vein work that may be an extension of those found at the Webfoot Mine. Considerable cat trenching has resulted in a large pit and waste dump where some precipitation accumulates. However, there does not appear to be any connection between the waste rock and surface water. The site is remote and appears to be rarely visited via the primitive access.

*Photo 123. Looking down into the Hidden Treasure exploration pit.  
(Photo by Schuld 9/15/10)*

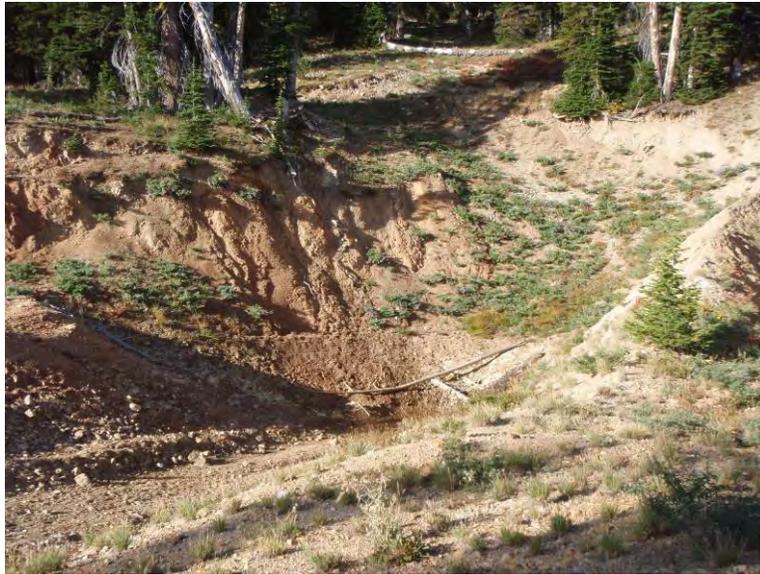
*Photo 124. Looking southwest into the Hidden Treasure exploration pit.  
(Photo by Elayer 9/15/10)*

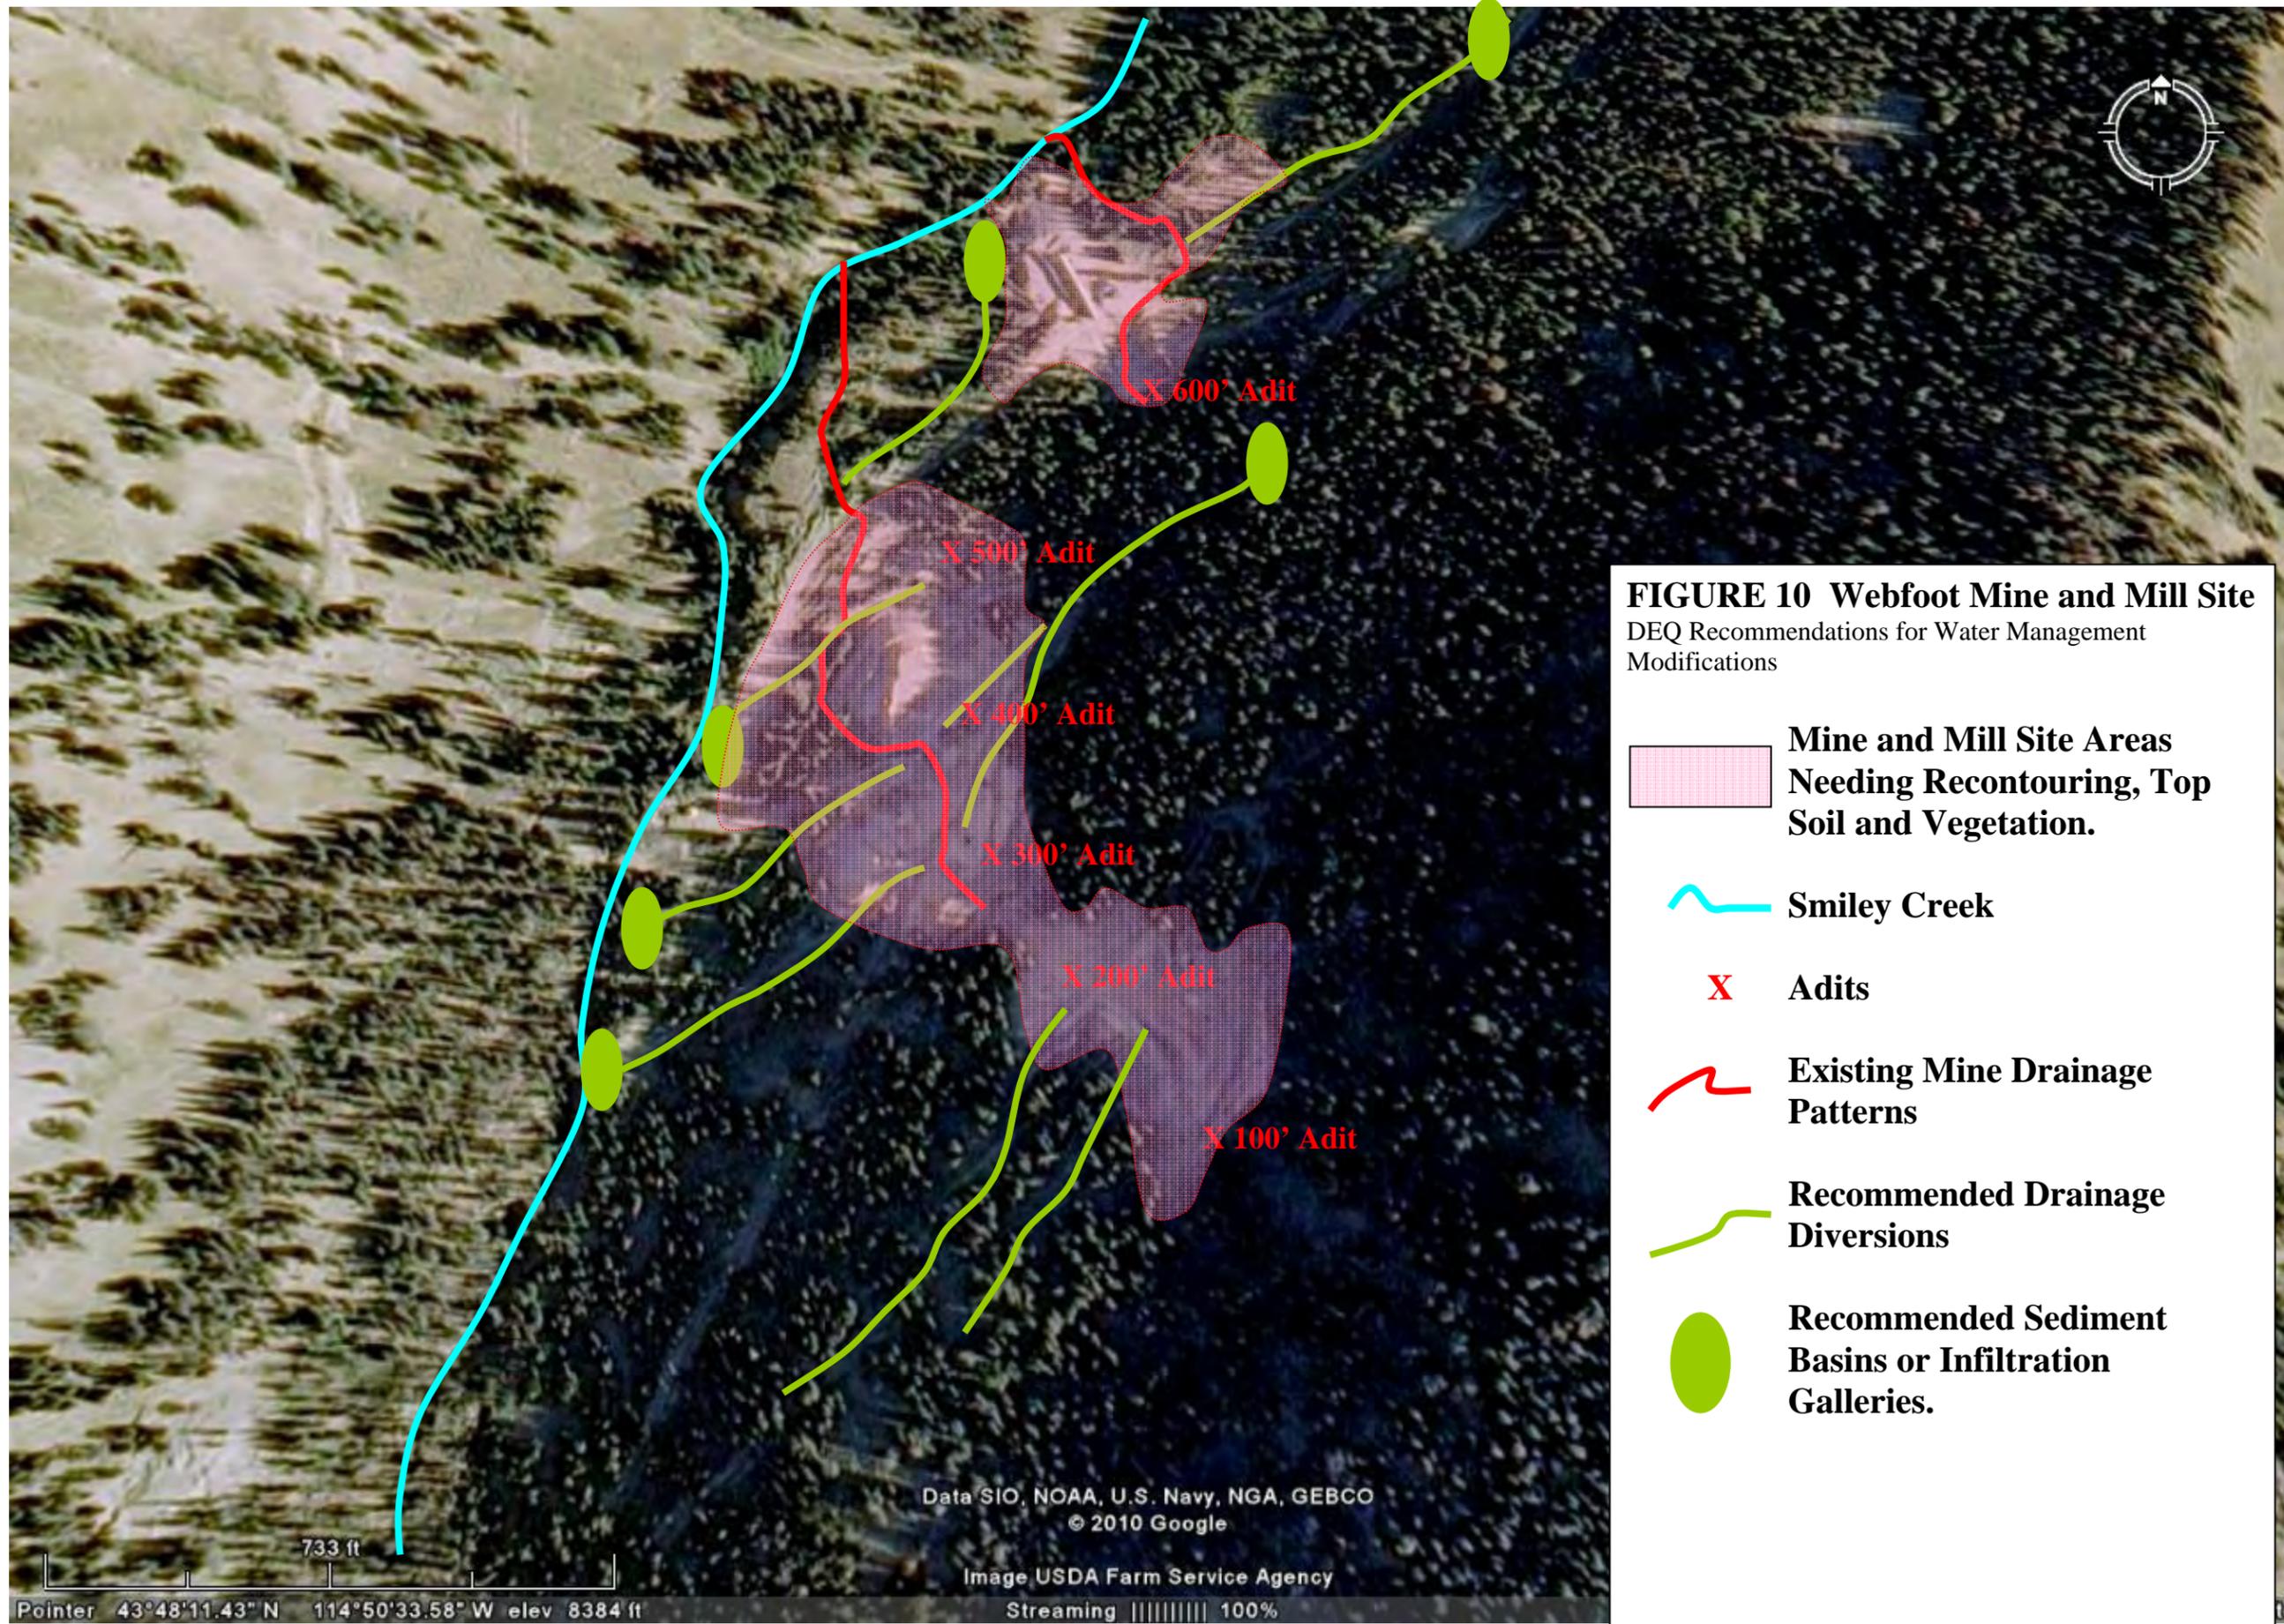
**FIGURE 10 Webfoot Mine and Mill Site**  
 DEQ Recommendations for Water Management  
 Modifications

no violations of Idaho's Water Quality Standards. However, DEQ strongly suggests the operators design and implement a comprehensive water management system diverting adit water away from waste dumps and discharging to shallow infiltration systems into good soils and vegetated areas. DEQ also recommends surface water and adit discharge be routinely monitored at the Webfoot Mine according to a formal water quality monitoring plan.
