***Sediment Source Analysis  
North Fork Coeur d'Alene River Subbasin***

***Submitted to:***  
*Glen Rothrock*  
*Idaho Department of Environmental Quality*

***Completed by;***  
*Kathy Dubé, Geologist*  
*Watershed Professionals Network*  
*Boise, ID*

***June 2007***

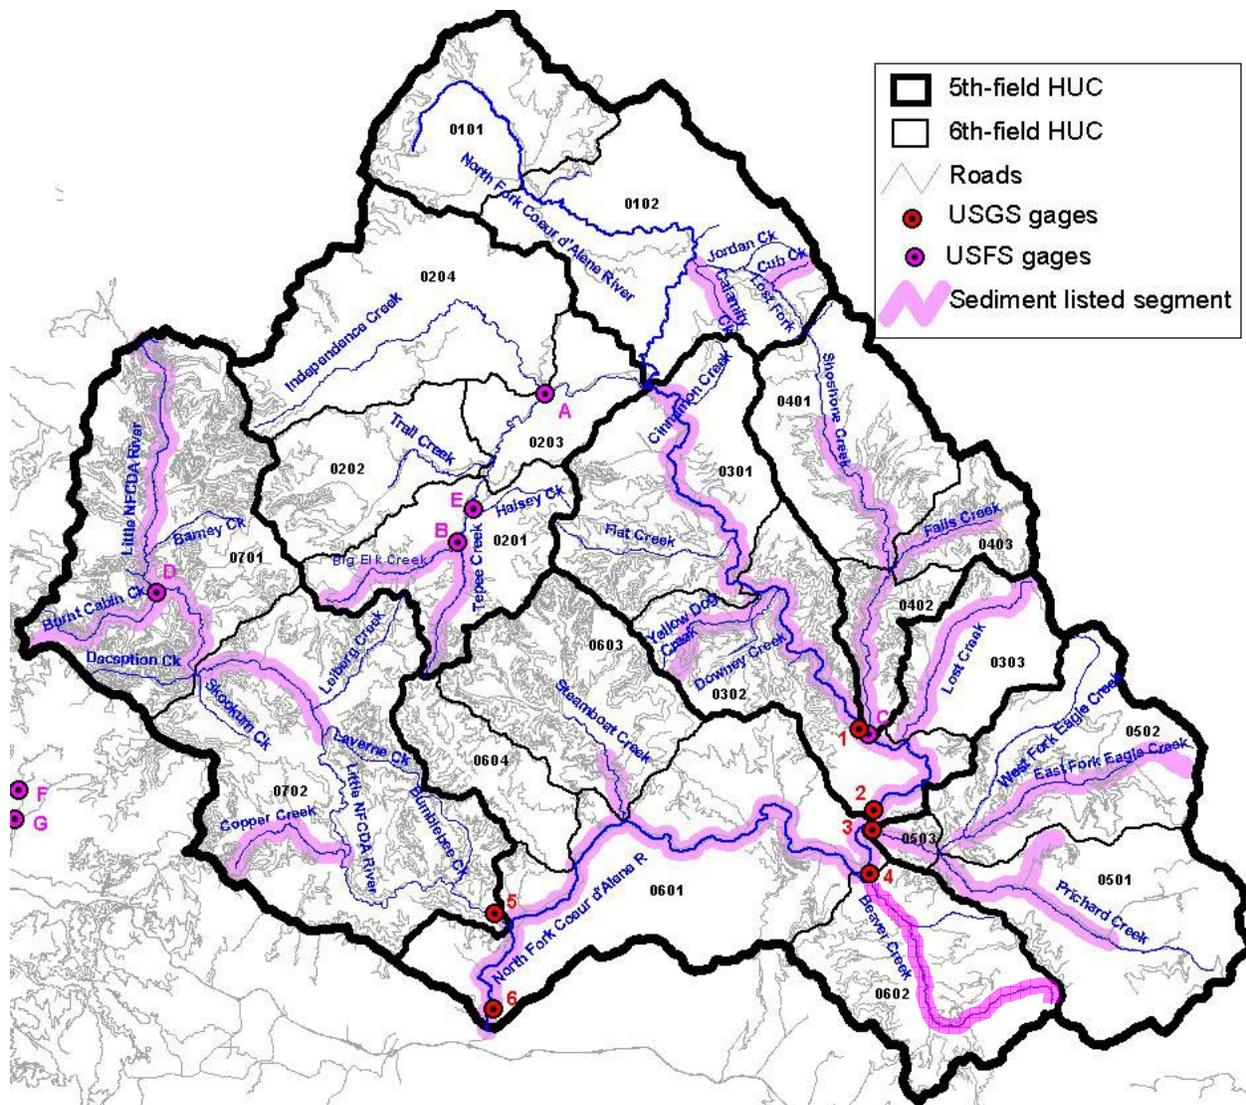
Figure 1. Listed Reaches, Subbasins, and Stream gages within the NFCDA Subbasin.

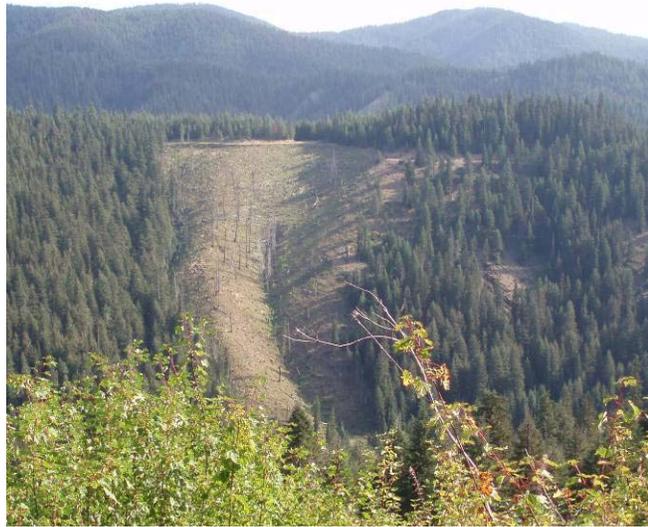
Several recent timber harvest units were visited in the upper Little North Fork watershed. No signs of increased surface erosion or mass wasting were apparent in these areas, and the area was revegetating quickly (see Photo 1). Current timber harvest practices are protective of stream channels and are intended to limit erosion and delivery of sediment to streams. Field observations indicate that they are effective.

**Photo 1. Recent Timber Harvest Unit**

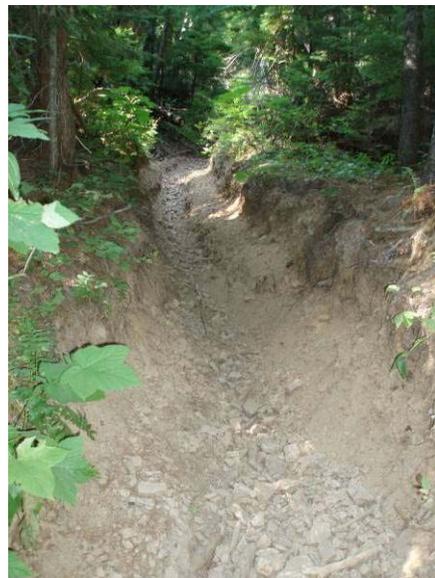
Erosion on a trail at Davis Saddle had caused trail erosion, a gully, and delivery of eroded sediment to a stream. Erosion from off-road vehicle use in the subbasin likely causes localized effects, but is probably not a substantial source compared to other inputs.

**Photo 2. Trail erosion cause by off-road vehicle use**

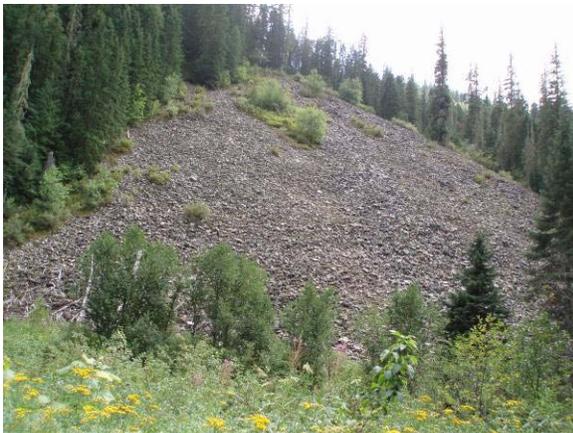
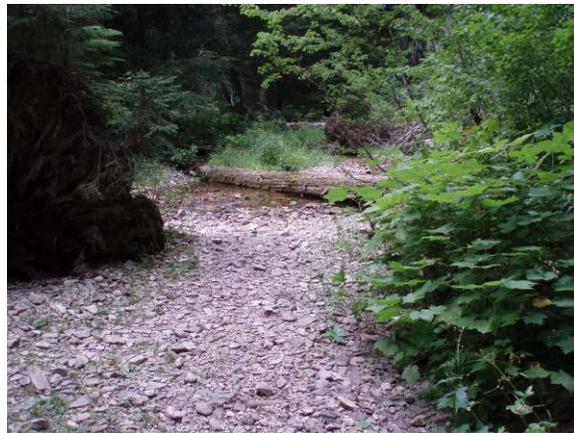
There were several areas noted on the aerial photographs, primarily in some areas burned in the 1910 fires and in the upper elevations on the west side of the watershed, that were sparsely vegetated and appeared to have many areas of talus (loose, cobbly to bouldery rocks covering the hillside). It is not known if this is a natural condition or if the areas did not revegetate following the 1910 fire, but these are likely areas with the potential for large natural inputs of cobbly material to streams. These types of talus slopes were observed on aerial photographs and along the road leading to the Grove of the Patriarchs. These features could be one of the causes of high coarse sediment input to the streams in the unmanaged West Fork Eagle Creek watershed upstream of the Grove, and likely in other unmanaged portions of the watershed.

**Photo 3. Talus slopes in the West Fork Eagle drainage and similar angular sediment choking the stream**

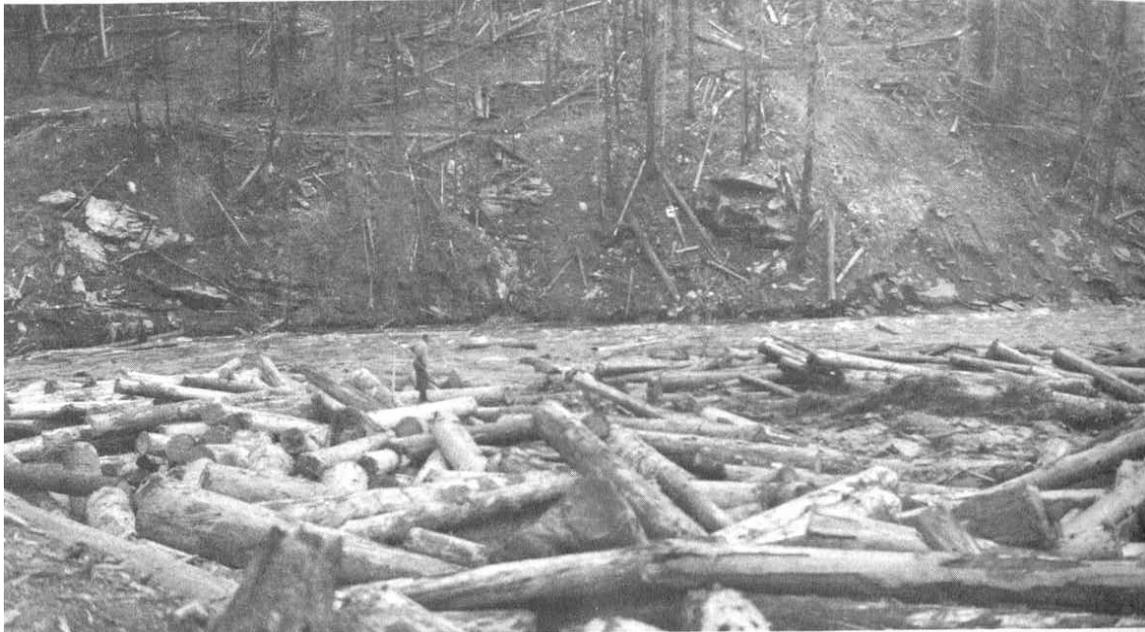
Timber harvest in the North Fork Coeur d'Alene subbasin began in the early part of the 1900s in the lower, easily accessible portions of the watershed. Timber was moved to mill by a system of flumes and splash dams that likely caused localized large inputs of sediment and erosion of streambanks. In some areas, timber was salvaged after the 1910 fires and transported down some creeks in log drives. This occurred in 1910-1912 in the lower 4 miles of Independence Creek, Tepee Creek "down from Magee", the North Fork CDA River from above Cathedral Rocks (Russell 1984).

**Photo 4. Early 1900s timber harvest showing lack of stream buffers and effects of log drives (photo from University of Idaho).**

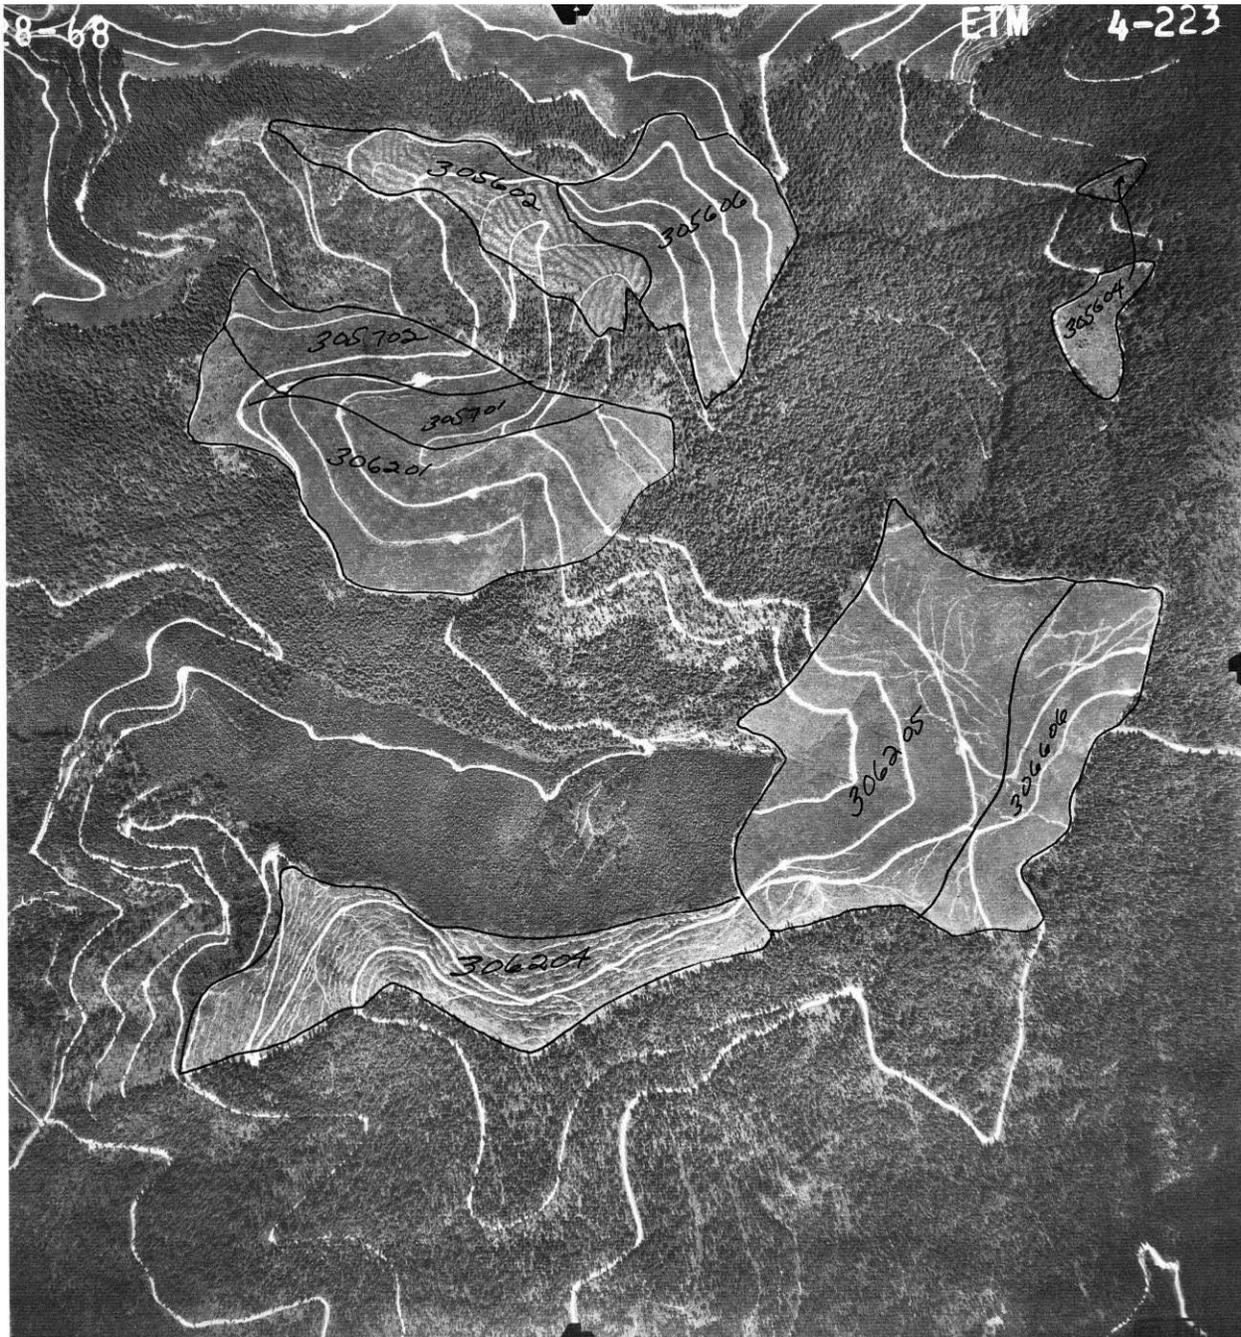
**Photo 5. 1968 Aerial Photograph of Barney Creek showing timber harvest and road building practices.**

Intensive harvest in the middle parts of the subbasin occurred in the 1950s and 1960s. Timber was moved to mills on trucks utilizing a dense network of roads to accommodate jammer harvest methods. This was also a period of high harvest-related sediment inputs since there were few or no stream buffers, skid trails and/or fire roads were constructed up small stream channels, and many miles of new roads were constructed using methods that do not meet today's standards (Photo 5). Most of these areas have revegetated and are no longer sediment sources (Photo 6).

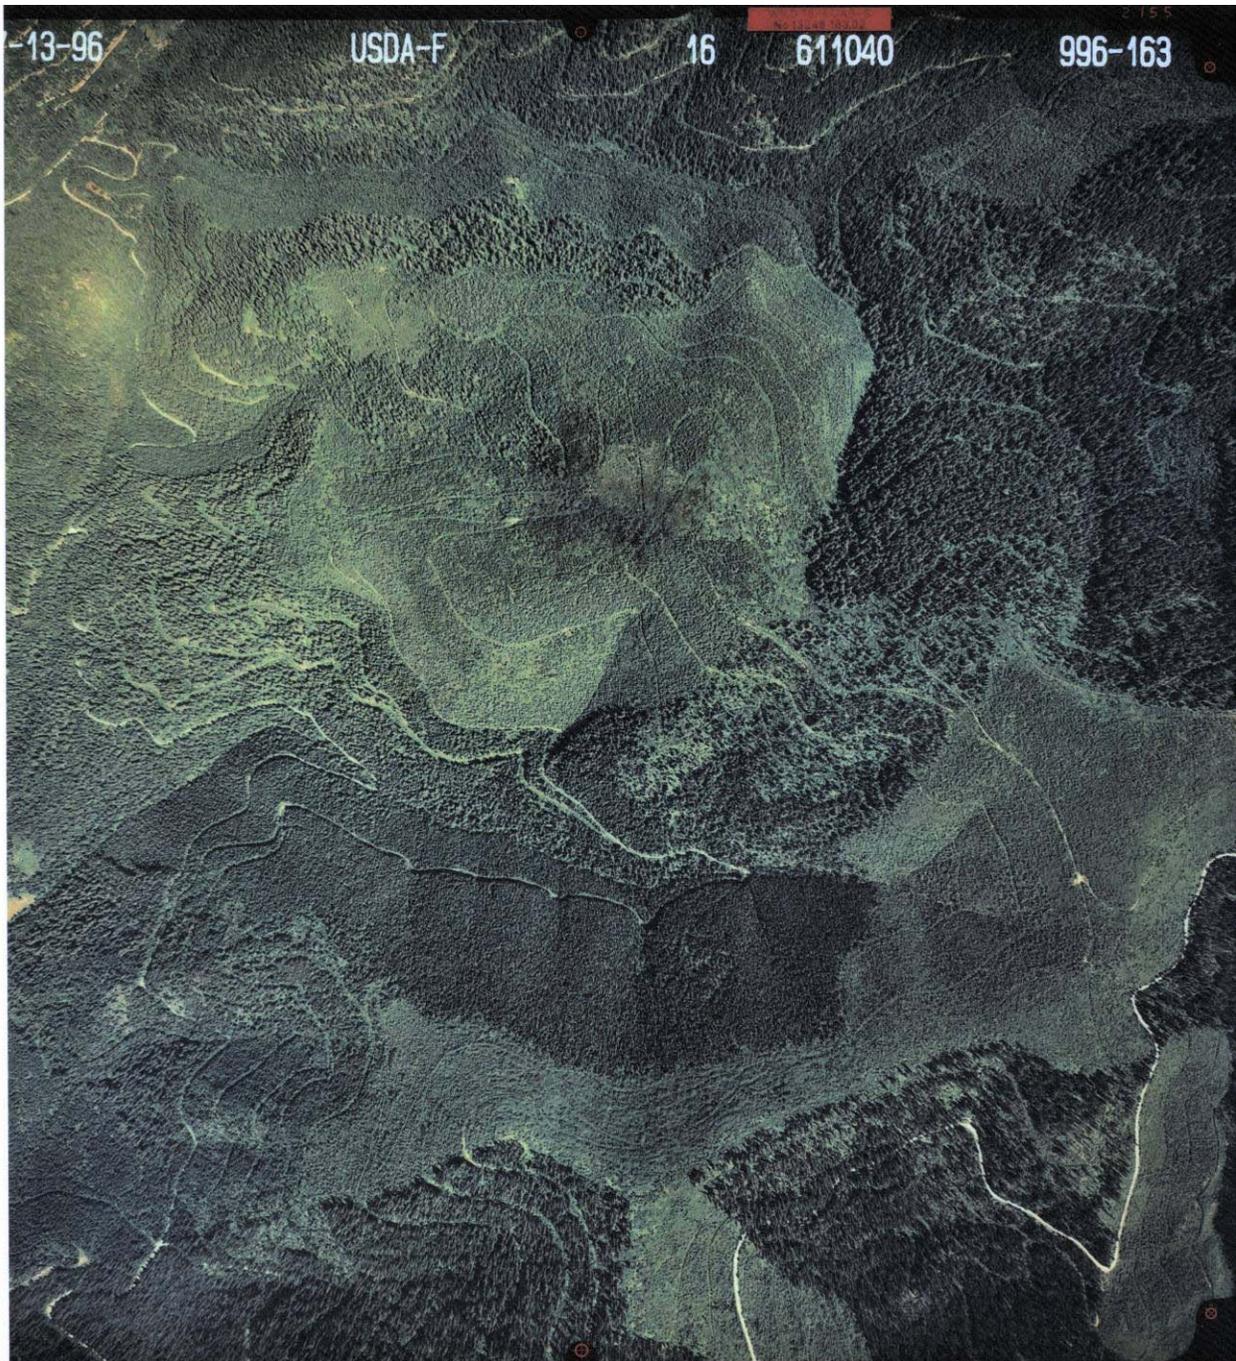
**Photo 6. 1996 Aerial Photograph of Barney Creek showing revegetation on past harvest units and non-system (inactive/closed) roads.**

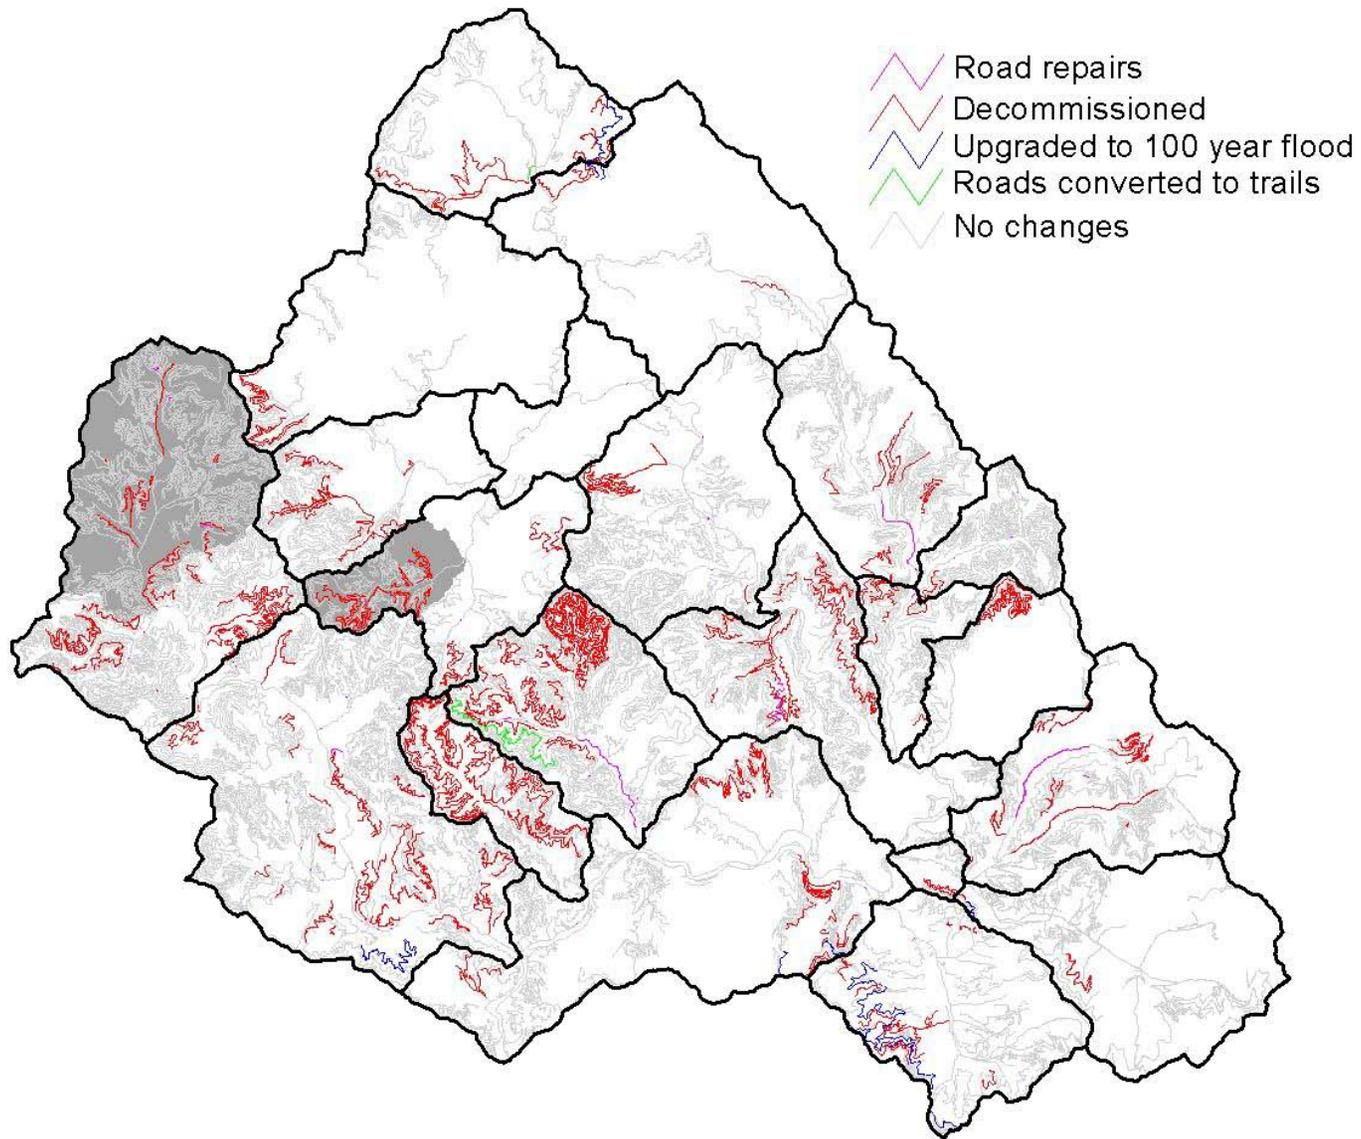
The total of 5,011 miles of road (Table 10) and 3,838 road/stream crossings (Table 11) were included in the current sediment source analysis. Roads were classified into three main groupings for analysis: currently open roads, currently closed roads, and decommissioned roads. Currently closed roads includes both system roads (those roads that are still considered part of the USFS transportation network) and non-system roads (old roads that have been abandoned for many years and are still on the landscape but are not in the USFS transportation network).

**Figure 2. Location and Status of Roads used in Analysis (note intensive study basins shaded in gray).**

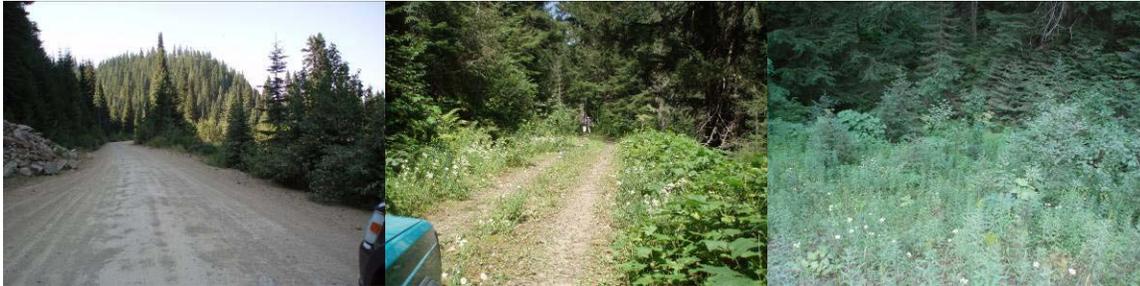
The majority of open major forest roads in the North Fork Coeur d'Alene subbasin are gravel surfaced with a 15-20 foot wide tread, and receive primarily administrative and recreational traffic. Open secondary roads are narrower, with a 10-15 foot wide tread and receive light recreational use. Secondary roads often have some vegetation growth on the tread. Closed roads are generally revegetate after 1-2 years of closure.

**Photo 7. Examples of main roads, secondary open roads, and closed/overgrown non-system roads**

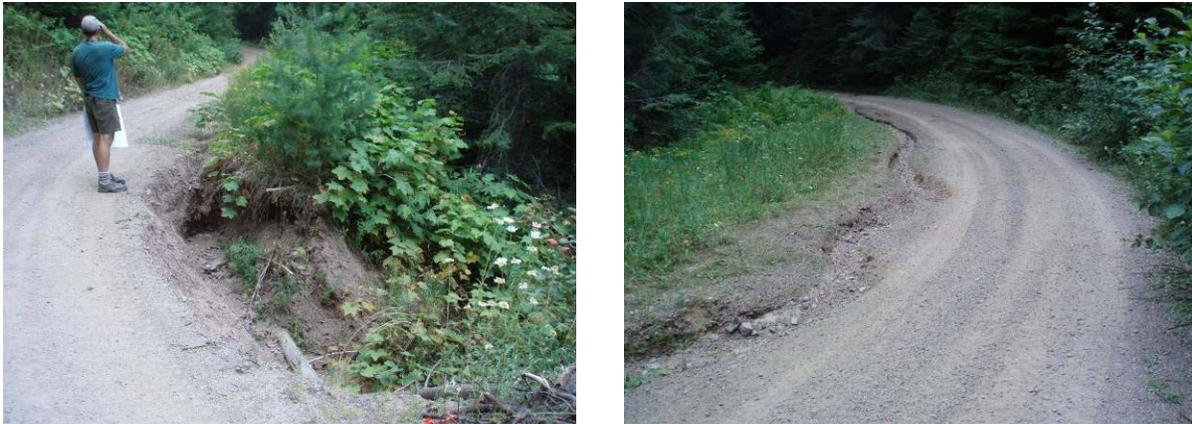
Culverts that are deteriorated or too small to handle high flows or high sediment or debris loads can plug, resulting in water ponding upstream of the fill and either flowing over the road and into the stream or down the road tread to the next crossing. Either way, gullies generally form under these circumstances and deliver sediment to streams. If the road fill saturates, the fill can fail, washing out the road prism and delivering the sediment to the stream.

**Photo 8. Examples of Road Washouts (left) and Gullies (right) in the Upper Little North Fork Drainage.**

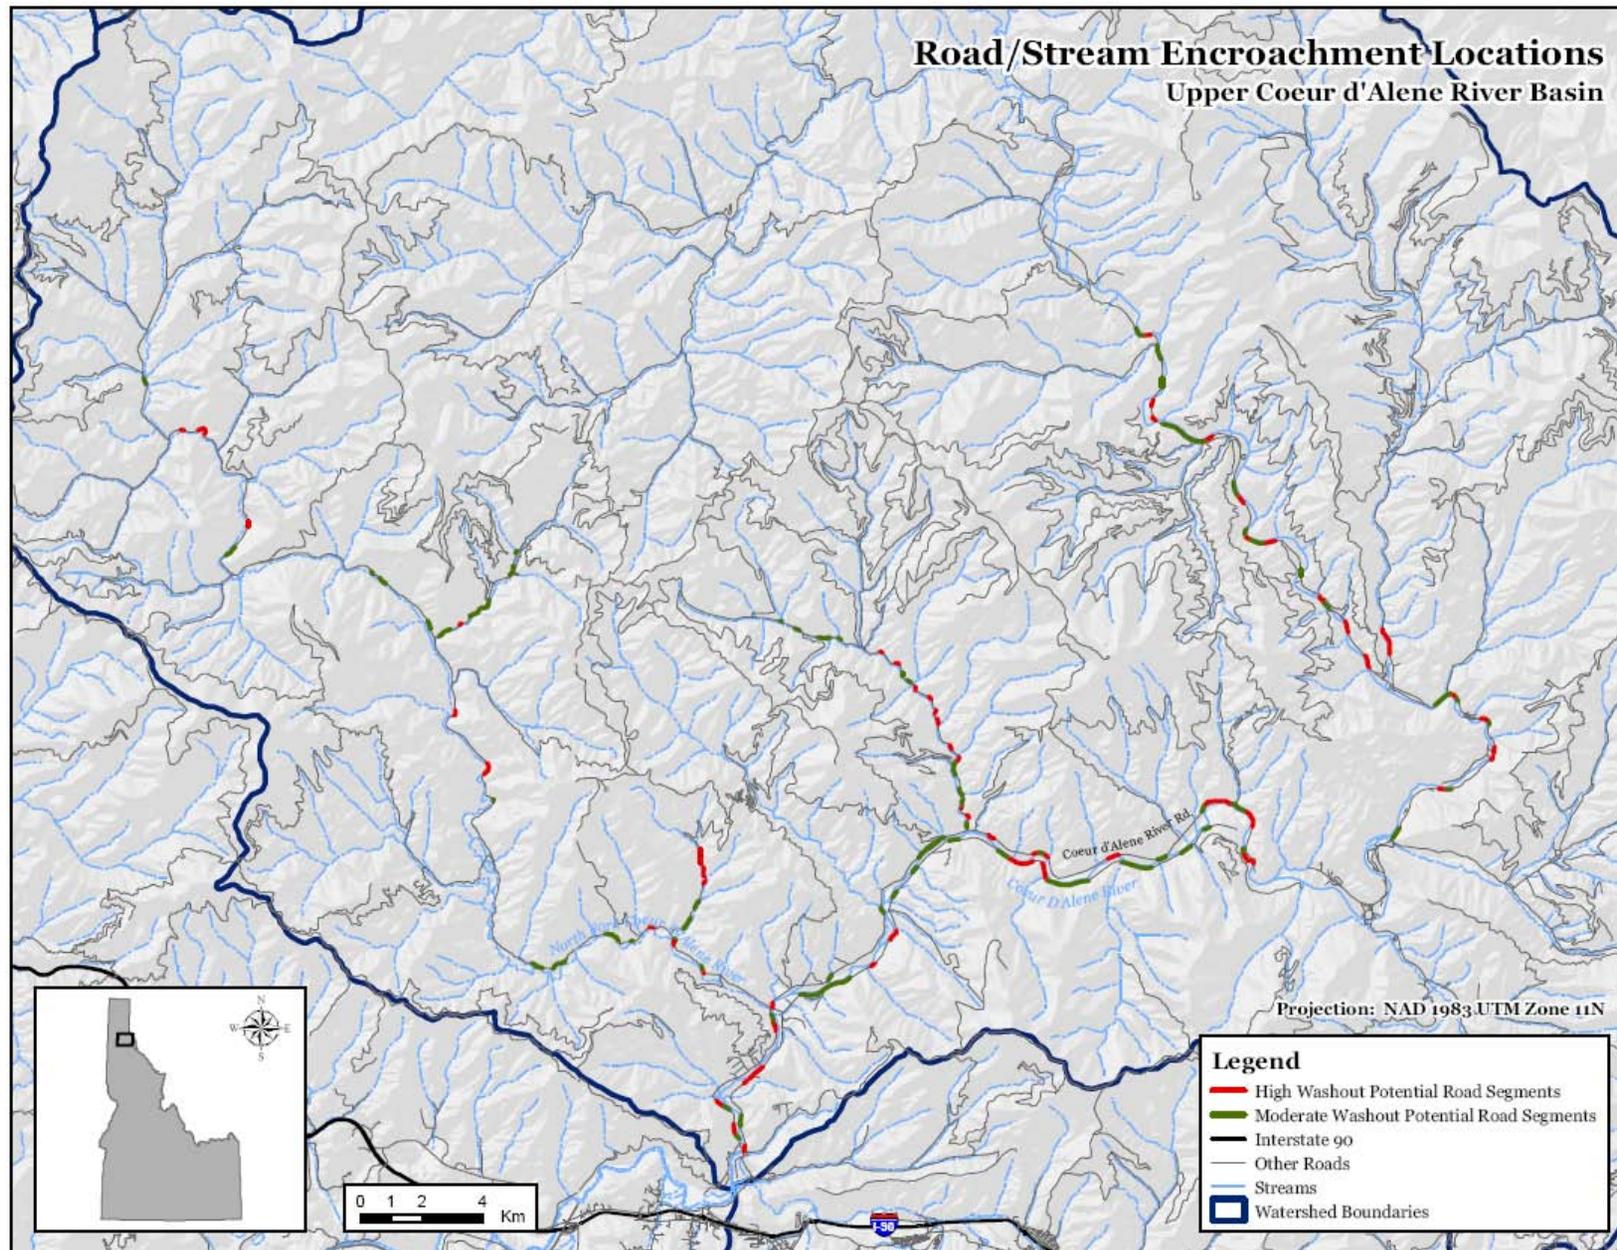
**Figure 3: North Fork Coeur d'Alene Road Encroachment locations.**

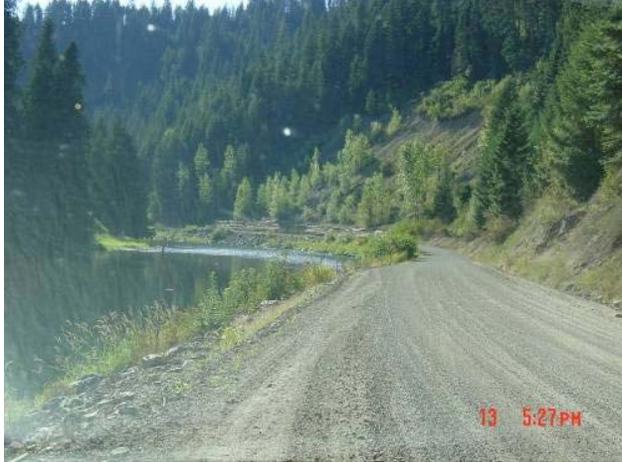
**Photo 9. Old River Road riprap along Grizzly Creek bend. Most of this bend was rated High failure potential.**

of road fill is 15 to 20 feet. Most areas adjacent to the river had only Moderate failure potential. The Old River Road (USFS Road 1-C) goes along the north and west side of the river and has more frequent, and longer, exposure to the river (Photo 9). It has a top width of 20 to 25 feet and the fill is 10 to 20 feet above the river (see maps). There are many locations of High failure potential. At Steamboat Rock, the road fill has been built out into the river which deflects the thalweg away from the former river bank, presumably in response to former washouts, so it appears unlikely to wash out the road in the future.

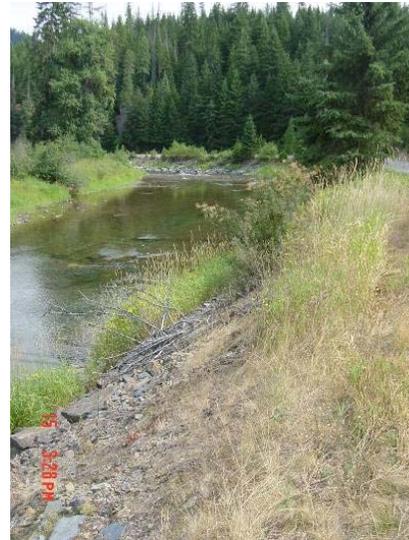
Road 208 (Photo 10) goes upstream from Prichard along the Middle segment of the North Fork CDA. It has a typical width of 30 feet plus 15-foot wide pullouts at locations with bank erosion problems. The river is steeper, very confined, and clearly capable of eroding large riprap. Estimated height of road fill is 8 to 15 feet. Side slopes were steeper than 1:1 where there was river impingement at an angle. Downstream of Venus Creek, 8-10 ft diameter riprap has been placed on the bank and some has washed into the river. This location has a pullout. Even areas without a scour pool at the toe commonly have oversteepened riprap. There are some straight segments where the river flows parallel to the road and trees have grown up on the riprap embankment.

**Photo 10. Road 208 looking downstream about 2 miles below Big Hank meadow. This section of road was rated Moderate failure potential in foreground and High failure potential in background.**

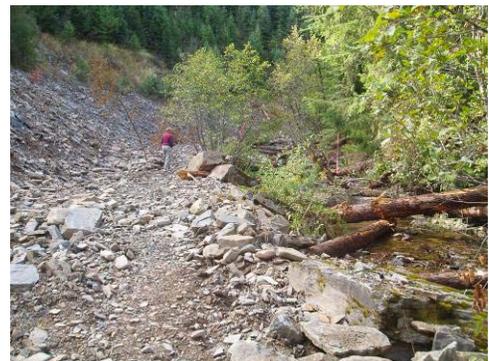
Road 513 was constructed immediately adjacent to, and within much of the valley of Yellowdog Creek. The USFS determined that the road was affecting the stream and was no longer needed for their transportation system, so they have decommissioned the road by pulling back the road fill and re-configuring the creek to improve access to the full valley width. This is an effective way to reduce road encroachment impacts to the stream.

**Photo 11. Decommissioned Road along Yellowdog Creek**

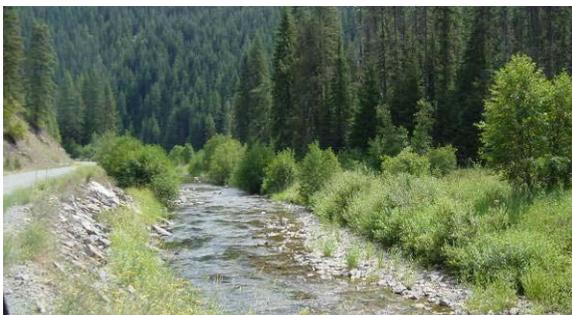
Road failure potential was not inventoried on Tepee Creek. From a couple miles below Magee downstream to nearly the confluence, the valley is narrow. The main road commonly lies against the north valley wall and it appears likely that the creek erodes away at the road during floods. River bends are riprapped either with imported rock or native, slabby rock (talus) that may have been excavated from the valley wall when constructing the road (Photo 12).

**Photo 12. Road along Tepee Creek.**

The crumbly rocks along the creek are clearly a major source of cobble-gravel sediment, and the presence of the road disrupts sediment delivery from the cliffs to the creek. At the same time, the road fill provides sediment whenever floods big enough to mobilize the riprap occur. The

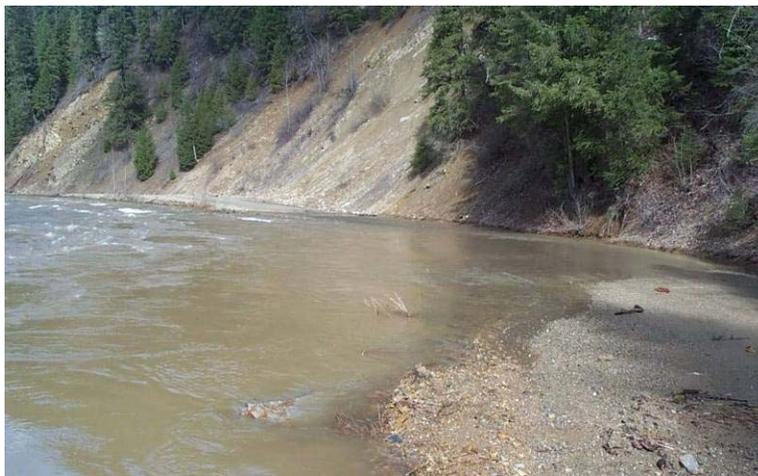
**Photo 13. Erosion of surfacing material along the old river road (just above Browns creek) on March 17, 2007 .**

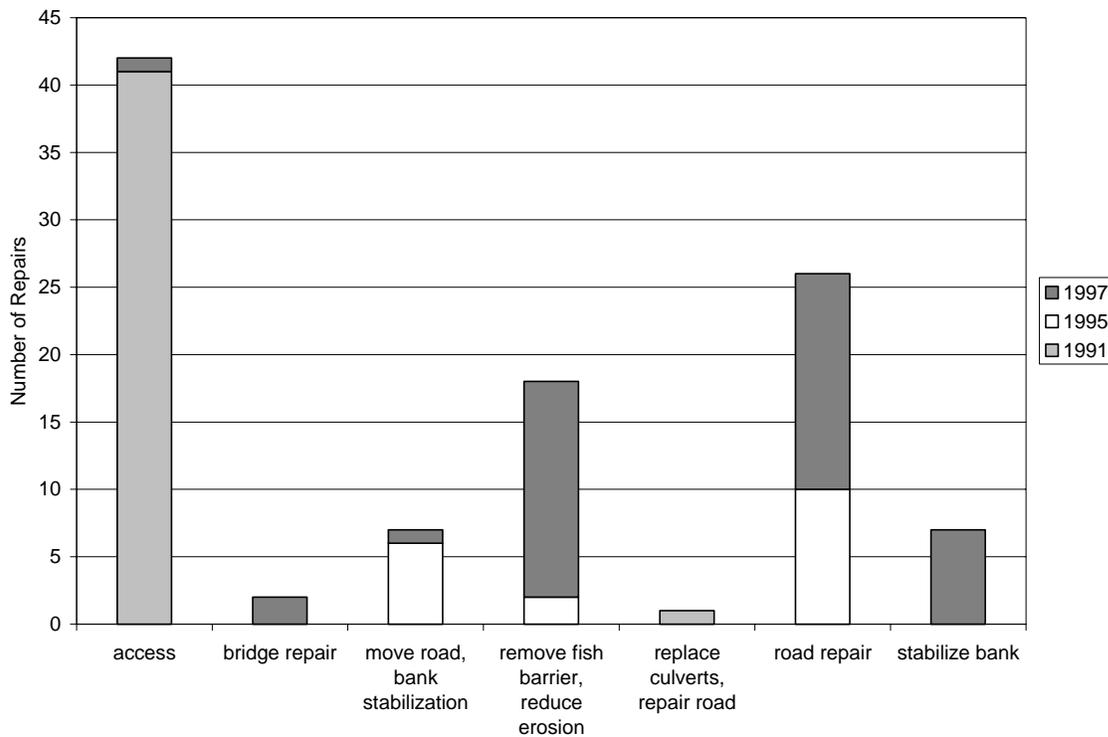
**Figure 4. Number of road repairs by year and reason for repair.**

Road repairs to provide access, or general road repair were the most frequently listed road issues. These include culvert failures, washouts, and general repairs. The next most frequent repair was to remove fish barriers, followed by bank stabilization, or moving roads away from streams. These data may not be complete or totally representative of road erosion processes occurring in the North Fork Coeur d’Alene area, but they are consistent with observations from the aerial photographs, and suggest that small culvert/road washouts and stream-parallel roads are the primary road erosion issues.

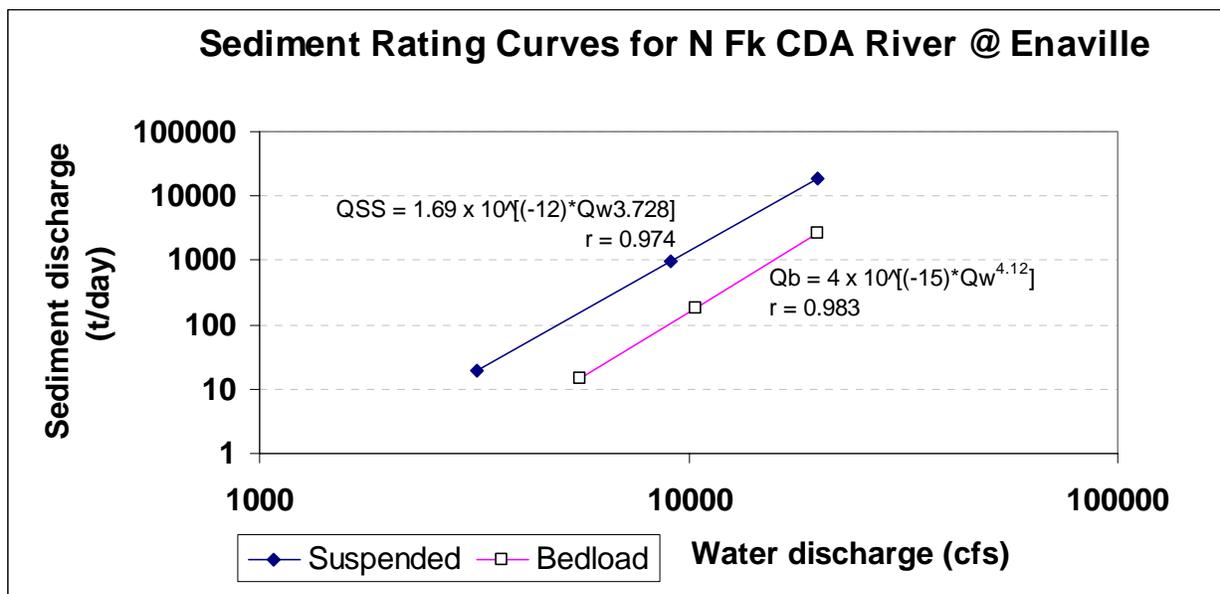
As a check on the estimated current sediment input budget listed in Table 18, comparison with total computed sediment input was made with recent measurements in the river. In 1999 and 2000, the United State Geological Survey (USGS) measured bedload and suspended sediment load at the *North Fork CDA River at Enaville* gage and seven other gauging stations in the Coeur d'Alene River basin (Clark and Woods 2000). Rating curves were developed by the USGS to predict sediment discharge for a given water discharge (Figure 5). Bedload and suspended sediment transport rates on the South Fork Coeur d'Alene River were an order of magnitude higher than on the North Fork. The rating curves had high correlation coefficients indicating a tight fit of the data to the curves.

Figure 5. Sediment Rating Curves for the North Fork Coeur d'Alene River at Enaville Gage Based on Measurements made in 1999 and 2000. (Clark and Woods 2000)

The 69 years of available daily flow records (1911-1912, 1940-2007) were used to estimate average annual sediment load at the gage for the full period of record, as well as for flows that occurred in the last 20 years (Table 19). Predicted average annual bedload transport is 10,000-11,000 tons per year. Predicted average annual suspended load transport is 67,000-72,000 tons per year. Bedload is 15% of suspended load, which is on the high-end of normal for a low-gradient river. Because sediment transport rates increase steeply and exponentially with discharge, the two years with the highest floods transported 39% of the bedload and 30% of suspended load for full the 69-year period. Since flood magnitudes in 1974 and 1996 were three times larger than the 20,000 cfs maximum discharge at which sediment was actually sampled, these two years could be introducing a large error in the results.
