P.O. Box 753
Kellogg, Idaho 83837
Phone: 208-512-3800
E-mail: landreclamation@yahoo.com

Restoration Techniques

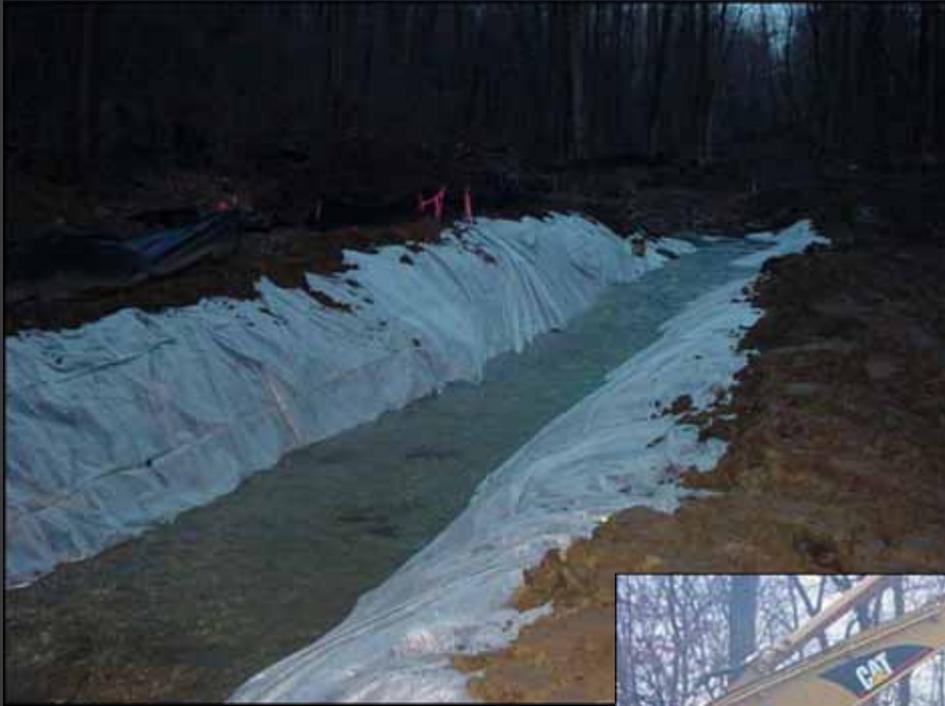
Bypass Channel

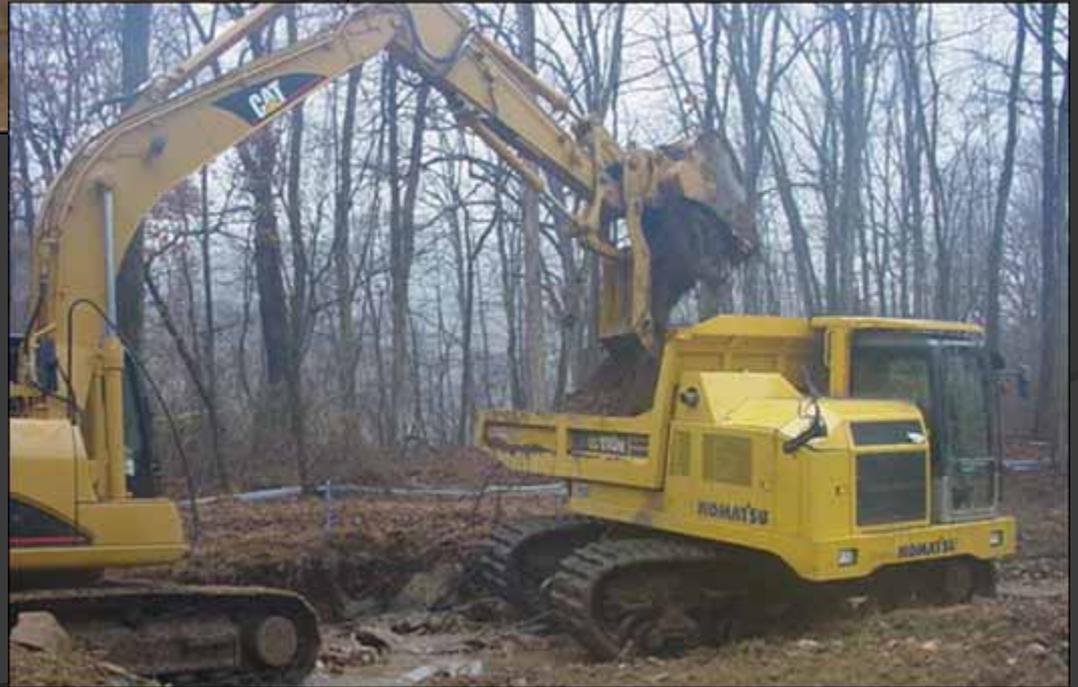
Excavating the new
channel and floodplain

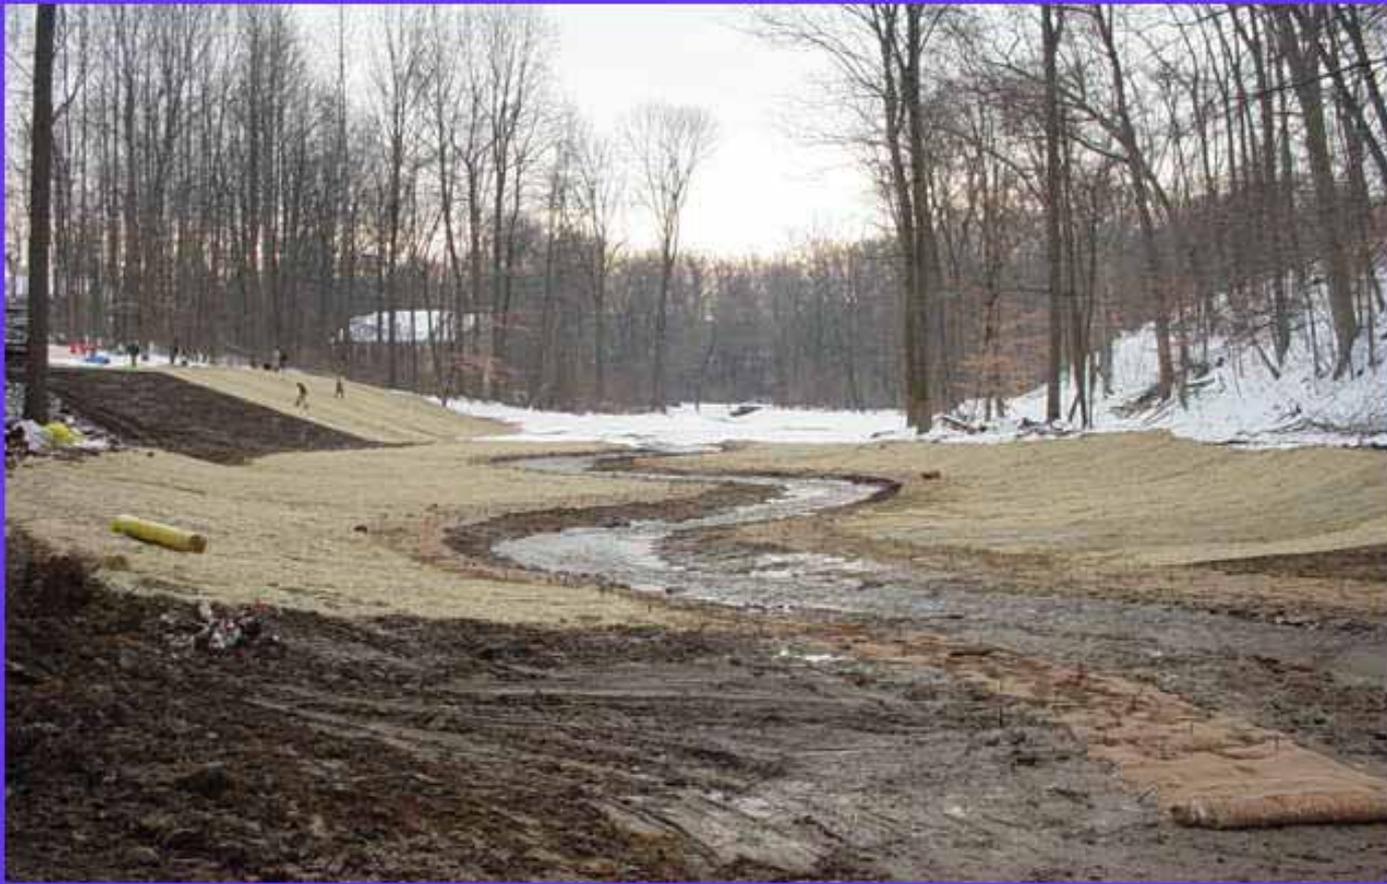
Stabilization during winter has its limitations

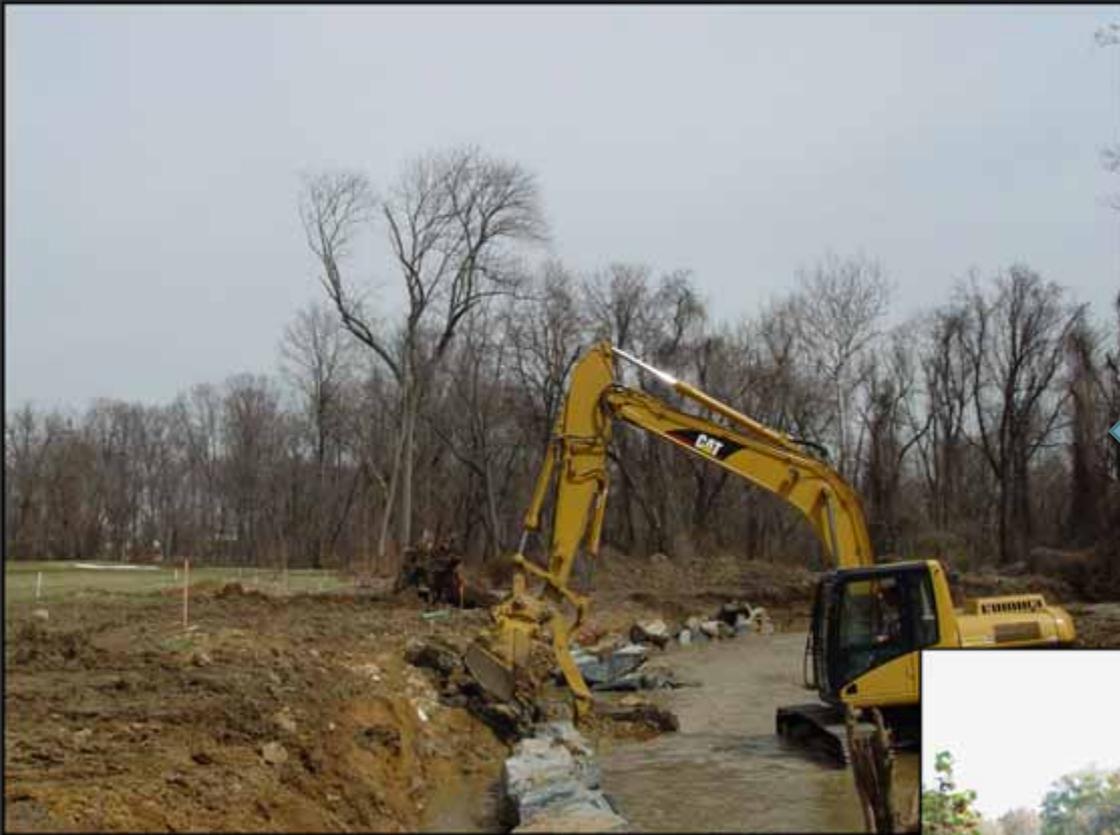
Boulder toe revetment
with root wads and log
vane

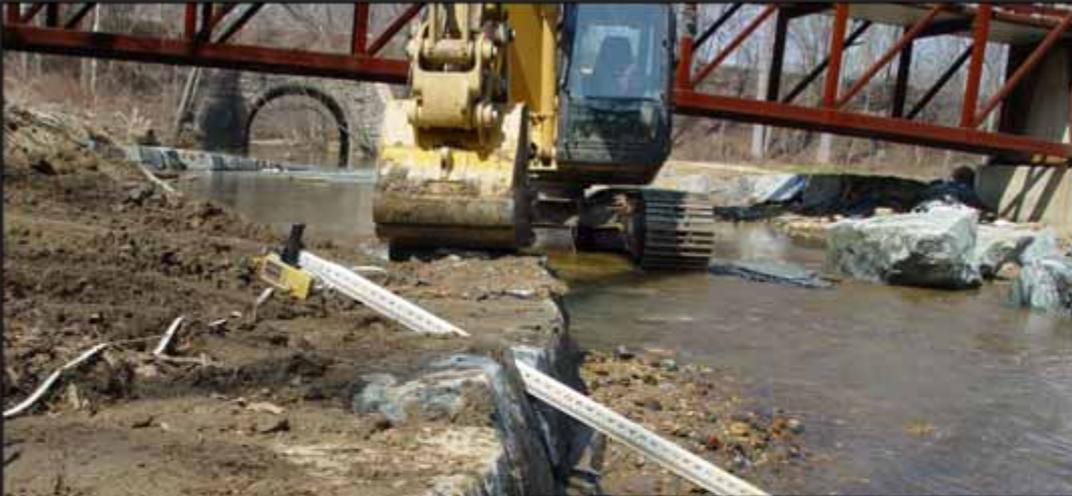
Rosgen rock vanes for grade control and bank protection

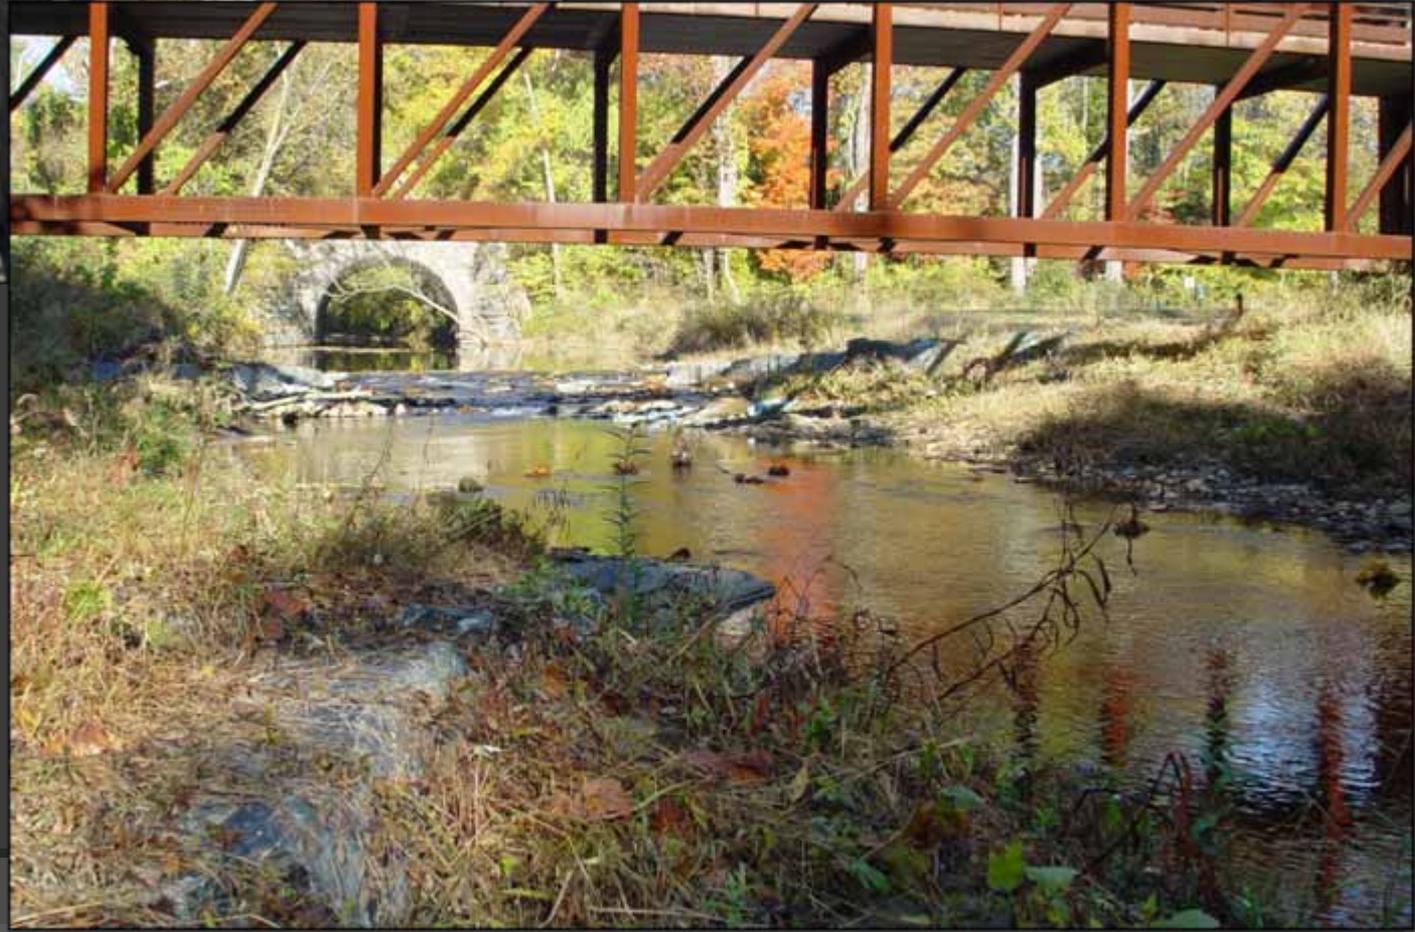
Channel realignment with boulder toe
Adding gravel to the riffle to benefit fish spawning and insect production

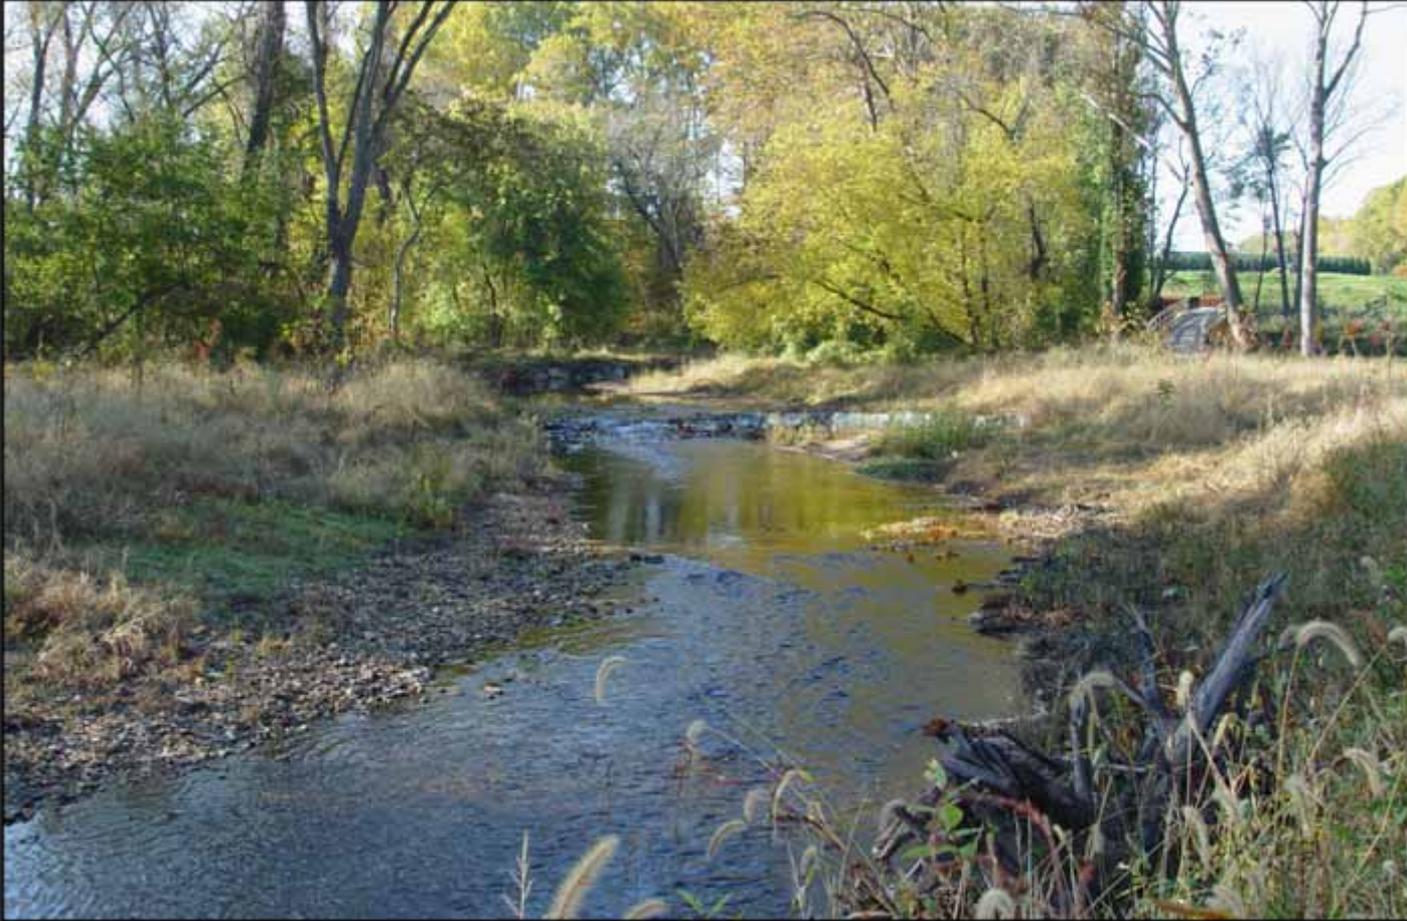
Re-alignment with boulder toe and cross vane

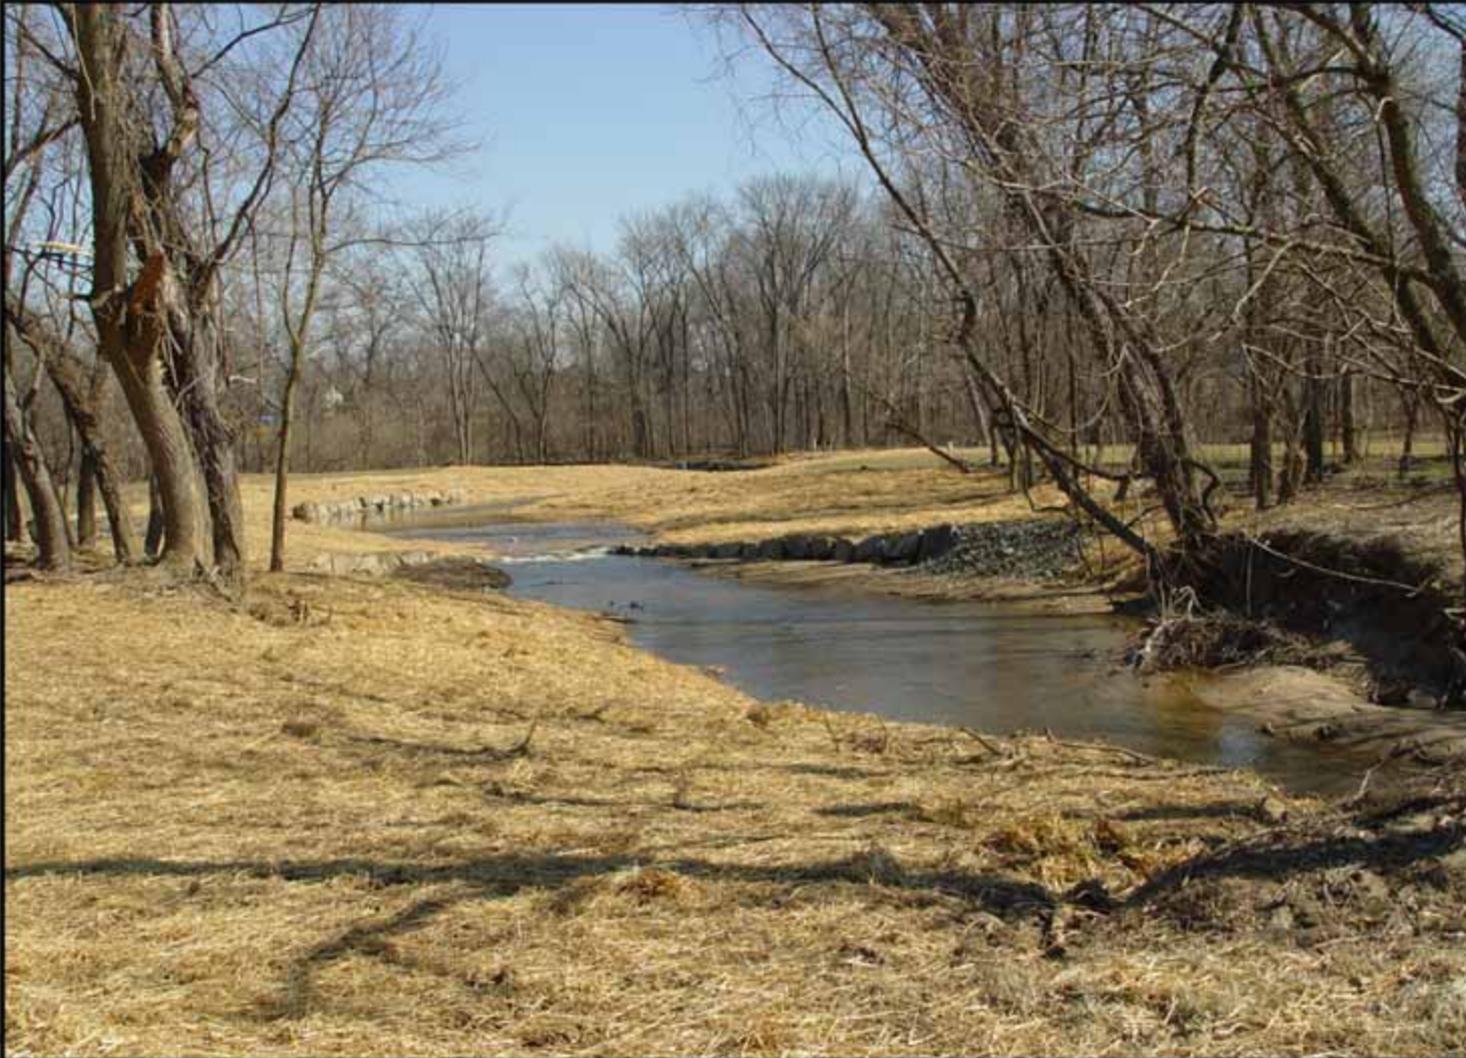
Transverse cobble bar due to debris jam

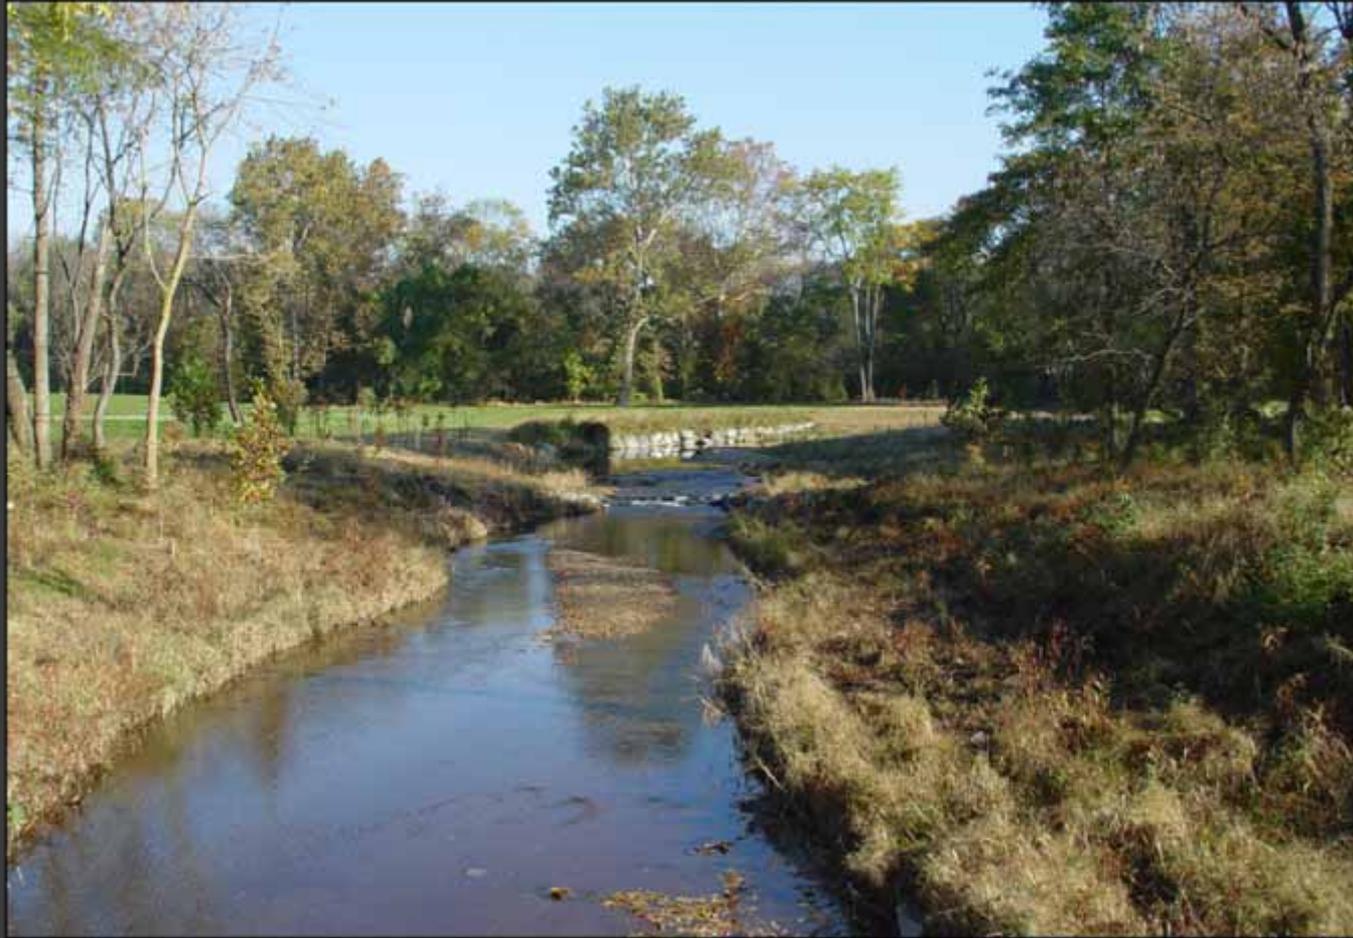
Passive Treatment System

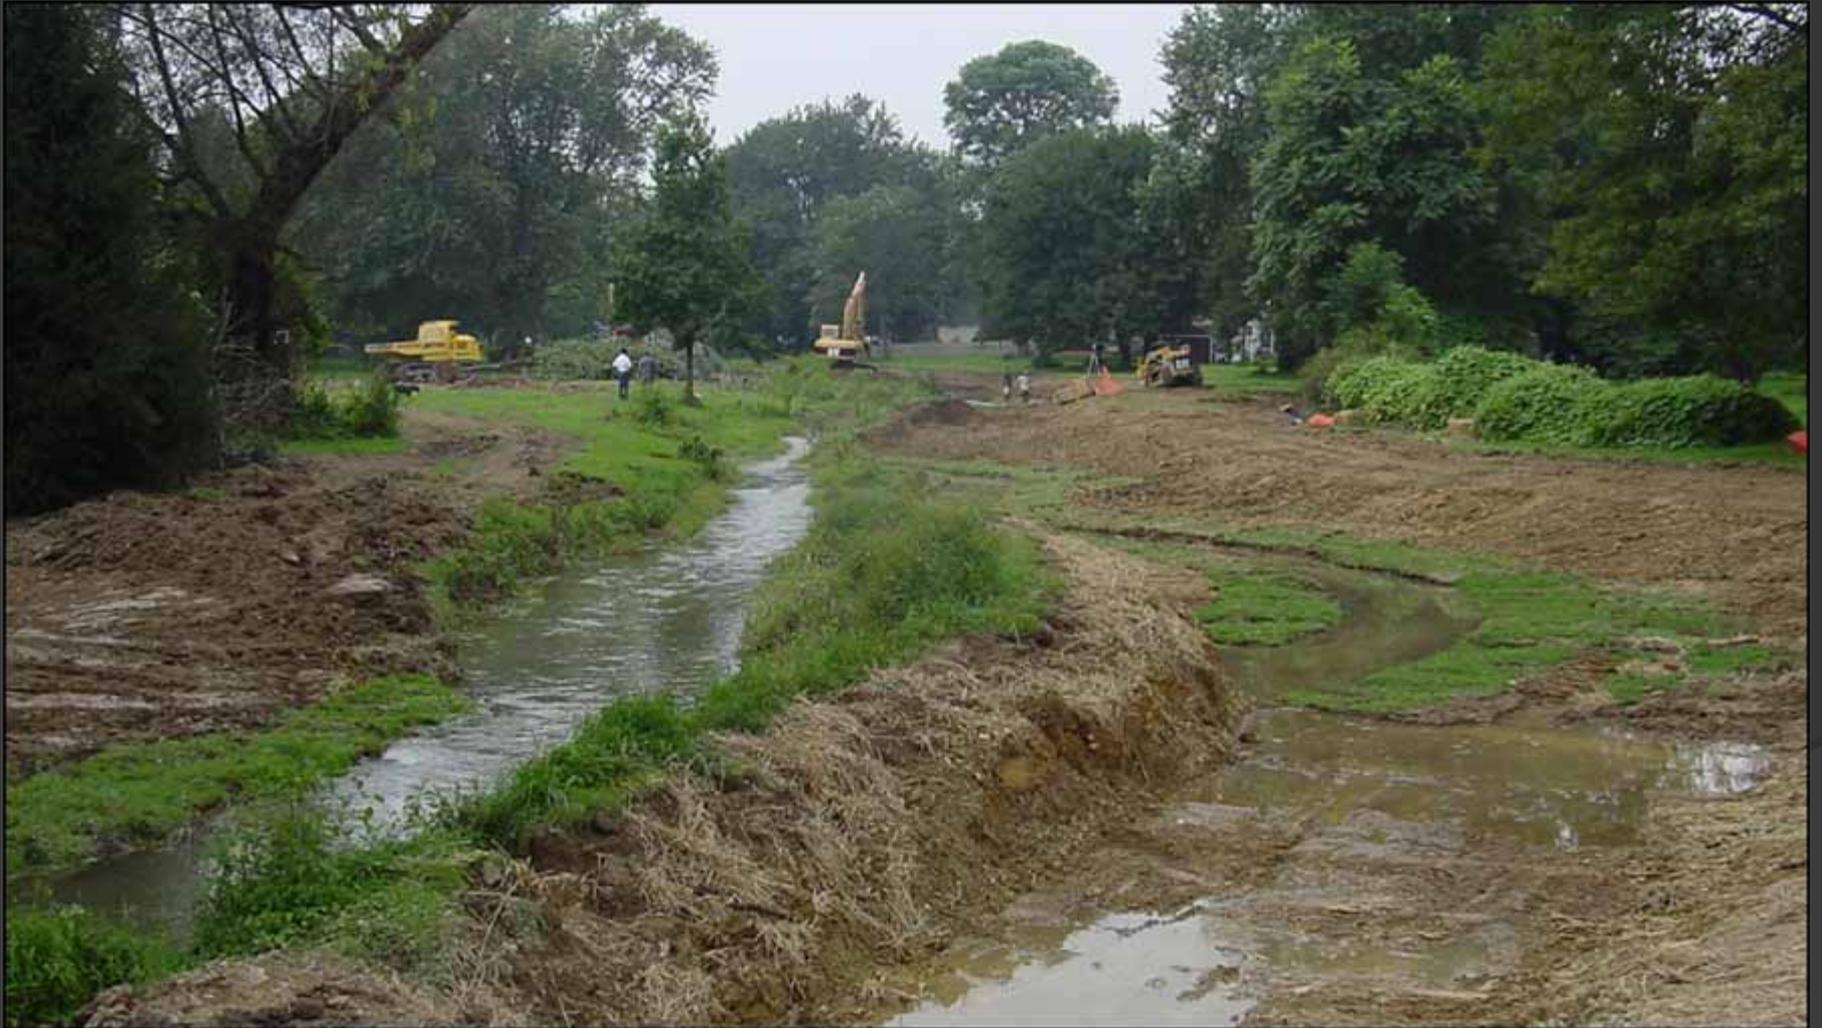
Meandering channel with in-line wetlands

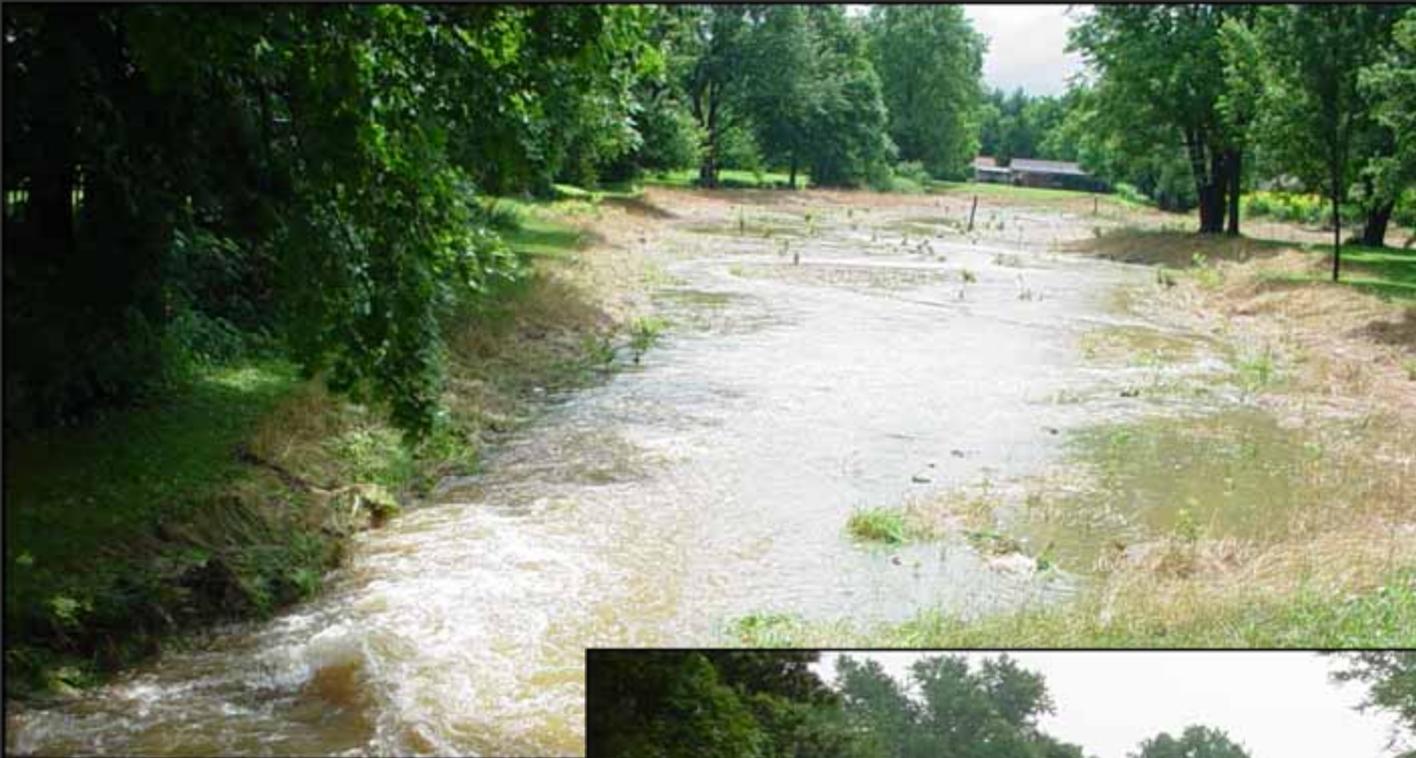
Flood flow conveyance is created

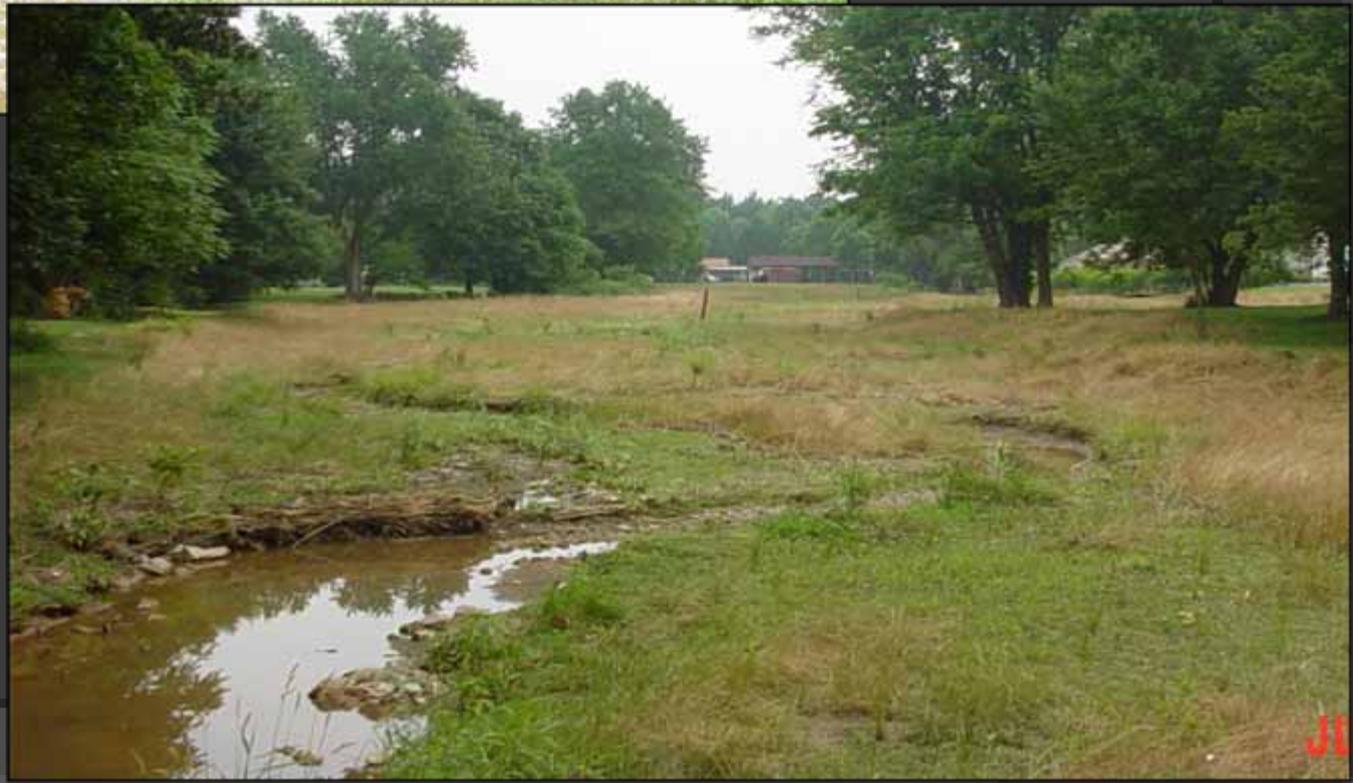
Removal of fine sediments
to create a bankfull bench

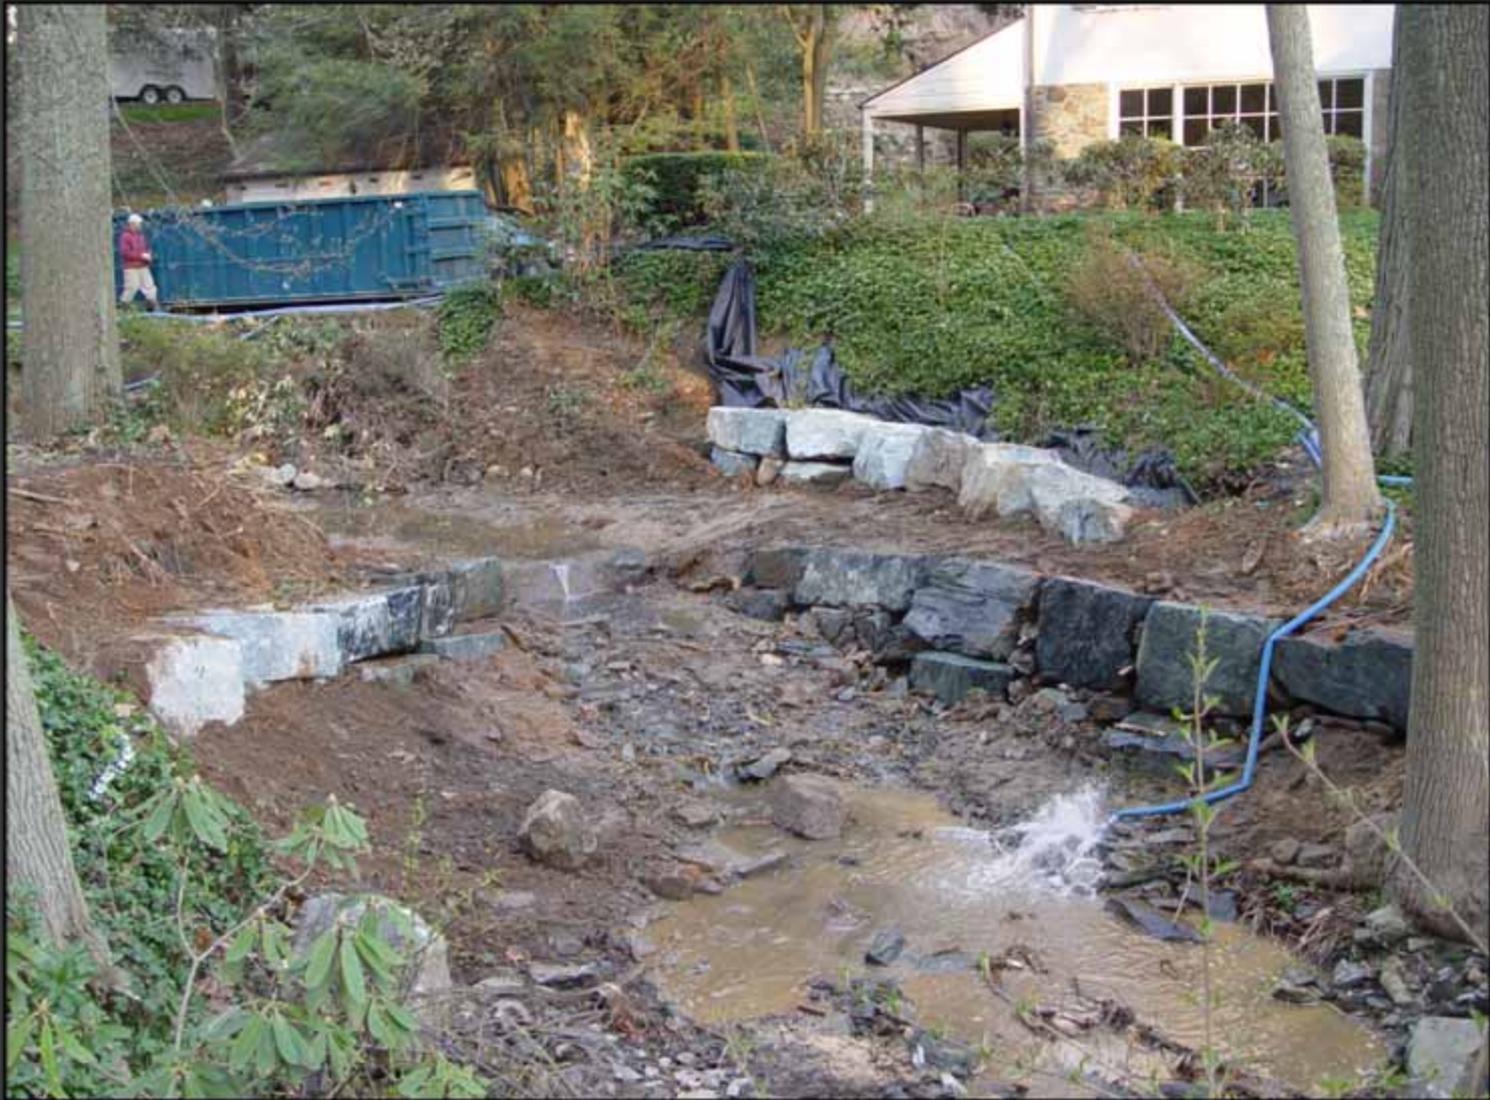
Cross vane with boulder bank revetment

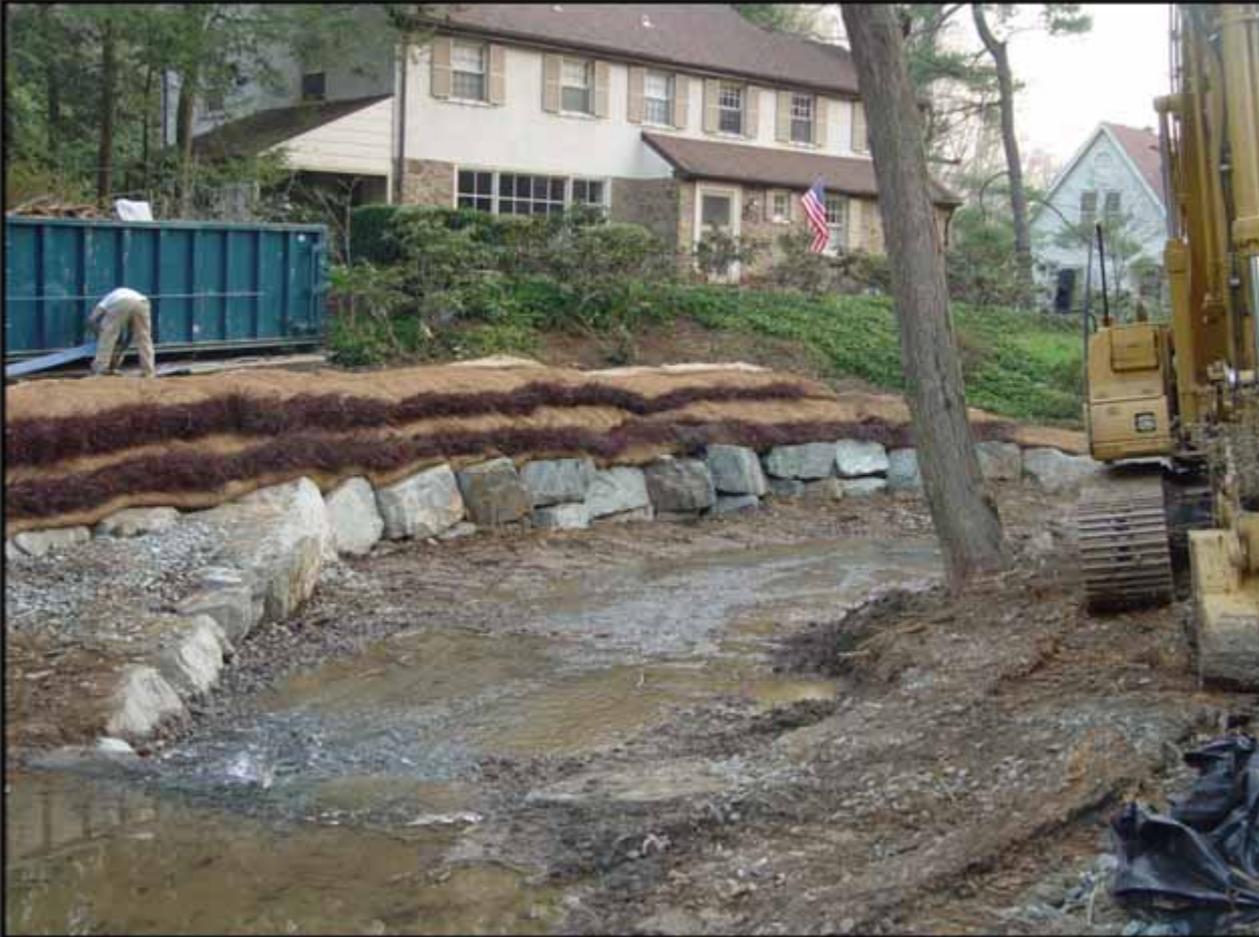
Boulder toe with live branch layering

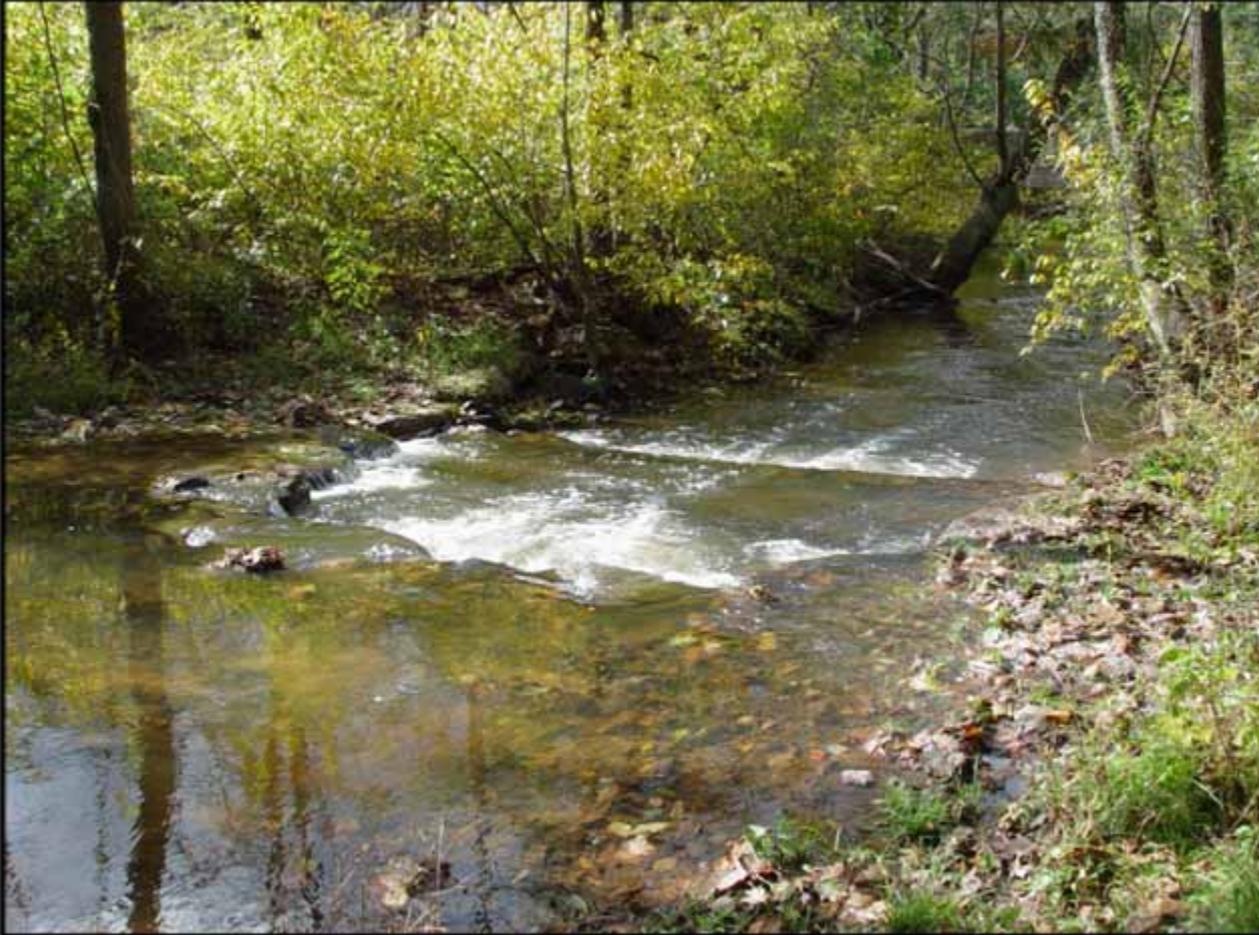
Cobble weir

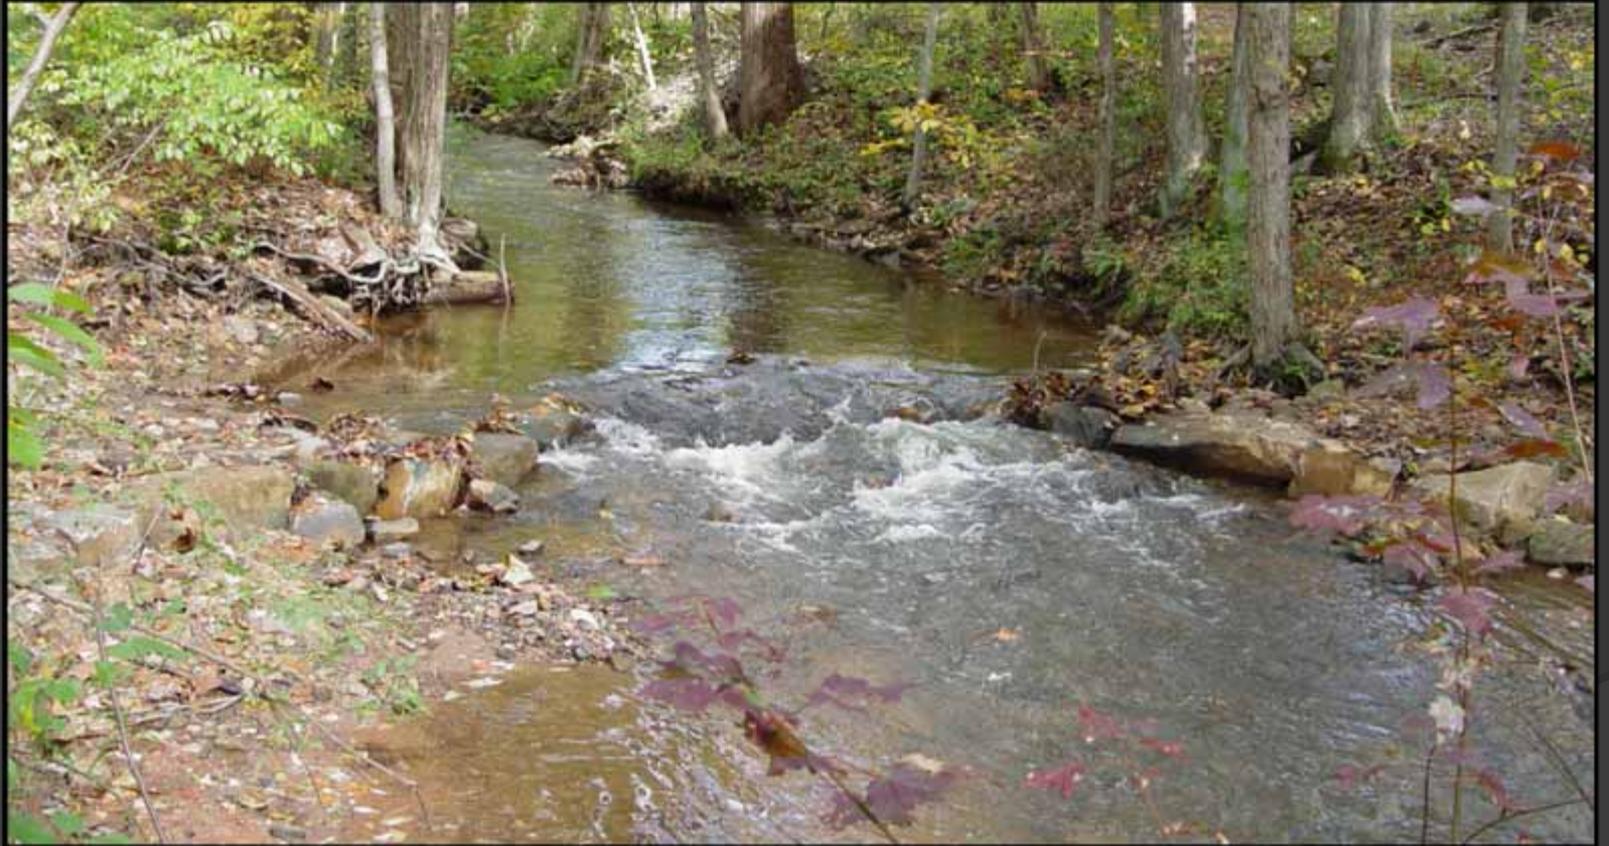
Rock vane arms with log throat

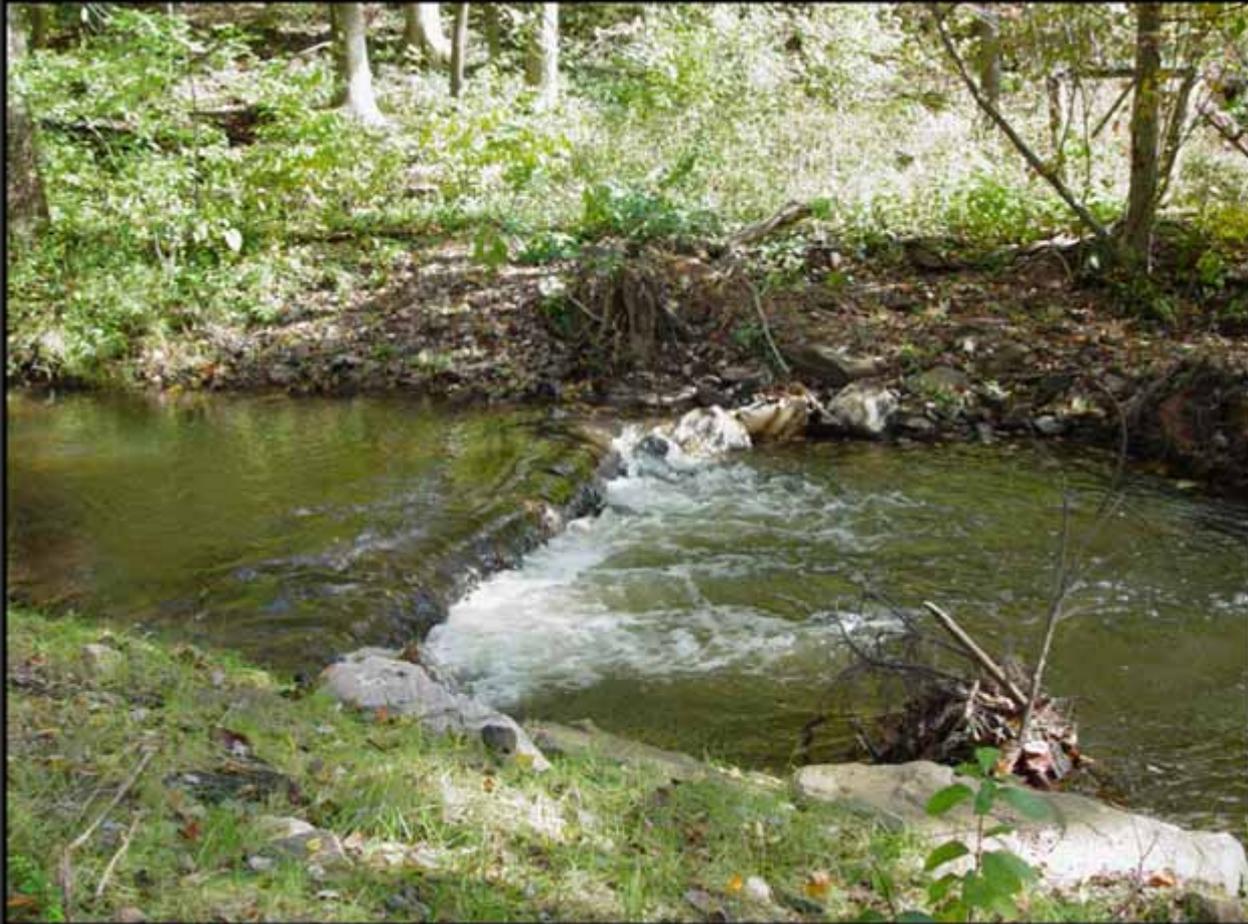
Bank sloping and re-vegetating
