2015 Performance and Progress Report

State of Idaho Nonpoint Source Management Program

**State of Idaho
Department of Environmental Quality**

May 2016

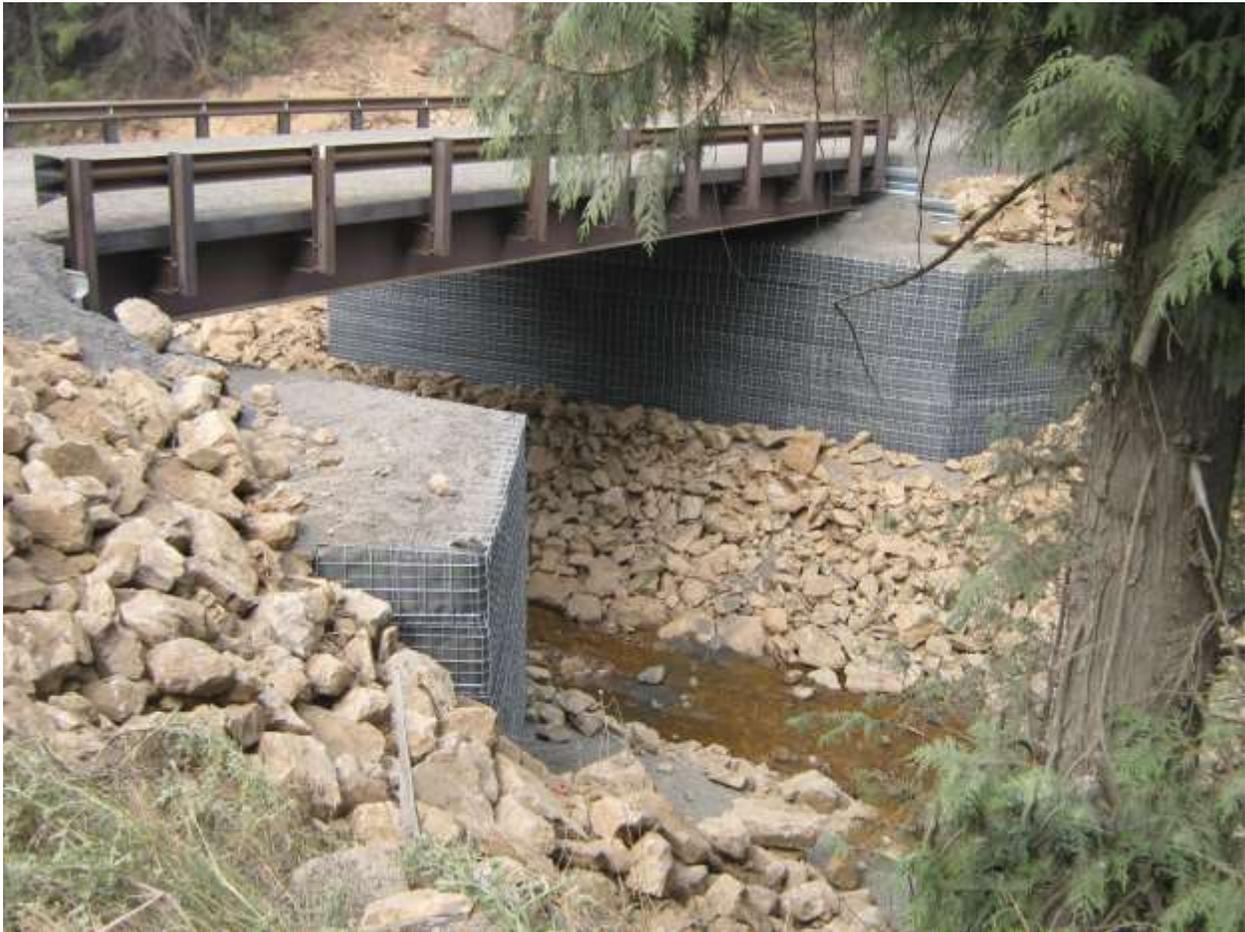
Cover photo: A bridge installed over Snake Creek in Clearwater County. The bridge replaced a covered culvert that would routinely plug, obstructing fish passage and increasing the sediment load in the creek. For more information, see page 45.

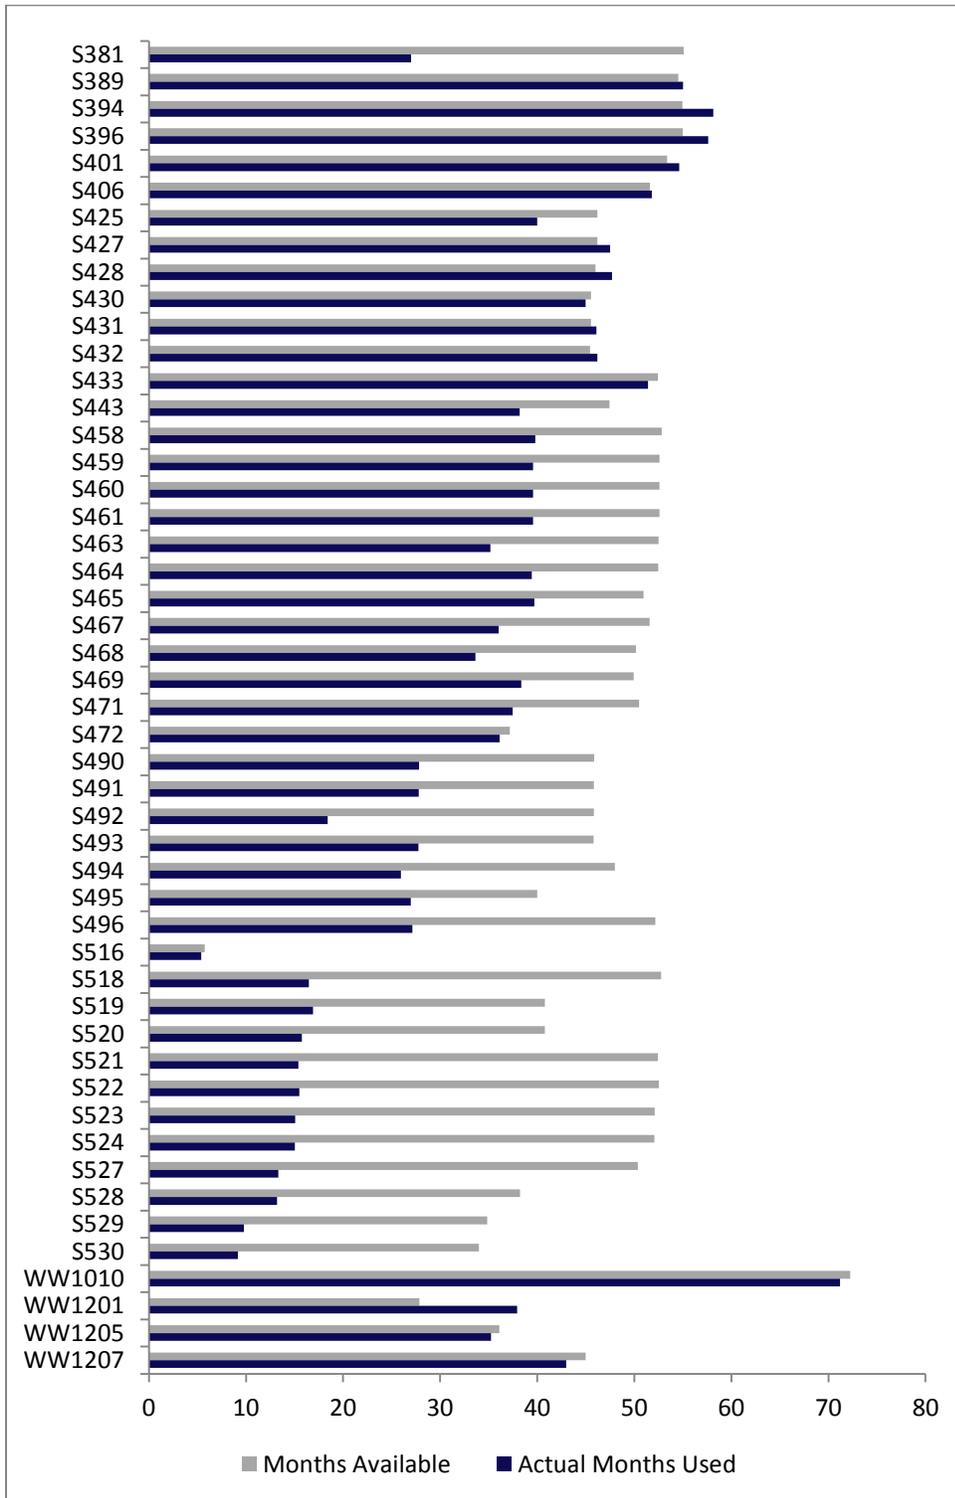
Figure 1. Active projects, time used, and total time available. The blue bars represent the total number of months the project has been underway. The gray bars represent total months available for project completion. (Note: Active projects are any projects funded in federal grant years 2009–2015, inclusive.)

Figure 1 compares the number of months work has been underway on each active project to the amount of time the project had at the outset to have its work completed. Figure 2 compares the amount of funding that has been expended (through November 30, 2015) on each active project to the amount of funding that was granted to the project at the outset. [Note: for an explanation of the aberrations noted in figures 1. and 2. for S471 reference the project status narrative found on page 39]

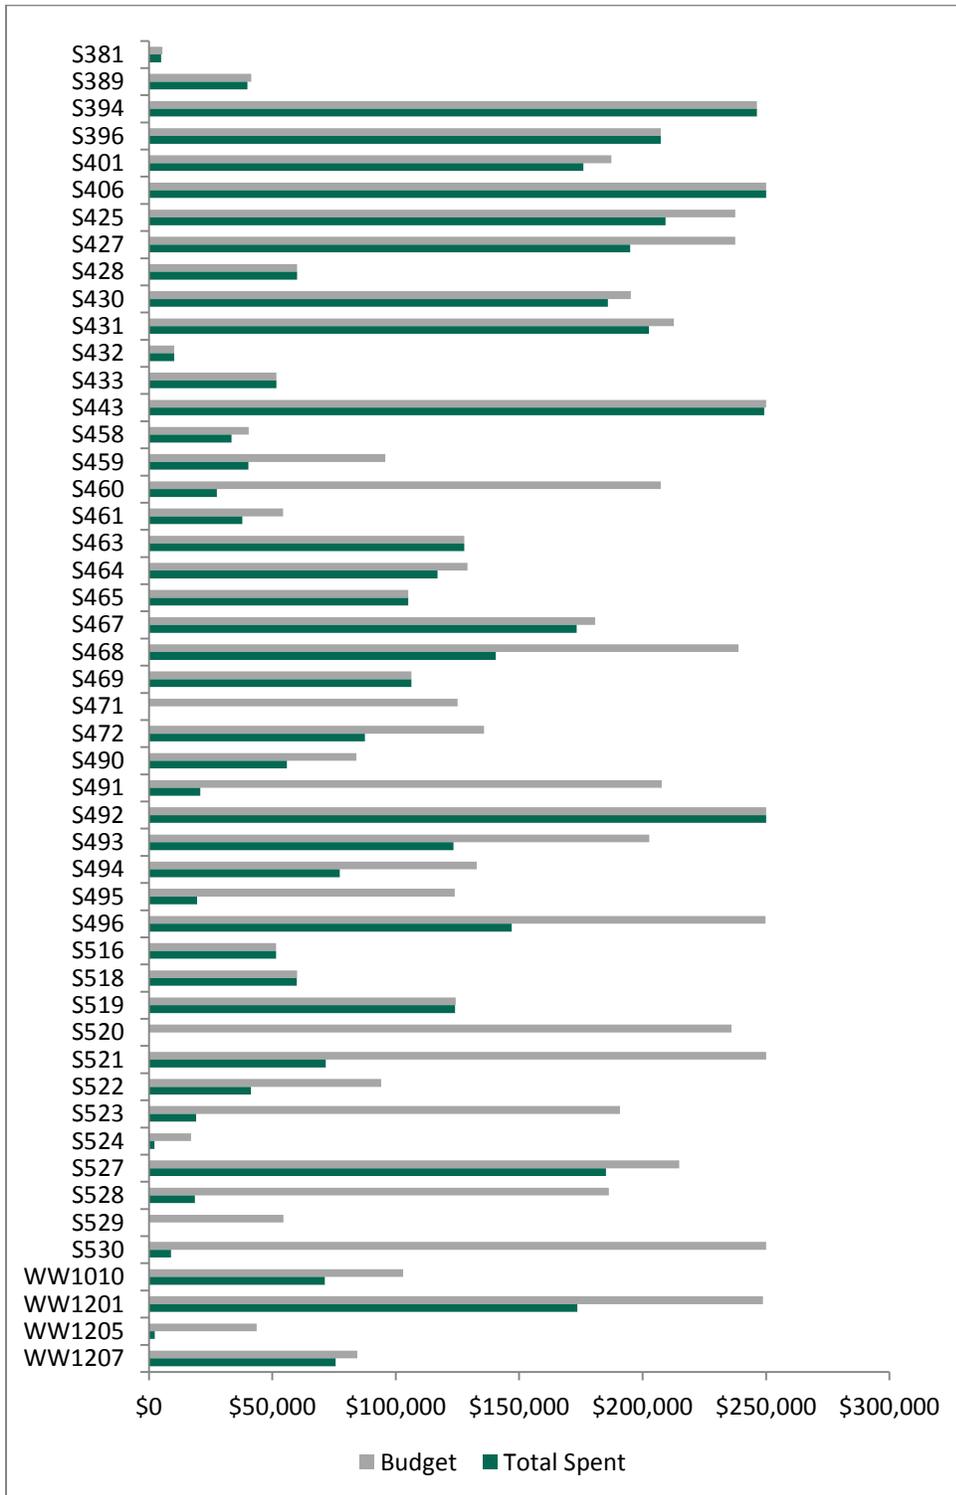
Figure 2. Budget usage by active projects. The gray bars represent the total federal funding for each project. The green bars show the amount spent by each, through November 30, 2015.

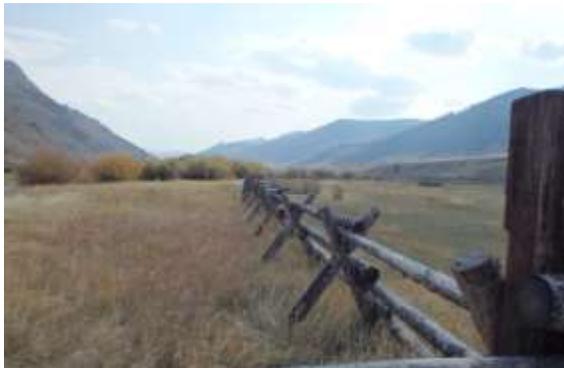
The effort to manage riparian grazing included fencing 1.75 miles of the lower East Fork Big Lost River to exclude cattle.

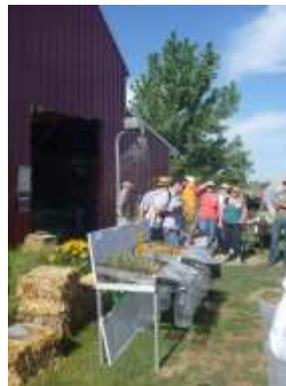
A rain simulation example demonstrated how soil covered with plant residues is the most important factor influencing water infiltration into the soil. A no-tillage system under cover of crop residues is the most efficient method for preventing and controlling erosion.

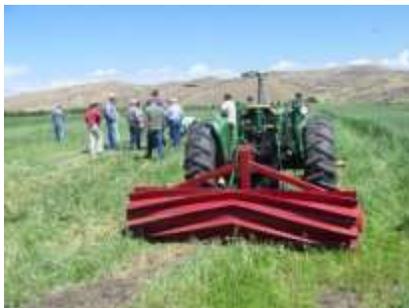
A roller crimper can turn a lush stand of cover crop into a thick, weed-suppressing mulch.

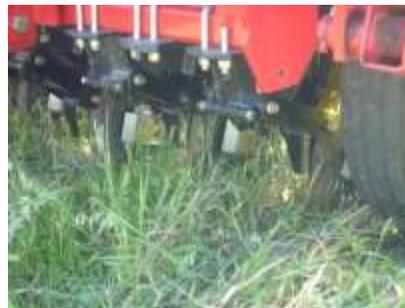
After crimping the cover crop, a no-till drill is used to penetrate the soil and to cut or move heavy surface residues creating a furrow. Seeds are dropped at a uniform depth and in firm contact with the moist soil to ensure a good stand.

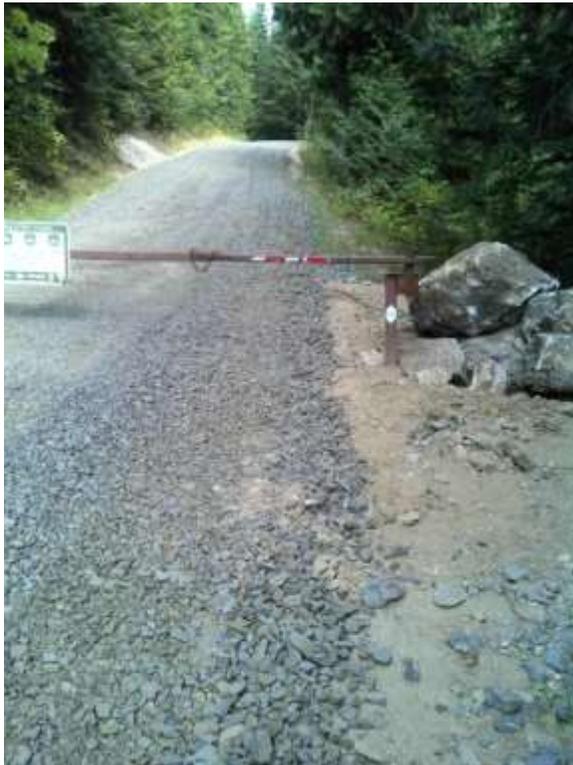
Recently rocked forest road.

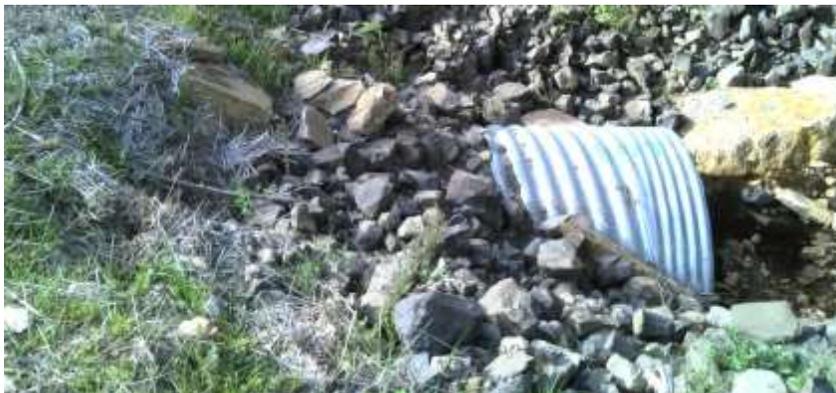
Culvert installation/replacement.

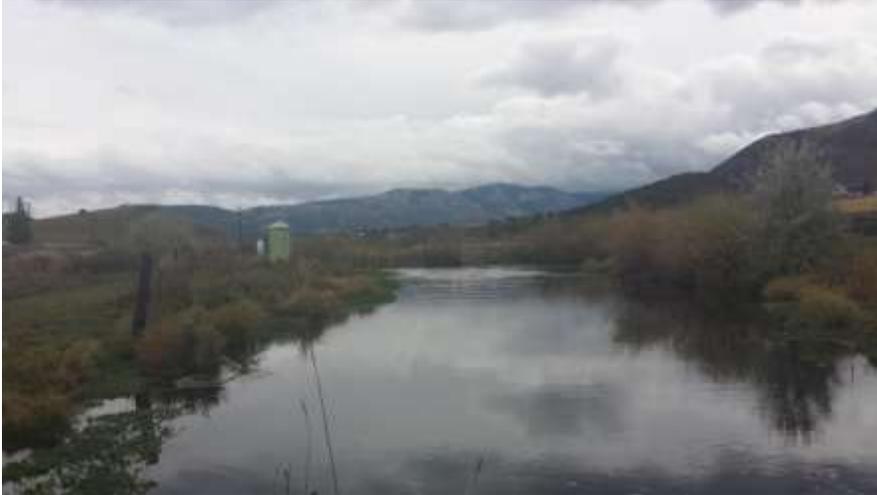
Looking upstream at an area where bank restoration work was completed. On the left side of the photo is the Topaz Gage Station. Work started at the post on the left and continued upstream to a point just past the Gage. The riparian area was fenced to exclude livestock.

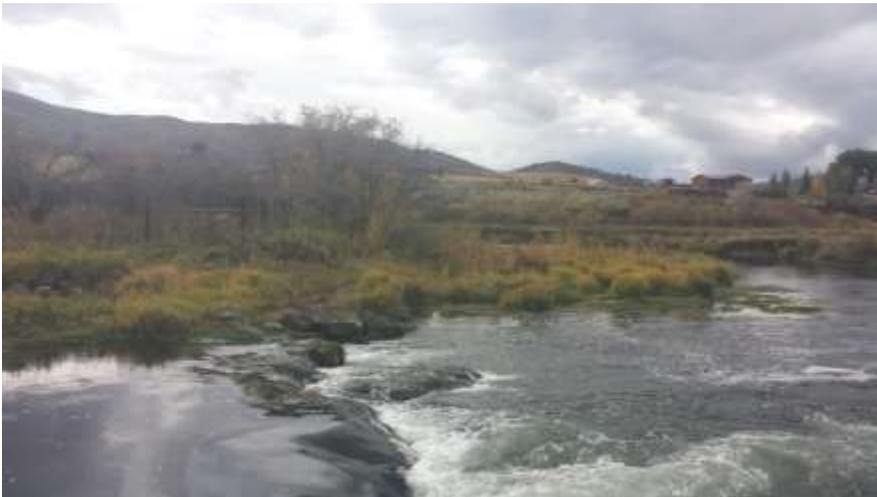
A section of streambank that was restored during the project. In 2011 one runoff event caused high water to wash around the end of the natural rock structure and erode about 11 feet of bank.

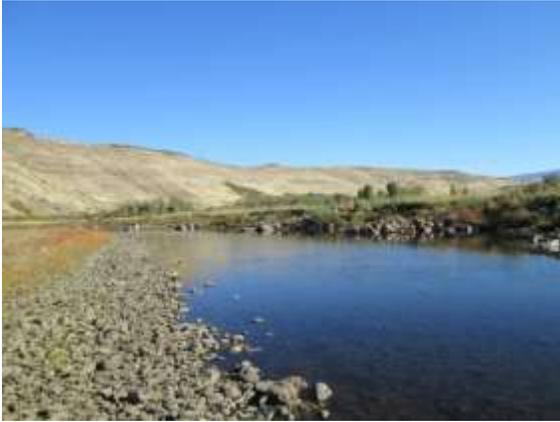
Barbs were built to deflect erosional energy away from bank.

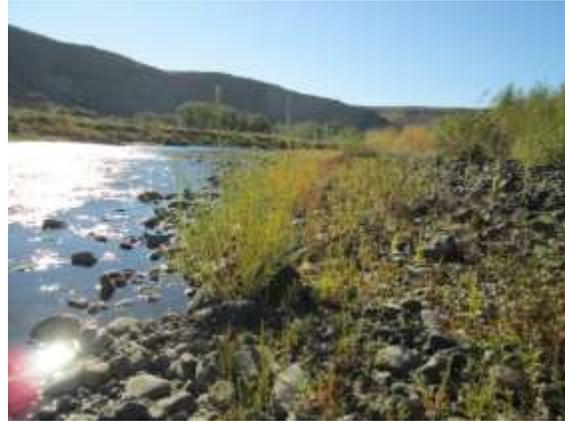
Willows planted along the bank are helping to restore the riparian area.

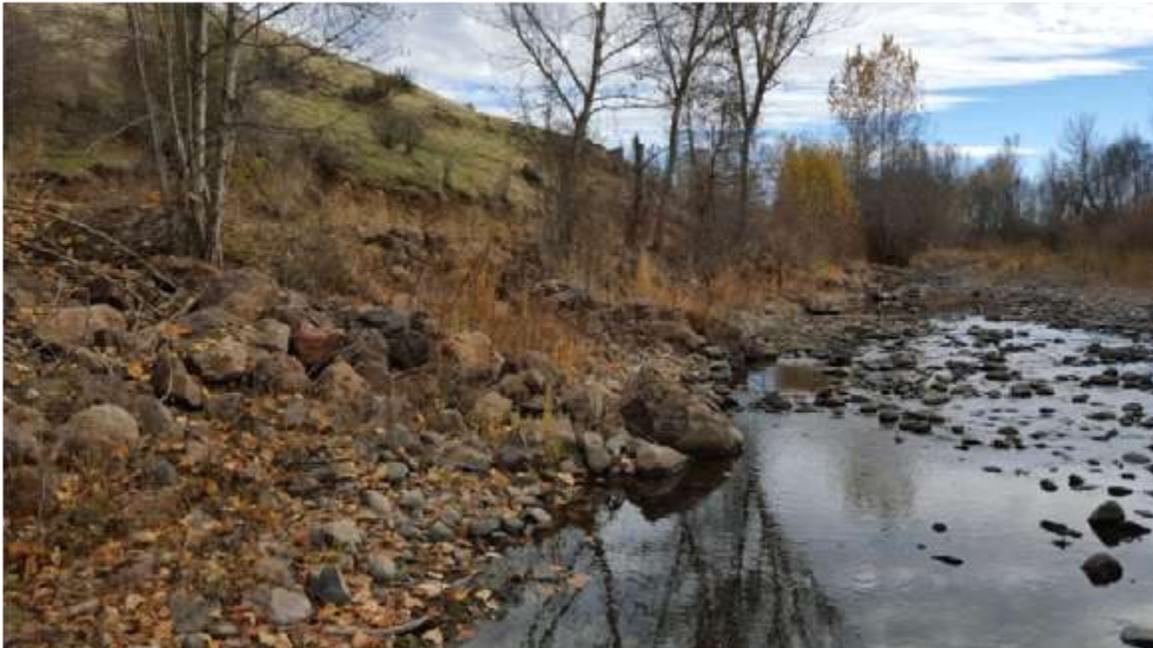
Prior to the start of this project, this section of the Little Weiser River was starting to erode and threatened to breach the Lindsay Ditch embankment. After installing river barbs and replanting the riparian area one can now observe sediment deposition occurring between the barbs, and willows establishing themselves along the banks.

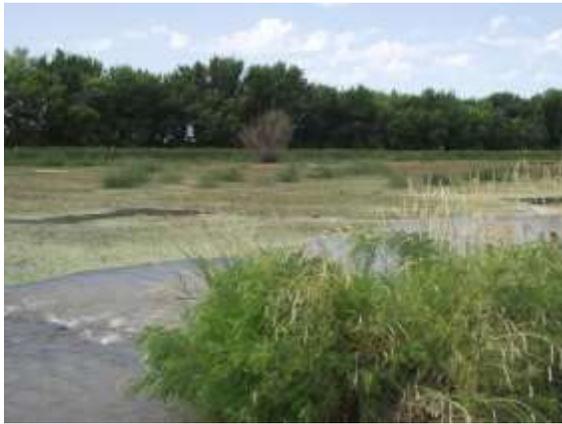
The spillway into the second pond, as observed in 2013.

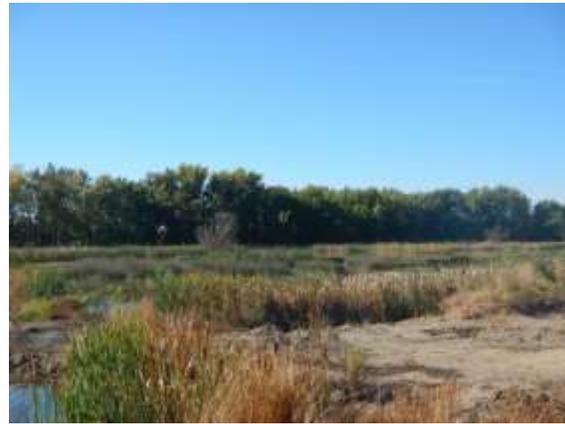
The same spillway into the second pond, as seen in 2015.. Established vegetation serves to intercept runoff from nearby fields. Slowing down runoff further allows the wetland to function to remove pollutants from the water.

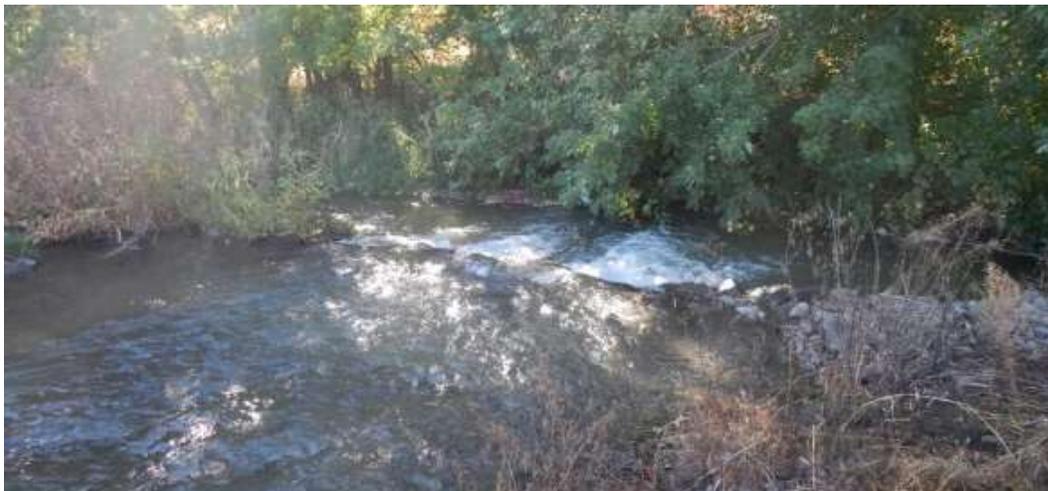
This picture shows the point where the spillway for the second/polishing pond discharges into the outlet ditch. During the irrigation season ditch water can be diverted into the wetland complex or can remain in the ditch until it eventually enters a large pipe and head gate and discharges into the River. The bypass allows options for scheduling maintenance during the irrigation season to be considered.

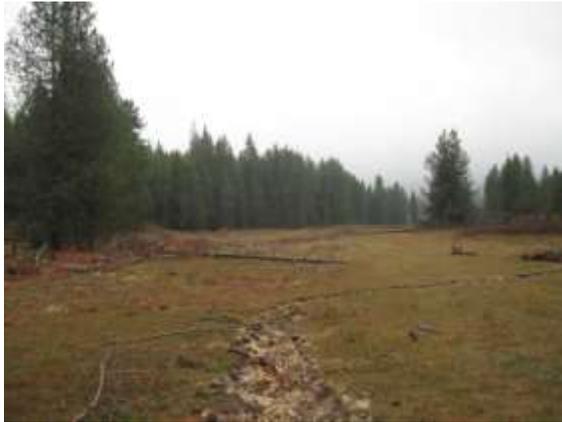
An overflow persuasion channel with large woody debris is restored in a meadow.

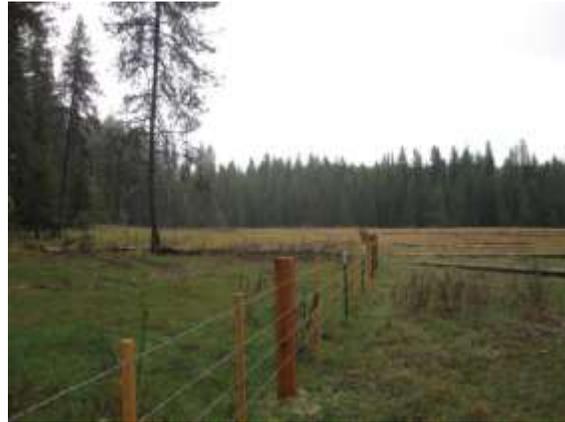
6,275 linear feet of fence was installed to protect 10.2 acres of stream channel and meadow.

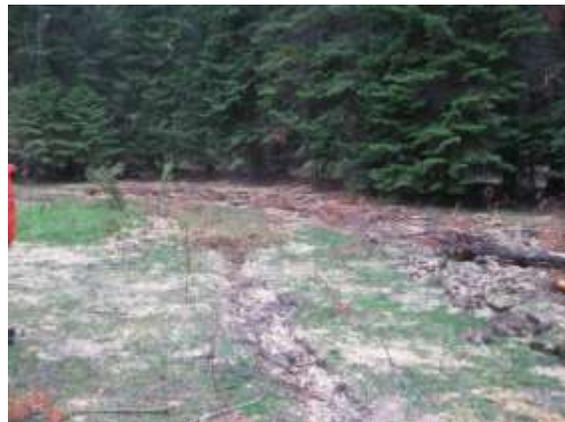
Riparian vegetation plantings and sedge mats provide streambank stabilization and proper meadow function.

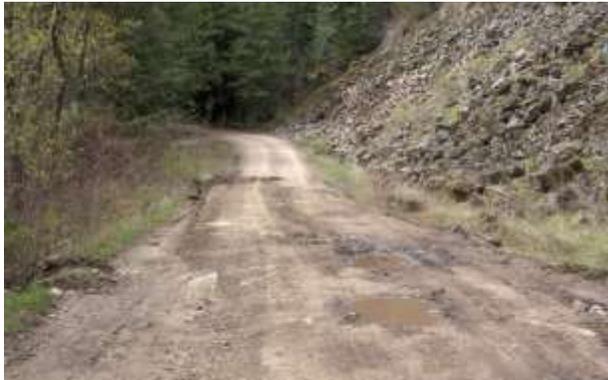
St. Maries River Road in May 2010, before the start of Phase I work, had numerous pot holes.

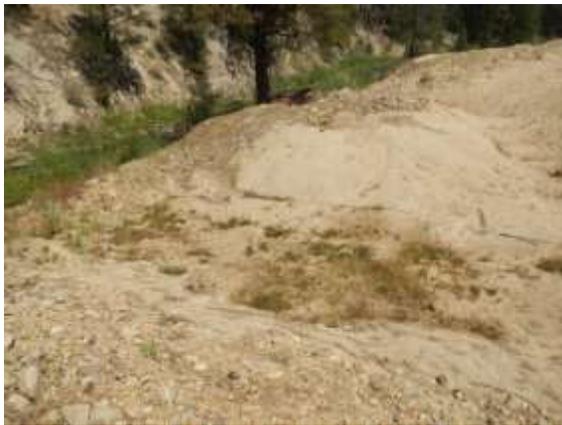
Sediment traps were created in tailings piles. Along Granite Creek, a tributary to Grimes Creek, traps were constructed to collect floodwaters and retain sediment. This year, low water and very dry conditions resulted in this sediment trap not receiving overland flows of any type.

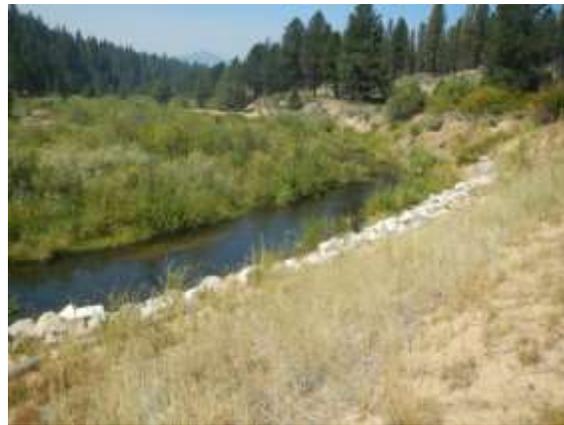
The results of stabilizing a length of streambank with rip-rap, compared to one that used bioengineering techniques to achieve a similar outcome. Using rip-rap to stabilize a length of eroding streambank is being discouraged in some circles in favor of using softer, bioengineered techniques.

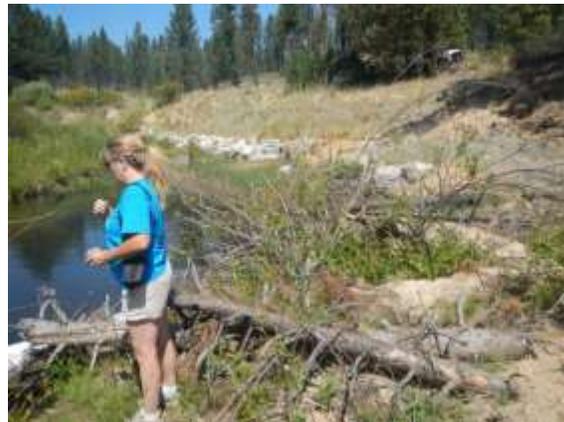
Bioengineered techniques used in the project were successful even during this very dry, low water year. Willows and other bushes were growing and appeared to be in good shape. In time, as root structures take hold, they are expected to provide subsurface stabilization and protection. As the riparian area grows expectations call for it to reduce stream velocity, reduce scour, and promote sediment deposition at the toe of the bank.

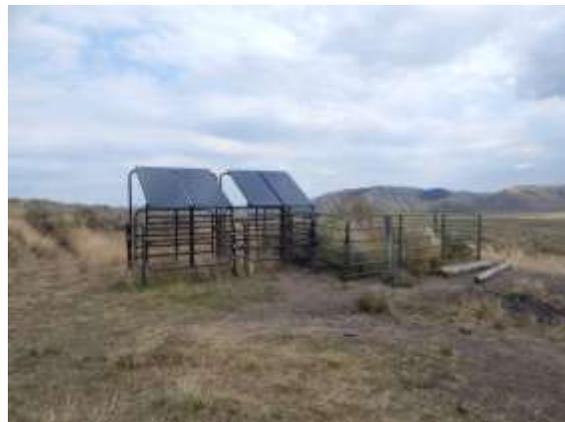
Solar panels are used to provide the energy needed to operate pumps that deliver water to troughs.

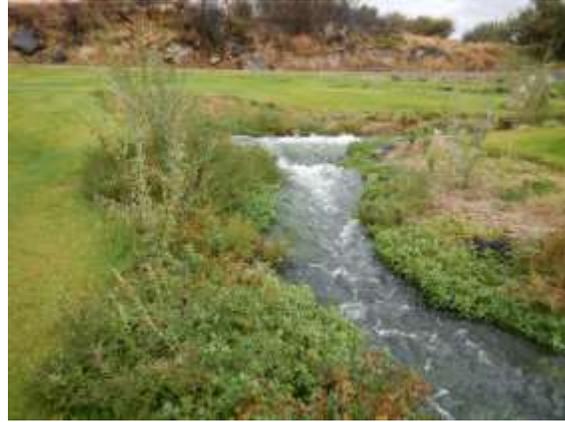
The rock that was placed along the banks is now mostly covered by new riparian vegetation growth.

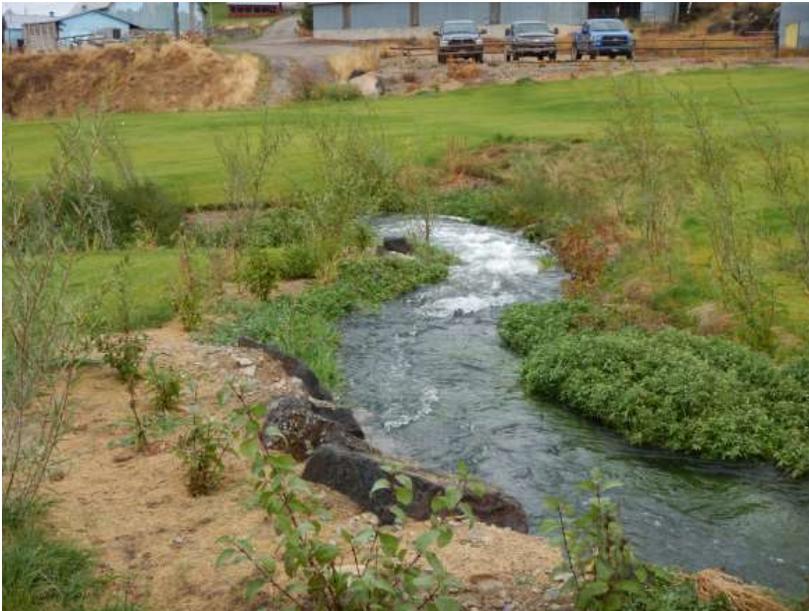
The riparian vegetation shown in the picture includes a mix of willows and dogwood. The willows grew 3–4 feet in year one, with many new branches. To this date 98% of the willows planted had survived.

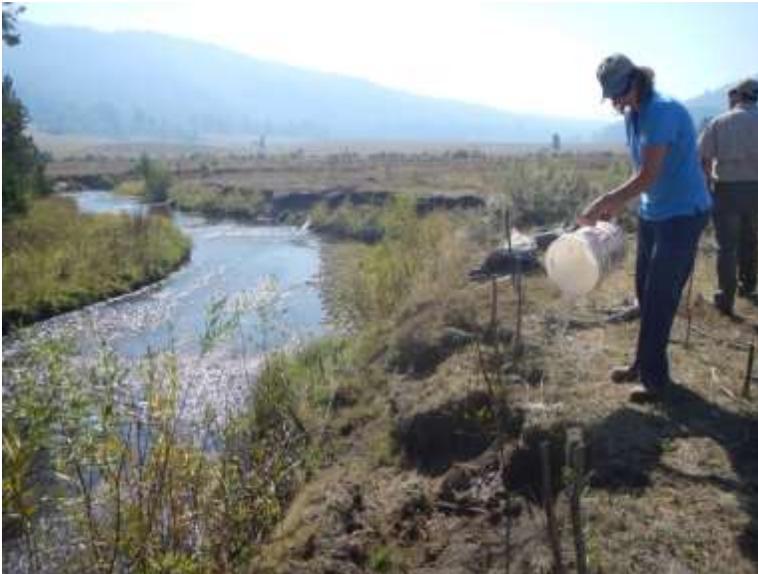
Dry conditions and low water levels compelled IDFG to increase their number of hand watering visits. This photograph shows willow weaving treatments at the water's edge and pole plantings on the bank of Boulder Creek. Over time the bank will collapse and create a more stable angle of repose.

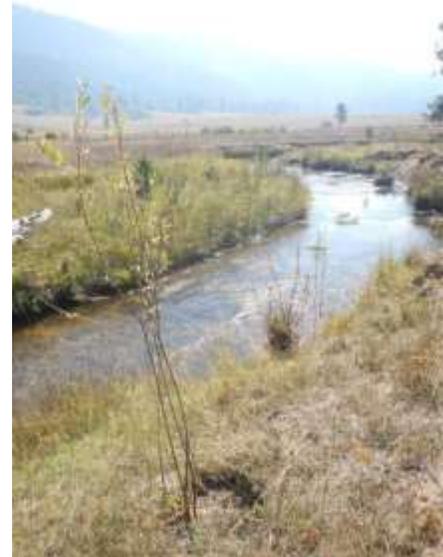
Pods are hand dug to a depth of 3-4 feet to ensure the plants roots are wet and able to reach water at any time of the year. IDFG and volunteers hand weed the sites and water pods to ensure successful rooting.

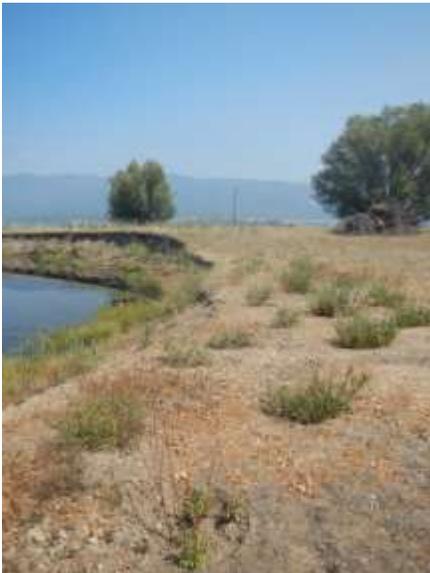
IDFG and volunteers planted 700 plants in 2015 on 68 acres adjacent to the Little Salmon River. This image shows pod plantings at the top of bank and willow poles stung lower into the bank. As the willows establish, the vertical bank will slump between the plantings to create greater stability.

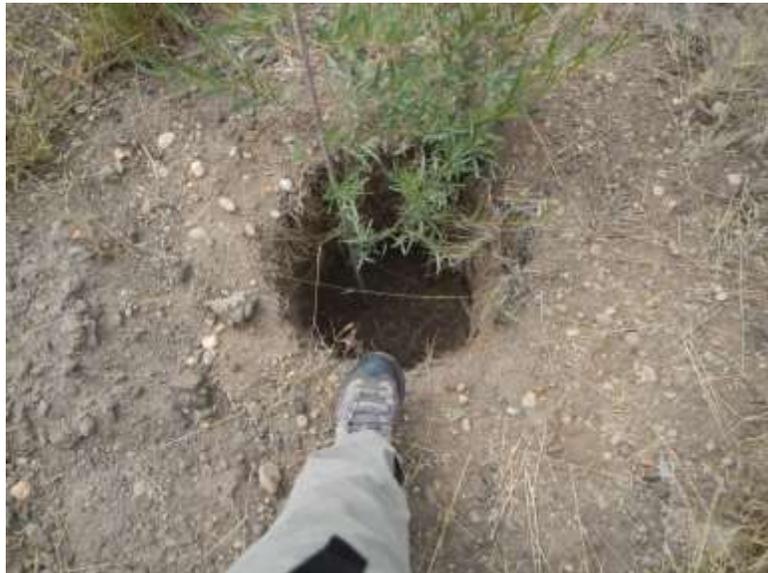
A steer auger was used to drill holes 6 feet deep into the capillary zone. Planting willows at this depth will ensure the roots remain wet, thereby increasing their chances of survival.

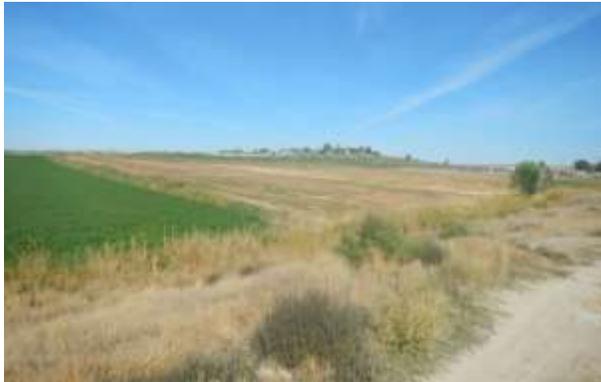
Burris Surface Upgrade. The irrigation water used on these fields was supplied by an earthen ditch. Conversion to a mainline eliminated washouts and water loss on the main ditch. Water management is now more efficient and crop yields have improved. Runoff and erosion has been reduced.

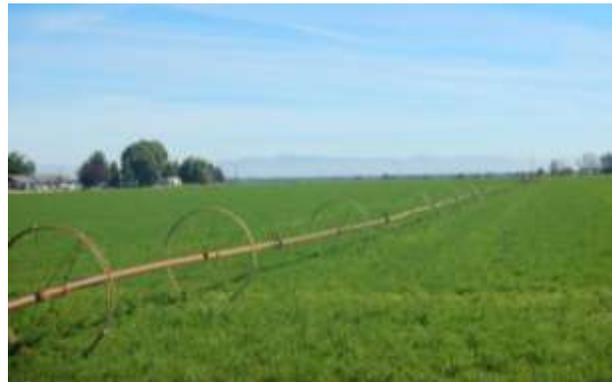
Hungate Wheel Line. Iron levels in irrigation water can cause rust to form on pipes. Using a wheel line to supply water for crops results in reduced levels of runoff, phosphorus mobilization, deep percolation, and erosion. After the wheel line system was installed runoff from fields was eliminated.

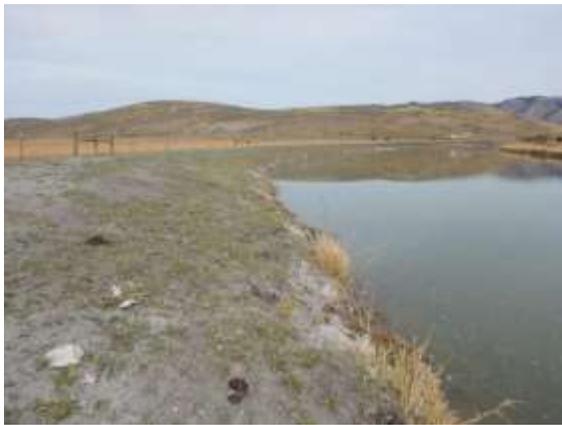
The new-sloped bank with the exclusion fence showing in the background. There is evidence of livestock having entered the excluded area. No invasive plants were observed on the site.

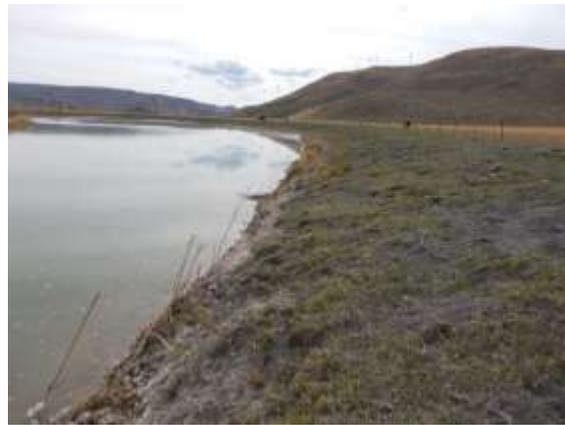
Willow poles were implanted in the bank at the water's edge. Livestock had foraged the willows causing many of the plantings to be lost. A few of the more hardy ones survived and are still growing.

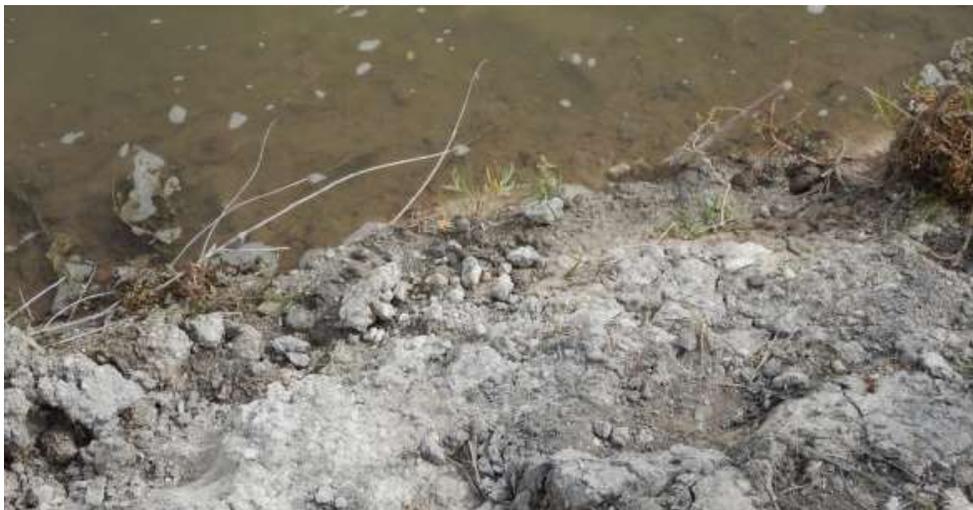
A number of small willows were observed growing naturally along the bank..

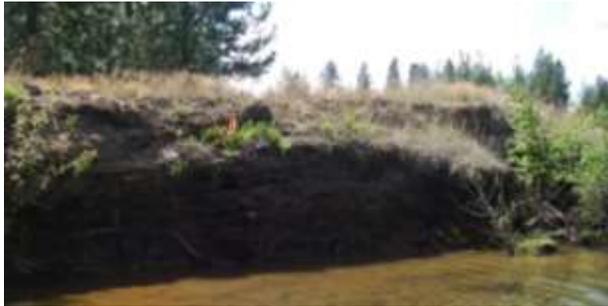
The condition of the streambank in the project area before stabilization efforts began.

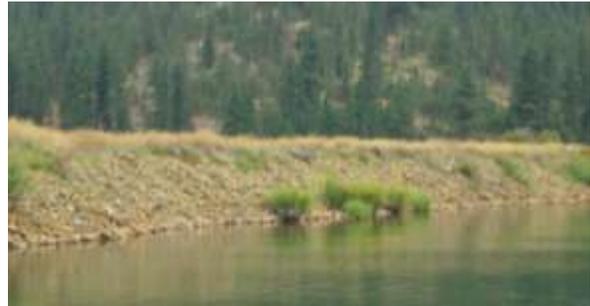
Some planted vegetation had survived and was seen thriving within the newly armored bank.

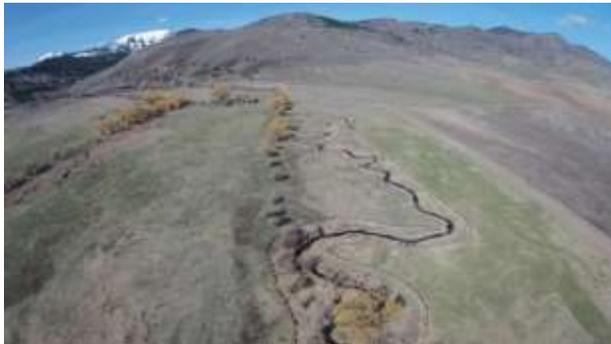
The old, straightened channels followed the row of trees and willows seen in the picture. The redesigned channels follow courses similar to the ones they followed prior to when the channels were straightened. Note the fencing built along the new channels to control grazing.

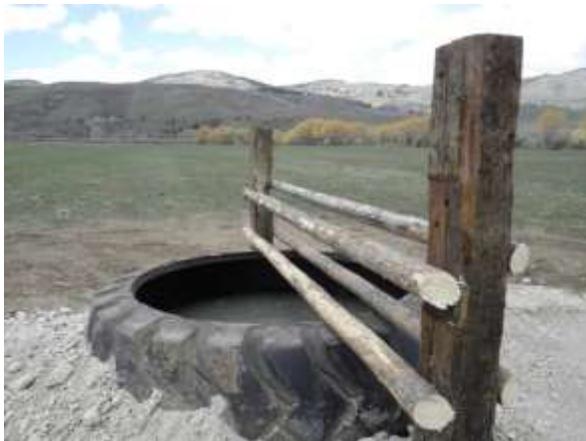
A float in the trough controls the flow of water to the site.

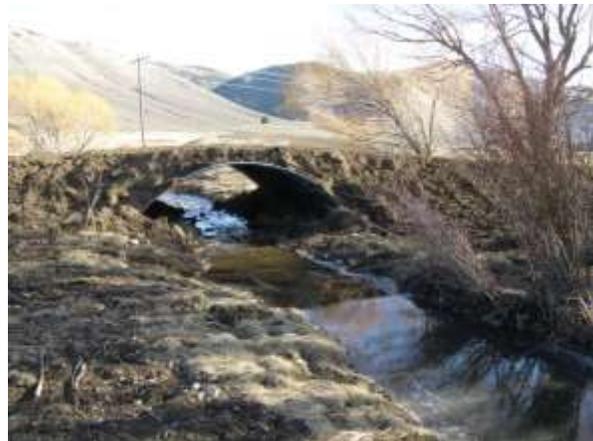
Pebble Creek flows unimpeded through this bottomless culvert, built to allow fish to migrate upstream towards the headwaters.

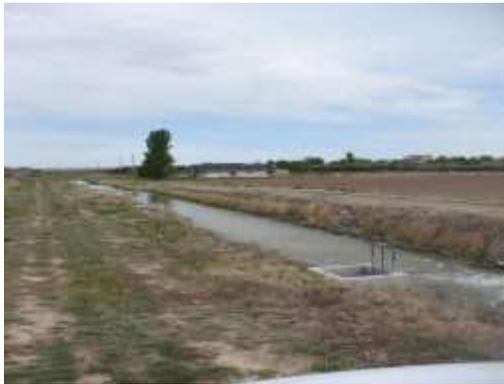
A series of head gates control water flow from the feeder lateral, under the road, and into nine wetland cells.

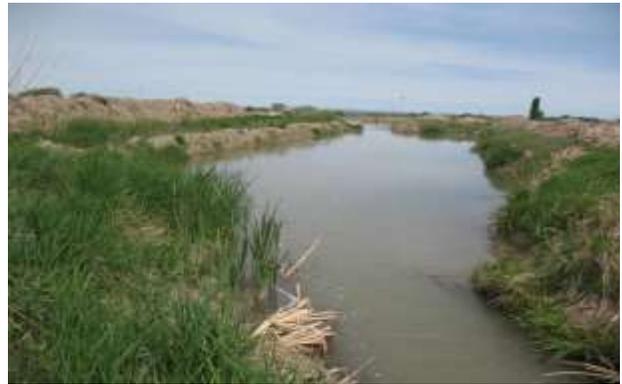
Water from the Coulee flows from a ditch into a series of three cleaning cells and then discharges into a large finishing pond.

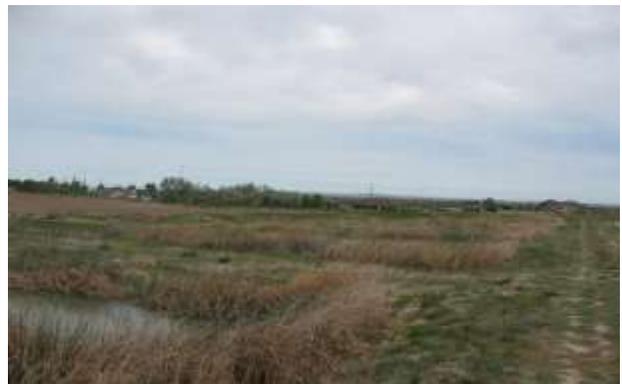
Wetland plants and grasses surround the filter cells. Cattails and bulrush serve to finalize the filtering process before the water is discharged into the River.

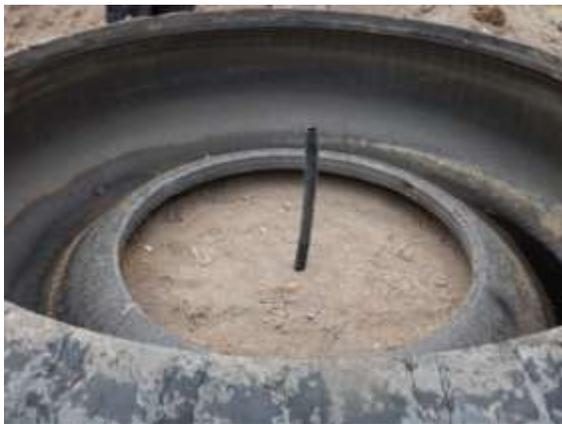
Plumbing to this trough must be installed before it can serve as a reliable site of off-stream water.

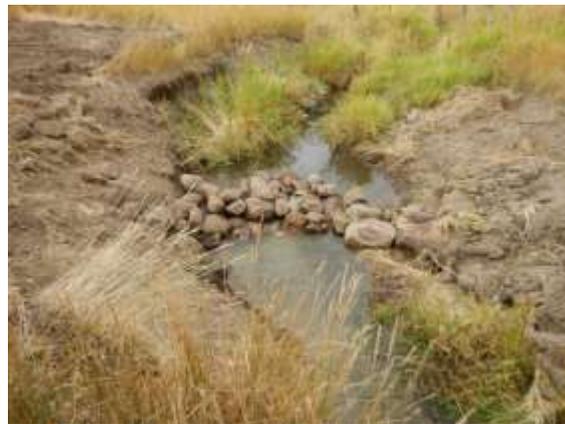
Rock checks were built to prevent the channel from further incising, which in turn will allow the riparian area to retain the level of moisture needed for vegetation to recover.

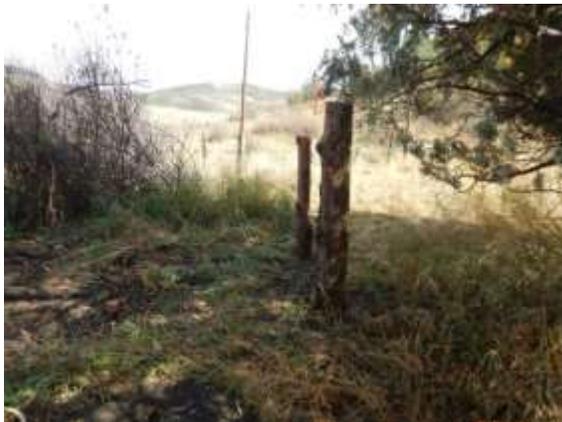
Brace posts are being used on cross fence to increase the life of the fence and to aid grazing management.

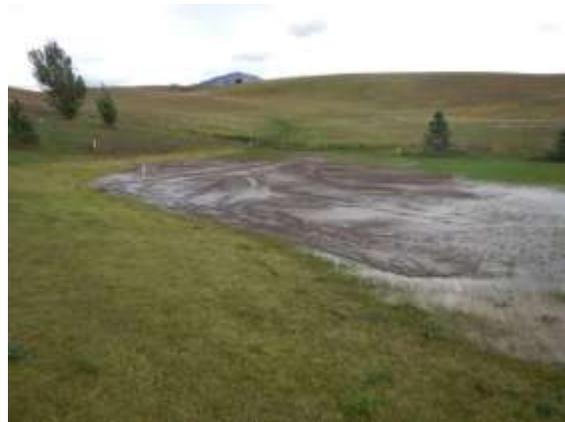
A rainstorm passed through the area the night before DEQ's evaluation resulting in severe cropland erosion. Plans are in place to construct water and sediment basins to prevent similar outcomes from occurring in the future following periods of high precipitation.

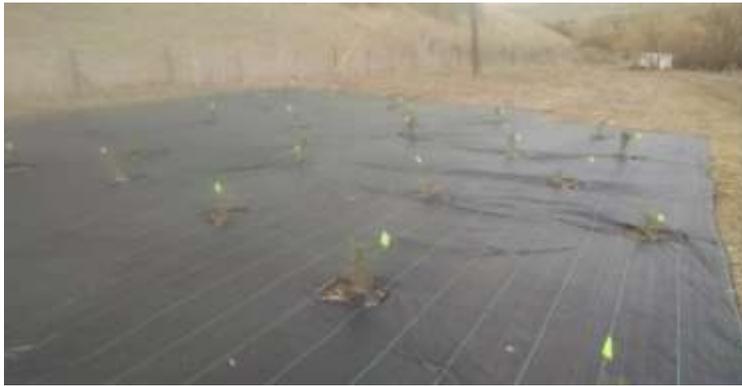
Ponderosa pine plantings (2-year seedlings).

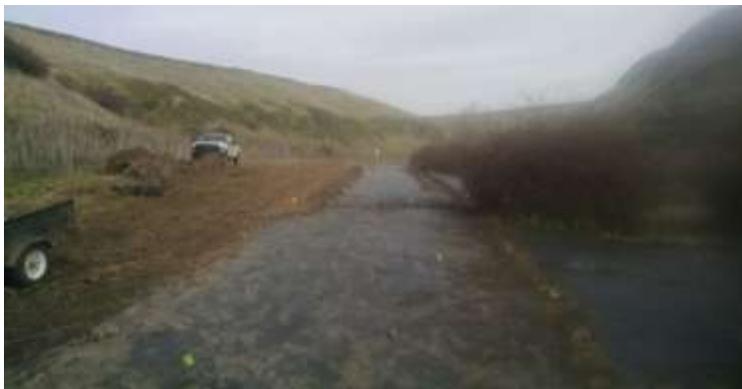
An installed weed mat.

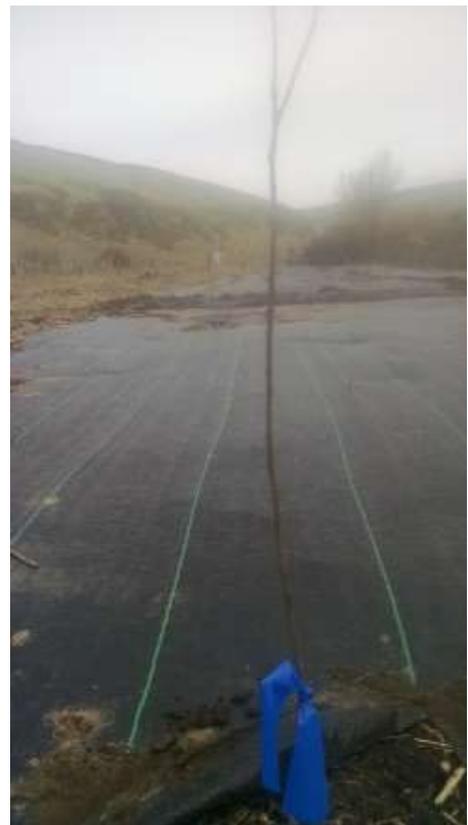
A Redosier dogwood planting.

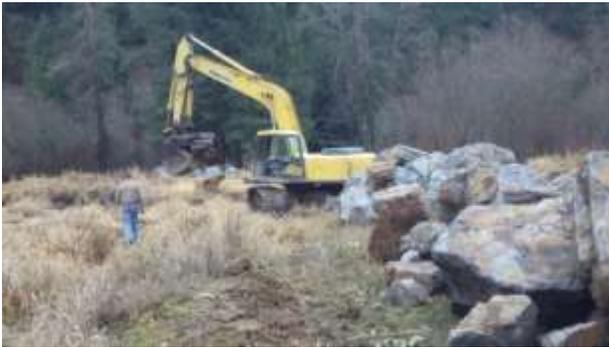
Large boulders were placed in the channel to serve as barbs to redirect flow

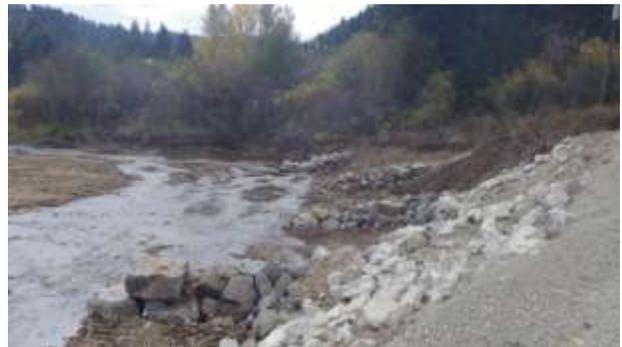
Barbs were constructed in place during low flow conditions

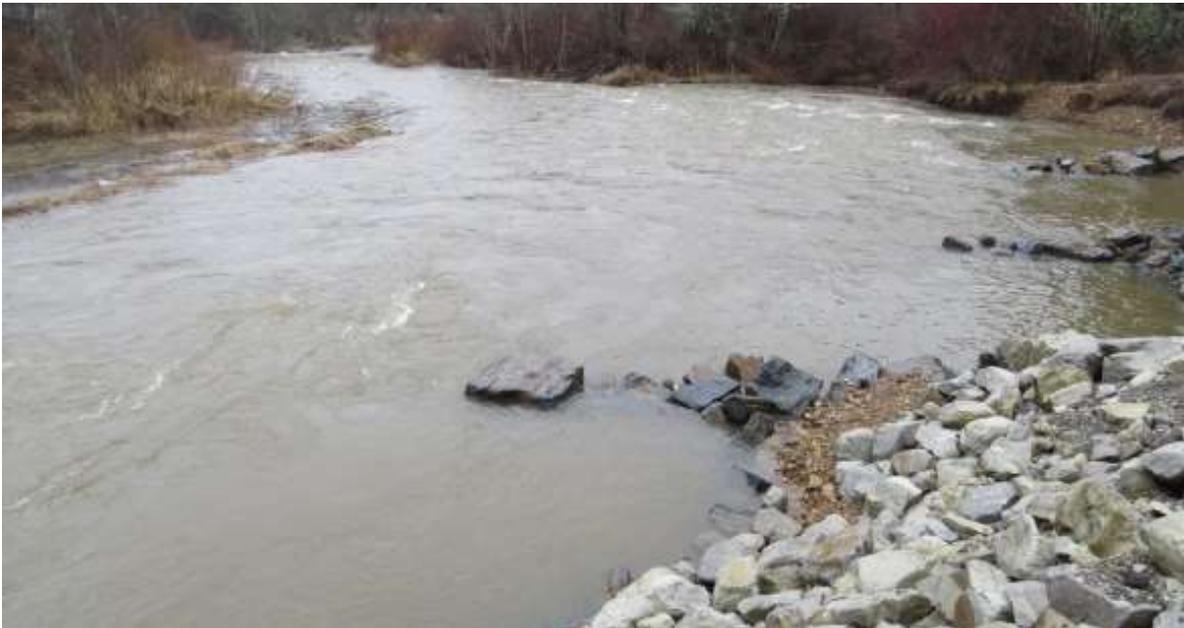
During runoff the barbs functioned as intended, to move the thalweg out from the bank of the creek.

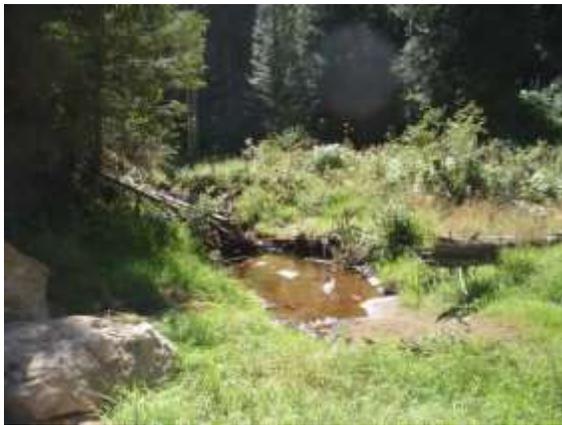
As the undersized culvert would become blocked, large amounts of sediment would accumulate upstream.

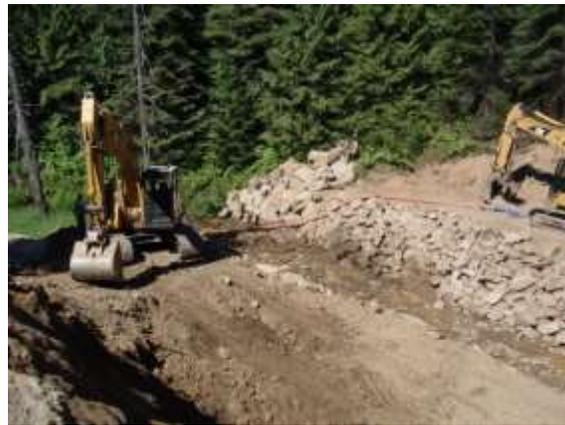
Large native rock is being used to stabilize the bank near the bridge site. One of the three excavator hoes used on the project can be seen on the right bank.

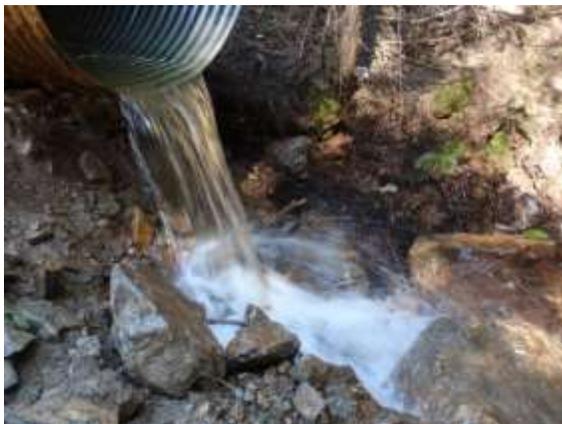
Outflow of water diverted from the job site.

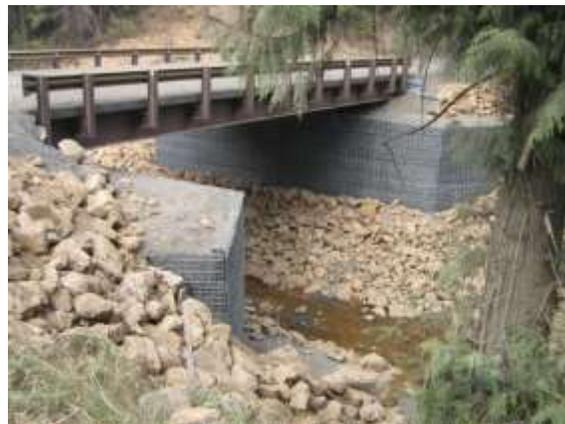
The bridge and supporting structures, near the end of the project.

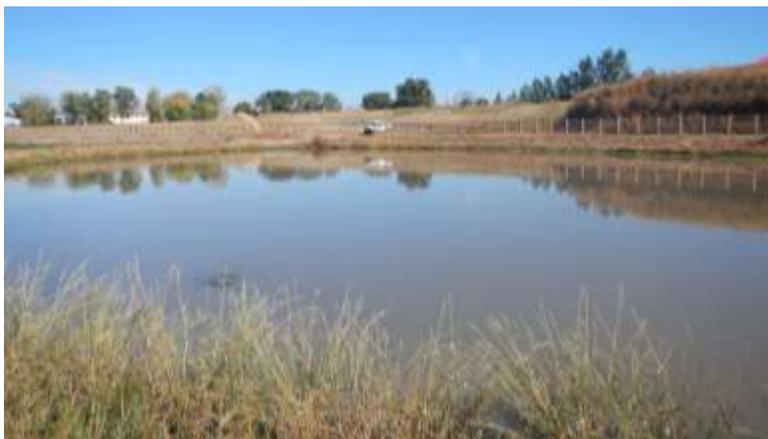
The NRCS designed this ½ acre pond and wetland on property donated by two adjacent landowners. Flow enters the pond in a 2-foot deep area that gradually slopes to a depth of 3-4 feet at the point of discharge. The Weiser Irrigation District has agreed to maintain this wetland.
