2015 Performance and Progress Report

State of Idaho Nonpoint Source Management Program

**State of Idaho
Department of Environmental Quality**

May 2016

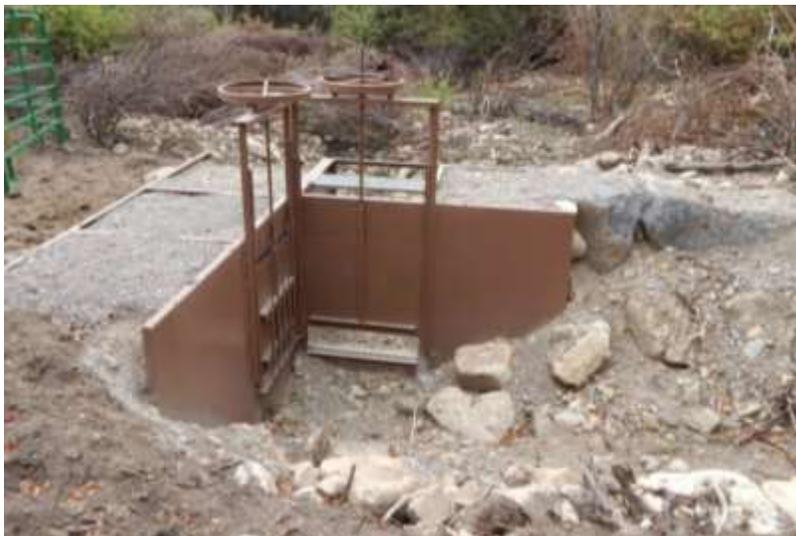
The head gate and clean out head gate will be used to control the flow into the irrigation system. The clean out head gate is partially open in this picture. Constructed closer to ground level than the other, it will be used to flush out sediment that builds up in front of the head gate.

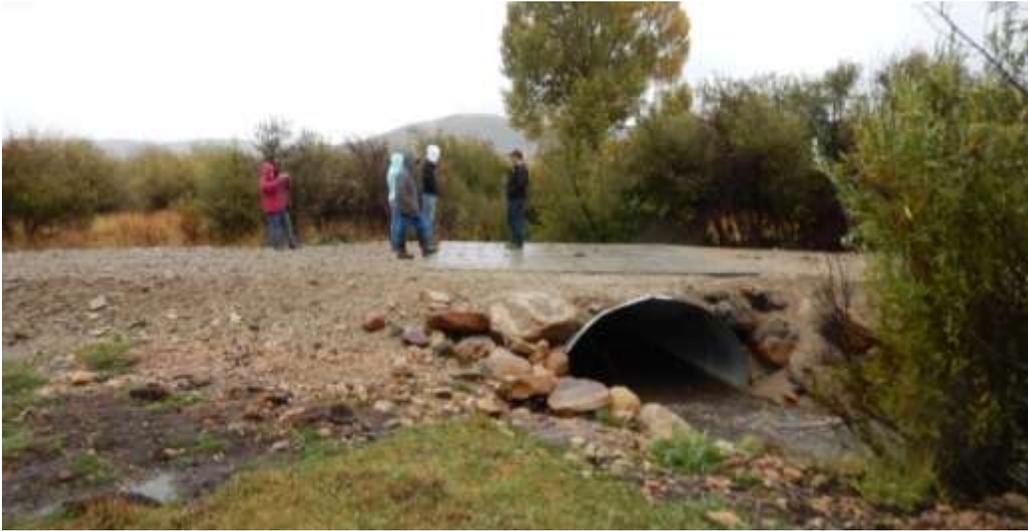
A crossing was installed over a new culvert. Cement was laid as the road surface above the culvert to provide added strength for heavy semi-trucks passing over the stream.

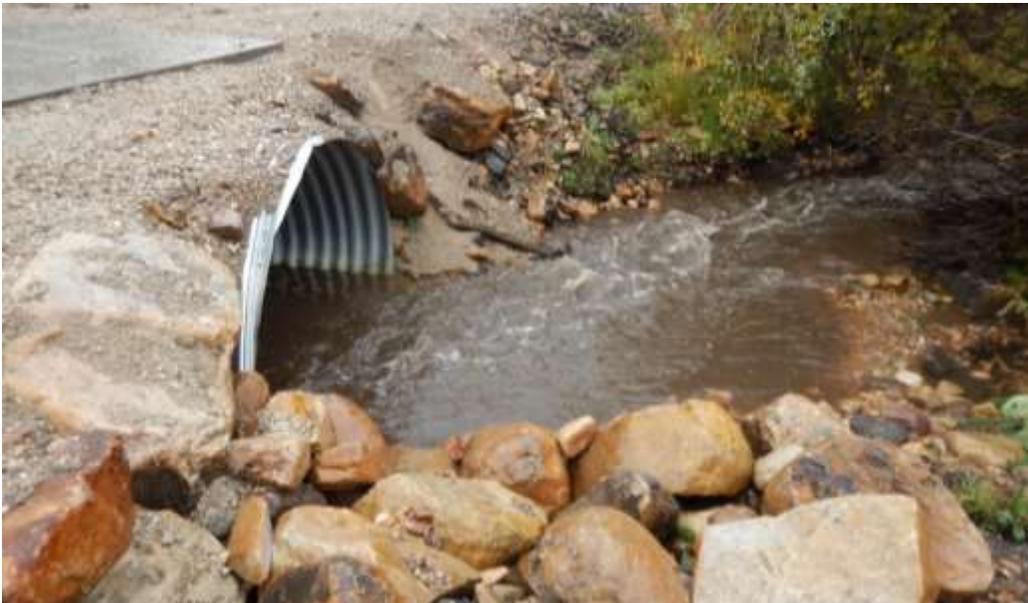
Due to the location of the crossing the approach of the stream could not be straightened. Instead, the bank was hardened to prevent the stream from washing around the culvert.

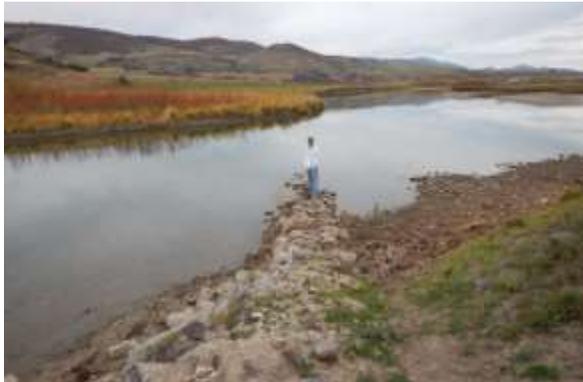
A rock barb was installed to protect the river bank from continuing to erode.

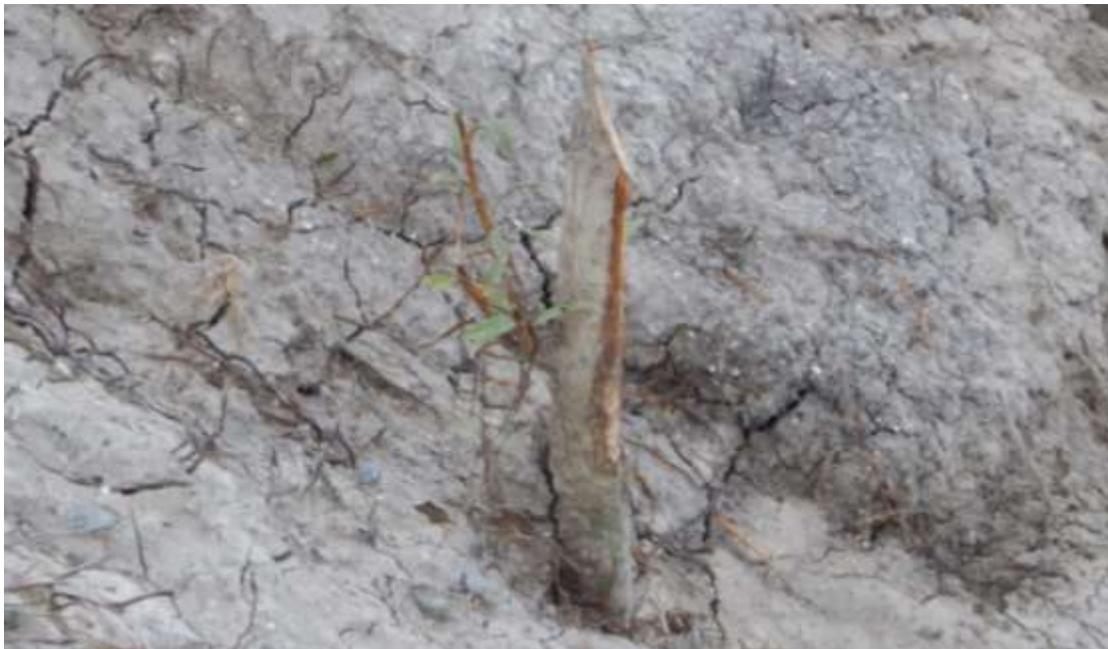
Some planted willows were damaged by rodents but were still managing to survive.

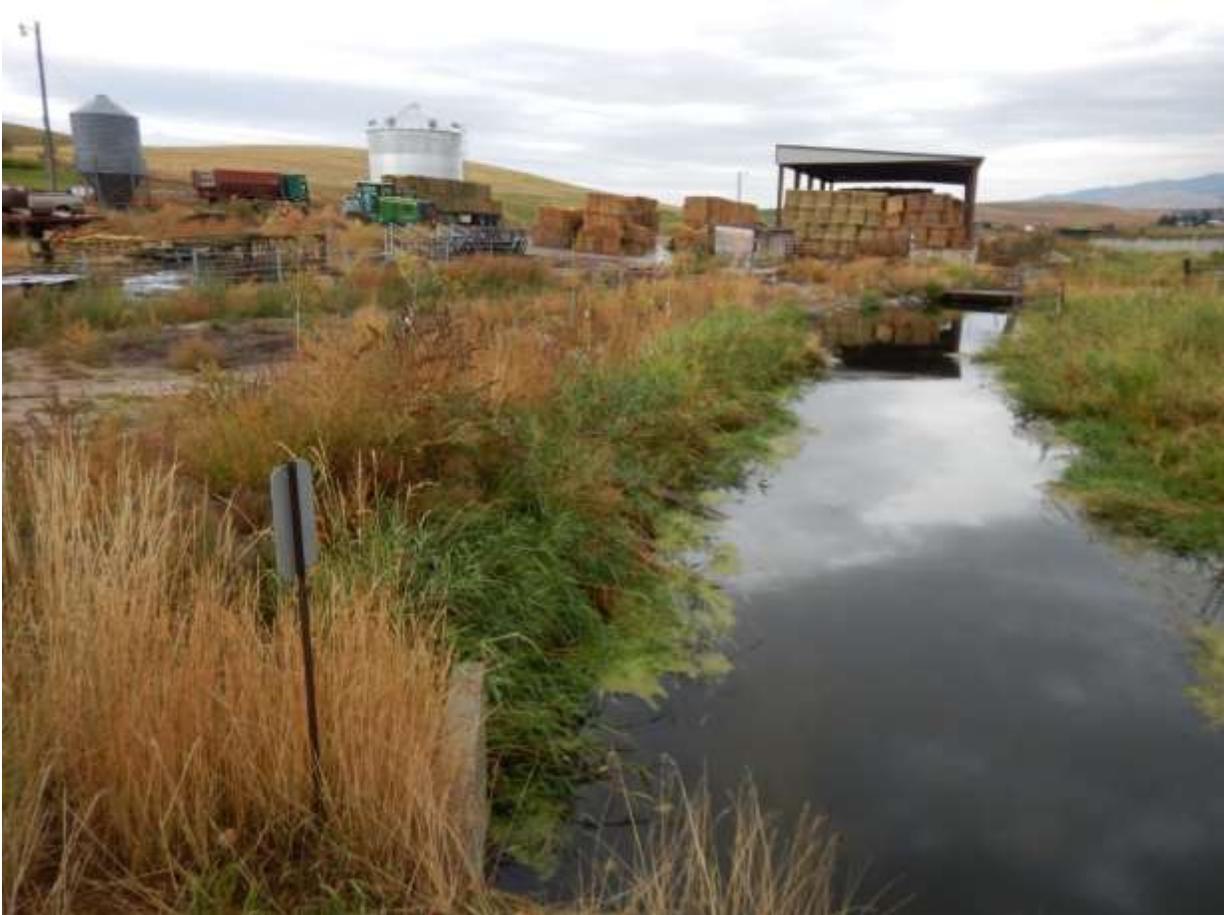
The riparian area was thriving following the latest round of plantings. A waste storage lagoon and water gap that were previously located on the left bank had been removed, with little evidence of their prior existence remaining.

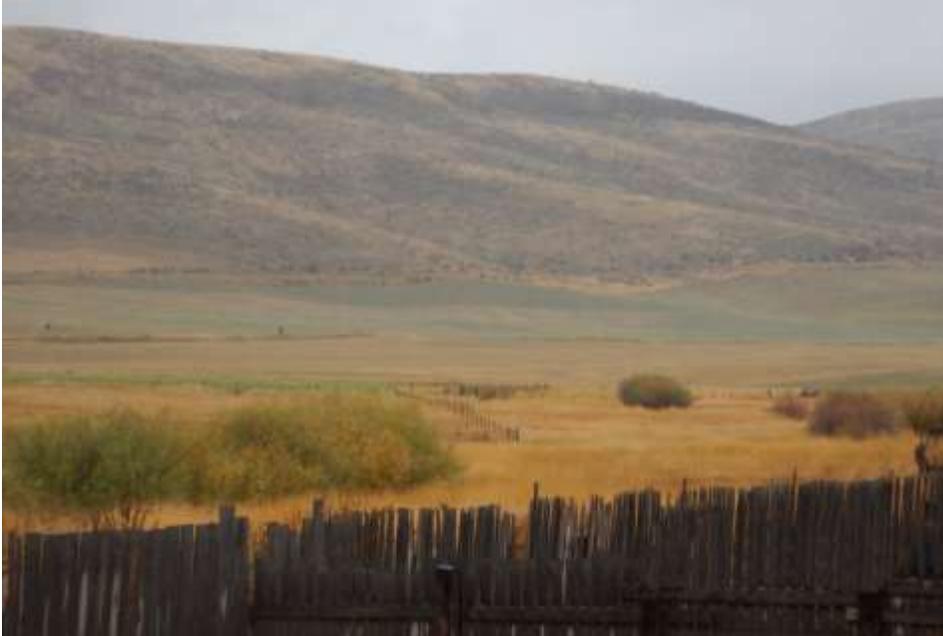
Fencing was installed to exclude livestock from accessing this unnamed tributary to Ovid Creek.

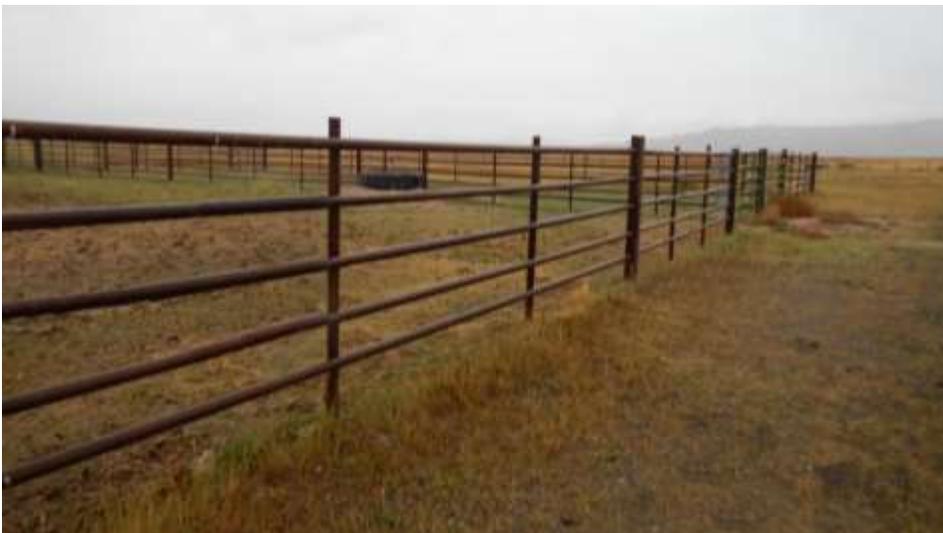
A trough was placed in the fence line to allow access from both corrals
