Big Wood River Watershed Management Plan

TMDL Five-Year Review

**State of Idaho
Department of Environmental Quality**

December 2017

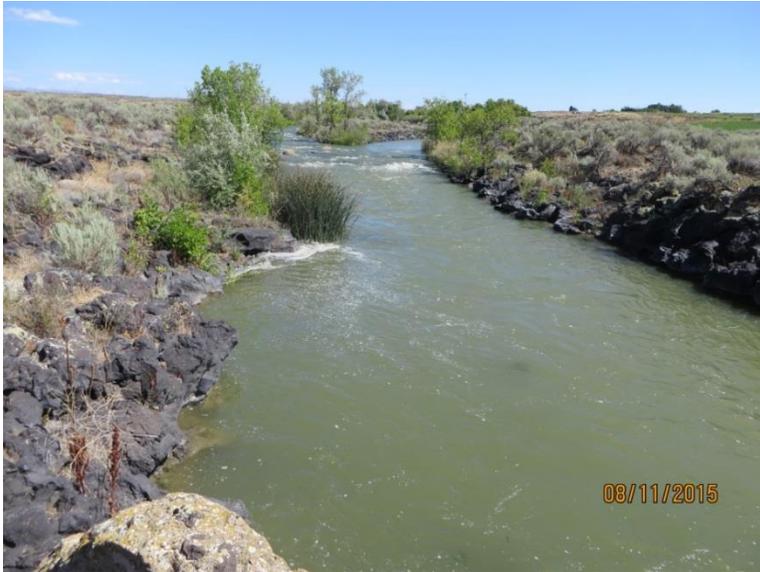
Figure 4
Monitoring site on the Malad River at Highway 26 crossing west of Gooding (August 11, 2015)

The water quality data suggest that the Malad River AU is generally improving. Exceedance of TP targets occurred only once, and TSS targets were never exceeded. Data show that the upstream portion has higher concentrations of TSS and TP, but these pollutants appear to settle out before reaching the mouth of the river. *E. coli* data are also higher at the upstream location and exceed standards at that location. These data suggest that pollutant problems still exist in the upper portion of the AU, and more work needs to be done before the TMDLs can be declared successful.

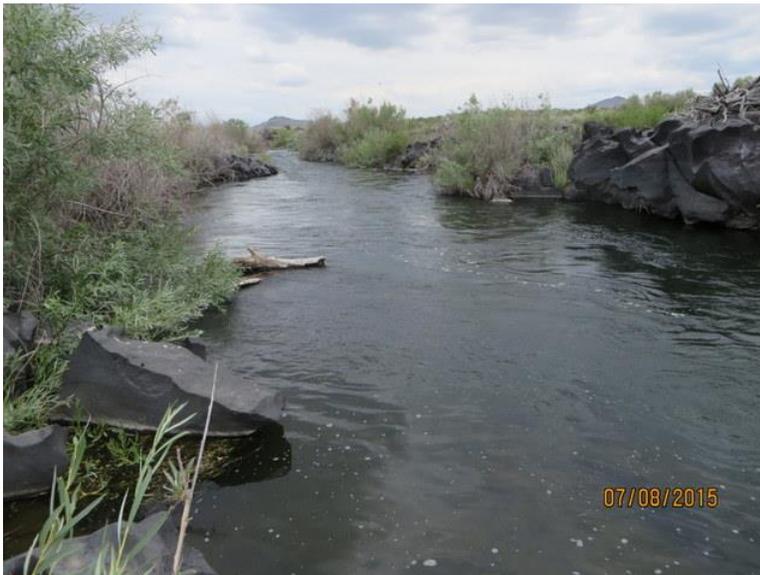
Figure 6
Monitoring site on the Big Wood River below Magic Reservoir (July 8, 2015)

The water quality data suggest that this Big Wood River AU is improving. Exceedance of TP and TSS targets occurred only once in the 2015 monitoring. Data show that the upstream portion has higher concentrations of TP but lower TSS, suggesting dissolved phosphorus not an edaphic phosphorus discharge from the reservoir. TSS was higher at the downstream sampling location consistent with an accumulation of agricultural return flow. *E. coli* counts were also higher at the downstream location and exceed standards at that location. These data suggest that pollutant problems, although relatively minor, still exist in the AU, and more work needs to be done before the TMDLs can be declared successful.

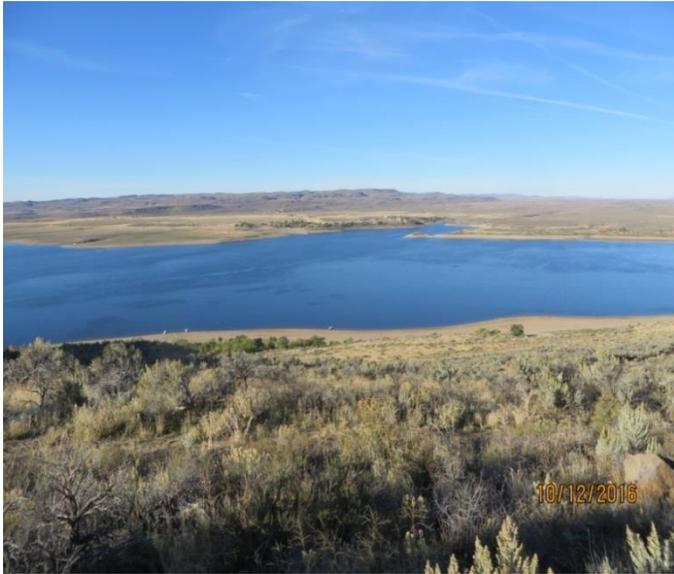
Magic Reservoir was not included in this 5-year review monitoring effort (Figure 7).

Figure 7
Magic Reservoir (October 12, 2016)

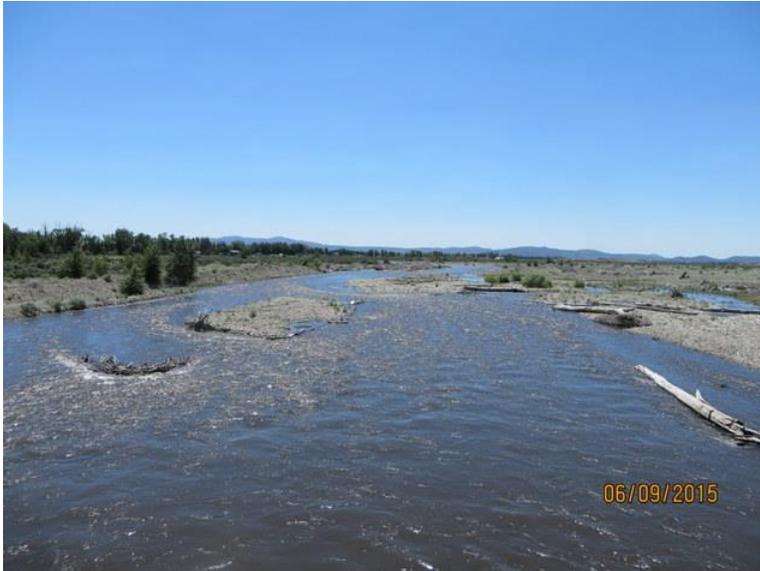
Figure 8
Big Wood River near Glendale diversion (June 9, 2015)

The water quality data suggest that this Big Wood River AU is still impacted by TP, sediment, and bacteria. Exceedance of TP and TSS targets occurred primarily following the spring runoff. *E. coli* data are higher at the downstream location and exceed standards at that location. These data suggest that pollutant problems, although relatively minor, still exist in the AU, and more work needs to be done before the TMDLs can be declared successful.

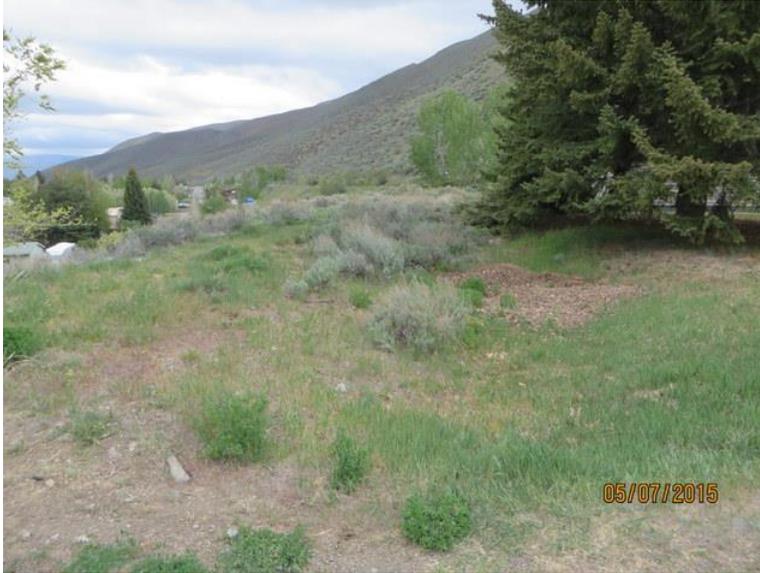
Figure 10
Seamans Creek AU location near Slaughterhouse Creek (channel nonexistent) (May 7, 2015)

This section has been included in Category 4a as having a completed TMDL (2002). The water body itself has never been monitored or assessed and DEQ will petition to remove it from the AU.

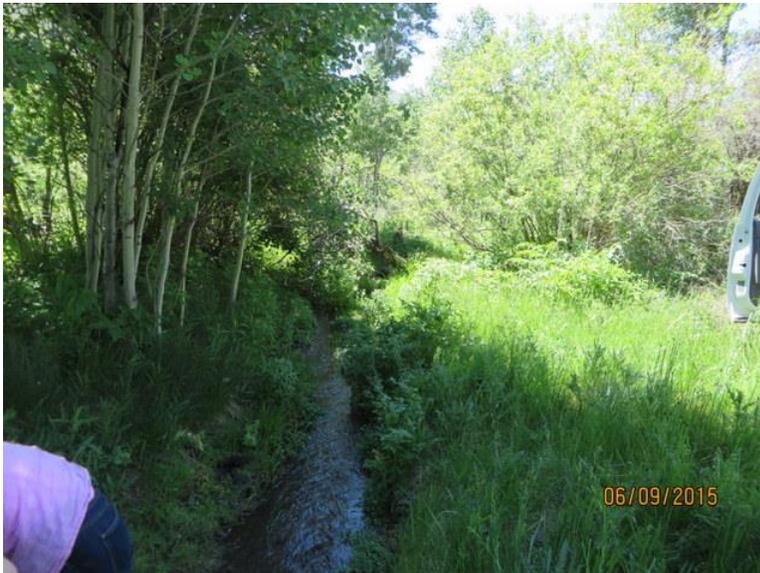
Figure 11
AU and BURP monitoring site on Slaughterhouse Creek above the irrigation pond with more persistent flows (June 9, 2015)

The AU shows a slight intrusion of sediment and phosphorus in spring consistent with spring runoff from the surrounding landscape. Although brief, the pollutants do exceed targets suggesting that possible source loading exists within the watershed. BURP results are difficult to interpret. Fisheries in these small, land-locked streams do not tend to be diverse; however, surface fine data suggest the AU is still impacted by sediment. There are no connections to other waters within the subbasin.

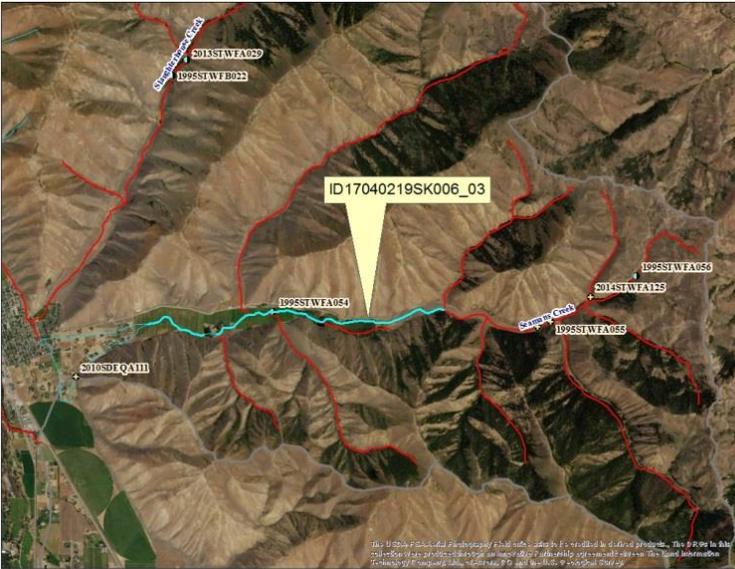
Figure 12
AU is the 3rd order of Seamans Creek from Big Dry Canyon to an incorrectly identified AU

No water quality data have been collected in ID 17040219SK006_03 in recent years because it is on private ground and tends to be ephemeral in nature. Water that passes through the channel during normal spring runoff is collected in the two diversion ponds. Subsequent efforts to monitor the BURP site establish in 1995 (1995STWFA054) at a location between the two ponds, have found a dry stream bed. No assessments of this AU can be made at this time. This section could also be category 4c. It should also be noted that this may have been historically connected to the Little Wood HUC 17040221.

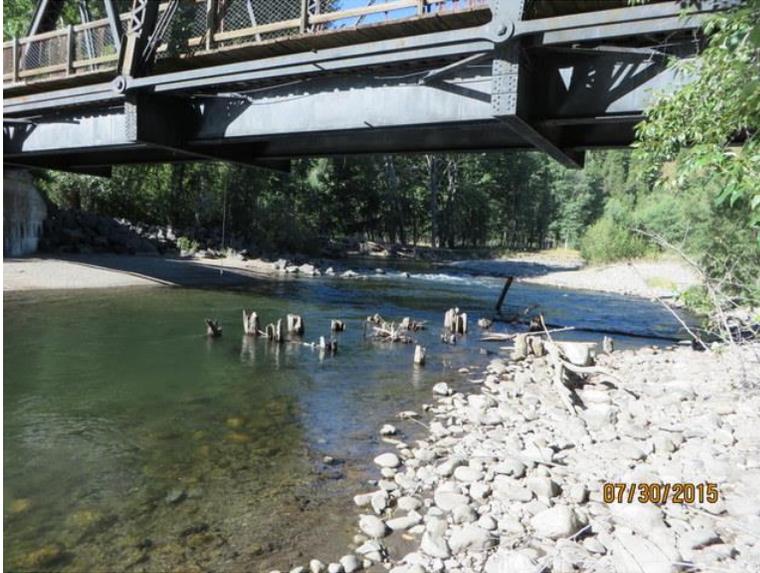
Figure 14
Big Wood River at the railroad truss (below Ketchum) is located within the upper reach of AU ID17040219SK007_05 (July 30, 2015)

The sampling data from previous BURP monitoring (2004STWFA056, 2004STWFA081, and 2010DEQA172) suggest this AU is affected by pollutants similar to other river AUs. Unfortunately BURP monitoring has not continued within this AU due to high water and private property access issues. Extra effort is needed to obtain permission from landowners to BURP this AU and establish an assessment site. The AU needs to be added to Category 4a for TP, sediment and *E. coli*.

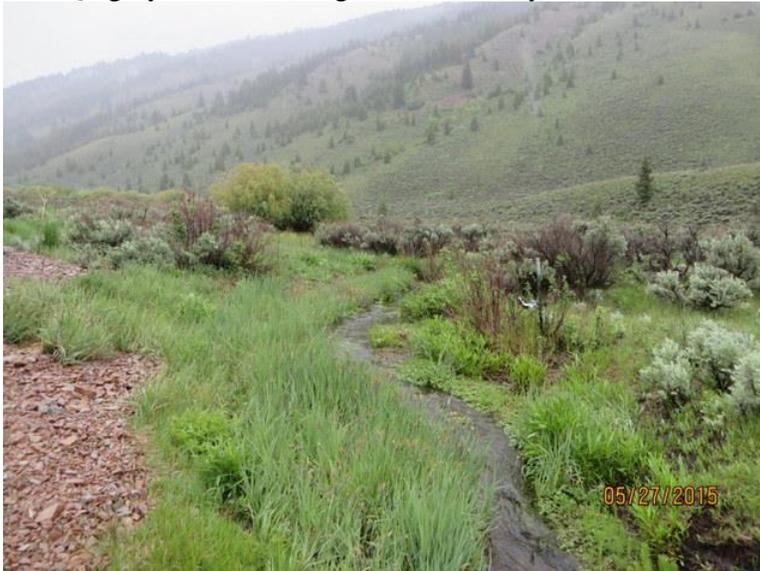
Figure 15) on the east side of the city of Hailey, just north of the Slaughterhouse Creek watershed. AU ID17040219SK008_02 includes 1st- and 2nd-order reaches and tributaries of Quigley Creek from headwaters to Deadman Gulch. The AU includes an irrigation diversion pond near the confluence of Deadman Gulch and approximately 2.8 km above the urban

Figure 15
Quigley Creek (May 27, 2015)

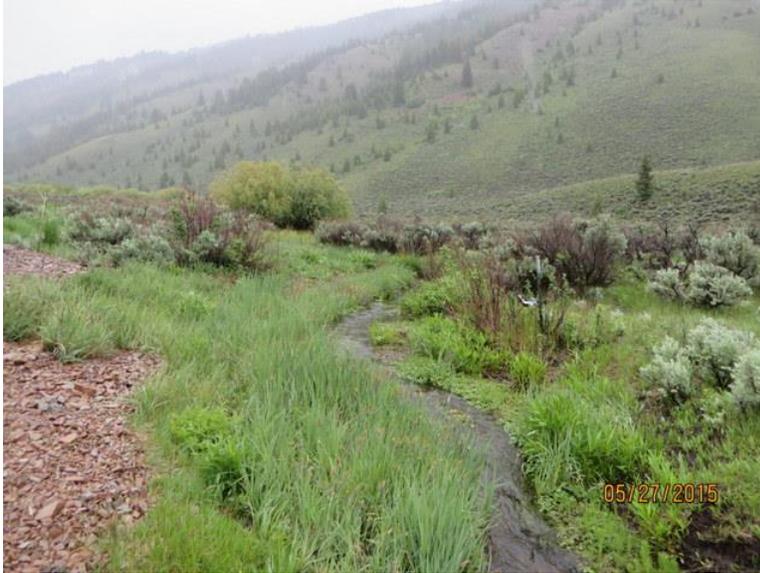
The AU shows no sediment or phosphorus exceedances and generally has a passing assessment score. It is reasonable to assume that this AU of Quigley Creek is meeting TMDL targets and is fully supporting its beneficial uses.

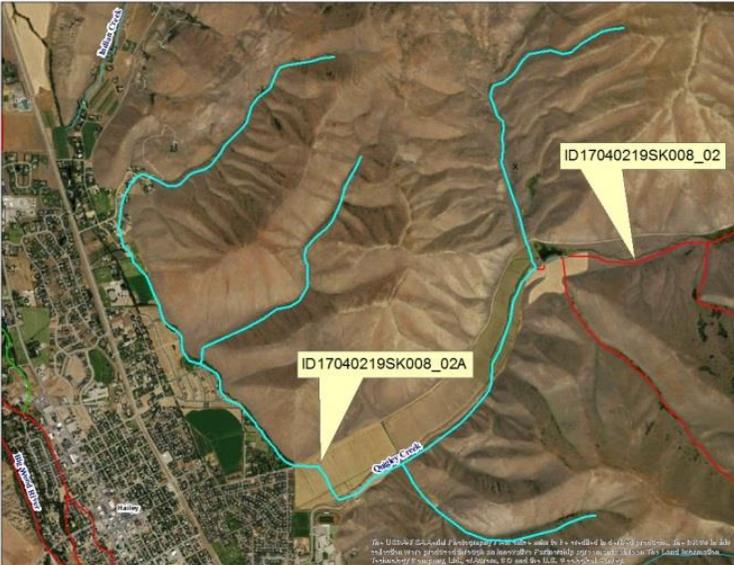
Figure 16

The AU is currently listed in Category 4c for flow alteration. No water quality sampling or BURP monitoring has occurred within this AU due to a lack of water.

AU starts at Deadman Gulch and continues to the mouth of the canyon, including Hyndman Gulch and two unnamed drainages. No connections to other waters are visible

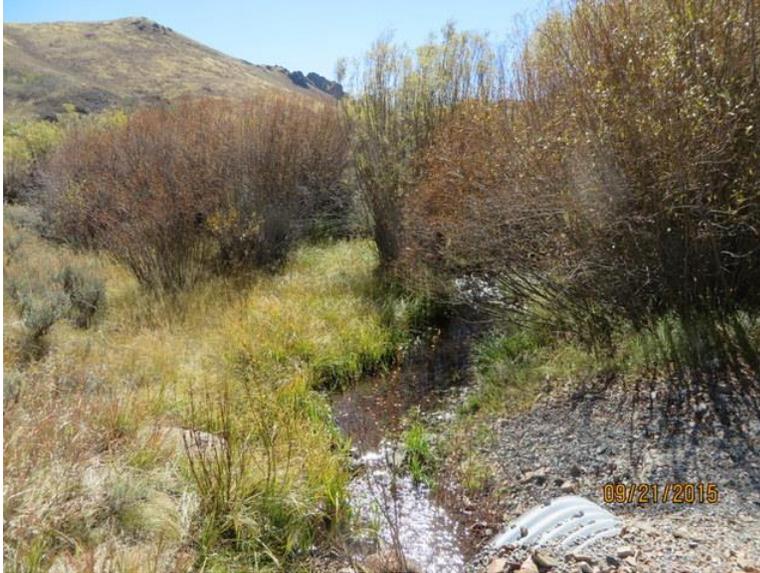
The AU shows no sediment or phosphorus exceedances and generally has passing assessment scores, although dry conditions may be hampering assessments. It is reasonable to assume that this AU of the East Fork Wood River is meeting TMDL targets and would likely fully support its beneficial uses if not for dry conditions.

Figure 17
Water quality samples were collected on upper Cove Creek for this AU (September 21, 2015)

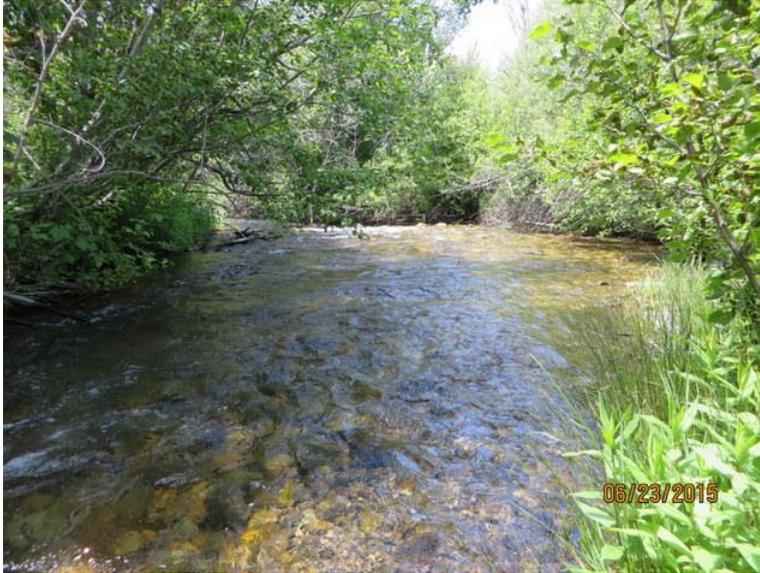
Water quality sampling data collected at one location (below Paymaster Gulch) (Figure 18) in this AU are presented in Table 18. Neither the TSS nor the TP targets were exceeded in 2015 sampling at a variety of flow levels. Wolman pebble counts on Cove Creek in 2015 show very low surface fines (Table 9). These data suggest that the AU is meeting its TMDL target goals at the sampling locations.

The AU shows no sediment or phosphorus exceedances and generally has passing assessment scores, although dry conditions may be hampering assessments. It is reasonable to assume that this AU of the East Fork Wood River is meeting TMDL targets and would likely fully support its beneficial uses if not for dry conditions.

Figure 18
Samples were collected from the East Fork Wood River below Paymaster Gulch (June 23, 2015)

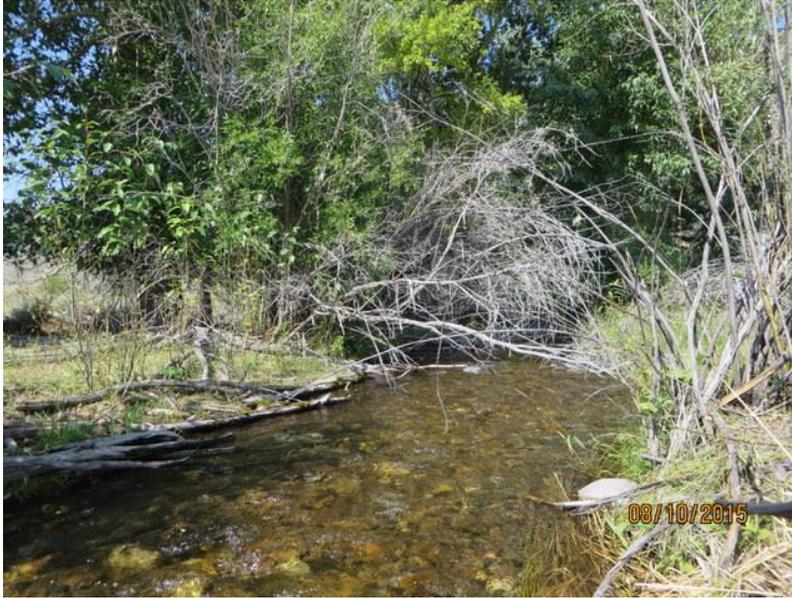
Water quality sampling data collected at one location (Wilson Creek) (Figure 19) in this AU are presented in Table 20. Neither the TSS nor the TP targets were exceeded in the 2015 sampling at a variety of flow levels. Wolman pebble counts on Cove Creek in this AU during 2015 show very low surface fines (Table 9). These data suggest that the AU would meet target goals at the sampling location.

The AU shows no sediment or phosphorus exceedances and generally has passing assessment scores, although dry conditions may be hampering assessments. It is reasonable to assume that this AU of Trail Creek has been fully supporting its beneficial uses up to now, but that may be changing due to drying conditions.

Figure 19
Samples were collected on Wilson Creek (August 10, 2015).

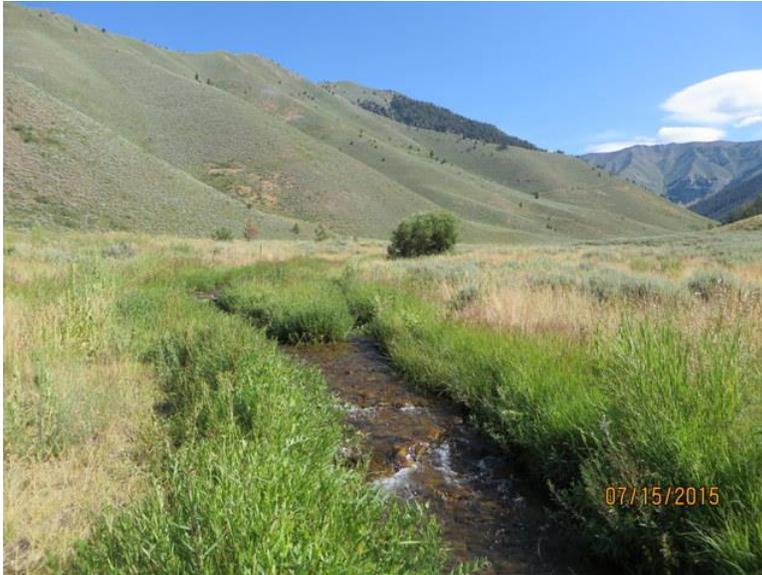
Despite the appearance of good water quality and little information on potential causality, the stream continues to score poorly with regard to bio-assessment parameters. These data suggest that some other pollutant or causative factor may be at work. Historic mining activity possibly released potential contaminants that are inhibiting biological activity. It would be worth exploring stressor identification techniques within this watershed in the future.

Figure 20
Samples were collected in Lake Creek above Sawmill Gulch (July 15, 2015)

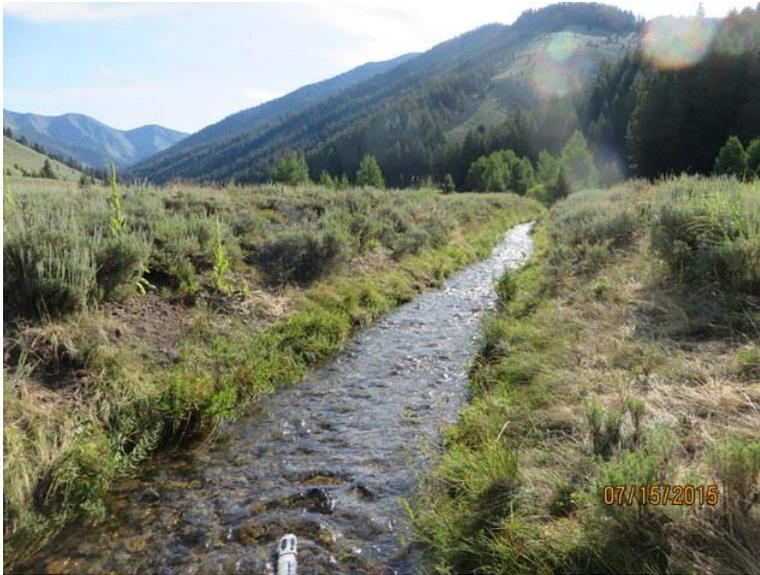
Despite the appearance of good water quality and little information on potential causality, the stream continues to score poorly with regard to bio-assessment parameters. These data suggest that some other pollutant or causative factor may be at work. Stream temperatures or historic mining activity may be inhibiting biological activity. It may be worth exploring stressor identification techniques within this watershed in the future.

Figure 21
Samples were collected in Eagle Creek just above USFS boundary (July 15, 2015)

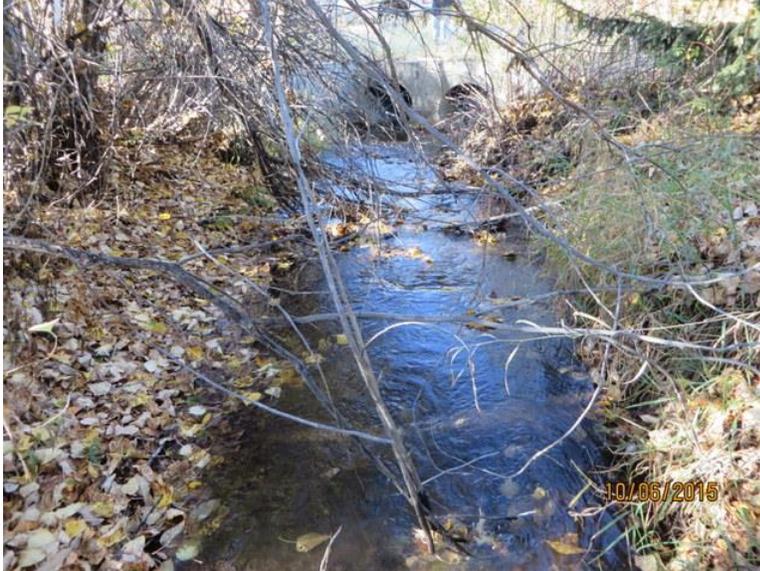
Water quality sampling data collected at one location (above Highway 75) (Figure 22) in this AU are presented in Table 28. The TSS and TP targets were not exceeded during the 2015 sampling. The Wolman pebble counts taken on Eagle Creek in 2015, show generally low-to-moderate surface fines (Table 9). Wolman pebble counts from one 2007 BURP site showed similar fines with 22.3% wet and 28.1% total fines. These data suggest that the AU is generally meeting its TMDL target goals at the sampling locations.

Despite the appearance of good water quality and little information on potential causality, the stream continues to score poorly with regard to bio-assessment parameters. These data suggest that some other pollutant or causative factor may be at work. Stream temperatures, historic mining activity, or suburban development may be inhibiting biological activity. It would be worth exploring stressor identification techniques within this watershed in the future.

Figure 22
Samples were collected in Eagle Creek upstream of Highway 75 (October 6, 2015)

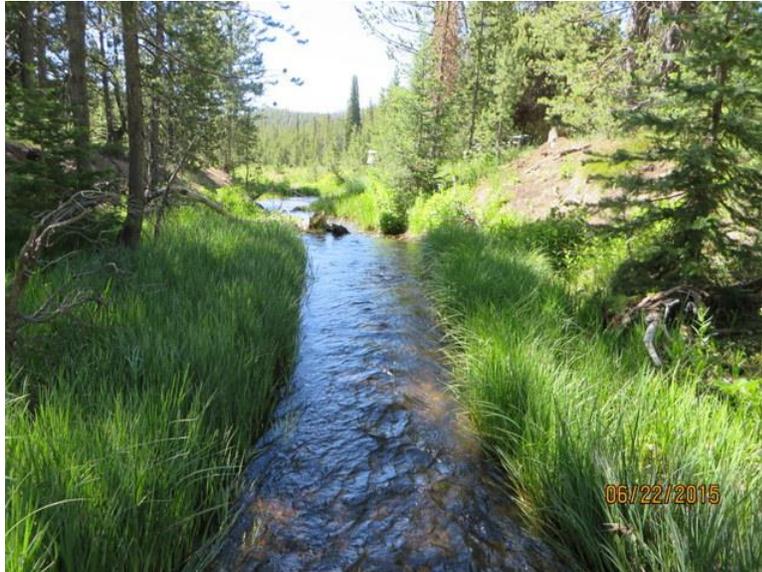
The Horse Creek AU (ID17040219SK018_02) is large with approximately 43 1st- and 2nd-order tributaries to the headwaters region of the Big Wood River. Horse Creek is the northern most tributary, but there are many others including Gladiator, Titus, Senate, Cherry, Coyote, Spring, Owl, King, Dooley, Anderson, Butterfield, Silver, Snow, Easley, Goat, and Konrad Creeks. Water quality sampling in 2015 took place on Horse Creek near Galena Summit (Figure 23).

Water quality sampling data collected at one location (Horse Creek) (Figure 23) in this AU are presented in Table 30. The TSS and TP samples taken in 2015 are generally low.

Horse Creek proper is a part of larger AU with many other streams that are in good condition. Horse Creek itself may not be in such good condition. Sampling on Horse Creek in 2015 does not show high TP or TSS; however, the stream continues to score poorly with regard to bio-assessment parameters. These data suggest some other pollutant or causative factor may be at work. Stream temperatures, historic mining activity, or low water conditions may be inhibiting biological activity. It may be worth exploring stressor identification techniques within this watershed in the future.

Figure 23
Samples were collected in Horse Creek west of Highway 75 (June 22, 2015)

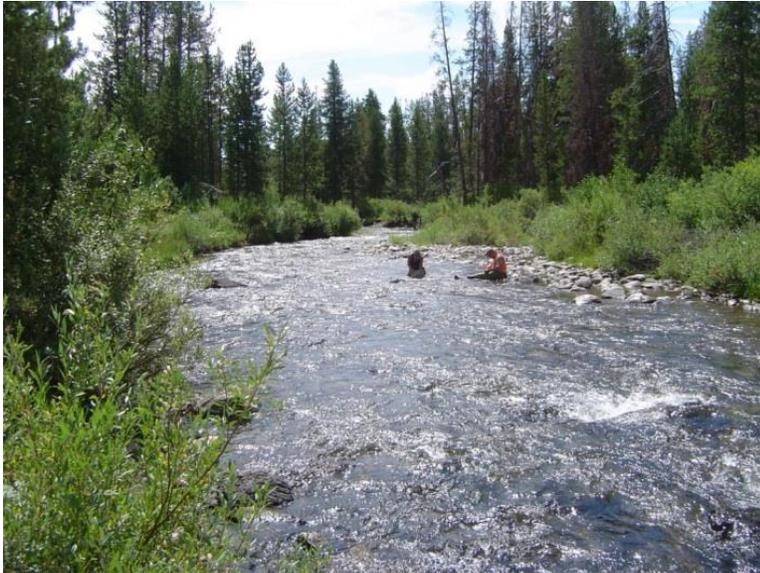
Water quality sampling data collected at one location (near Silver Creek campground) (Figure 24) in this AU are presented in Table 32. The TSS and TP samples taken in 2015 are generally very low.

The condition of this AU appears to be consistent with its present listing as a fully supporting stream.

Figure 24
Samples were collected in Big Wood River upstream of Silver Creek campground (August 11, 2004)

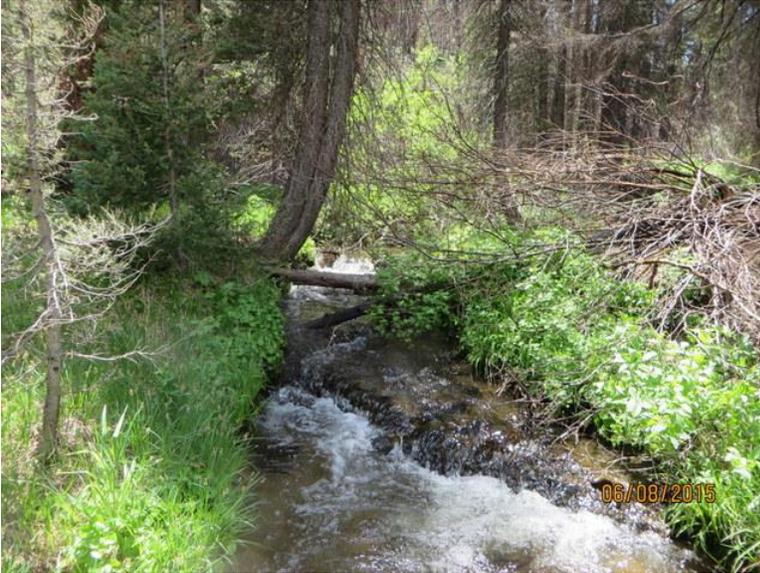
Water quality sampling data collected at one location (Left Fork Placer Creek) (Figure 25) in this AU are presented in Table 34. The TP samples taken in 2015 are relatively high with exceedances of the target occurring six times throughout the sampling period.

The Left Fork Placer Creek sampling in 2015 shows high TP; however, that particular stream did score well in 2014 with regard to bio-assessment parameters. It is not clear what causes high TP in these streams. An investigation into the chemical specific nature of phosphorus may shed some light on potential sources. Streams in this AU have been exposed to recent wildfire that may in turn affect the release of phosphorus from soils and ash. Periodic low assessment scores in the AU, especially in Warm Springs Creek, may have resulted from fire, low water, or both. More work is needed in these watersheds; a division of the AU into four AUs, one for each sub-watershed, may help with future screening of water quality concerns.

Figure 25
Samples were collected in Left Fork Placer Creek upstream of road crossing (June 8, 2015)

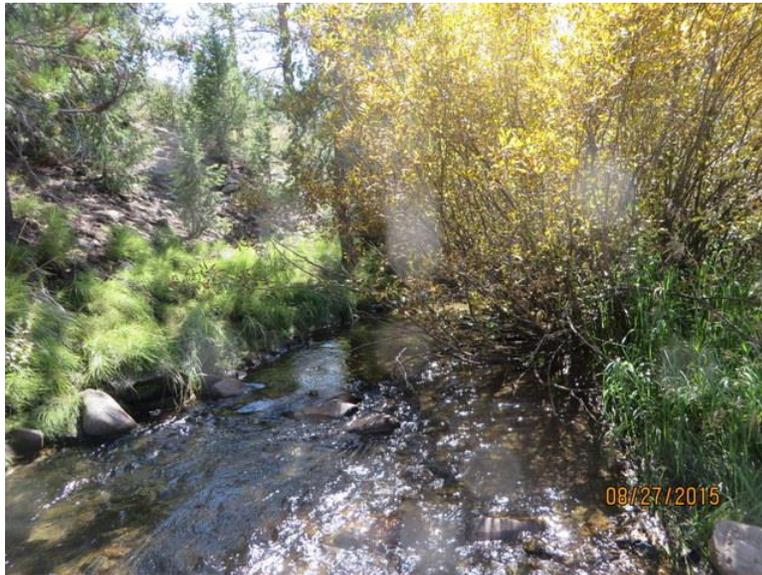
The Placer Creek sampling in 2015 shows occasional high TP; however, that particular stream did score reasonably well with regard to bio-assessment parameters in 2013 and 2014. It is not clear what causes high TP in these streams. An investigation into the chemical-specific nature of phosphorus may shed some light on potential sources. Streams in this AU have been exposed to recent wildfire that may affect the release of phosphorus from soils and ash. Periodic low assessment scores in the AU, especially in Warm Springs Creek, may have resulted from wildfire, low water, or both. More work is needed in these watersheds; a division of the AU into four AUs, one for each sub-watershed, may help with future screening of water quality concerns.

Figure 26
Samples were collected in Placer Creek above the confluence with Warm Springs Creek (August 27, 2015)

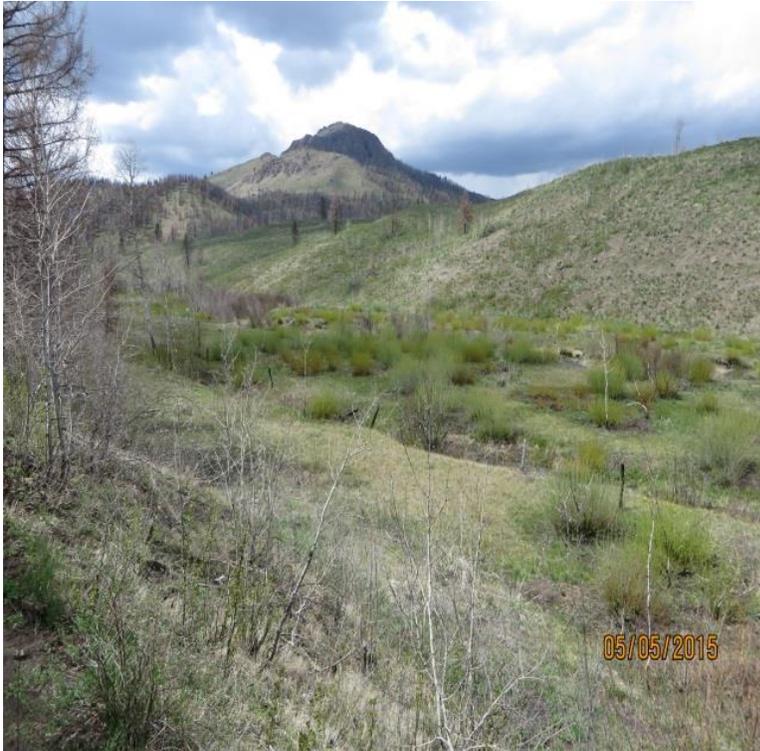
Figure 27
Greenhorn Creek (May 5, 2015)

The Greenhorn Creek watershed is likely affected by low flow conditions. It is not clear to what extent low flow or beaver activity affect sampling results. Further work needs to be done in the AU to determine if the TP and sediment TMDLs are appropriate.

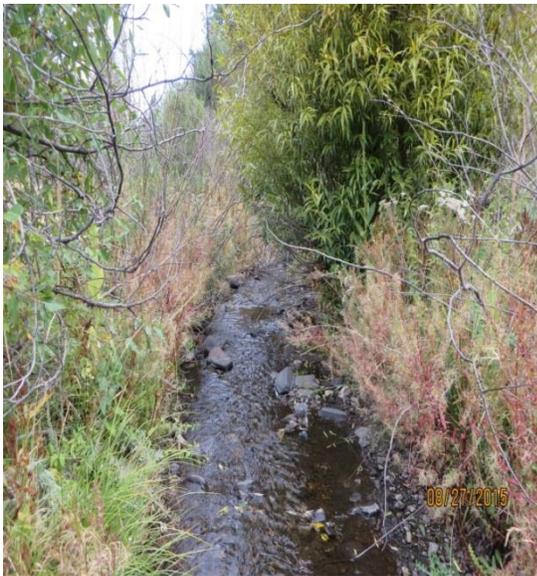
Figure 29

The Greenhorn Creek watershed is likely affected by wildfire and low flow conditions. It is not clear to what extent low flow or beaver activity affect sampling results. Further work needs to be done in the AU to determine if the TP and sediment TMDLs are appropriate.

Samples were collected in Greenhorn Creek immediately above the USFS boundary (August 27, 2015).

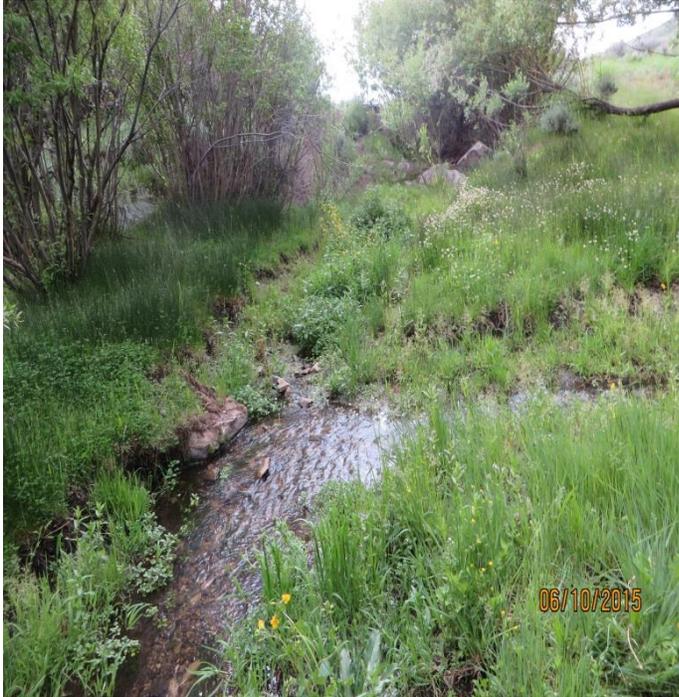
Figure 28
Samples were collected in the 2nd-order segment of Croy Creek at the confluence with Kelly Gulch (June 10, 2015)

The Croy Creek watershed is likely affected by wildfire and low flow conditions. The watershed is clearly impacted by excess fine sediment and *E. coli*. The watershed is partially within BLM grounds and substantially private. Suburban development and livestock grazing are likely major components and contributors to sediment and *E. coli*. Further work needs to be done in these AUs to achieve the objectives of *E. coli* and sediment TMDLs.

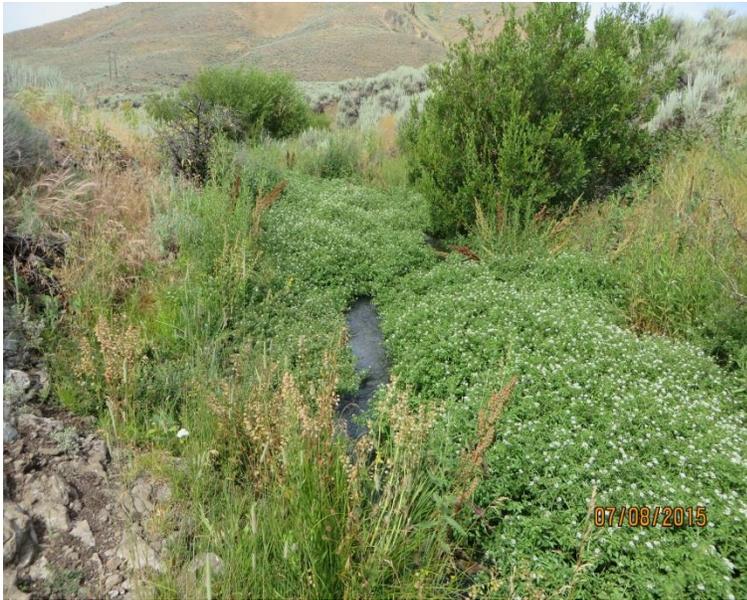
Figure 29
Samples were collected in Rock Creek above the confluence with East Fork Rock Creek (July 8, 2015)

The Rock Creek watershed is likely affected by low flow conditions. The watershed also tends to be low gradient and depositional by nature. Land use has also likely impacted excess fine sediment, and deposition likely remains in the system, although it does not seem to be distributing in the water column. The watershed is partially within BLM grounds and substantially private. Livestock grazing was likely a major component and contributor to sediment in the past. Substantial work has taken place in this AU to achieve the objectives of the TMDLs. It is likely to take some time for bedload sediment to move out of the system and to restabilize. Some streams will likely remain sediment depositional because of low gradient and low flow. The temperature TMDL also looks forward to a return of riparian cover in headwater streams.

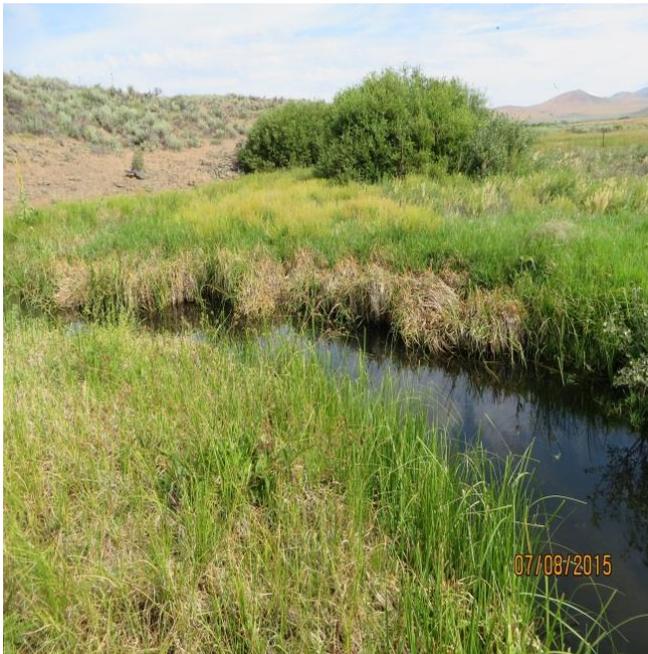
Figure 30
Samples were collected in Rock Creek immediately north of Highway 20 (July 8, 2015)

The Rock Creek watershed is likely affected by low flow conditions. The watershed also tends to be low gradient and depositional by nature. Land use has also likely impacted excess fine sediment and deposition likely remains in the system, although it does not seem to be distributing in the water column. TP also is high within this AU and is likely tied to the excess depositional sediment that remains in the system. The watershed is partially within BLM grounds and substantially private. Livestock grazing was likely a major component and contributor to sediment and TP in the past. Substantial work has taken place in this AU to achieve the objectives of the TMDLs. It is likely to take some time for bedload sediment to move out of the system and to stabilize. Some portions of the stream will likely remain sediment depositional because of low gradient and low flow.

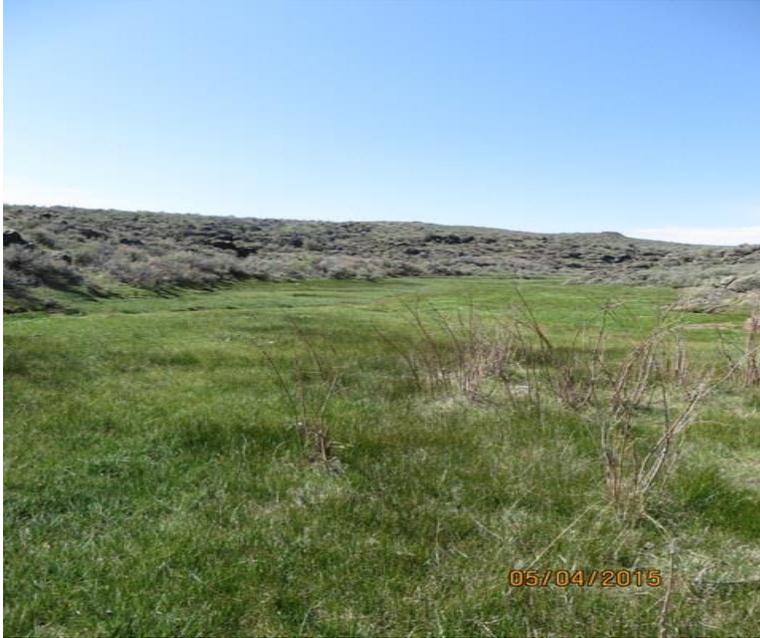
Figure 31
Thorn Creek, below Thorn Creek Reservoir (May 4, 2015)

The Thorn Creek watershed is likely affected by low flow conditions. It is not clear why the AU was included in the approved TMDL as it appears the waters cannot be assessed. Since the pollutants of concern cannot be assessed, the AU should be assigned to Category 4c for flow alteration.

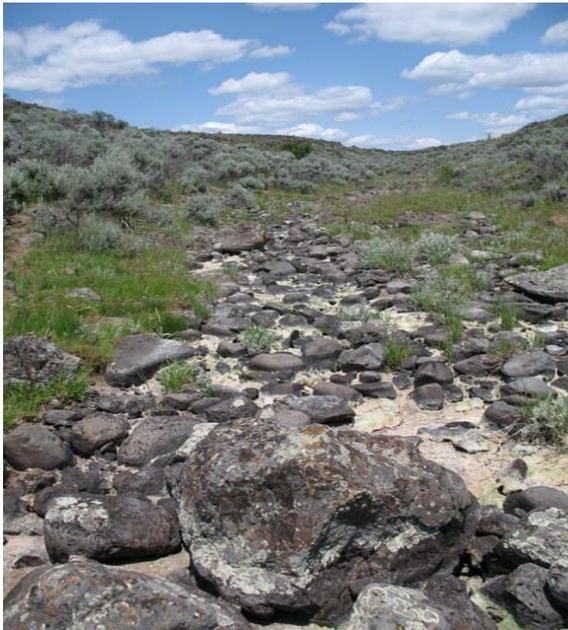
Figure 32

The tributaries and a small portion of the headwaters of Dry Creek are in the 2nd-order AU, and Dry Creek itself forms most of the 3rd-order AU. The watershed exists entirely on lava flows that occur below the Bennett Hills. Over millennia flowing water has cut deep canyons through the lava rock. Dry Creek exists in one such canyon where the 3rd-order AU likely encounters ground water base flow deep within the canyon. The smaller tributaries often exist in lesser canyons or on lava surfaces where no ground water is intercepted and periodic flows are typically related to brief snowmelt and rainstorms. The 2nd-order AU is entirely ephemeral or episodic in nature (Figure 32).

No water chemistry data were collected due to the ephemeral or episodic nature of the AU. The listings in Category 5 of the Integrated Report for this AU should be changed to either Category 4c for flow alteration or unassessed until such time that these waters can be evaluated with a low water protocol.

Fourmile Creek represents the ephemeral/episodic tributaries of the 2nd-order AU (June 6, 2011)

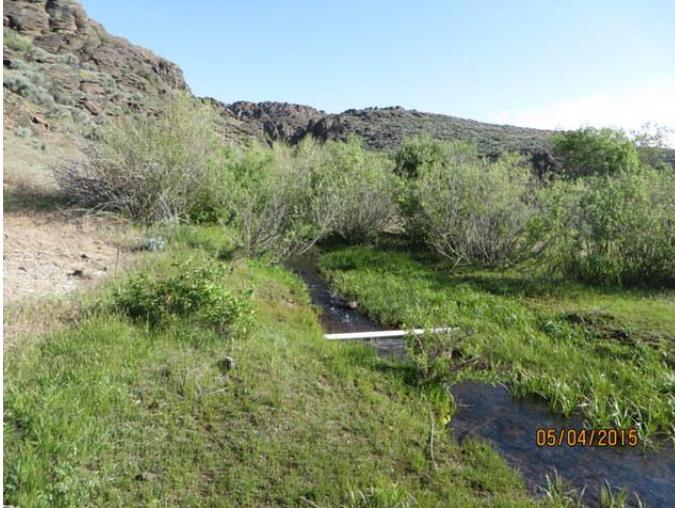
Figure 33
Samples were collected in Dry Creek above Coyote Creek confluence (May 4, 2015)

No water chemistry data were collected on the lowest reach of the AU as it is located on private lands. Flows are regulated by use for irrigation and the creek channelized through private property up to the point where the AU connects with the North Gooding Main Canal. The reach is ponded in sections and may be dewatered in others. It is recommended that future monitoring be coordinated with the private property owner. This monitoring should be done to verify if sediment is a pollutant of concern for this reach and to identify the cause for the “unknown” listing in Category 5 of the Integrated Report.
