Coeur d'Alene Lake Tributaries Temperature TMDL

Agricultural Addendum Plan

Prepared by Mark Hogen with the Idaho Soil and Water Conservation Commission

August 2015

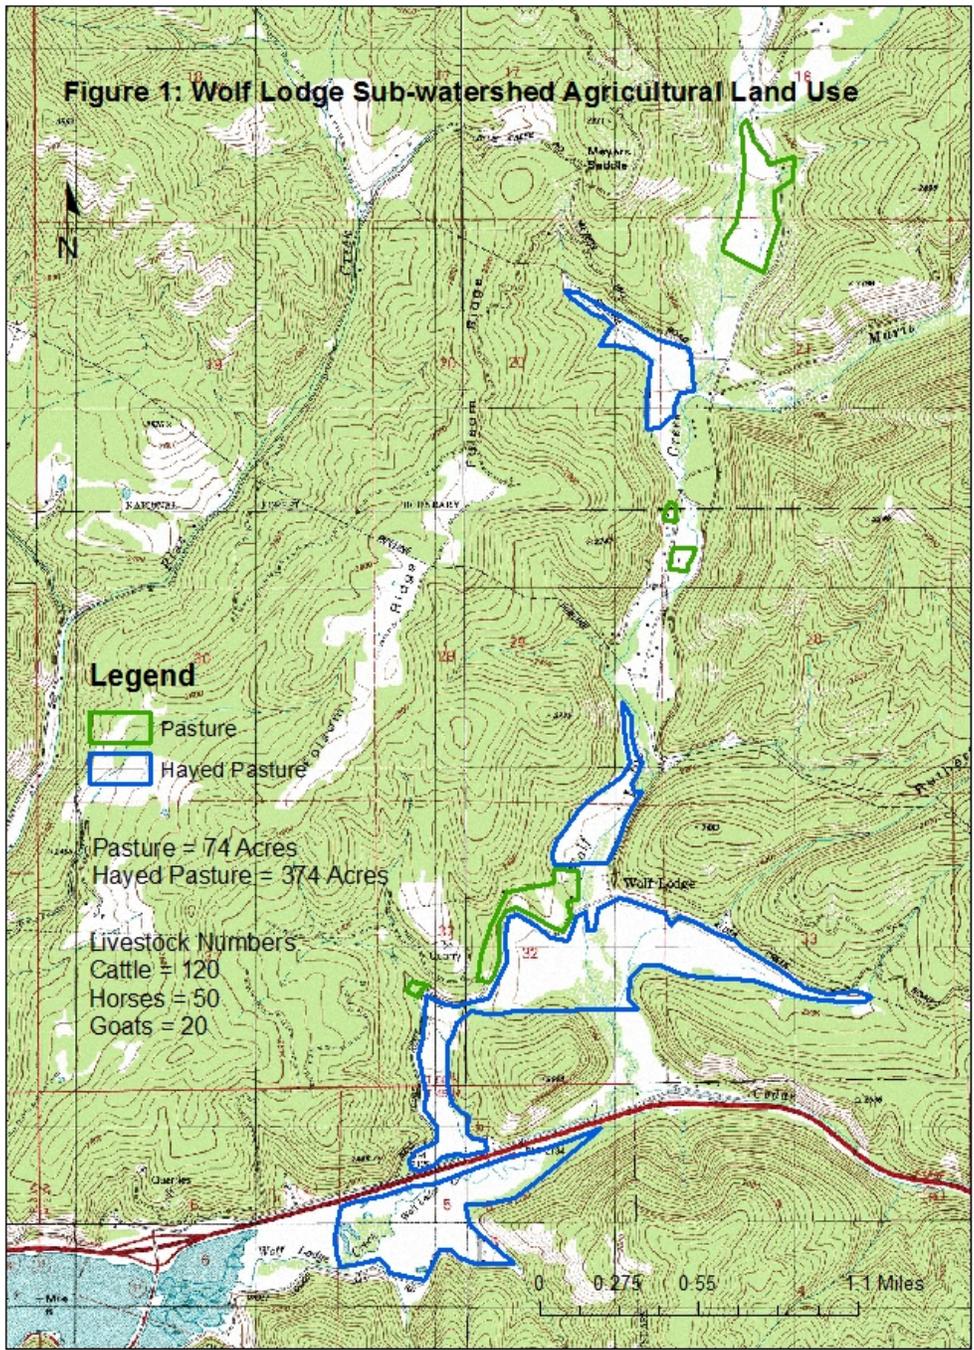
An agricultural land use inventory was completed within Wolf Lodge Creek sub-watershed private lands and the following was observed: pasture land= 74 acres, hayed pasture= 374 acres. The agricultural land use inventory conducted for Wolf Lodge Creek and tributaries has been summarized on Figure 1. Livestock numbers were estimated at 120 cows, 50 horses and 20 goats on pastures within the Wolf Lodge Creek sub-watershed. Direct livestock access to Wolf Lodge Creek and Rutherford Gulch tributary was observed. Riparian fencing and vegetative plantings would be beneficial to water quality at these access areas.

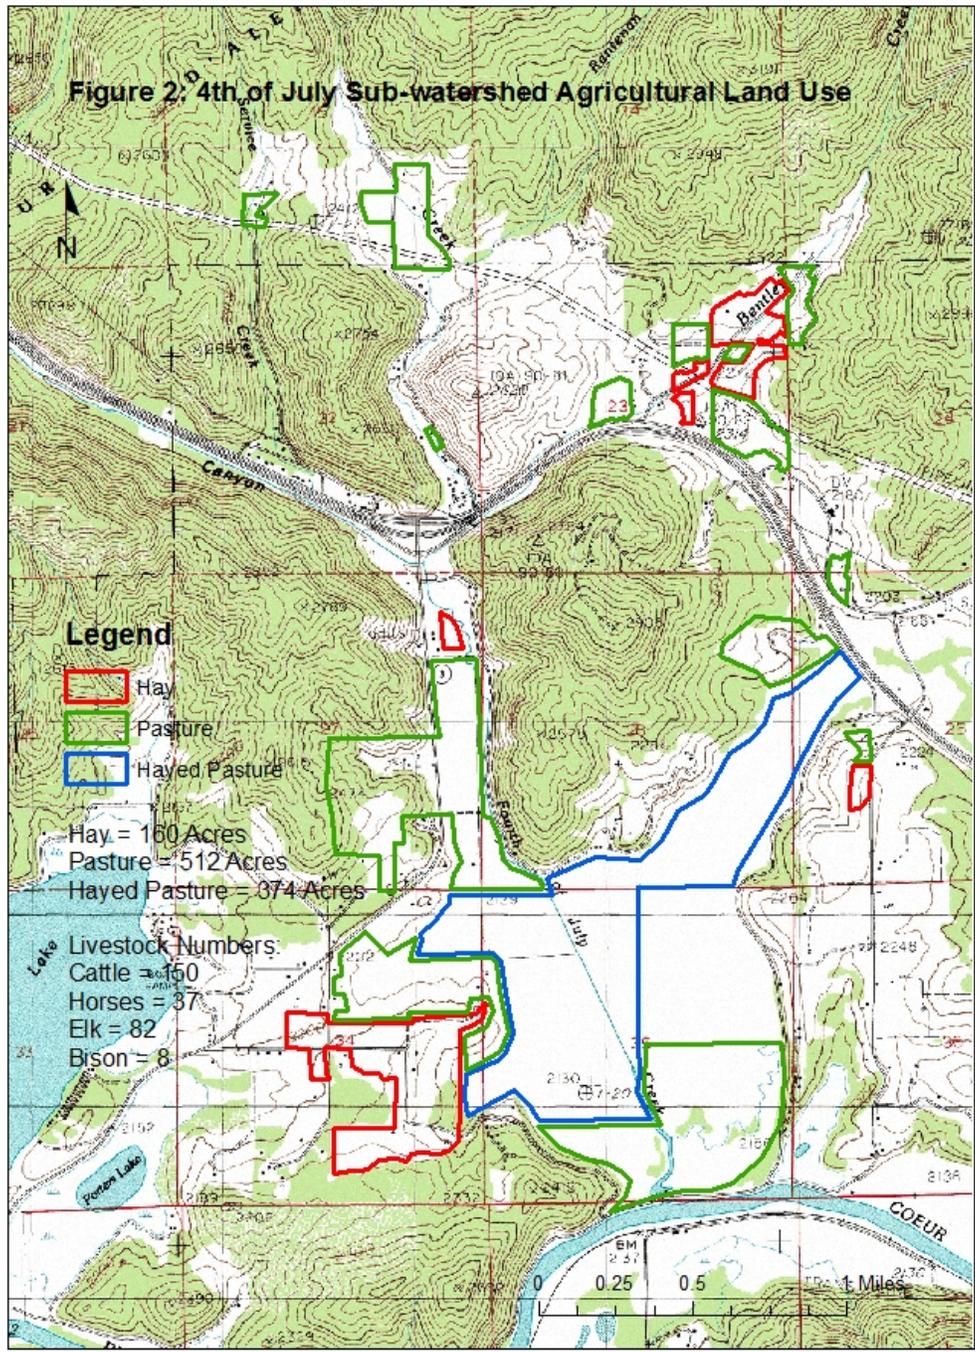
An agricultural land use inventory was completed within 4th of July Creek sub-watershed private lands and the following was observed: hay land = 160 acres, pasture land= 512 acres, hayed pasture= 374 acres. The agricultural land use inventory conducted for 4th of July Creek and tributaries has been summarized on Figure 2. Livestock numbers were estimated at 150 cows, 37 horses, 82 elk, and 8 bison on pastures within the 4th of July Creek sub-watershed. Direct livestock access to 4th of July Creek and Service Creek tributary was observed. Riparian fencing and vegetative plantings would be beneficial to water quality at these access areas.

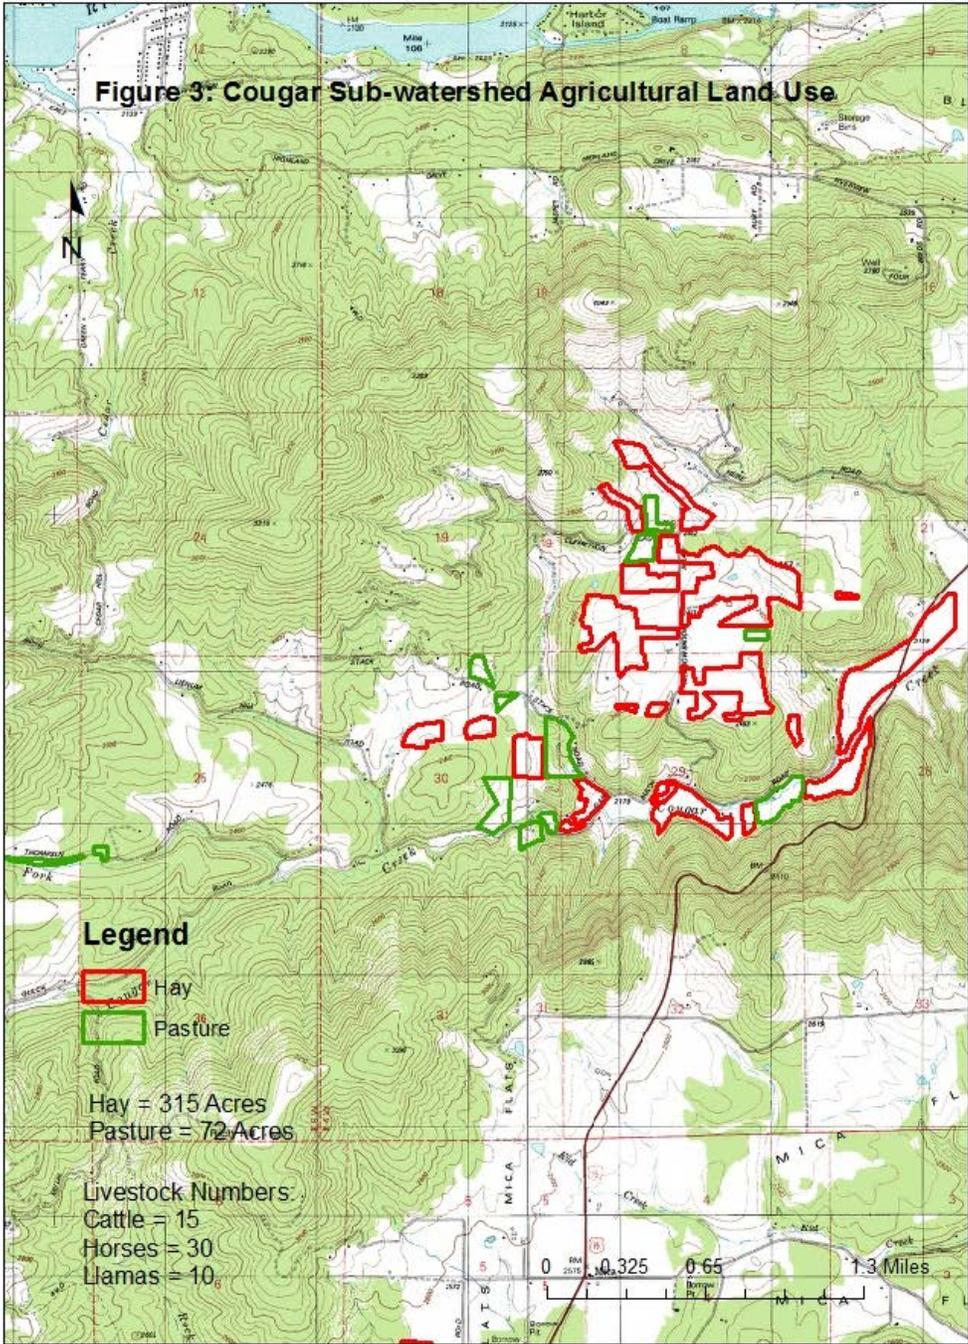
An agricultural land use inventory was completed within Cougar Creek sub-watershed private lands and the following was observed: hay land = 315 acres, pasture land= 72 acres. The agricultural land use inventory conducted for Cougar Creek has been summarized on Figure 3. Livestock numbers were estimated at 15 cows, 30 horses, and 10 llamas on pastures within the Cougar Creek sub-watershed. Minimal direct livestock access to Cougar Creek was observed. According to DEQ's shade analysis, Cougar Creek has a shade deficit of 2-15% on the lower agricultural reach. Increasing the riparian buffer on roughly 2500' of adjacent hay land to Cougar Creek, could evidently increase shading and approach DEQ's recommended target. The overall agricultural impact to Cougar Creek is very slight. This author would support the delisting of Cougar Creek from the next published Integrated Report for sediment and temperature.

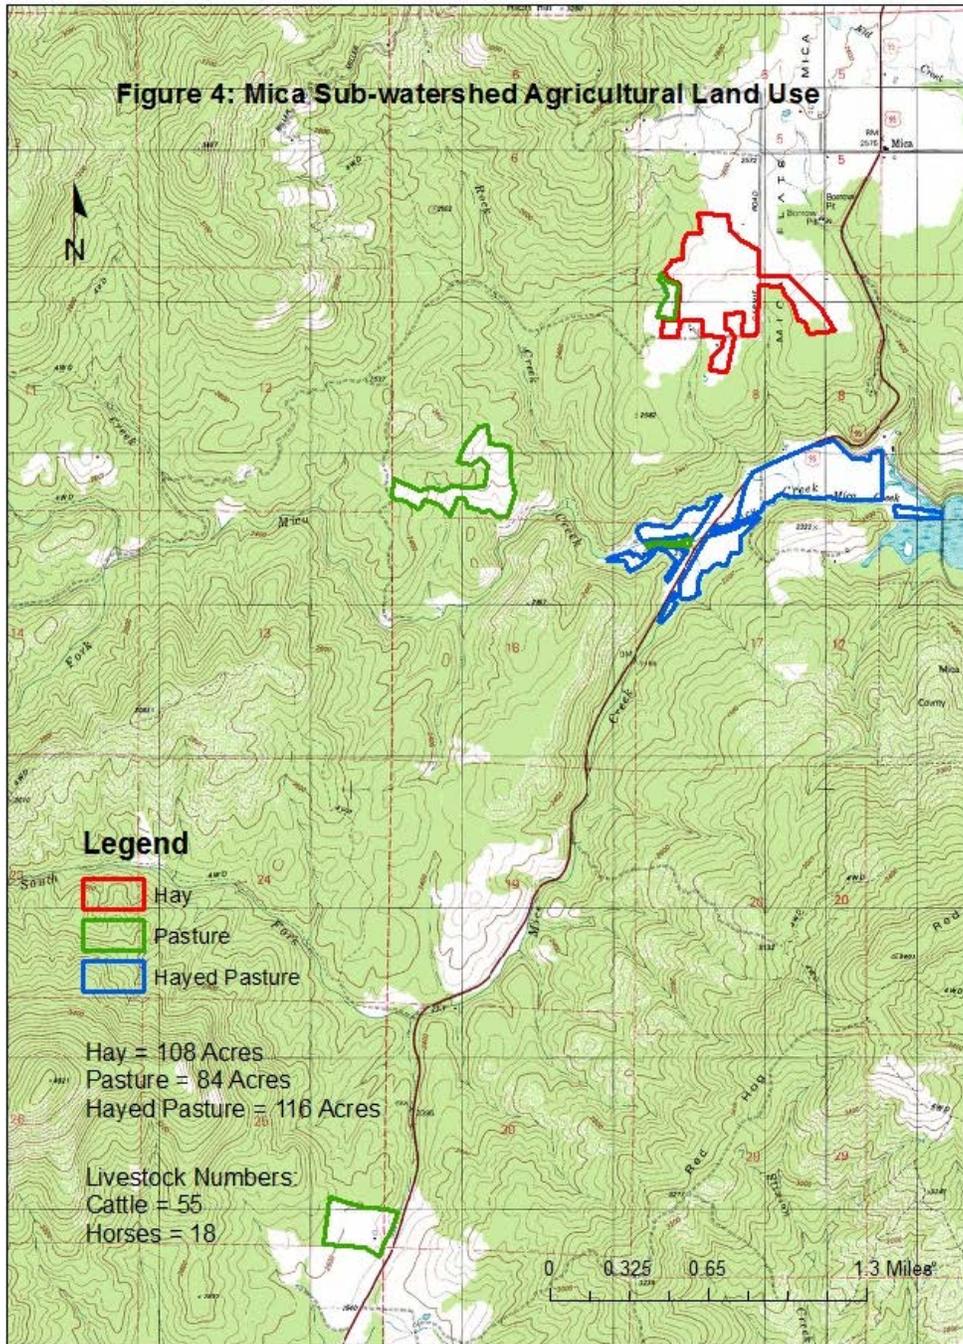
Figure 4: Mica Sub-watershed Agricultural Land Use

An agricultural land use inventory was completed within Mica Creek sub-watershed private lands and the following was observed: hay land = 108 acres, pasture land= 84 acres, hayed pasture = 116 acres. The agricultural land use inventory conducted for Mica Creek and forks has been summarized on Figure 4. Livestock numbers were estimated at 55 cows and 18 horses on pastures within the Mica Creek sub-watershed. No uncontrolled livestock access to Mica Creek was observed. Pathfinder analysis was completed by ISWCC staff on the south fork and main stem of Mica Creek adjacent to private agricultural land in August, 2010. According to DEQ's shade analysis, Mica Creek has a shade deficit of 2-7% on the lower agricultural reaches. The ISWCC shade results in 2010 were slightly lower than DEQ's estimates and was most likely due to active streambank protection work taking place on eroding banks. Not only did this work target sediment reduction but included the planting of hundreds of new willows. With now up to 5 years of growth in some sections, shade should be quickly approaching DEQ's recommended shade target. The overall agricultural impact to Mica Creek is insignificant at present. This author would support the delisting of Mica Creek from the next published Integrated Report for sediment, bacteria, and temperature. See Appendix A for more detail.

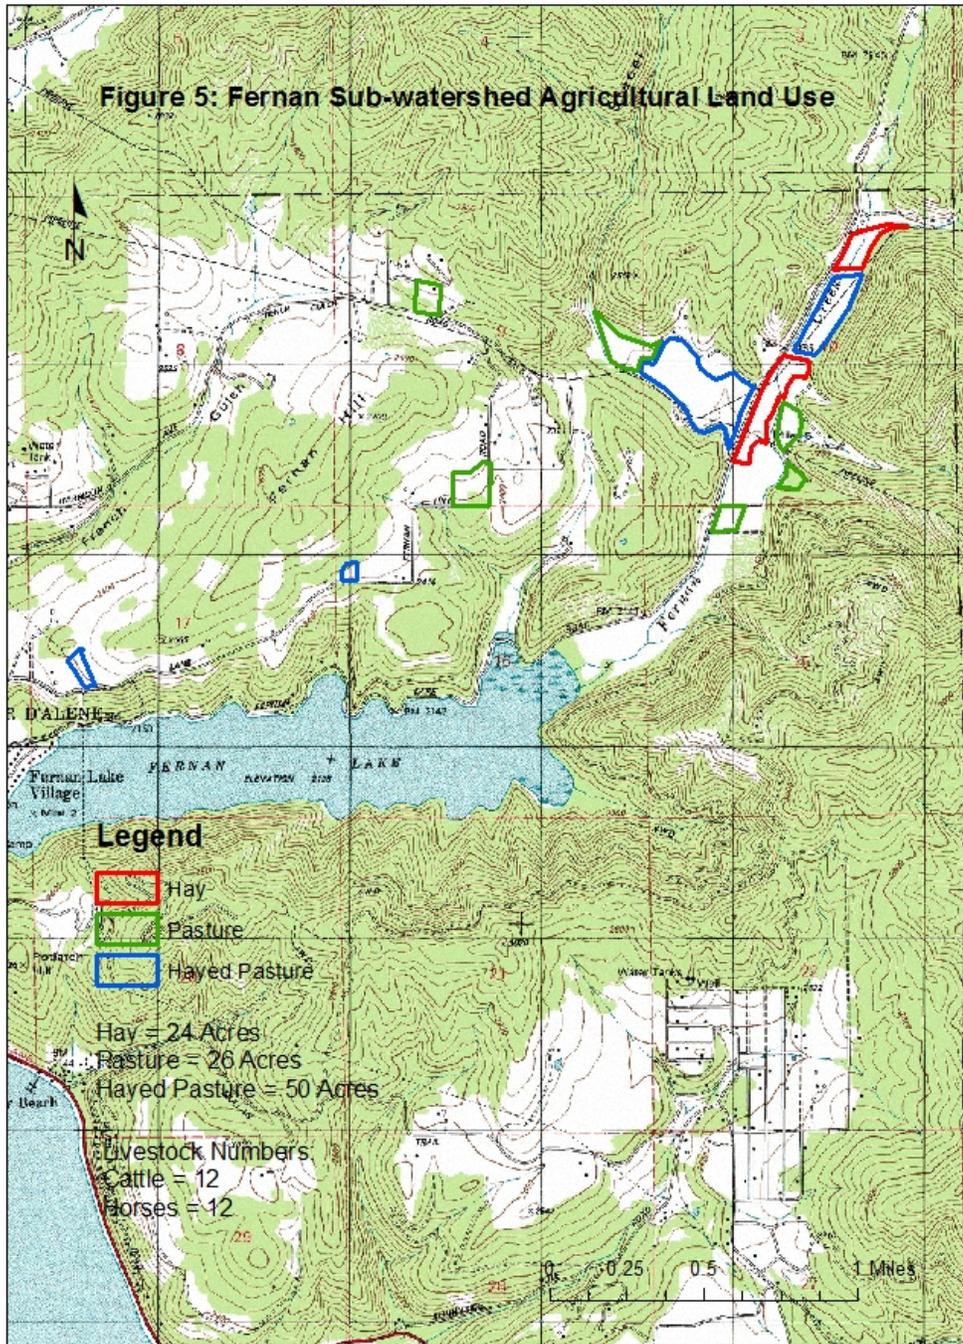
Figure 5: Fernan Sub-watershed Agricultural Land Use

An agricultural land use inventory was completed within Fernan Creek sub-watershed private lands and the following was observed: hay land = 24 acres, pasture land= 26 acres, hayed pasture= 50 acres. The agricultural land use inventory conducted for Fernan Creek has been summarized on Figure 5. Livestock numbers were estimated at 12 cows and 12 horses on pastures within the Fernan Creek sub-watershed. No direct livestock access to Fernan Creek was observed. An attempt was made to gain permission to walk and survey Fernan Creek through agricultural private land. Numerous landowner permission letters were sent out with no responses. The overall agricultural impact to Fernan Creek is minimal at present. In addition, this author feels that agriculture has no significant impact to the water quality of Fernan Lake.

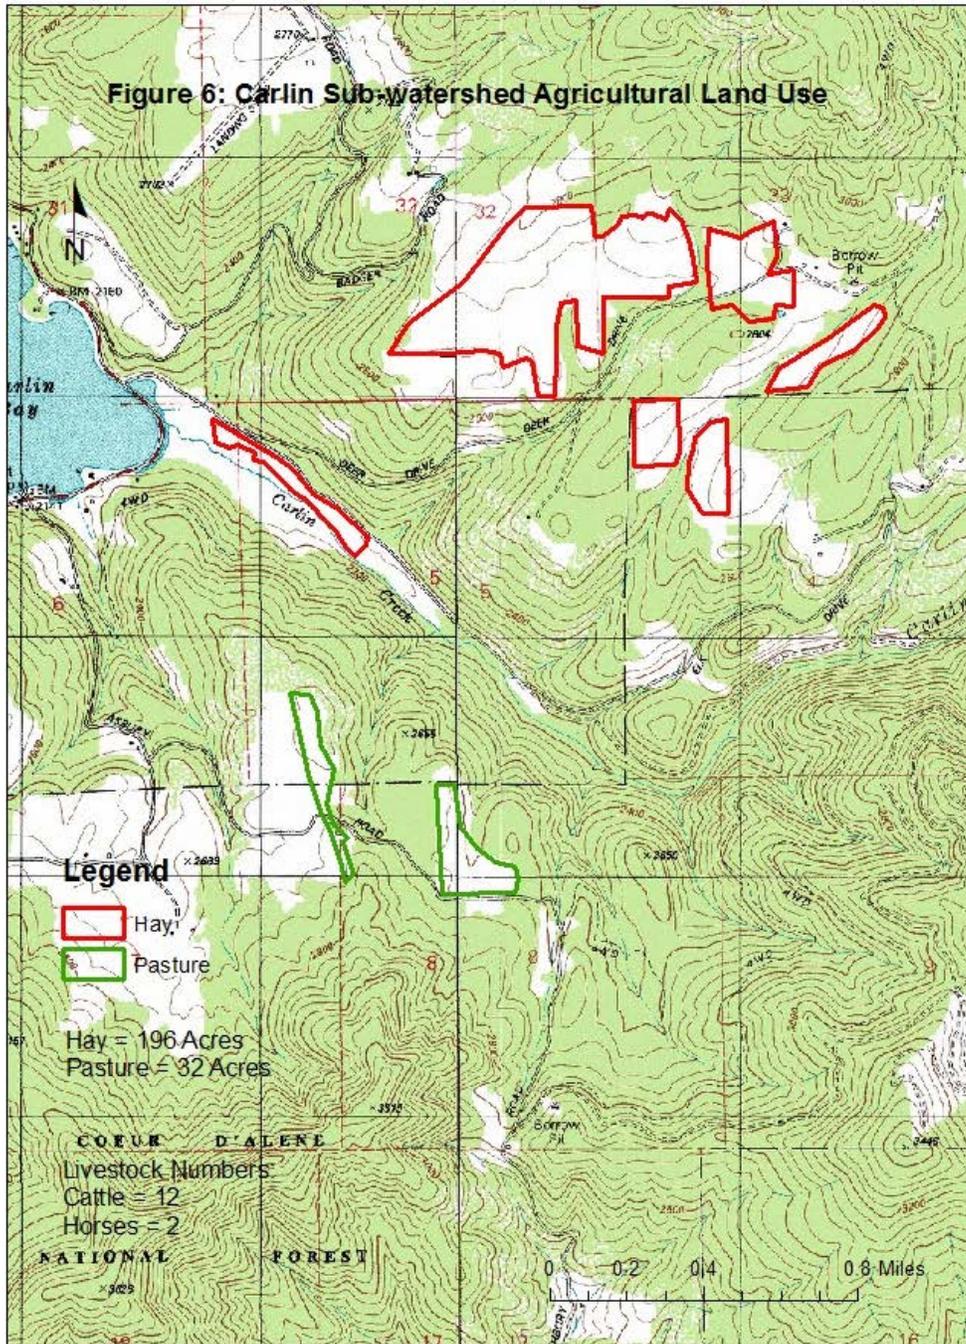
Figure 6: Carlin Sub-watershed Agricultural Land Use

An agricultural land use inventory was completed within Carlin Creek sub-watershed private lands and the following was observed: hay land = 196 acres, pasture land= 32 acres. The agricultural land use inventory conducted for Carlin Creek has been summarized on Figure 6. Livestock numbers were estimated at 12 cows and 2 horses on pastures within the Carlin Creek sub-watershed. No direct livestock access to Carlin Creek was observed. This author feels that agriculture has no significant impact to the water quality of Carlin Creek.

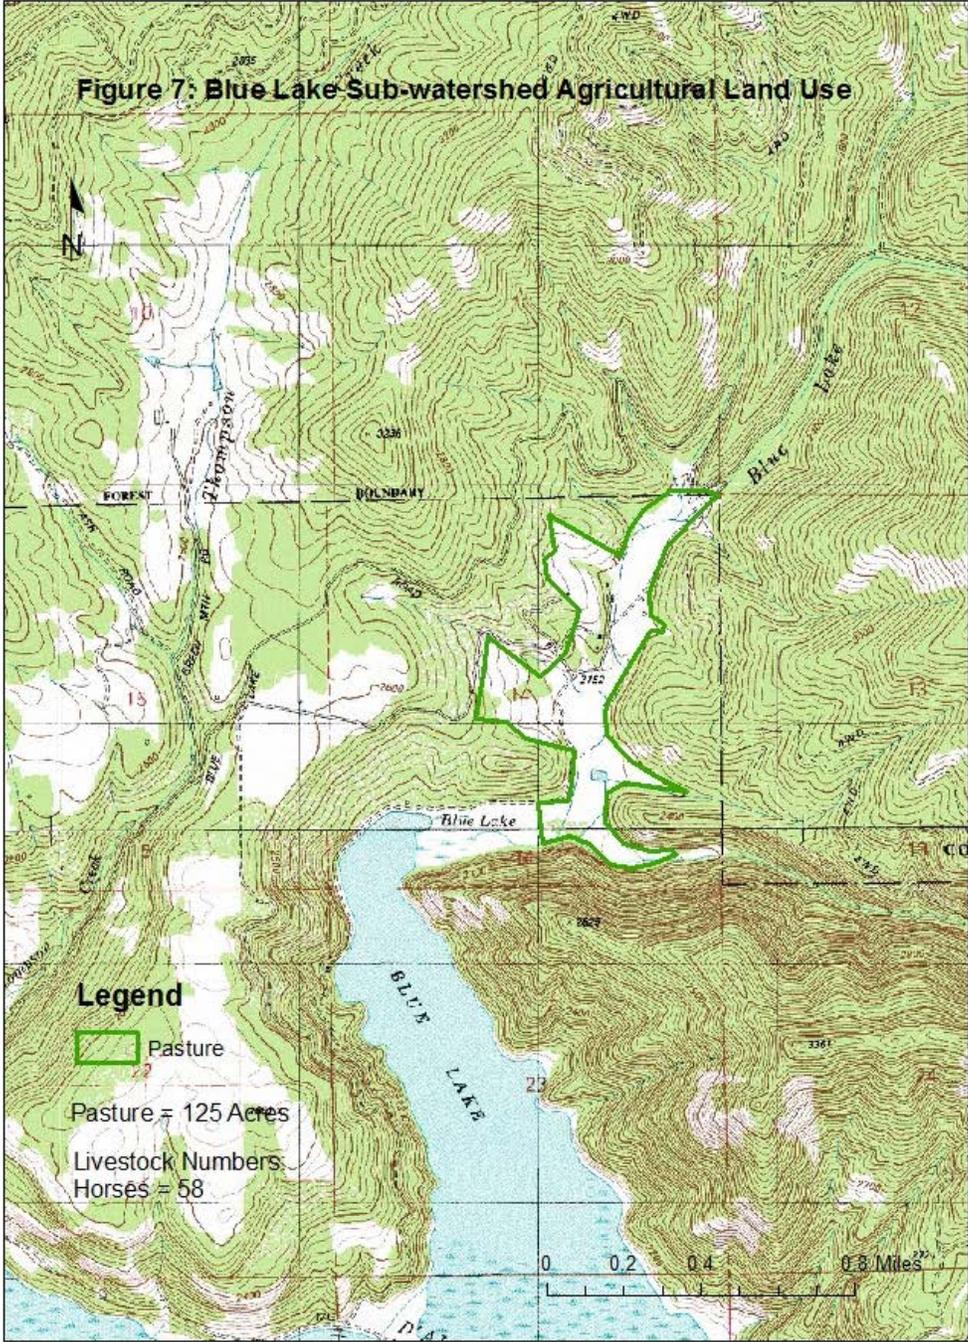
An agricultural land use inventory was completed within Blue Lake Creek sub-watershed private lands and the following was observed: pasture land= 125 acres. The agricultural land use inventory conducted for Blue Lake Creek and tributaries has been summarized on Figure 7. Livestock numbers were estimated at 58 horses on pastures within the Blue Lake Creek sub-watershed. Direct livestock access to Blue Lake Creek was observed. Streambank stabilization, riparian fencing, and vegetative plantings would be beneficial to water quality at these access areas.

Within private land, the first 1,200' of Blue Lake Creek is totally blown out and was not inventoried. NRCS's Stream Visual Assessment Protocol (SVAP), NRCS's Streambank Erosion Condition Inventory (SECI), and DEQ's Pathfinder Protocol for ground truthing actual % shade was conducted on the first agricultural reach below the blow out. Lastly, SVAP and estimated % shade was conducted on additional reach inventoried. The total length of Blue Lake Creek inventoried was 1,900 feet. The field analysis was conducted by ISWCC staff in mid-October 2013. The leaves were just starting to drop, but still fairly well intact for % shade determination. On the ISWCC pathfinder reach, actual % shade exceeded DEQ's existing shade by 6%, but still -56% below DEQ's target shade. The other estimated reach was found to be better at 40% shade, but still significantly under DEQ's target shade. SVAP ratings for the two reaches turned out to be: 900' fair, and 1,000' severe. The blown out reach and the reach below had a very severe SECI which indicates bank erosion, bank instability, and lack of bank cover and/or vegetation. See Appendix A and B for more detail.

With USFS/private landowner involvement and adequate funding from various sources, about 2,200 feet of Blue Lake Creek would be a perfect candidate for a complete stream make-over. Also, one Blue Lake Creek road/stream crossing has 3 large culverts that have a 4 foot outlet drop and certainly pose a fish barrier when water is flowing (late fall through late spring).

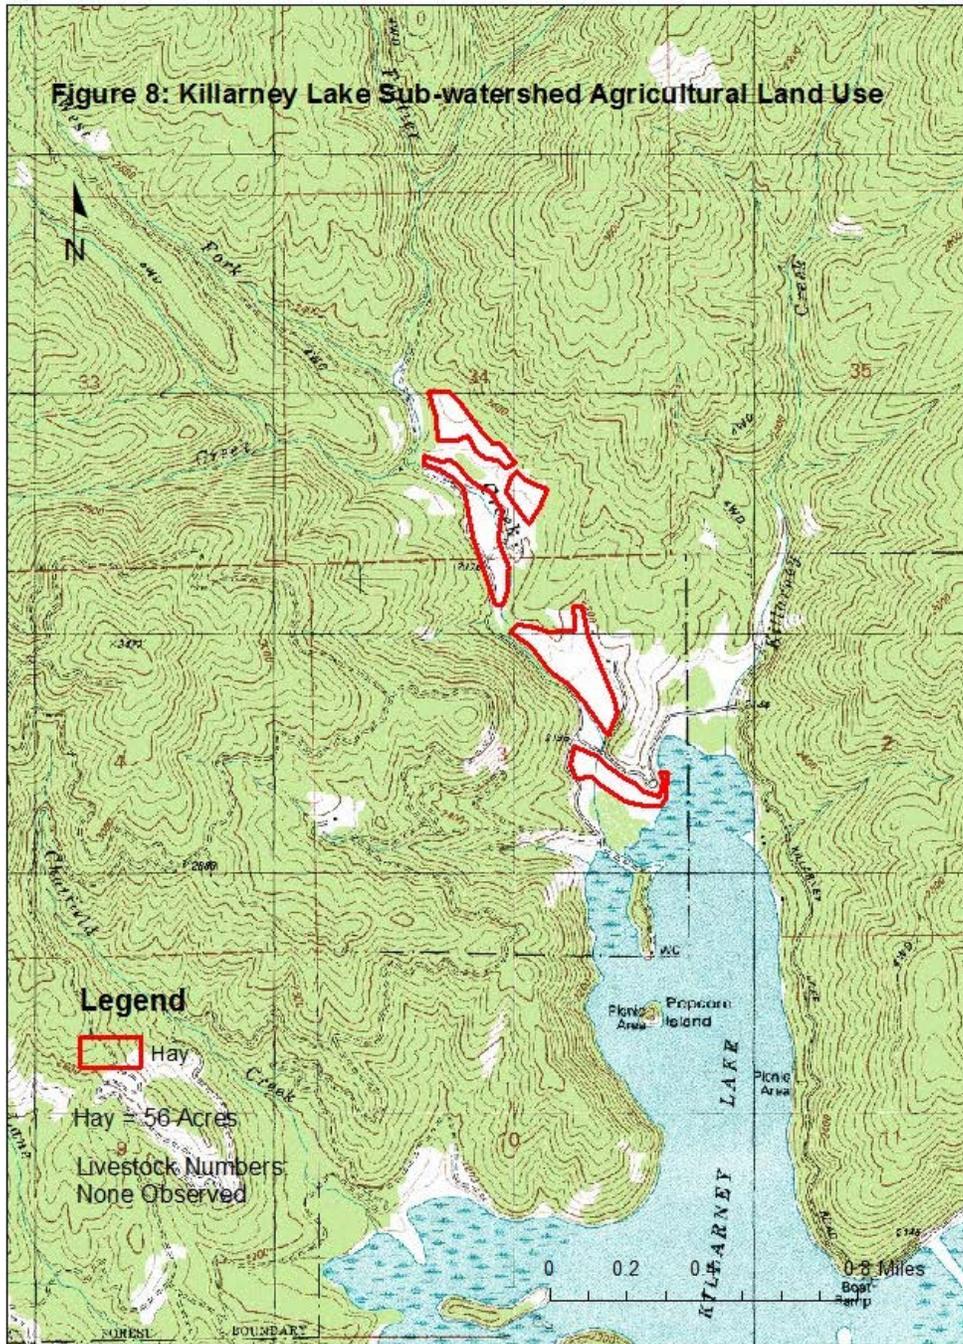
Figure 8: Killarney Lake Sub-watershed Agricultural Land Use

An agricultural land use inventory was completed within Fortier Creek sub-watershed private lands and the following was observed: hay land = 56 acres. The agricultural land use inventory conducted for Fortier Creek has been summarized on Figure 8. No livestock was observed on pastures within the entire Killarney Lake sub-watershed. This author feels that agriculture has no significant impact to the water quality of Killarney Lake or its tributaries.

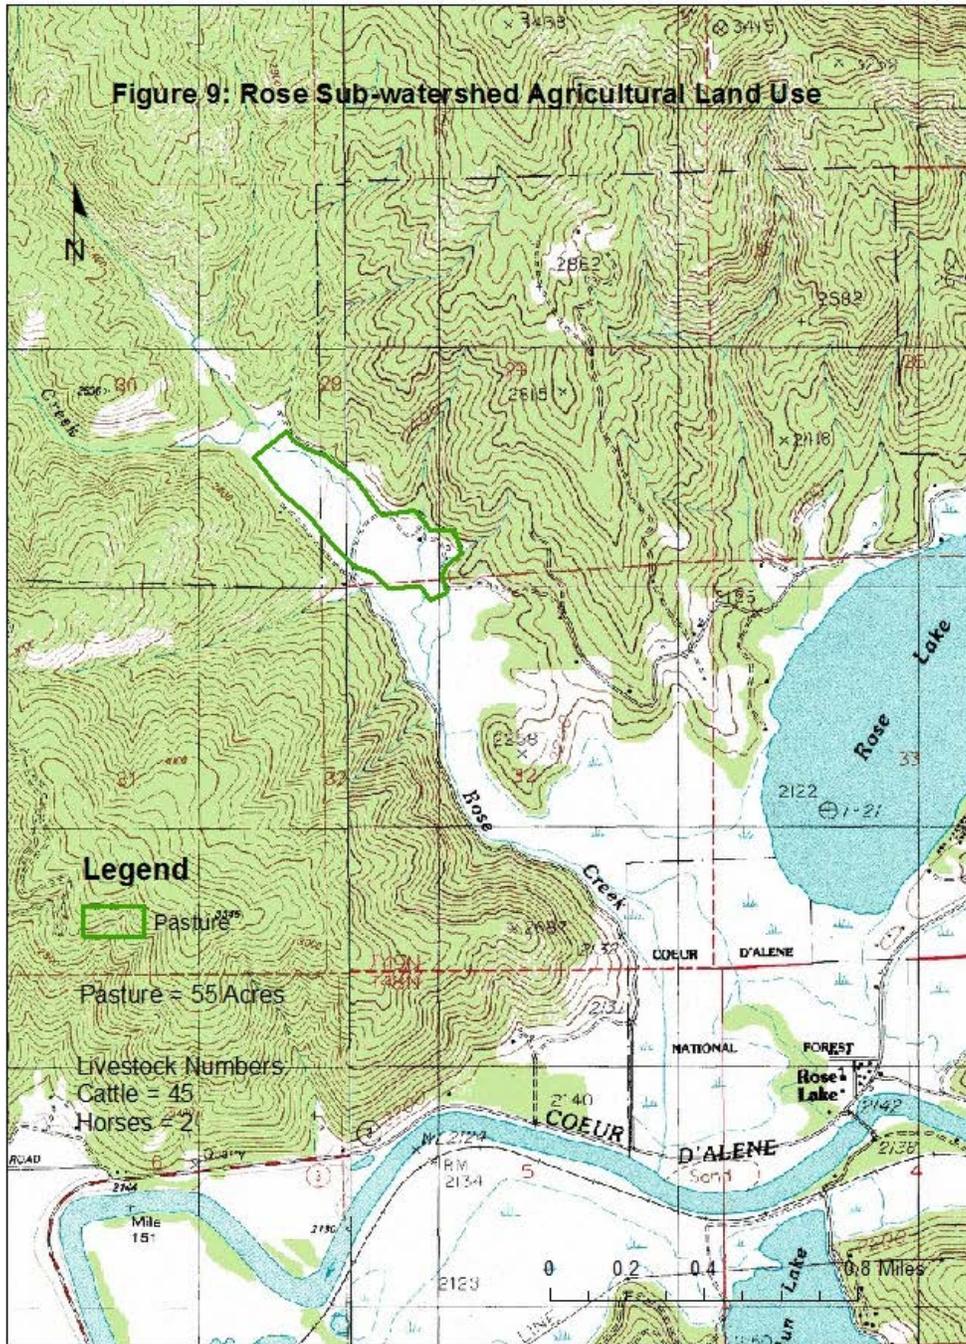
Figure 9: Rose Sub-watershed Agricultural Land Use

An agricultural land use inventory was completed within Rose Creek sub-watershed private lands and the following was observed: pasture land= 55 acres. The agricultural land use inventory conducted for Rose Creek has been summarized on Figure 9. Livestock numbers were estimated at 45 cows and 2 horses on pastures within the Rose Creek sub-watershed. The leased cattle are allowed to graze for a short period in the summer and are then moved out. A good stubble height was observed after grazing. No livestock access to Rose Creek was observed.

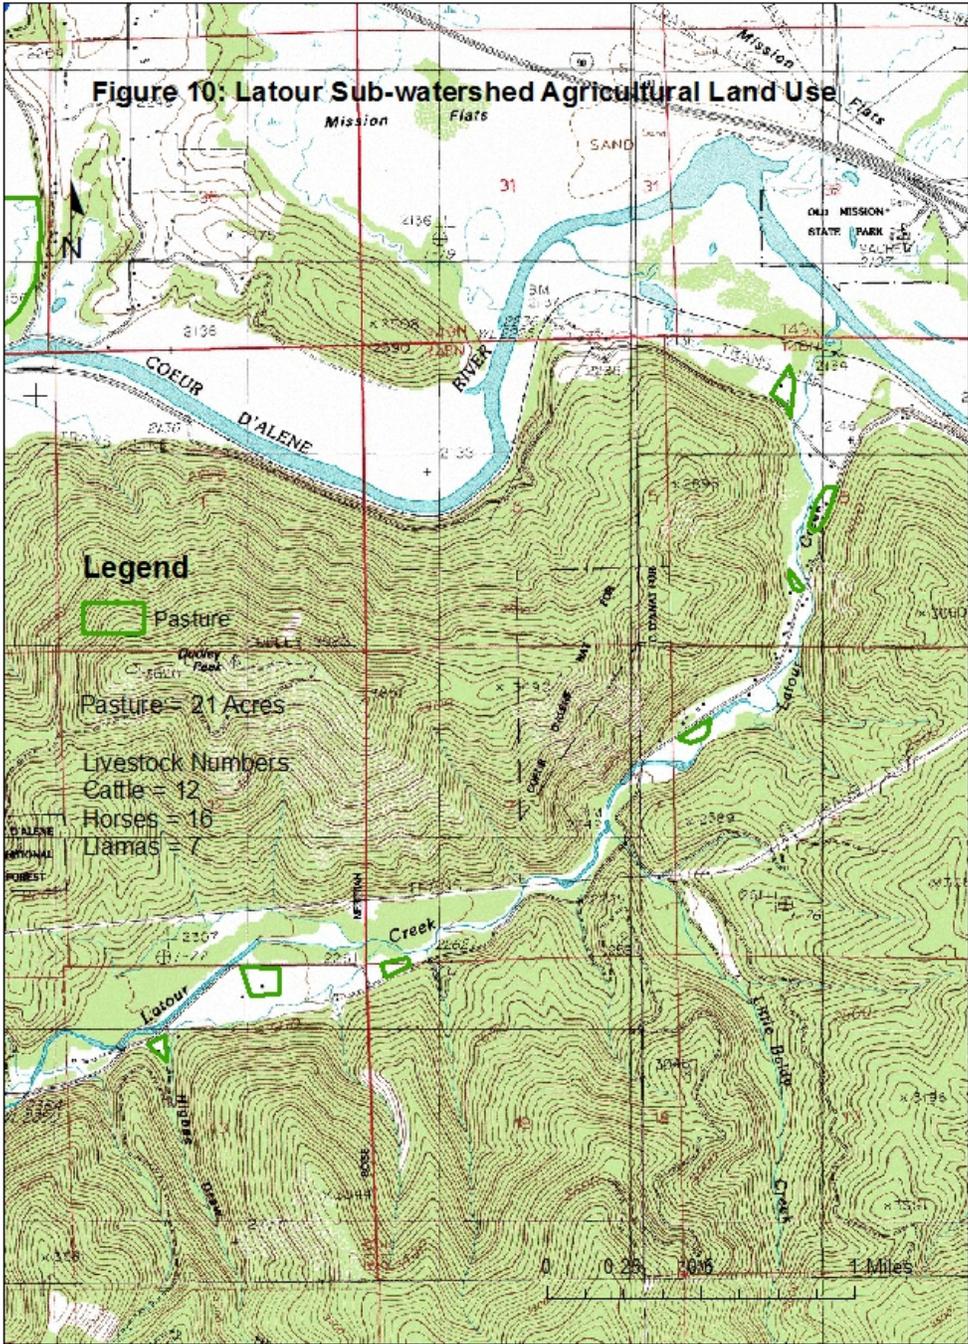
An agricultural land use inventory was completed within Latour Creek sub-watershed private lands and the following was observed: pasture land= 21 acres. The agricultural land use inventory conducted for Latour Creek has been summarized on Figure 10. Livestock numbers were estimated at 12 cows, 16 horses, and 7 llamas on pastures within the Latour Creek sub-watershed. No direct livestock access to Latour Creek was observed. Since the original Latour Creek TMDL implementation plan was drafted in 2002, agricultural use continues on a major decline within this sub-watershed. This author feels that agriculture has no significant impact to the water quality of Latour Creek.
