Subject: Site Assessment of the Alamance Mine, Elk City Mining District,  
Idaho County, Idaho

## ABBREVIATED PRELIMINARY ASSESSMENT

**Site Name:** Alamance Mine

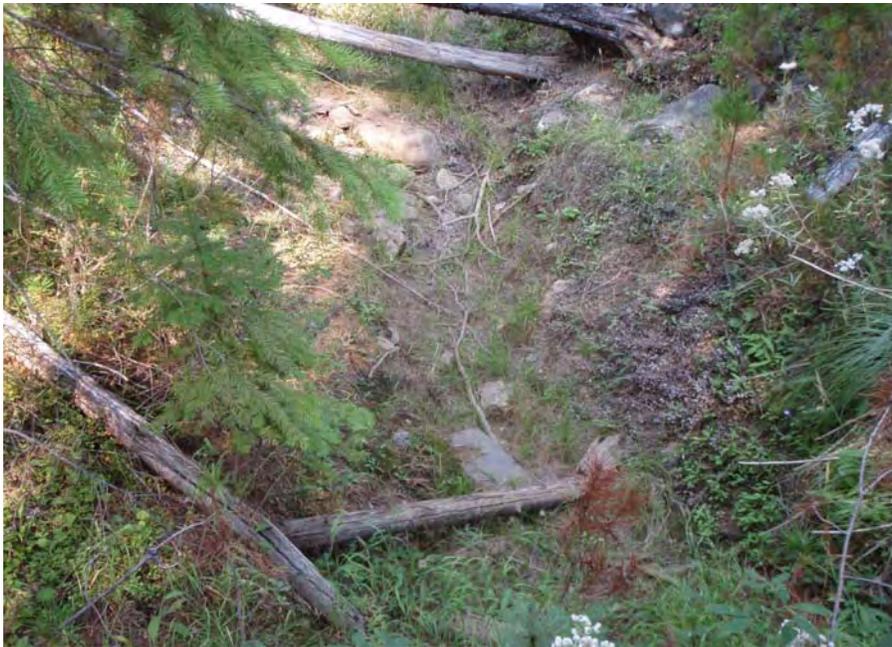
**Photo 1.** Some of the extensive trenching and disturbances in the area.

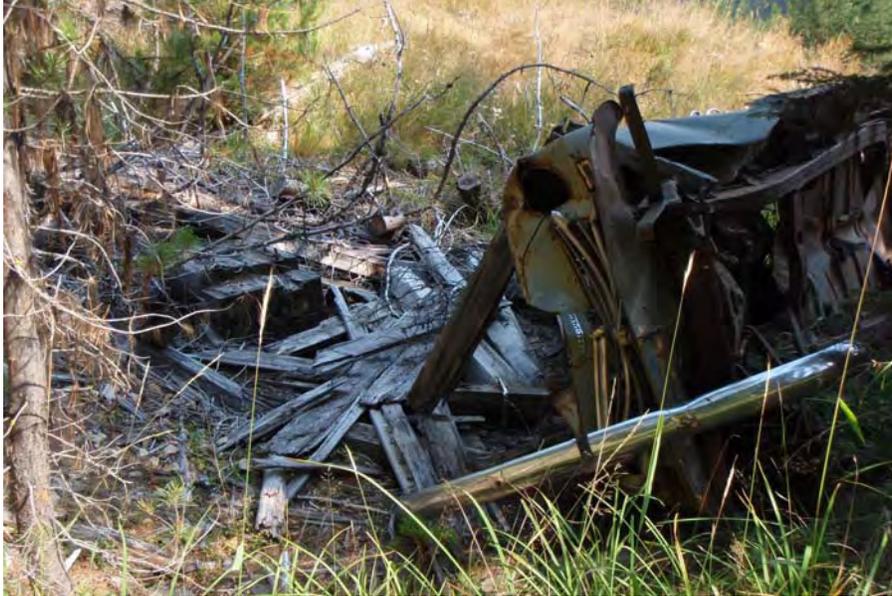
**Photo 2.** Appears to be a collapsed shaft with headframe and old cars.

It appears the site for the Alamance has been undergoing remedial actions. According to Scott Sanner, the BLM has been addressing physical hazards such as filling in the two shafts with fill material. This work occurred in September 2011 (Scott Sanner, *pers. comm.*).

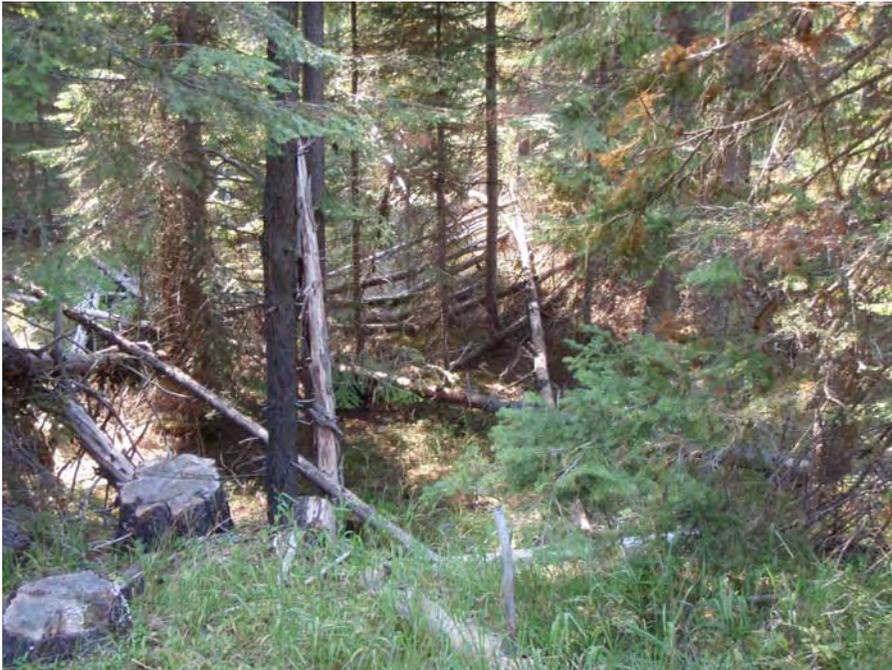
**Photo 3.** Area was well vegetated with mature trees and grass. Some of the trees are 50-60 feet in height and are growing throughout the mined area.

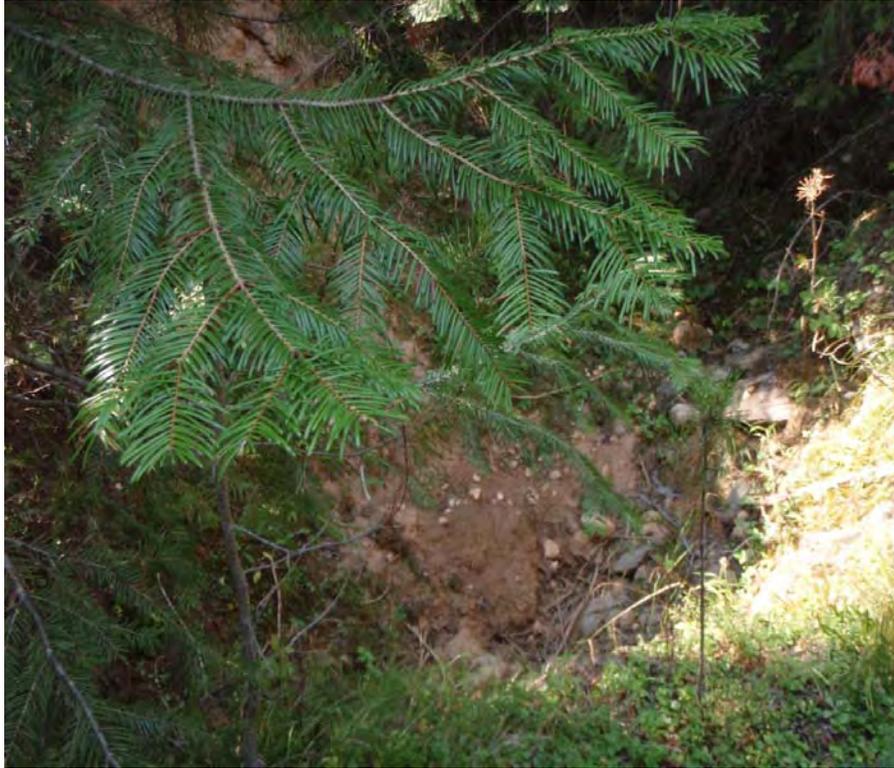
**Photo 4.** Close-up of one of the numerous ditches throughout the area.

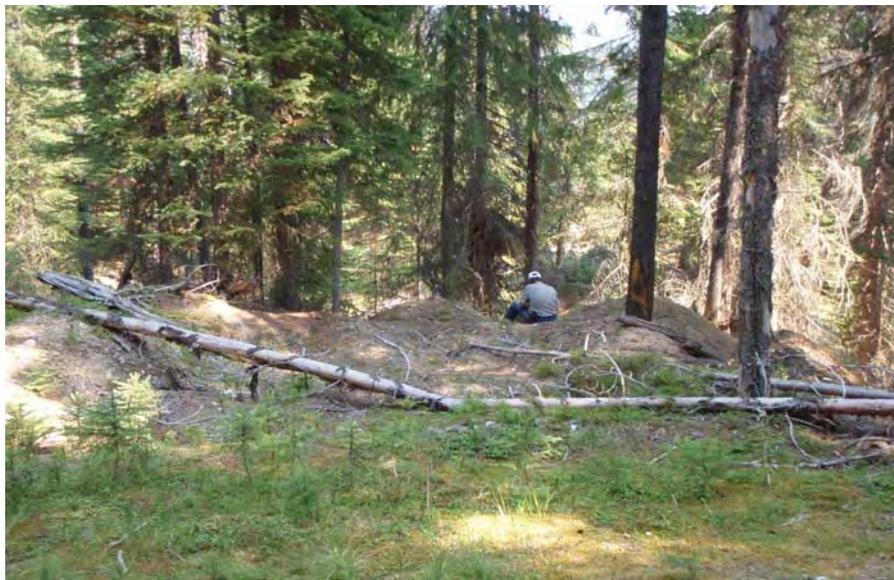
Waste piles/dumps are scattered throughout the area. The waste dumps consist of country rock with no mineralization evident. No evidence of sulfides was encountered during the survey.

**Photo 5.** This waste pile/dump was approximately 80 cubic yards in volume.

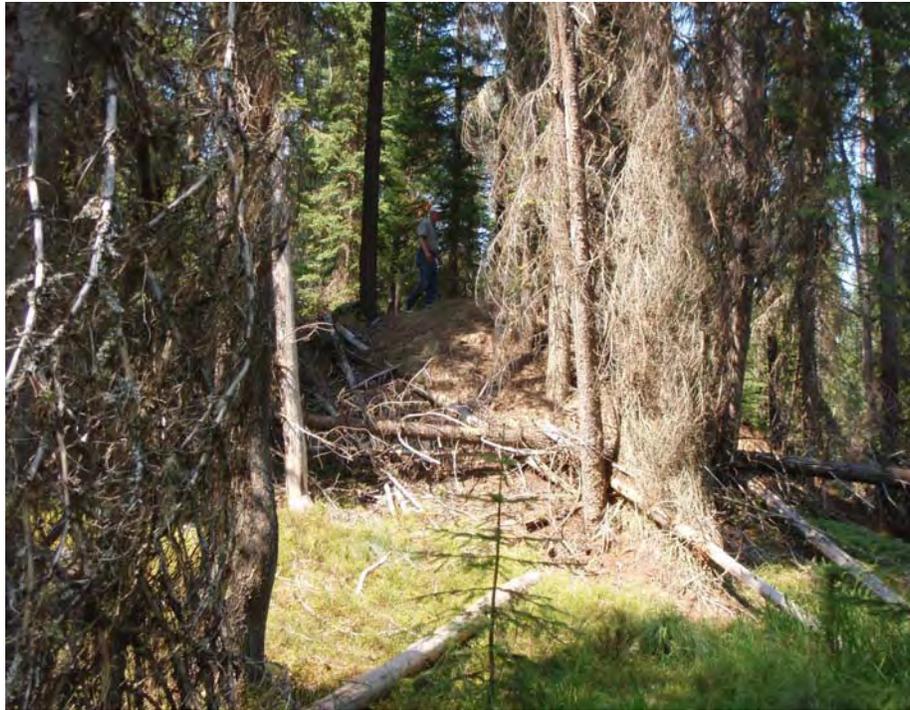
A road runs across the other end of the waste dump shown in Photo 6 and evidence of a bulldozer flattening the top of the waste dump was observed. No evidence of the shaft or adit which produced this waste was detected. The dump was composed of country rock with no evidence of mineralization or sulfides.

**Photo 6.** Waste dump of approximately 500 cubic yards.

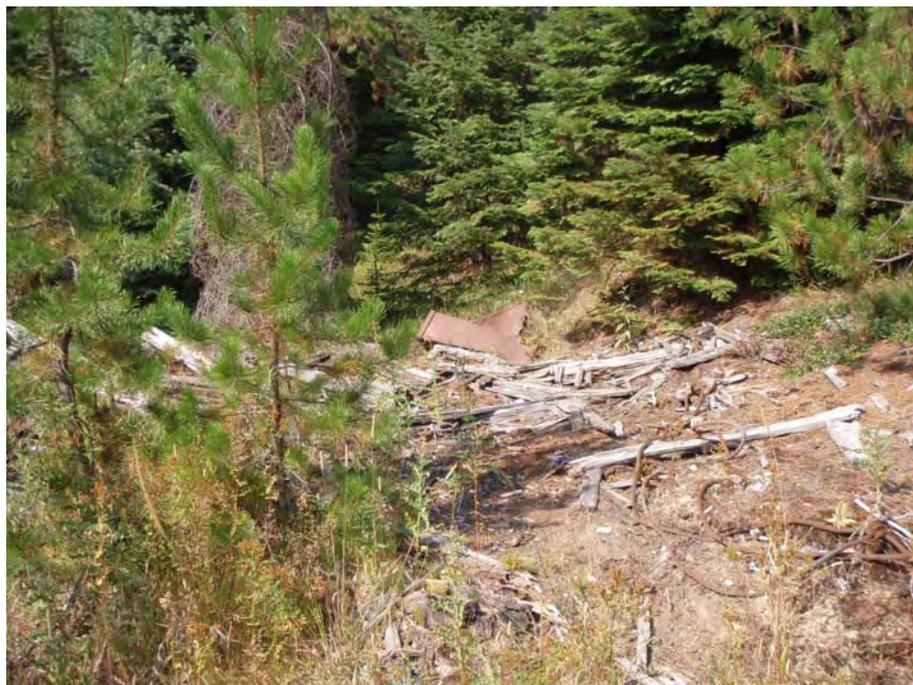
**Photo 7.** Building and mining debris left behind from the mining operation.

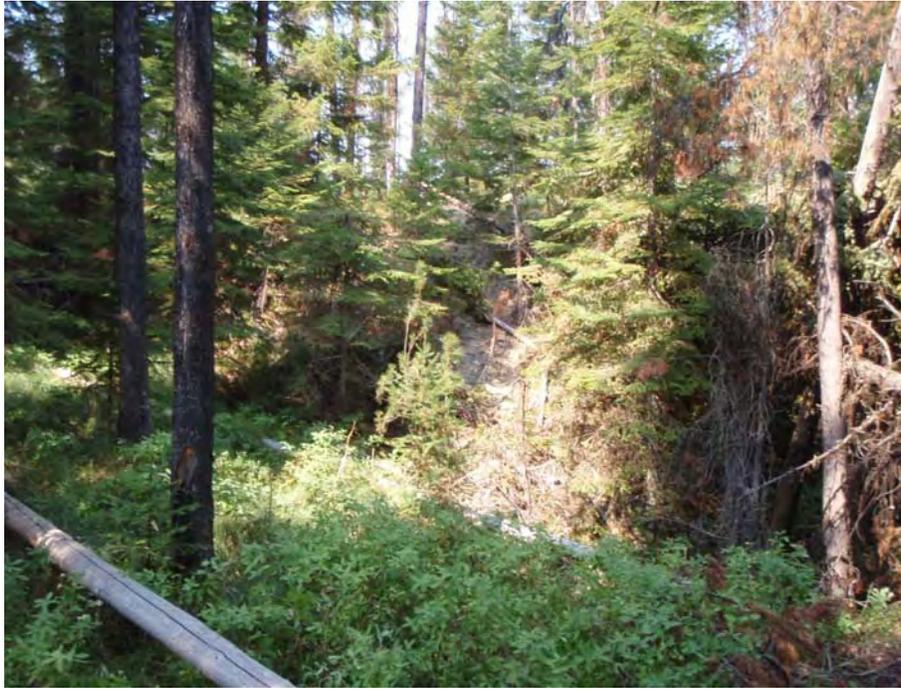
**Photo 8.** One of many trenches or collapsed adits seen at the mine site.  
Now well vegetated and stabilized.
