**REMEDIAL ACTION COMPLETION REPORT  
PHASE I REMEDIAL ACTION CONSTRUCTION ACTIVITIES  
CENTRAL FARMERS FERTILIZER FACILITY  
IN GEORGETOWN CANYON, IDAHO  
NU-WEST MINING, INC and  
NU-WEST INDUSTRIES, INC.**

January 28, 2010

GLOBAL ENVIRONMENTAL TECHNOLOGIES L.L.C.

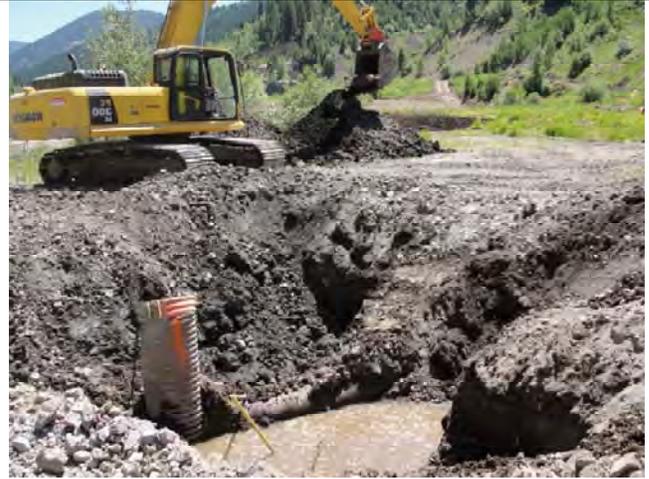
LEAKING EXISTING 18 INCH CONCRETE PIPE CONNECTING TO CMP RISER IN TANK SPRING PIPELINE EXCAVATION - LOOKING SOUTHEAST- PHOTO DATED 07/21/09 GET LLC

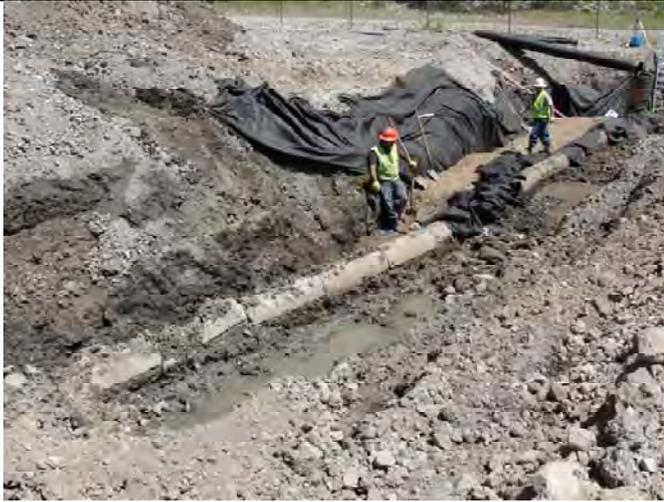
BUILDING DRAINAGE TRENCH AND DRAIN GRAVEL ENVELOPE AND EXPOSING BROKEN AND LEAKING 18-INCH CONCRETE PIPE TO CMP RISER - LOOKING WEST- PHOTO DATED 07/22/09 GET LLC

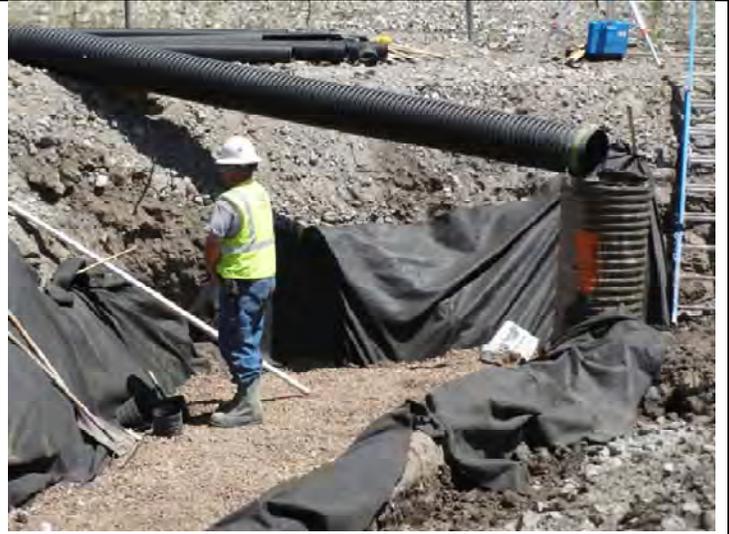
DRAINAGE TRENCH CONSTRUCTION WITH TANK SPRING BYPASS PUMPAGE INTO CMP- LOOKING WEST- PHOTO DATED 07/22/09 GET LLC

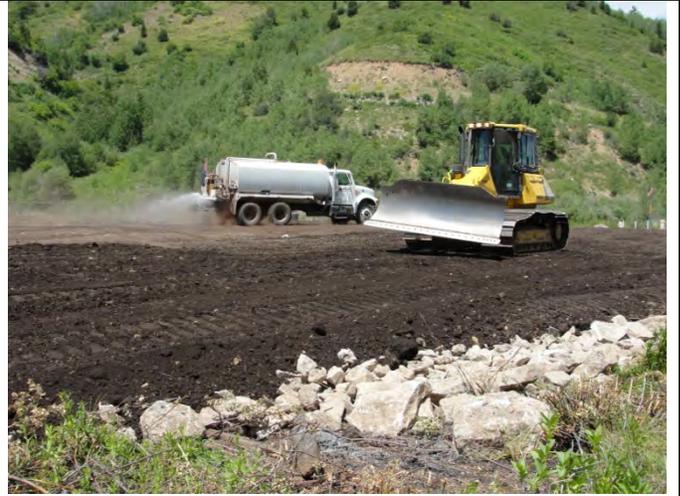
EAST SIDE OF SLURRY PIT WITH LOW SPOTS FILLED WITH COMPACTED FOUNDATION ROCK FOR DRIVABLE SURFACE - LOOKING NORTHWEST- PHOTO DATED 07/21/09 GET LLC

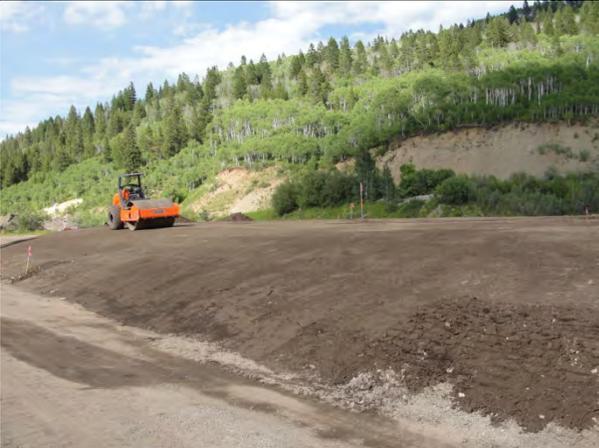
SECOND LIFT ON SLURRY PIT SURFACE - LOOKING NORTHEAST- PHOTO DATED 07/22/09 GET LLC

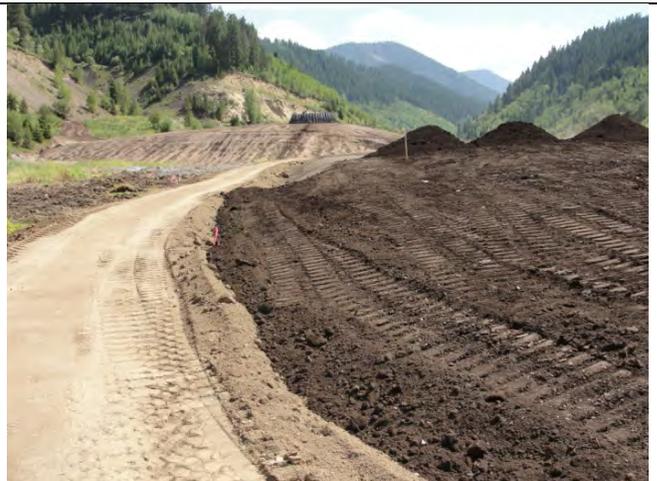
PLACEMENT OF OUTER FOUNDATION OF SOIL TO CONSTRUCT OUTER BANK TO ANCHOR TRENCH - LOOKING SOUTH TOWARDS FURNACE FILL- PHOTO DATED 08/01/09 GET LLC

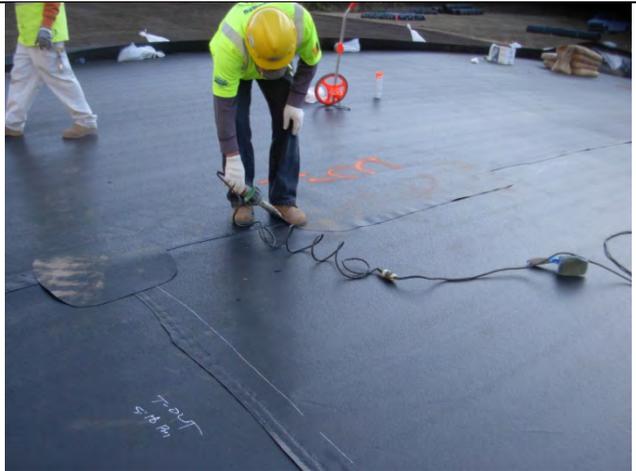
PATCHING DESTRUCT SAMPLE ON SLURRY PIT CAP PRIOR TO REPAIR TESTING - LOOKING NORTHEAST-  
 PHOTO DATED 08/19/09 GET LLC

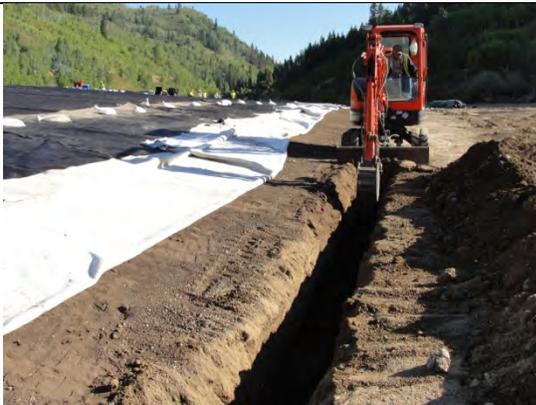
EXCAVATING LAST SEGMENT OF ANCHOR TRENCH EAST SIDE SLURRY PIT WITH LINER LAID BACK -  
 LOOKING NORTH- PHOTO DATED 08/21/09 GET LLC

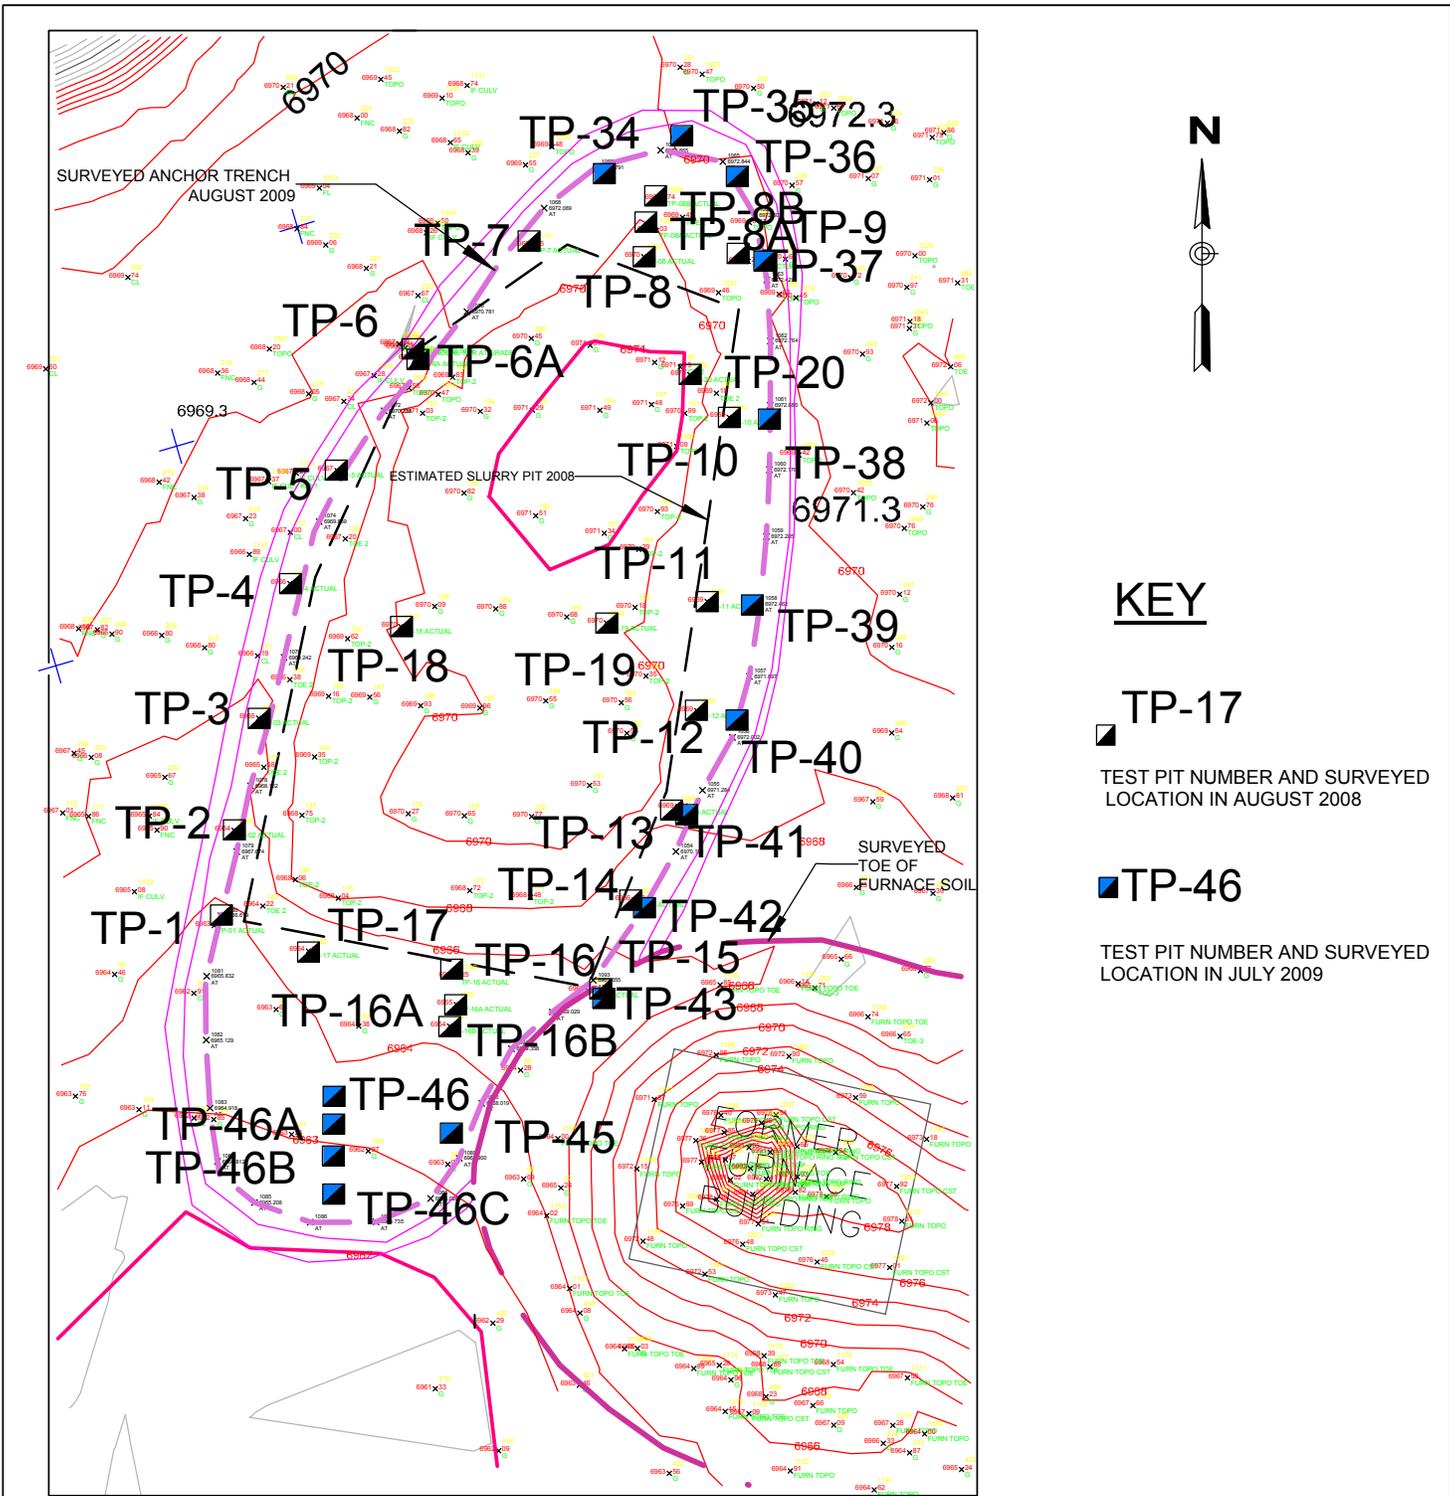
anchor trench. The permanent closure of this area was addressed with an engineered cover over the ore area described in this report that completely covered the elemental phosphorus based on the results of both 2008 and 2009 test pit results. No elemental phosphorus was encountered in the anchor trench excavation during cover placement.
