Wolf Lodge Creek Watershed Assessment and Restoration Prioritization Plan

Near Coeur d'Alene, Idaho

Submitted To:
Idaho Department of Environmental Quality
2110 Ironwood Parkway
Coeur d'Alene, ID 83814

December 2016

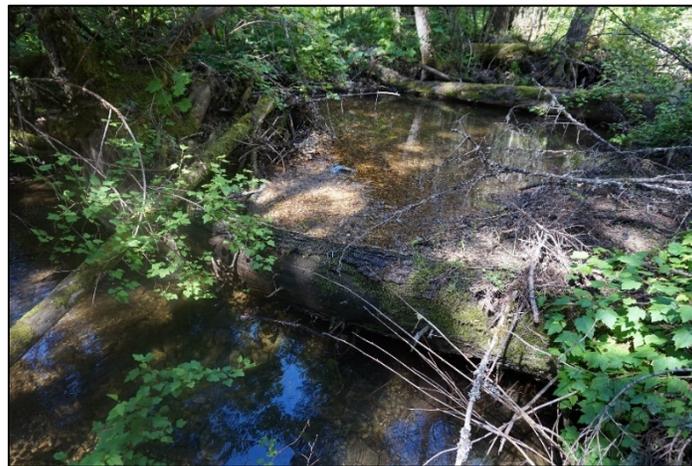
Figure B1-11. Cross section 4 upstream log-step pool.

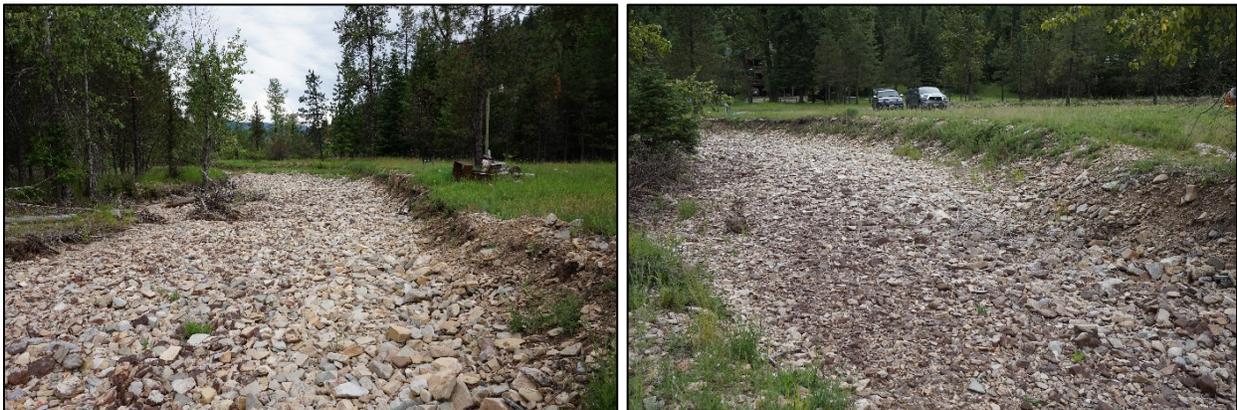
Figure B2-4. Mid-reach downstream view (left). Right bank levied by previous owner (right).

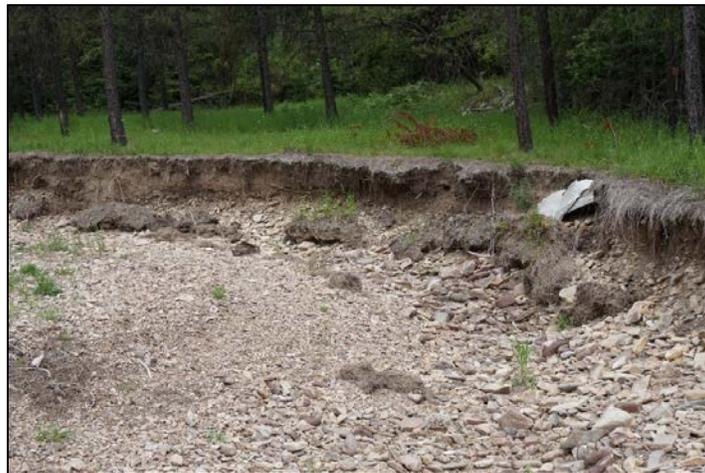
Figure B2-6. Cross section 1 pool upstream view. Rapidly eroding bank and bank blocks.

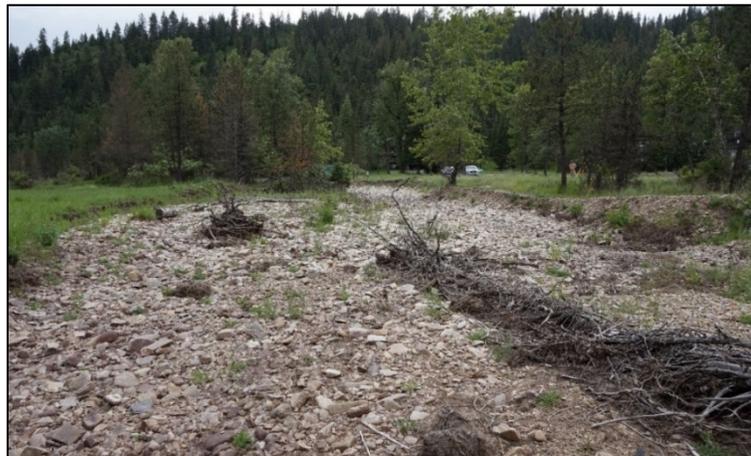
Figure B2-8. Cross section 2 riffle downstream. Wide riffle that appears to be a result of vegetation removal and bank instability.

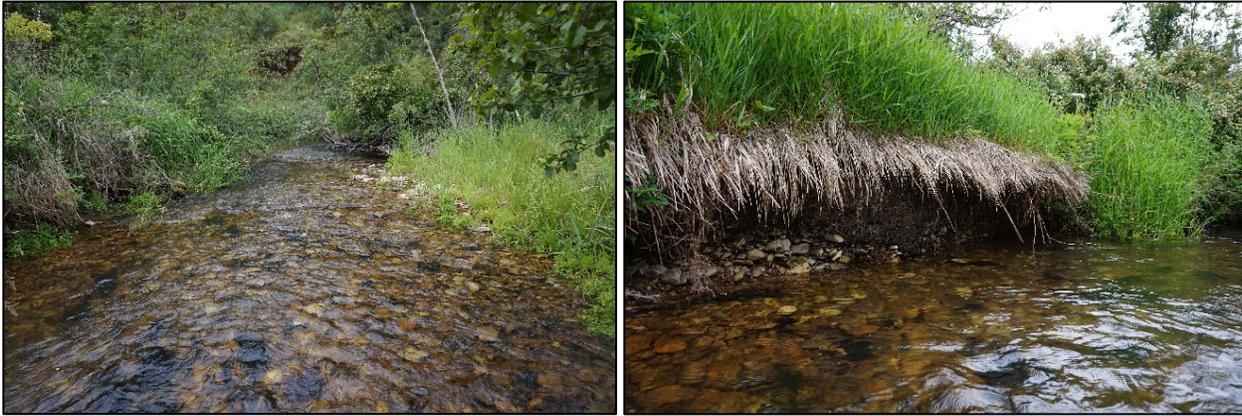
Figure B4-3. Typical riffle in WLC2 (left). Higher bank covered with reed canary grass (right).

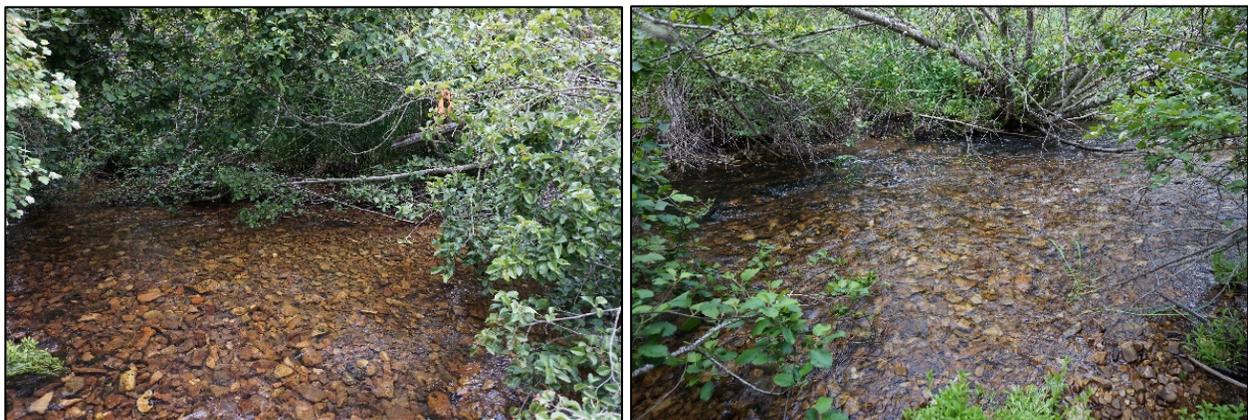
Figure B4-5. Cross section 1 riffle with thick alder (left) and upstream (right).

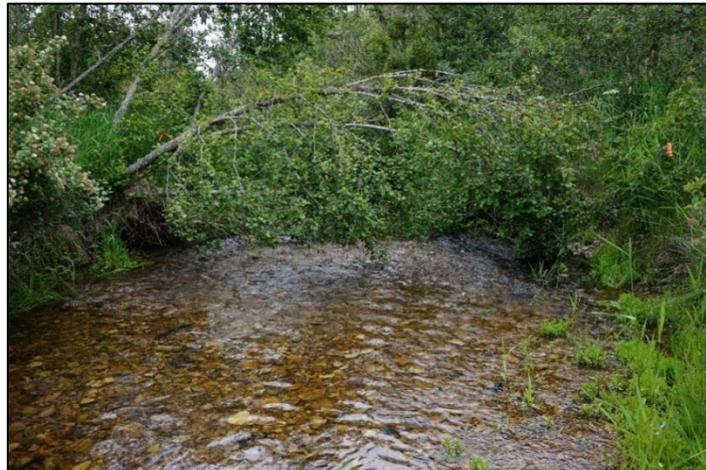
Figure B4-9. Cross section 3 riffle downstream view with overhanging alder.

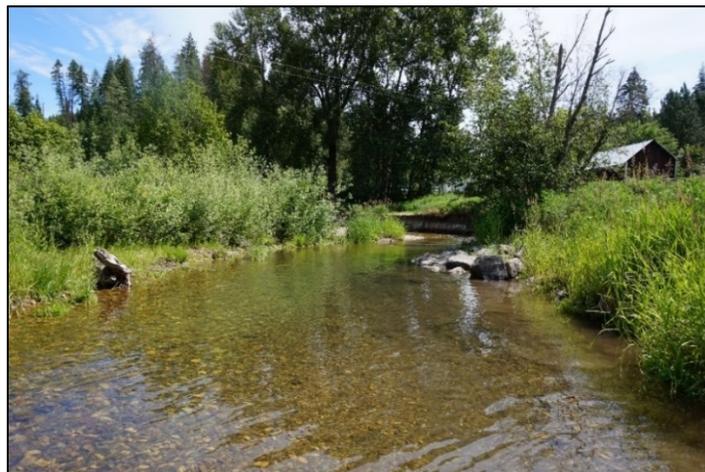
Figure B5-10. Cross section 3 upstream pool with riprap on left bank.

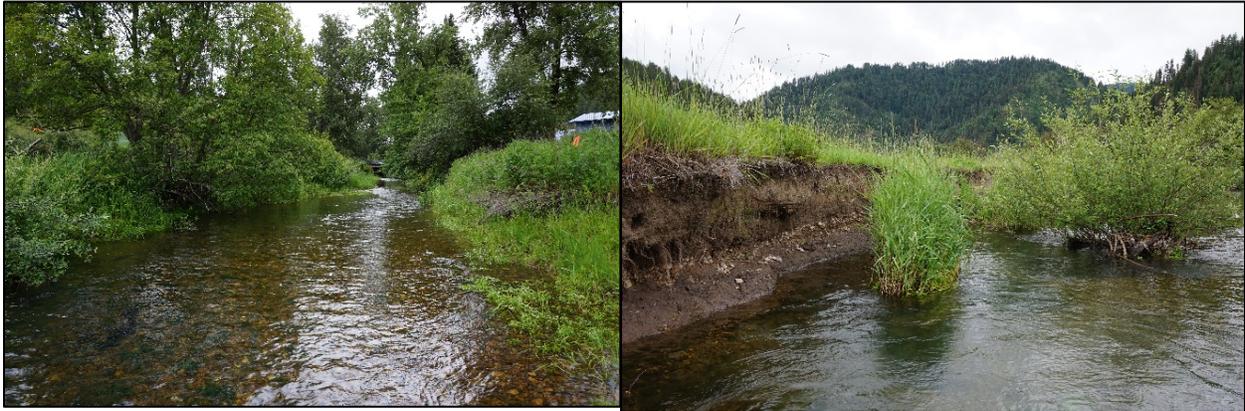
Figure B6-4. Cross section 1 upstream view of sub-reach (left). Large bank blocks indicate large erosion rates (right).

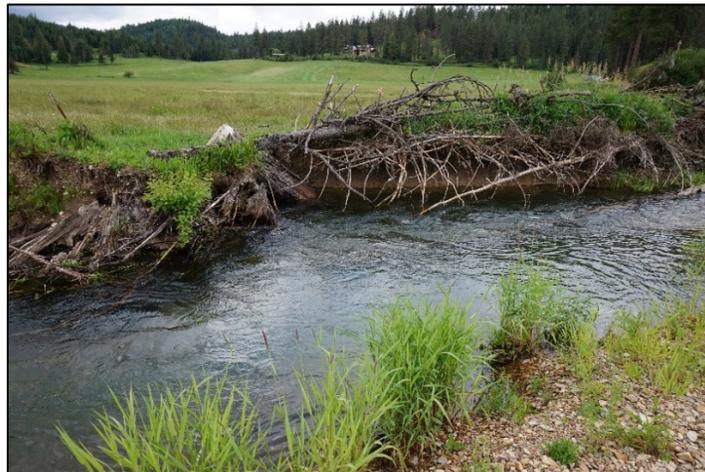
Figure B6-8. Cross section 2 pool with undercut banks and evidence of dredging.

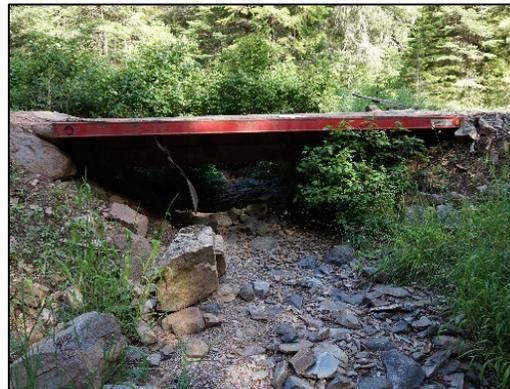
Stringer

BRIDGE DATA	
Construction materials:	Wood deck, steel stringers, native approach grades
Deck condition:	Stable, wood
Stream channel constricted by bridge?	Yes

RISK ASSESSMENT	
Overtopping:	Possible
Mass Failure	Possible, fillslopes eroding at bridge inlet/outlet.
Erosion:	Medium, fillslopes eroding at bridge inlet/outlet.
Significance of problem:	Medium, fill is eroding and bridge is undersized.

RECOMMENDATIONS	
Talk with landowner about potential removal/replacement.

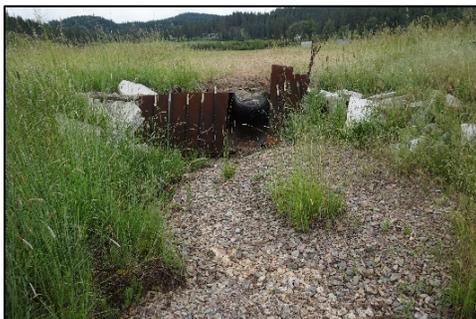
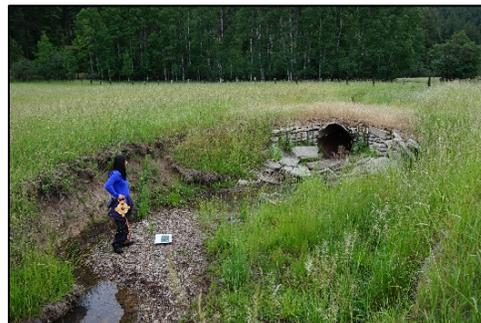
CULVERT DATA	
Diameter:	5 ft.
Length:	21 ft.
Alignment with stream:	Culvert is aligned with stream.
Culvert installation:	Stacked rock forms fillslopes. Vertical.
Energy dissipation at outlet:	No, downstream bank erosion is severe.
Armoring:	Not adequate.
Condition:	Both inlet and outlet are degraded and not properly designed.

RISK ASSESSMENT	
Overtopping:	Possible. Plugging risk is high.
Mass Failure	Probable during high flow event, especially if inlet is plugged.
Erosion:	High, extreme bank erosion at outlet.
Significance of problem:	Recommend replacement.

COMMENTS	
Scour in channel?	Yes.
Scour at outlet?	Yes, excessive.
Road fill eroding into channel at crossing?	No
Fish concerns?	Ephemeral, non-fish bearing stream.

RECOMMENDATIONS	
Replace culvert and integrate with upstream/downstream channel and streambank restoration treatments.

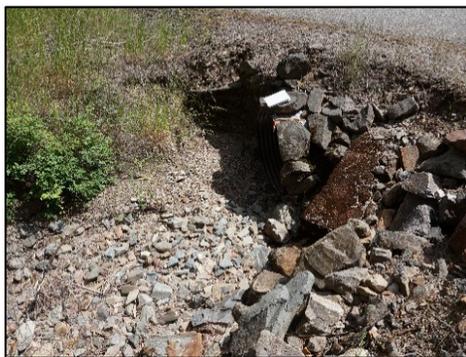
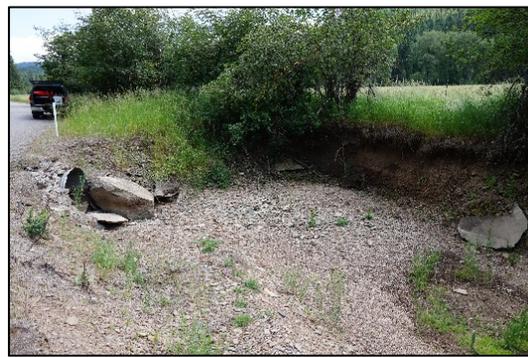
CULVERT DATA	
Diameter:	5 ft.
Length:	25 ft.
Alignment with stream:	No, alignment is causing severe bank erosion.
Culvert installation:	Not installed level with stream bed.
Energy dissipation at outlet:	No, several bank erosion and channel incision downstream of outlet.
Armoring:	Not adequate.
Condition:	Culvert is in relatively good condition, outlet erosion major issue.

RISK ASSESSMENT	
Overtopping:	Probable, would likely overtop if plugged.
Mass Failure	Possible due to lack of hydraulic capacity.
Erosion:	Severe upstream and downstream of culvert.
Significance of problem:	High, significant source of sediment to channel.

COMMENTS	
Scour in channel?	Yes, at outlet due to alignment of culvert.
Scour at outlet?	Yes, at outlet due to alignment of culvert.
Road fill eroding into channel at crossing?	Yes
Fish concerns?	Ephemeral, likely non-fish bearing.

RECOMMENDATIONS	
Replace culvert, stabilize fillslopes, and stabilize streambanks at inlet/outlet.

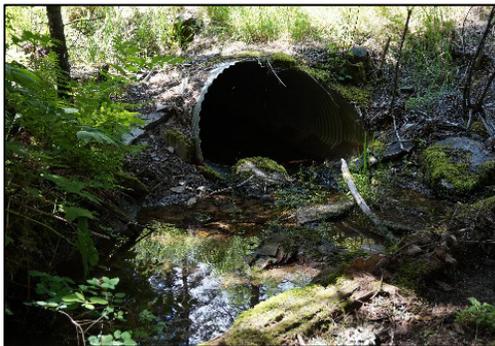
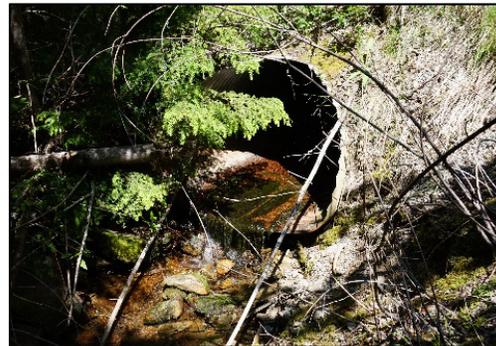
CULVERT DATA	
Diameter:	2.5 ft x 4 ft
Length:	55 ft
Alignment with stream:	Culvert is aligned with stream.
Culvert installation:	Culvert is installed on grade with stream profile.
Energy dissipation at outlet:	Adequate.
Armoring:	Adequate.
Condition:	Good condition.

RISK ASSESSMENT	
Overtopping:	Unlikely.
Mass Failure	Unlikely.
Erosion:	Medium, road fill eroding downstream on river left.
Significance of problem:	Low.

COMMENTS	
Scour in channel?	No.
Scour at outlet?	Minor scour at culvert outlet.
Road fill eroding into channel at crossing?	Yes, downstream.
Fish concerns?	Fish passage may be compromised. Fish observed upstream.

RECOMMENDATIONS	
Further evaluate fish passage conditions and replace as needed. Low priority.

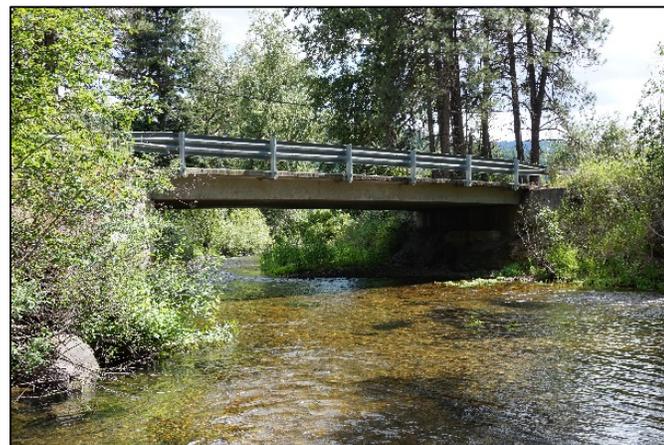
Upstream Bridge Inlet

BRIDGE DATA	
Construction materials:	Concrete abutments/stringers.
Deck condition:	Stable, paved.
Stream channel constricted by bridge?	Yes.

RISK ASSESSMENT	
Overtopping:	Unlikely.
Mass Failure	Unlikely.
Erosion:	Low.
Significance of problem:	Low.

COMMENTS	
Scour in channel?	No.
Scour at outlet?	No.
Road fill eroding into channel at crossing?	Road fill on river left contributing sediment to channel.
Fish concerns?	No.

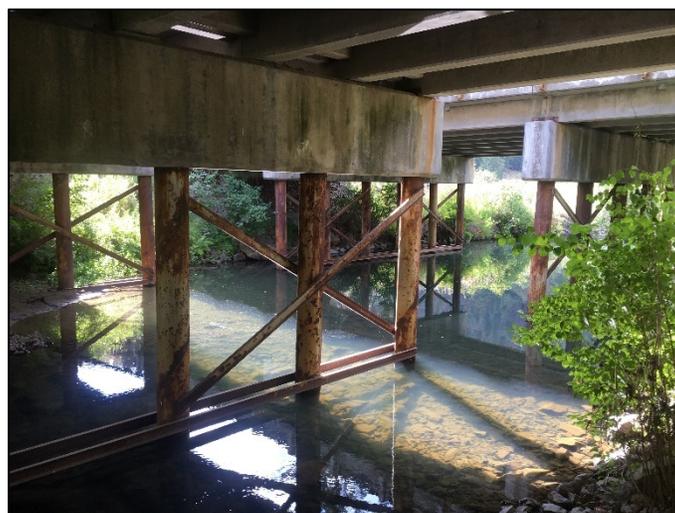
View of Pier Supports and Stringers

BRIDGE DATA	
Construction materials:	Concrete abutments w/ metal.
Deck condition:	Asphalt, stable.
Stream channel constricted by bridge?	Yes.

RISK ASSESSMENT	
Overtopping:	Unlikely.
Mass Failure	Unlikely.
Erosion:	Low.
Significance of problem:	Low.

COMMENTS	
Scour in channel?	No.
Scour at outlet?	No.
Road fill eroding into channel at crossing?	Yes.
Fish concerns?	No.

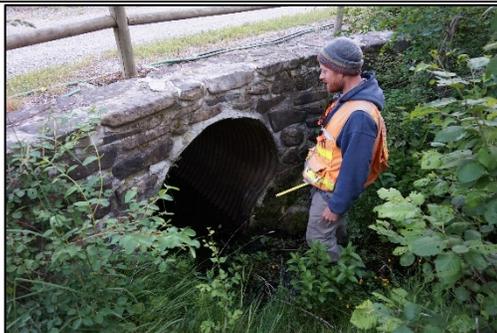
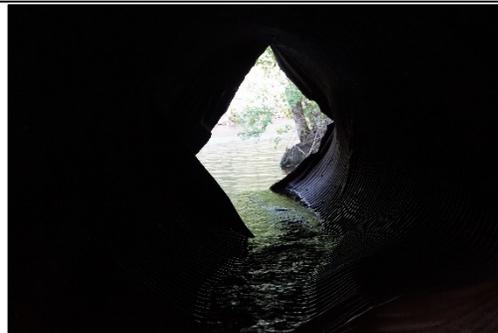
CULVERT DATA	
Diameter:	42 in.
Length:	23 ft.
Alignment with stream:	Not aligned with stream.
Culvert installation:	Damaged/not aligned.
Energy dissipation at outlet:	Inadequate.
Armoring:	Inlet/outlet fillslopes armored.
Condition:	Culvert is partially compromised and crushed.

RISK ASSESSMENT	
Overtopping:	Moderate due to potential for plugging.
Mass Failure	Moderate due to potential for plugging.
Erosion:	Moderate.
Significance of problem:	Moderate.

COMMENTS	
Scour in channel?	Yes.
Scour at outlet?	Yes.
Road fill eroding into channel at crossing?	No.
Fish concerns?	1 foot drop at outlet limits fish passage

RECOMMENDATIONS	
Replacement.

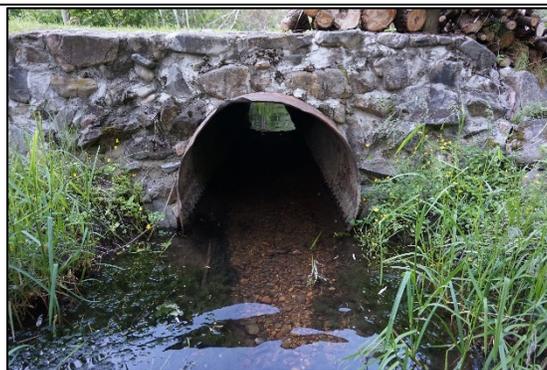
Outlet

CULVERT DATA	
Diameter:	30 in
Length:	20 ft
Alignment with stream:	Misaligned.
Culvert installation:	Constricts channel.
Energy dissipation at outlet:	Inadequate.
Armoring:	None.
Condition:	Fair condition.

RISK ASSESSMENT	
Overtopping:	Low.
Mass Failure	Low.
Erosion:	Moderate.
Significance of problem:	Low.

COMMENTS	
Scour in channel?	Deposition at inlet.
Scour at outlet?	Yes.
Road fill eroding into channel at crossing?	No.
Fish concerns?	No.

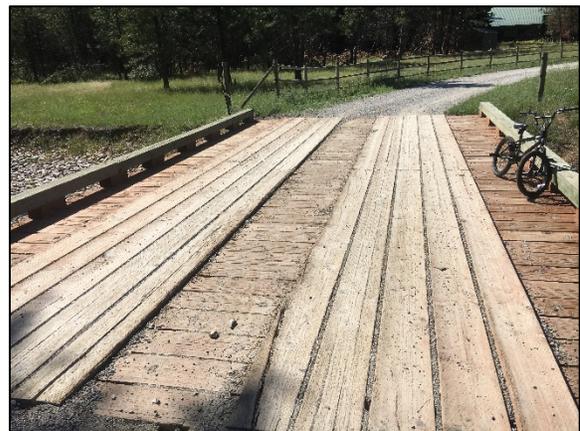
Wooden Deck

BRIDGE DATA	
Construction materials:	Concrete abutments, wooden deck.
Deck condition:	Stable, wooden.
Stream channel constricted by bridge?	Yes.

RISK ASSESSMENT	
Overtopping:	Possible during large flood event.
Mass Failure	Possible during large flood event.
Erosion:	Bank erosion upstream/downstream or crossing.
Significance of problem:	Moderate.

RECOMMENDATIONS	
Replace bridge or increase span/freeboard.

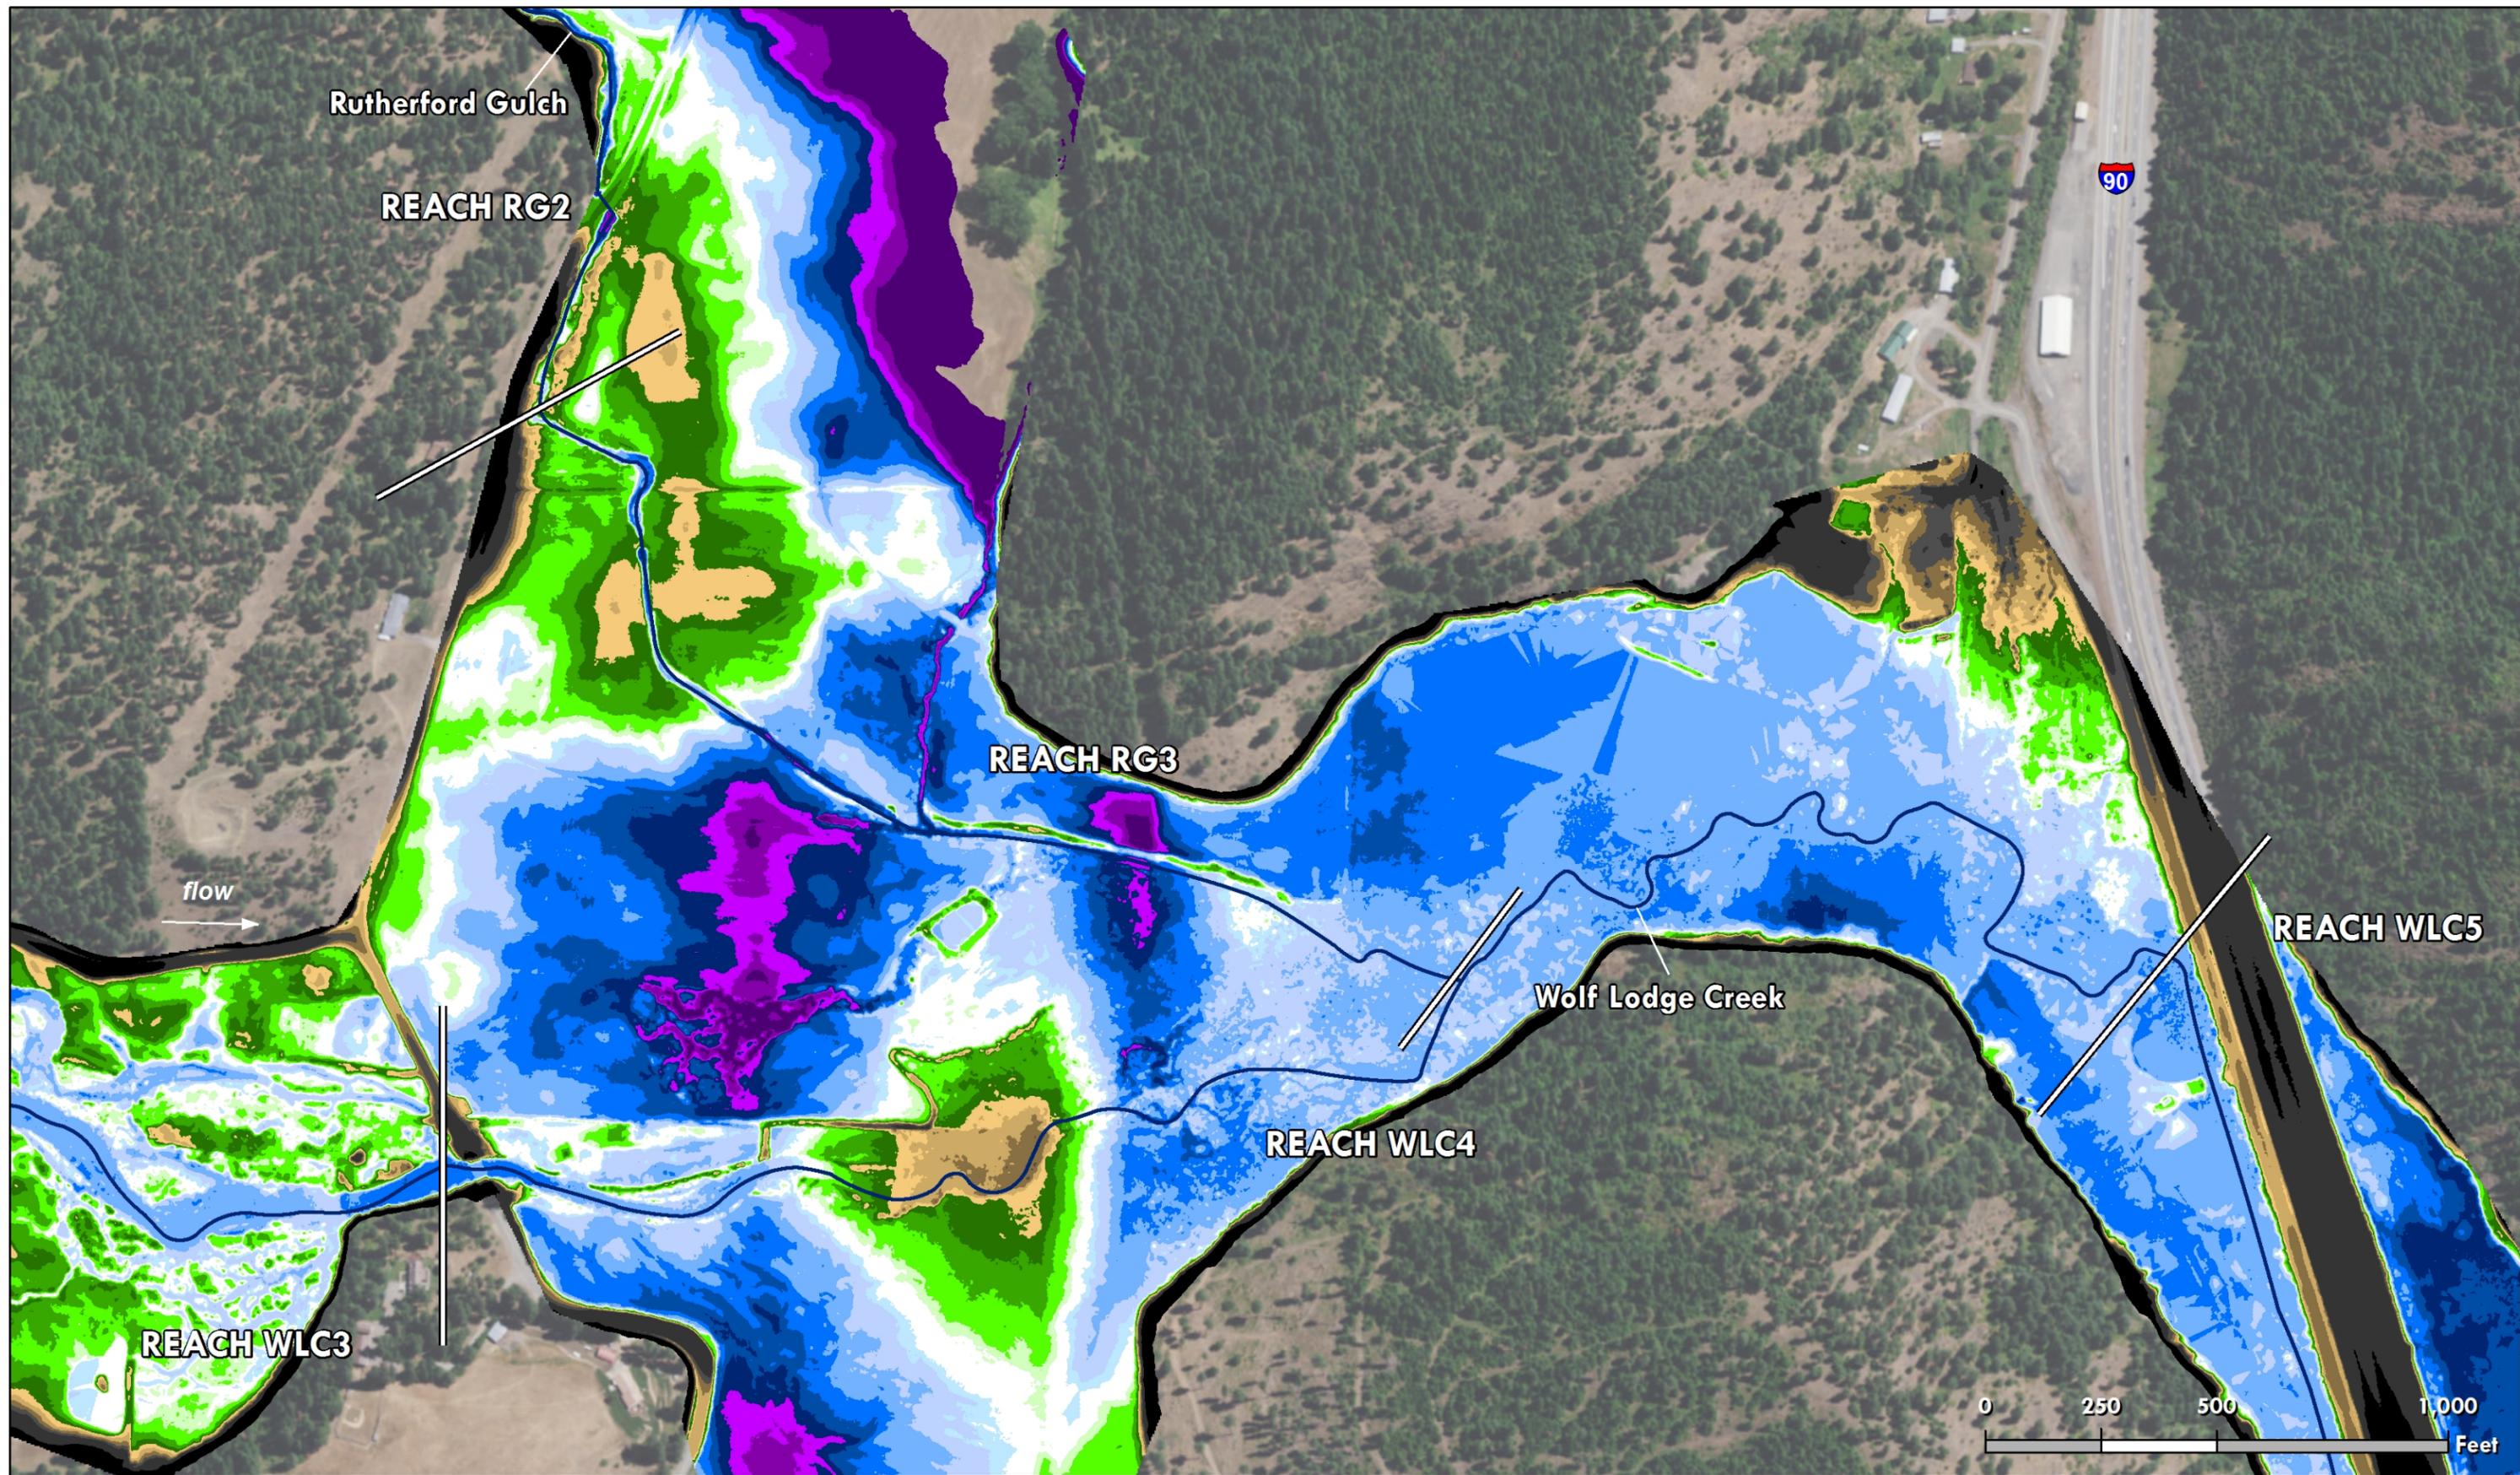
**Wolf Lodge Creek Watershed Assessment
 and Restoration Prioritization Plan**
**Figure E6. Floodplain connectivity of Reach WLC3
 (downstream).**

Floodplain connection is limited in the downstream portion of Reach WLC3, and at the WLC3 geomorphic survey location (Appendix E, Figure E6). In this area, the channel is pinched between the eastern valley toe and residential and agricultural development. As a result of flow constriction into the channel, a meander bend directly downstream is actively eroding at a high rate. A conceptual restoration design for the upper portion of the site is included in Attachment A.

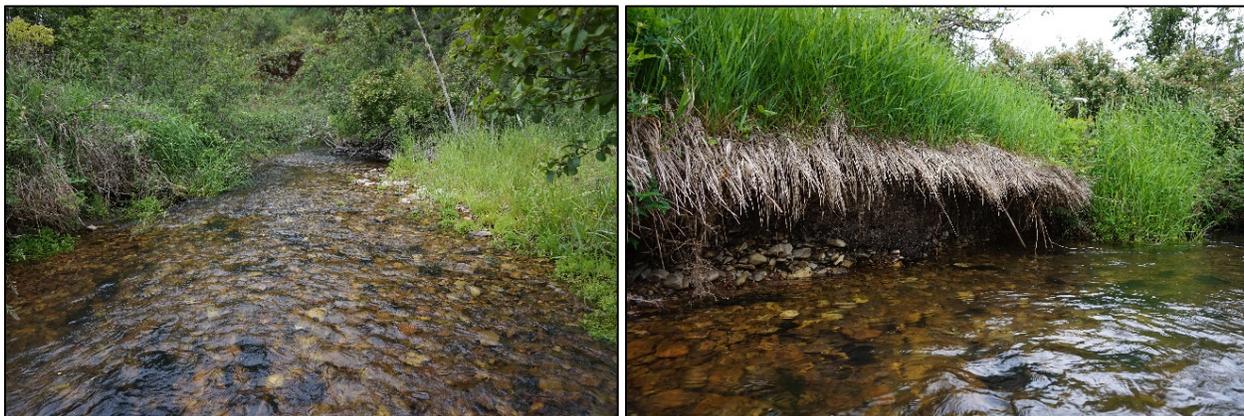
WLC2 begins at the confluence of WLC1/LC1 and ends at the culvert at Meyers Hill Road. This reach is heavily vegetated and relatively undisturbed by residential development and agriculture in recent history. The surrounding land is owned by a mixture of private owners, who use the land for horses and grazing but have left an adequate riparian corridor. While the stream appears to have relocated to the edge of the valley floor at some time in its history, the reach appears stable and at equilibrium. WLC2 is classified as a B4 stream type for the majority of the reach with small inclusions of C4 stream type where the floodplain width expands. Stream gradient from Light Detection and Ranging (LiDAR) data is 0.01 ft/ft, while the subreach geomorphic survey indicates a bed slope of 0.008 ft/ft. Width-to-depth ratios are lower compared to upstream reach LC1 and downstream reach WLC3. WLC2 appears to be at equilibrium, with a diverse range of habitat and adequate amounts of large wood. Beaver sign is present in the reach, though no active dams were located during the survey. Undercut banks, protected by vegetation, provide habitat for native westslope cutthroat trout. WLC2 banks are much less erodible when compared to WLC3 which has similar geomorphic attributes and the reach contributes 4% of the total sediment load of the watershed. Invasive reed canarygrass (*Phalaris arundinacea*) was found throughout the reach.

Figure 4-4. Typical channel and bank conditions in Reach WLC2.

WLC2 is a healthy, functioning creek. Recommendations include the addition of large wood for habitat enhancement and removal of reed canarygrass. Overall, this reach can provide a reference for restoration in disturbed reaches. The healthy riparian plant communities and increased access to floodplain reduced both bank erosion and channel migration rates.

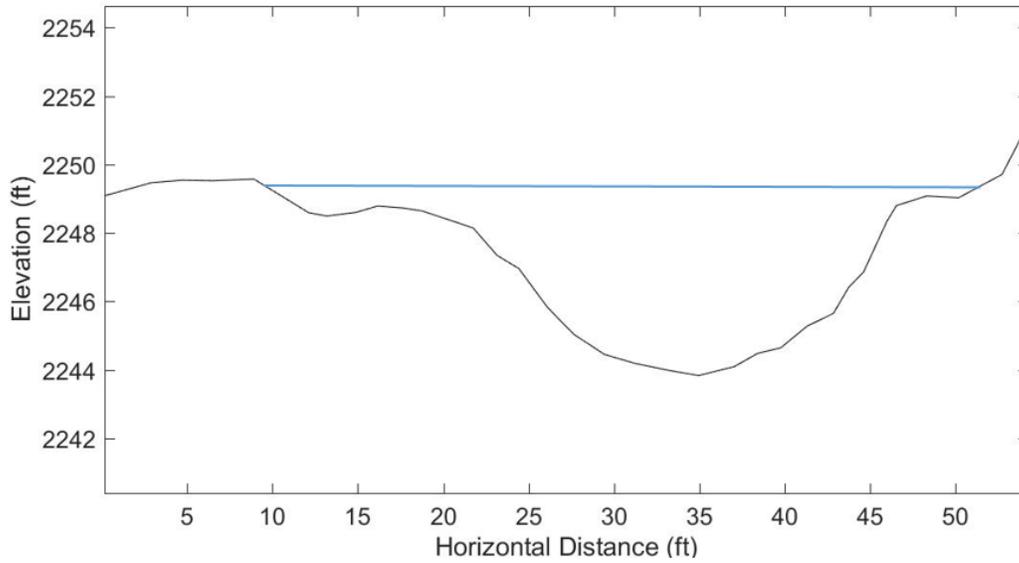
Figure 4-5. Cross section 4 on WLC2, deep pool caused by log jam. Blue line represents bankfull stage.

Bankfull Width (ft)	42.2
Mean Depth (ft)	2.7
Max Depth (ft)	5.6
Bankfull Area (ft ²)	111.6
Width/Depth Ratio	15.9
Hydraulic Radius	2.5

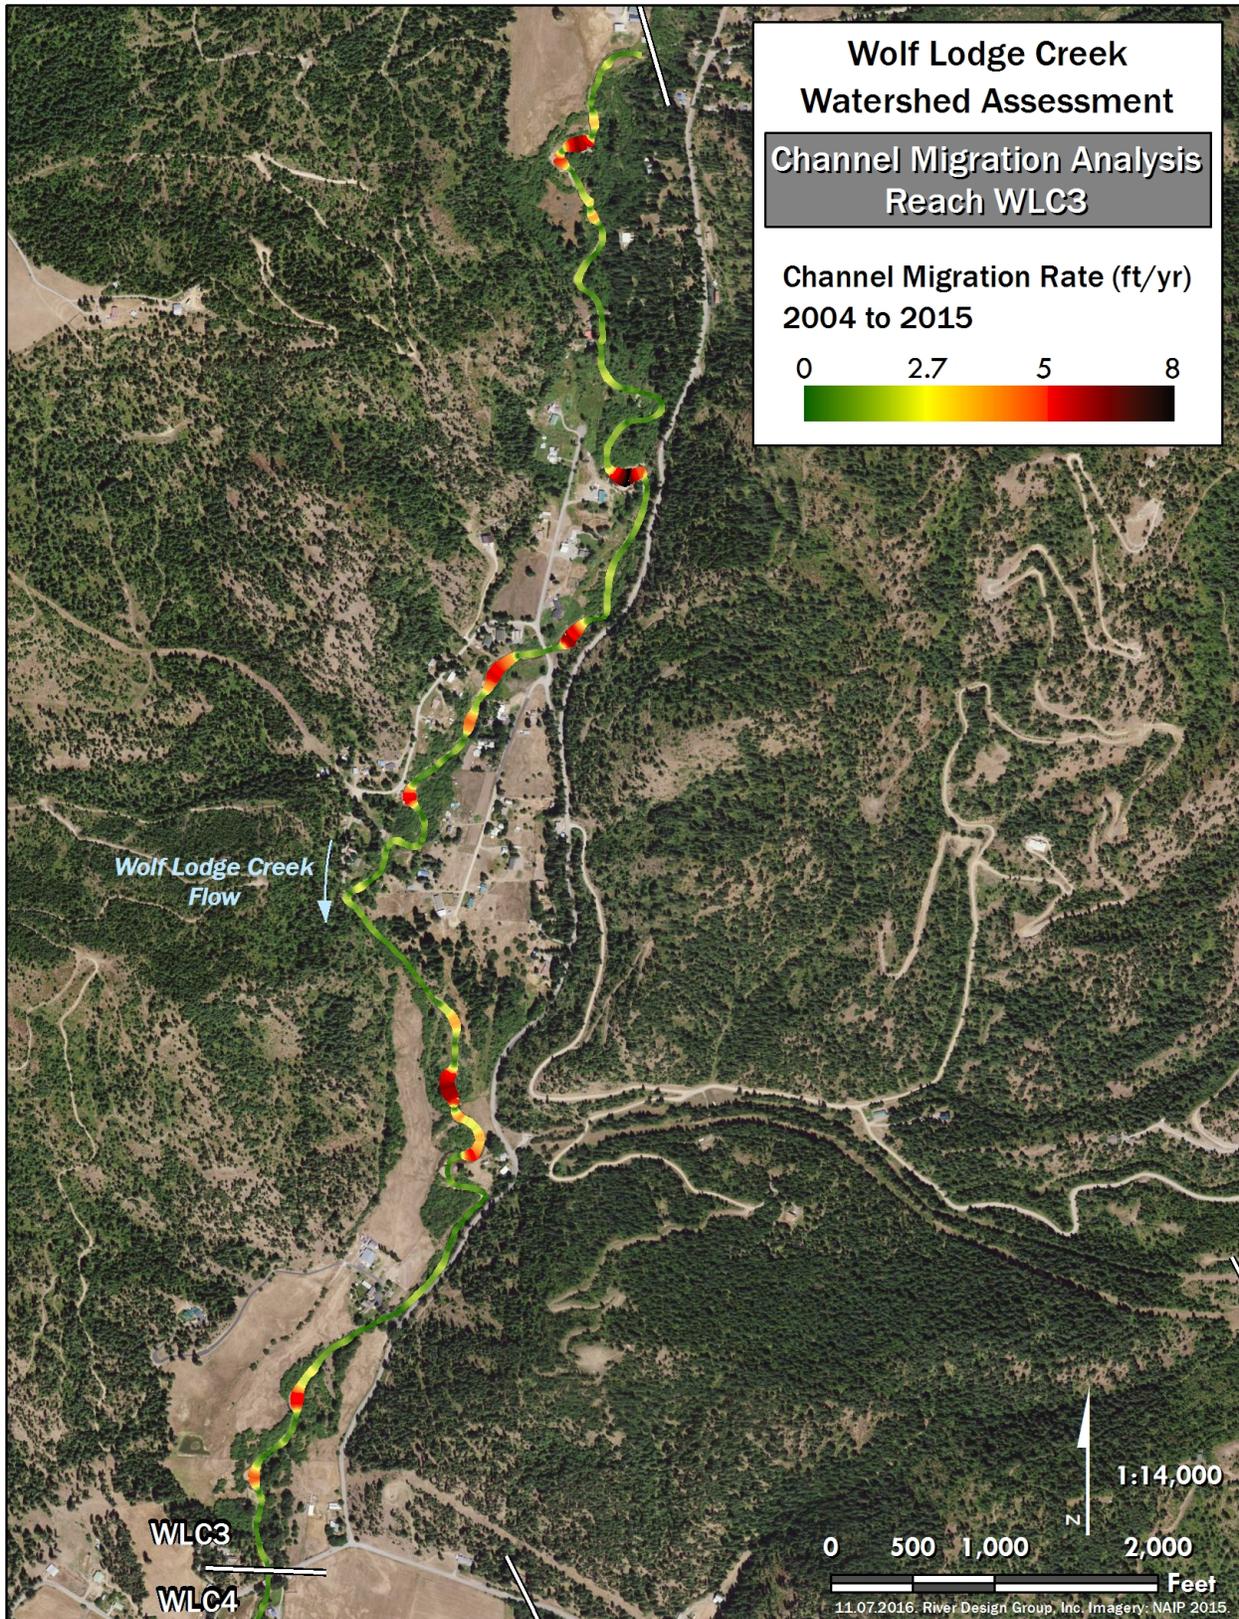
WLC3 has the highest frequency of large migration rates of any sites in the watershed. Areas with high erosion rates ranged from 2-7 ft of migration per year between 2004 and 2015 (Figure 4-9). Two sites were the focus of previous mitigation efforts (EP1 and EP2). Bank at these sites stopped migrating following mitigation project implementation, however banks downstream of the projects still have high rates of lateral migration. The geomorphic assessment site focused on the meander bend with the greatest lateral migration rate. The tall, unstable bank has been eroding at a rate of 4-6 ft per year between 2004 and 2015. Upstream of this bend is a second site that has undergone rapid migration in the past 11 years with 3-4 ft of migration per year. Beaver activity appears to have caused a channel avulsion, resulting in accelerated lateral migration. While beaver sign was present throughout WLC3, WLC2, WLC4, WLC5, and MC2, beaver induced erosion was not observed at other sites in the reach.

Figure 4-9. Channel migration analysis for Reach WLC3.

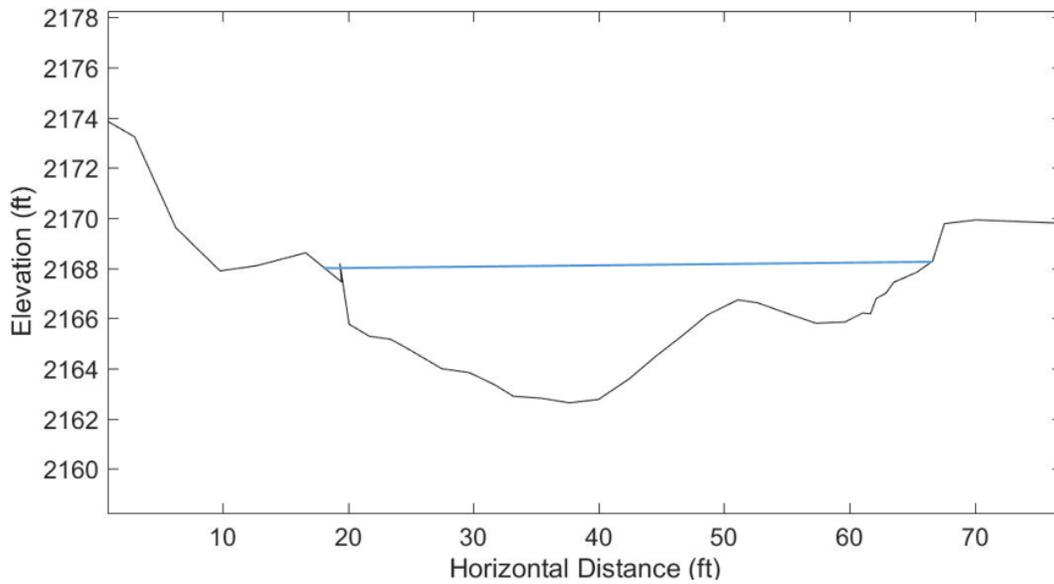
Figure 4-10. Cross section 1 on WLC 3. The blue line represents bankfull stage.

Bankfull Width (ft)	48.4
Mean Depth (ft)	3.3
Max Depth (ft)	5.7
Bankfull Area (ft ²)	154.7
Width/Depth Ratio	14.8
Hydraulic Radius	3.0

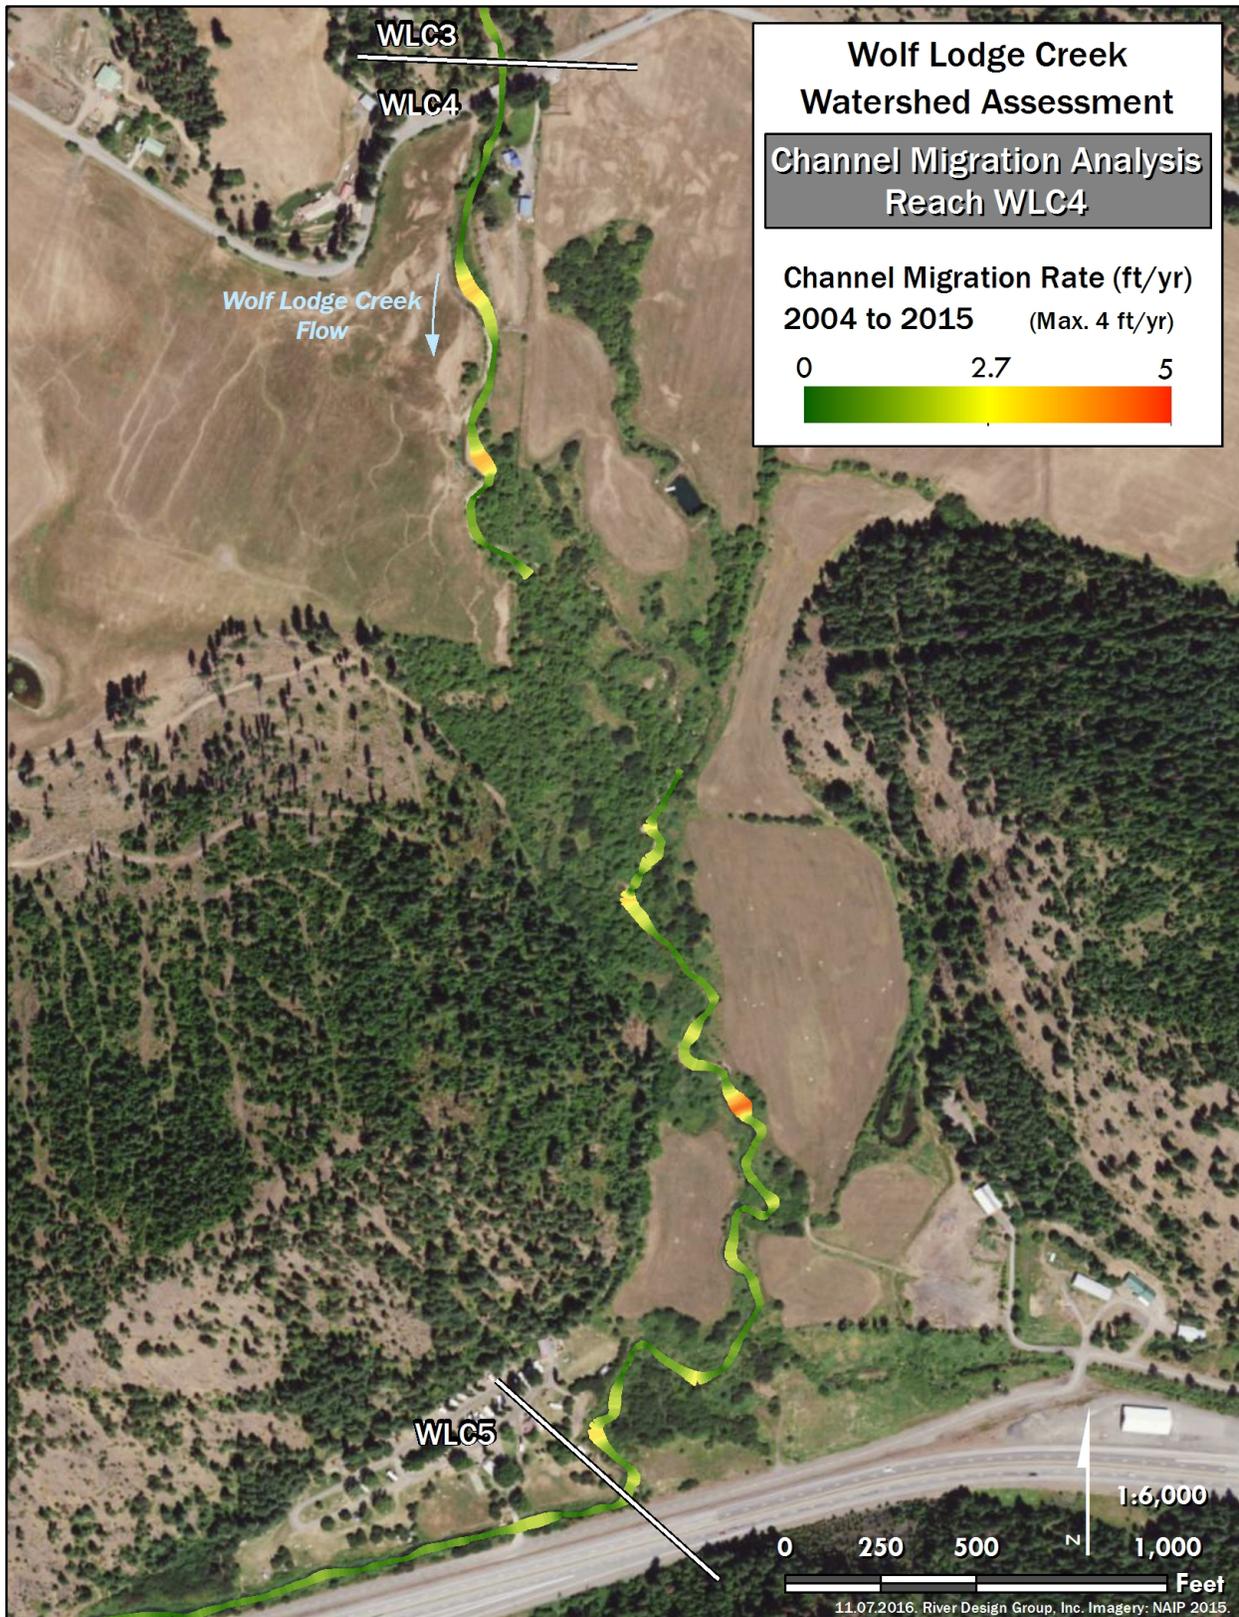
Channel migration analysis results indicate that banks in the impaired sub-reach are migrating at an average rate of three ft per year (Figure 4-13). These rates are rapid, but slower when compared to migration rates in WLC3. A 2009 flood appears to have caused the majority of bank erosion during the 2004-2015 timeframe for the study. Lower rates are observed in the downstream section of the reach where vegetation is present, except for a short section of channel where vegetation density precludes identification of the bank lines. The areas with the most rapid migration rates are located where deep pools have been created from dredging.

Figure 4-13. Channel migration analysis for Reach WLC4.

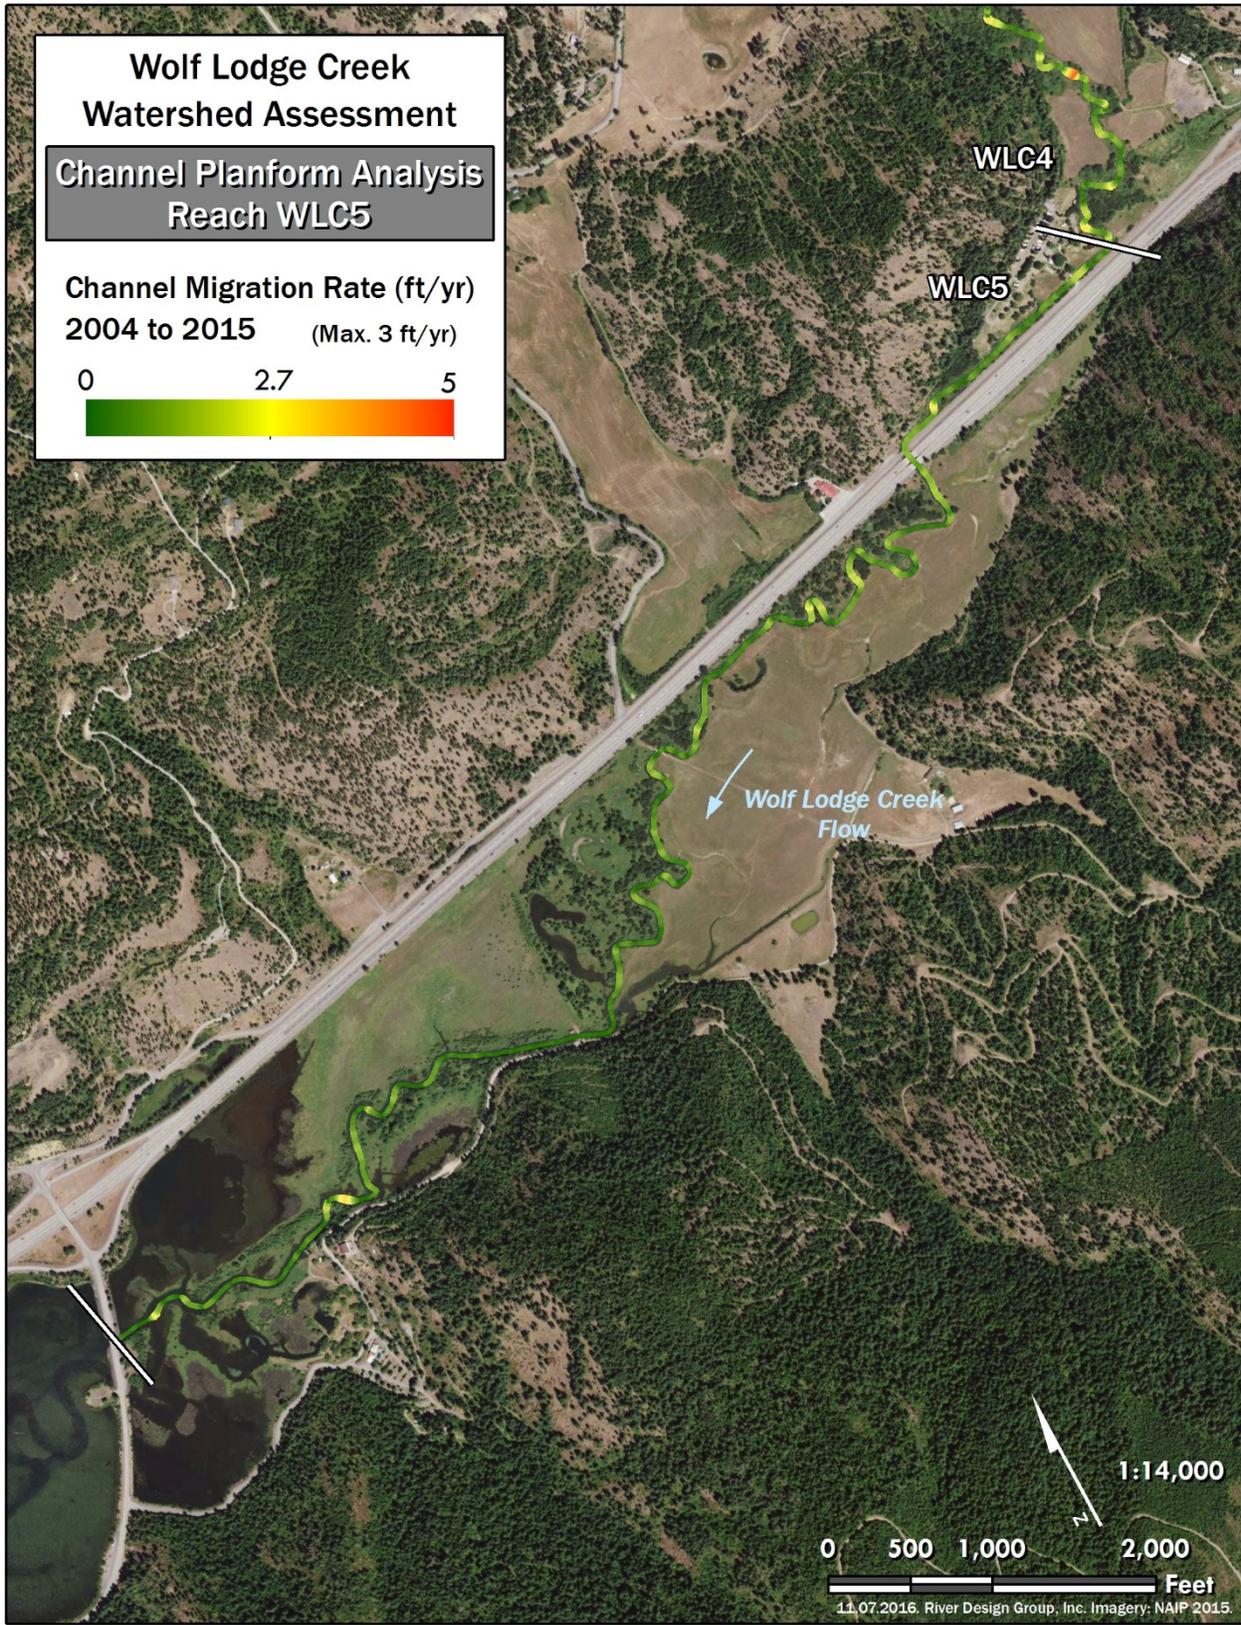
Aerial analysis of channel migration between 2004 and 2015 shows minimal change in the reach, largely due to the lower energy environment created by the backwater effect from Lake Coeur d'Alene (Figure 4-16). Velocity and shear stress in the channel is very low even during high flows. Translation of the channel in the down valley direction is the most prevalent change to channel planform. This migration is at a natural rate given the geomorphic conditions that exist and is not a cause of concern. However, channel widening that is being driven on the river left bank from grazing, if continued, could compromise aquatic habitat by increasing bank erosion and potential for channel aggradation and pool filling.

Figure 4-16. Channel migration analysis for Reach WLC5.

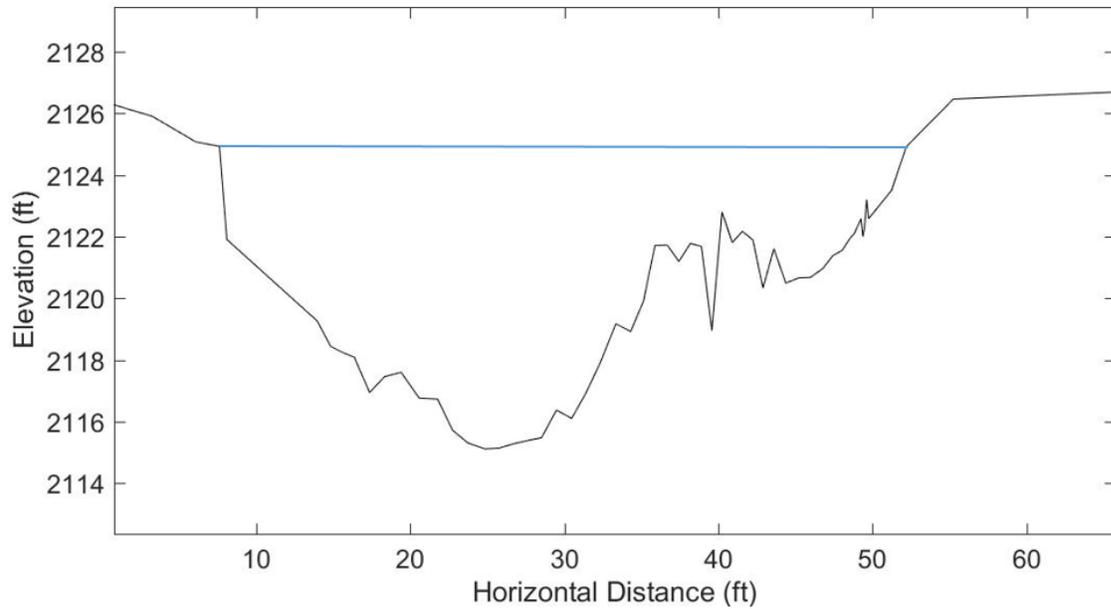
A geomorphic survey was completed in the middle of WLC5 where the channel is free of lateral impingement from Interstate 90. This reach has been impacted from grazing and the channelization and hard stabilization associated with the interstate. The reach classified as an E6 stream type. A 1,400 ft longitudinal channel profile, four cross-sections, large wood survey, and BEHI assessment were completed in the reach. The average bankfull slope was 0.0002 ft/ft compared to a water surface slope of 0.00004 ft/ft. Pool cross-section and descriptive statistics are included in Figure 4-17 and Table 4-15. Large wood was abundant throughout the reach, but was not considered a driver on channel form. A pebble count was not conducted on WLC5, as the bed and banks consist of silty-clay particles.

Figure 4-17. Cross section 1 on WLC5. The blue line represents bankfull stage.
