Wolf Lodge Creek Watershed Assessment and Restoration Prioritization Plan

Near Coeur d'Alene, Idaho

Submitted To:
Idaho Department of Environmental Quality
2110 Ironwood Parkway
Coeur d'Alene, ID 83814

December 2016

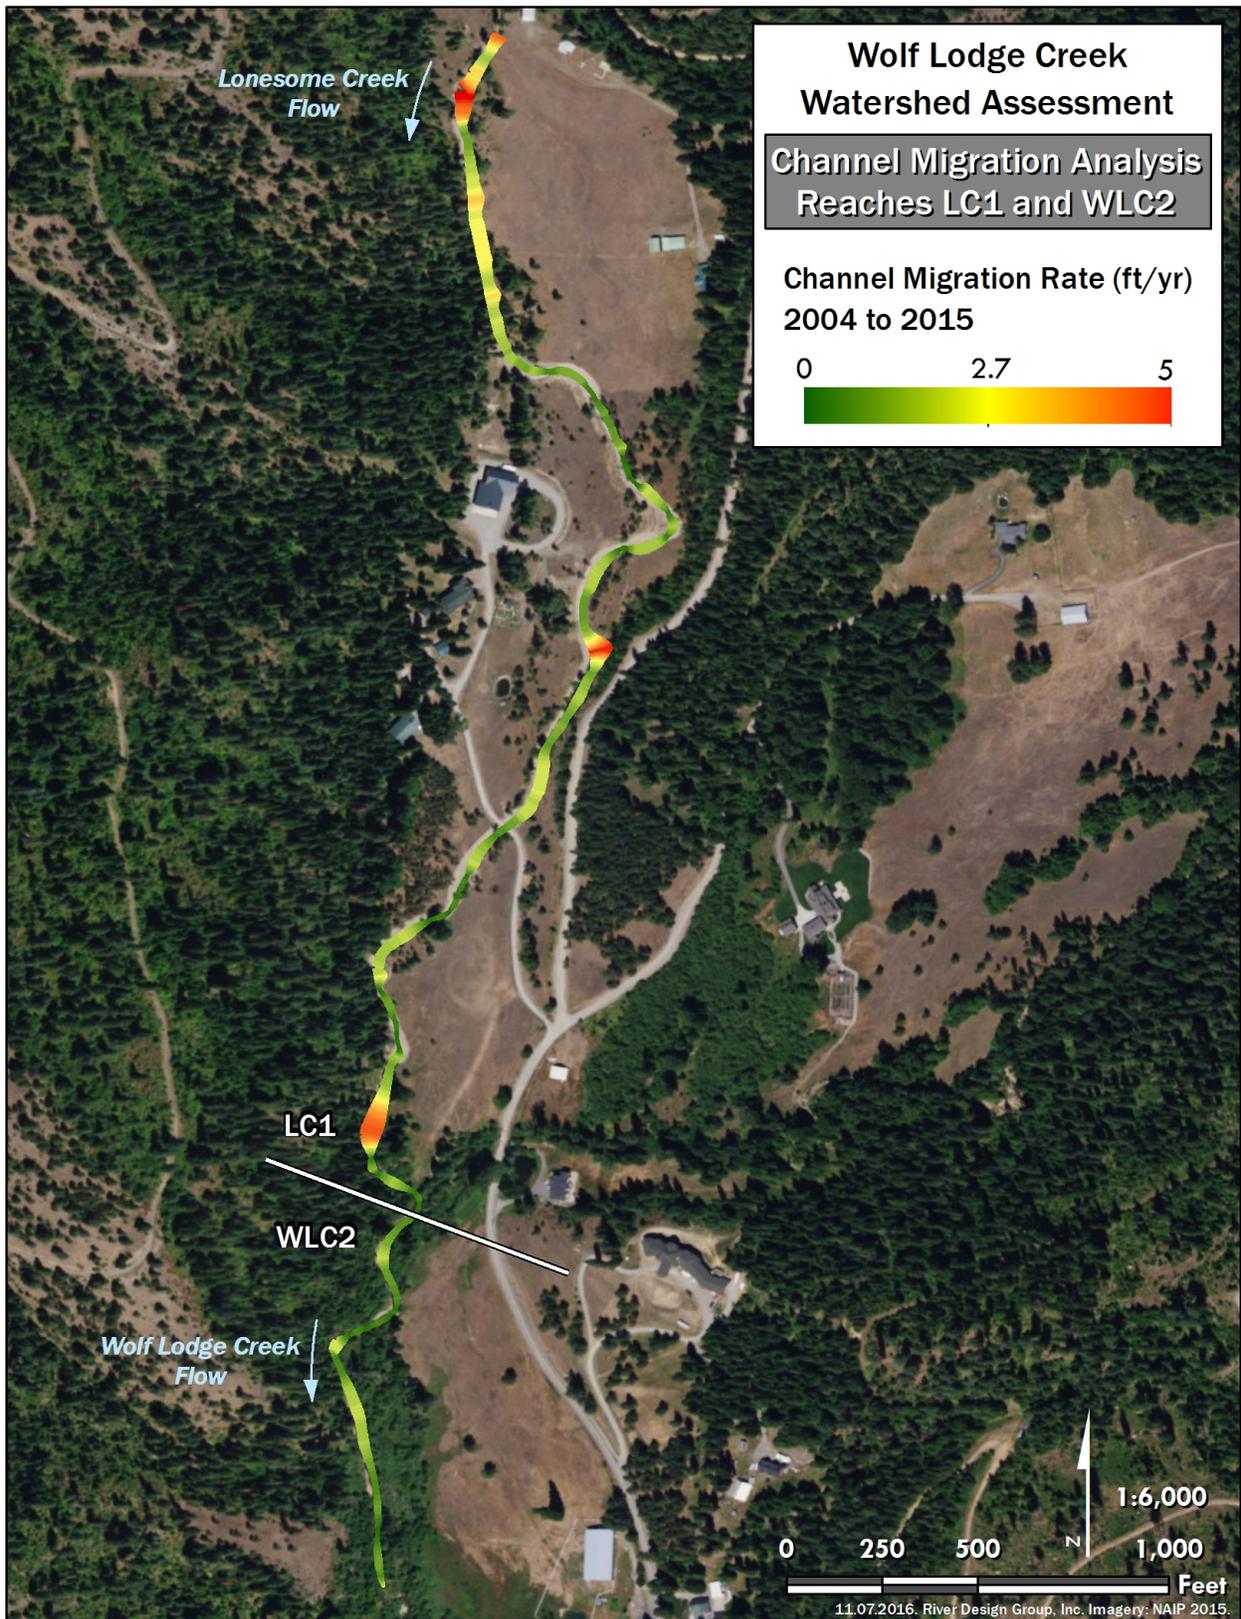
Channel migration analysis results indicate that LC1 has experienced minimal lateral migration over the past 11 years (Figure 4-18). This is likely the result of the channelization and leveeing of the reach during the early 2000s. While channel migration has been limited, significant widening has occurred, nearly doubling the width of the channel. Small areas where banks have eroded and migrated include small patches on the left bank where levees were not built and flow is now concentrated on erodible soil and bank materials. Rates of migration range from 1.5-2 ft/year. These rates are influenced by the construction efforts in the channel since extensive work was conducted during the time period examined.

Figure 4-18. Channel migration of Reach LC1 and the upstream portion of Reach WLC2.

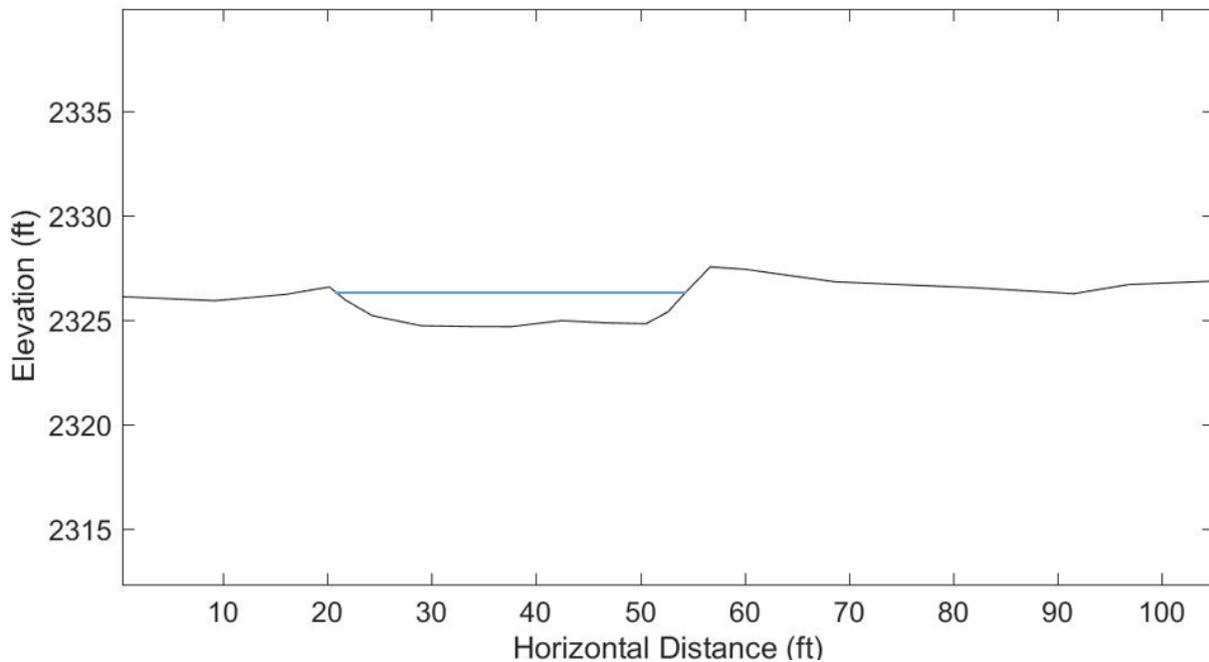
Figure 4-20. Cross section 4 pool on LC 1. The blue line represents bankfull stage. Channel complexity is lacking and the right bank has been leveed.

Bankfull Width (ft)	30.3
Mean Depth (ft)	0.8
Max Depth (ft)	1.0
Bankfull Area (sq ft)	23.3
Width/Depth Ratio	39.3
Hydraulic Radius	0.8

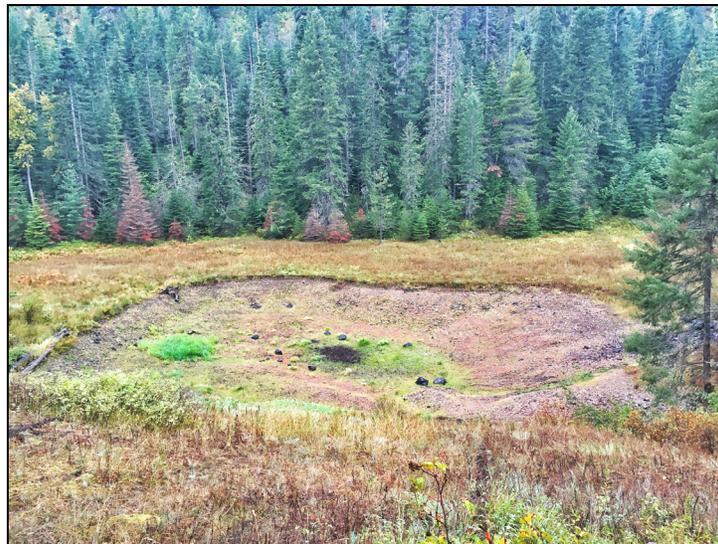
During the 1990s the sediment trap was constructed to decrease the amount of sediment being transported from the headwaters to the lower reaches in the watershed (Figure 4-23). Increased sediment flux was anticipated from timber harvest activities upstream. Inspection of the sediment trap reveals that very little bedload is being transported to and deposited in the trap. The majority of bedload is being deposited upstream of the trap and has caused localized adjustments in the channel slope and energy gradient, causing channel braiding. The grade control structure on the upstream end of the trap is the cause of the deposition. The amount of bedload material that has been deposited in this reach is not excessive, suggesting that the original concern of increased bedload from timber harvest activities has not been observed. Local sediment sinks in large wood structures throughout SC1 have likely buffered impacts of coarse sediment increases from logging. Sediment trap removal and restoration of the channel and floodplain in the vicinity of the sediment trap is recommended.

Figure 4-23. Sediment trap on Stella Creek.

In conclusion, SC1 is a healthy aquatic ecosystem that has natural geomorphic process and form. The removal of the existing sediment trap and grade control features is recommended, which would be one component of a larger valley and channel restoration effort to help restore floodplain connectivity, sediment transport, and fish passage between the upper and lower reaches of Stella Creek. Conceptual designs are included in Attachment A of this report.

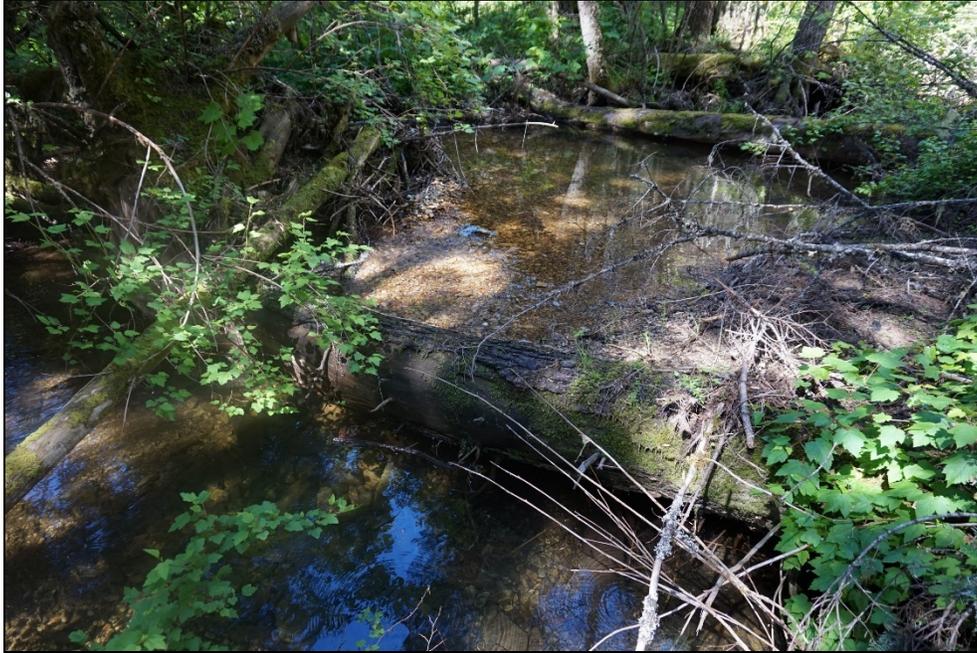
In addition, large wood features in this reach provide local sediment sinks that buffer increased sediment load from logging efforts upstream. Figure 4-24 highlights an example of this process. The sub-reach in which the geomorphic assessment was conducted contains four log step features that serve as large, local sinks for sediment. If the frequency of occurrence of log steps

Figure 4-24. Log step that is storing sediment locally and buffering impacts from upstream timber harvest.

is constant throughout the reach, hundreds of local sinks exist to store sediment. These buffers are critical to downstream community resilience to flooding and sedimentation. Recommendations include conservation and maintenance of current land management strategies to protect these riparian forests from logging, fire, and disease.

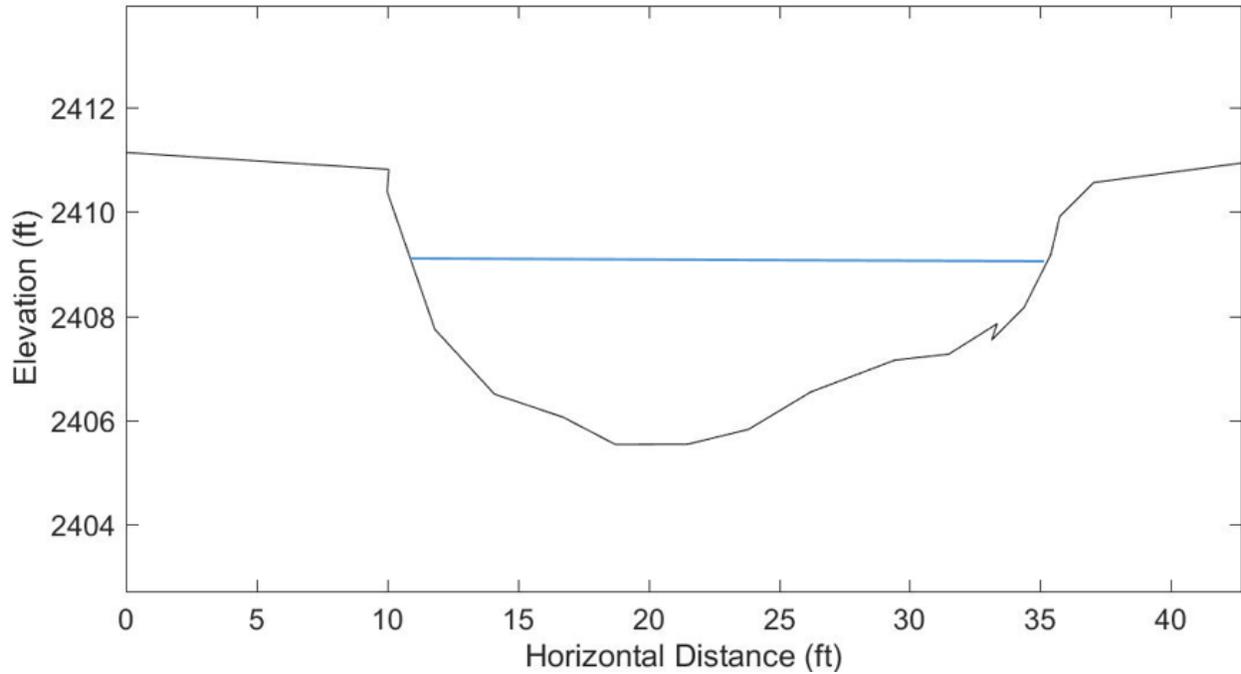
A geomorphic survey was completed at the downstream end of SC1 where the forested channel exits a large meadow. This reach appears undisturbed from direct human impacts for at least the last 70 years, with well-established secondary growth forests making up the riparian environment. The stream is classified as a B4 stream type. A 400 ft longitudinal channel profile, two riffle cross-sections, two pool cross-sections, pebble count for riffle and pool, large wood survey, and BEHI assessment were completed in the reach. The cross-sections were located in representative channel habitat features. The average bankfull slope is 0.022 ft/ft compared to a water surface slope of 0.025 ft/ft. Pool cross-section and descriptive statistics are included in Figure 4-25 and Table 4-22. Large wood is abundant throughout the reach and provides aquatic habitat complexity. Overall, this reach is a stable channel that has reached equilibrium and provides ample, diverse habitat for aquatic species.

Figure 4-25. Cross section 4 scour pool in SC1, below the log step shown in Figure 5-16. The blue line represents bankfull stage.

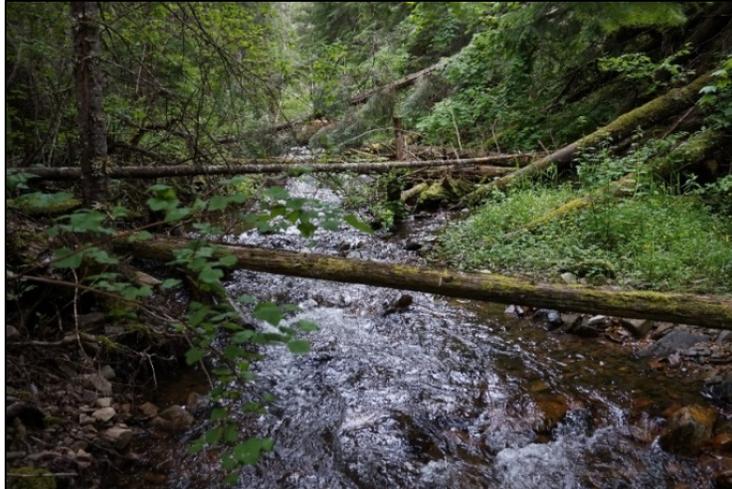
This reach has been logged and is recovering from past forest management activities. The forest is a mixture of cedar and pine secondary growth. Riparian vegetation communities are limited to the bankfull width of the stream with pine forest cover dominating the floodplain. Instream large wood is prevalent throughout the reach (Figure 4-27).

Figure 4-27. Typical channel conditions in MC1.

This reach is functioning with minimal human disturbance occurring in recent history. Recommendations include limiting future logging operations in this drainage to limit the potential for an increase in hillslope activity and sediment loading to MC1.

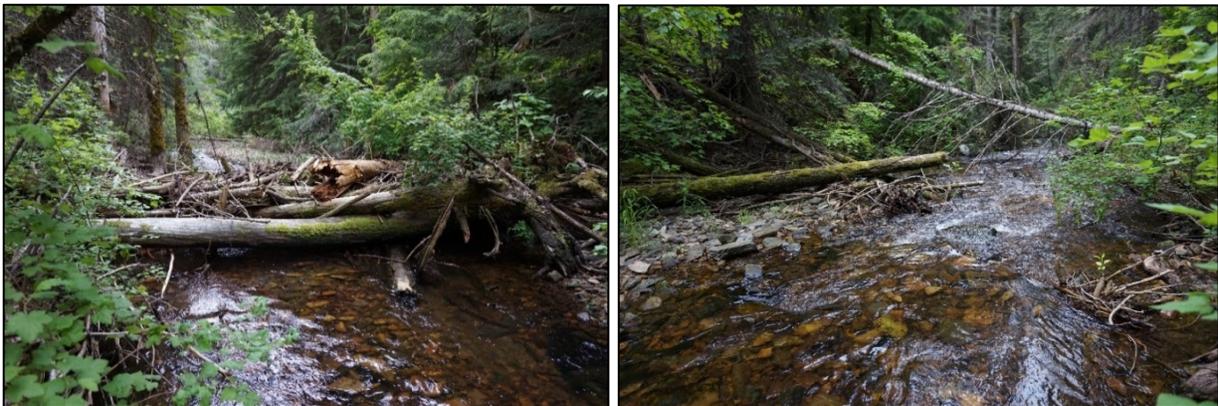
MC1 is relatively undisturbed from human activity, with complex aquatic habitat and low bank erosion. The stream is classified as a B4 stream type and transitions to a C4 type toward the downstream end of the reach. Intermittent bedrock intrusions on the left bank and in the channel are present. Grains in the channel are more angular than other reaches, suggesting hillslope activity is contributing the bulk of the sediment supply to the reach. The bed of the channel is armored, indicating low bedload transport rates. Slope of the reach is 0.0195 ft/ft, which is slightly steeper than the downstream MC2. Despite similarities in slope, this reach can be used as a reference reach for MC2 given the significant confinement of MC1. Removal of the downstream sediment trap is supported by the amount of local storage of sediment within the channel. Large wood features create depositional environments where pockets of gravels are being stored, as well as a well-connected floodplain that allows for deposition of fines during flood events. The diversity of habitat in the reach is driven by the interaction with large wood aggregates and single pieces (Figure 4-28).

Figure 4-28. Channel spanning log jam that forms a deep pool upstream (left) and breached log jam that has retained sediment as a lateral bar on the left bank (right).

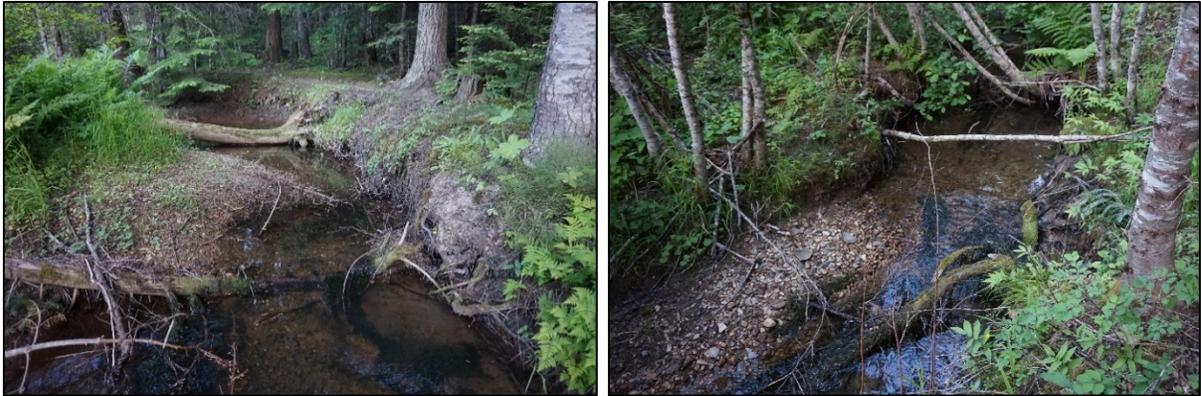
One reach, SLC1, was delineated on Searchlight Creek. The confluence with Marie Creek is located at the boundary between MC2 and MC3. The entirety of the reach in the study area is privately owned, but the headwaters of Searchlight Creek are in the Idaho Panhandle National Forest. SLC1 is classified as a B4 stream type. Bank characteristics vary throughout the reach (Figure 4-33) but are generally composed of non-stratified, silty-clay soils. Erosion potential from SLC1 is low due to the presence of woody vegetation, moderate bank angles, and bank surface protection from root systems. Overall, the reach is currently stable.

Figure 4-33. Typical streambank conditions in SLC1.

Three culverts are present in the reach. Removal or modification of two of the structures is recommended to prevent the potential for clogging and failure. Additionally, the most downstream culvert may present a seasonal barrier to fish passage. Results of the stream crossing inventory are included in Appendix D. Recommendations include replacement of two culverts and maintaining adequate riparian buffers in the headwaters of the drainage.

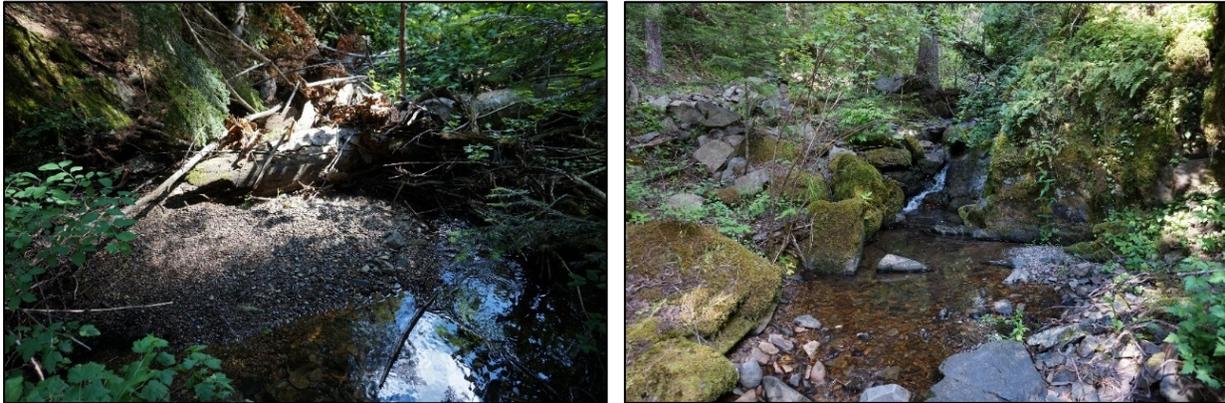
RG2 begins downstream of RG1 where a distinct increase in channel slope and valley confinement occurs. RG2 is classified as a predominately A3 stream type with localized inclusions of high gradient, bedrock controlled rock steps (Figure 4-34), and lacks a floodplain. Channel segments connecting steeper bedrock controlled segments exhibit B4 stream type characteristics with decreasing slope. Fine sediments are deposited in pools with dominant substrate comprised of coarse gravel and large cobble.

Figure 4-34. Typical step pool and force pool morphology formed by instream large wood (left) and bedrock intrusions (right).

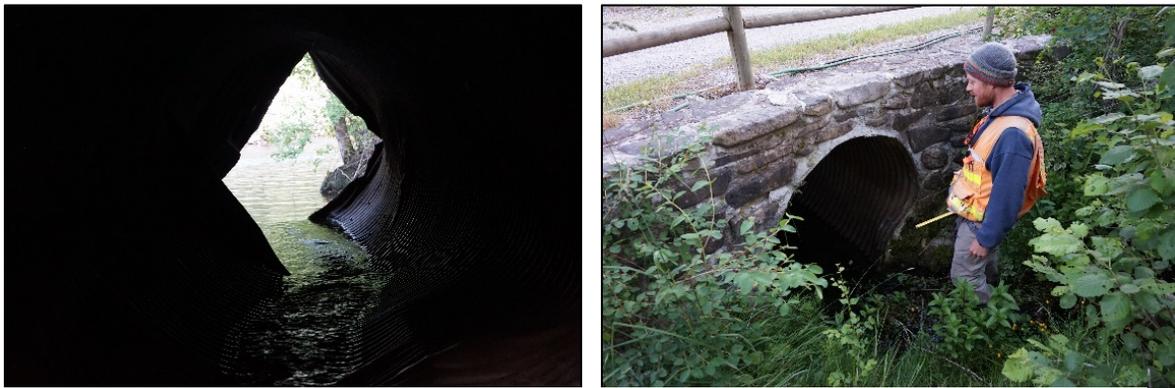
Figure 6-6. SLC_Culvert1 stream crossing.

SLC_Culvert1 measured 23 ft in length and 42 inches in diameter. It is located on a private driveway that spans Searchlight Creek at the confluence with Marie Creek. The culvert is compromised and is in poor condition (Figure 6-6). The culvert is partially collapsed which decreases hydraulic capacity and increases the likelihood of plugging which could result in failure of the road prism. Energy dissipation at the outlet is inadequate and the channel bed is scoured resulting in a 1 ft drop at the outlet. Replacement of the culvert is recommended to lower failure risk, increase hydraulic capacity, and improve fish passage conditions.

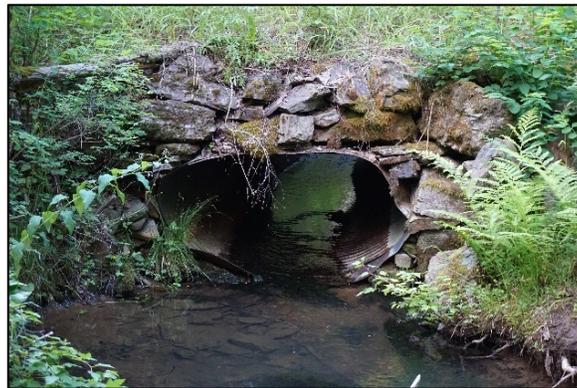
Figure 6-7. SLC_Culvert 3.

SLC_Culvert3 measured 15 ft in length and is located on Searchlight Creek (Figure 6-1). The crossing appears to support non-motorized use and is in poor condition. The culvert is structurally compromised and the upstream and downstream alignment has resulted in bed scour and streambank erosion. The culvert should be removed, and the approach grades lowered to floodplain elevation to reduce floodplain obstructions.

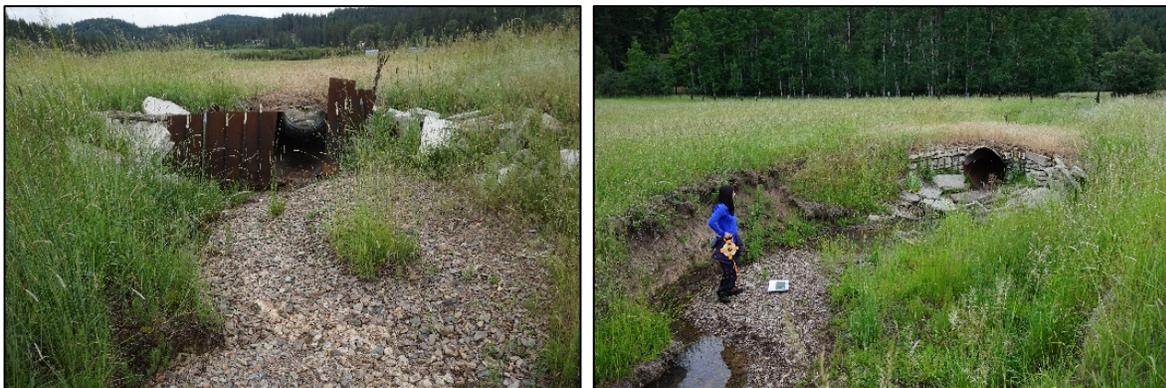
Figure 6-8. RG3_Culvert.

This culvert is located on private property on Rutherford Gulch. The 21 foot long culvert is in poor condition and affecting streambank stability and sediment transport characteristics. The channel upstream of the culvert inlet is aggrading and widening. Severe erosion is occurring at the culvert outlet due to concentrated flow that impinges on unstable, vertical streambanks (Figure 6-8). Mass failure of the crossing is probable in the event of plugging and overtopping.

Replacement of the culvert with a new structure that provides significantly more hydraulic capacity is recommended. Culvert replacement should be coordinated with restoration actions described in Section 8 and Attachment A.

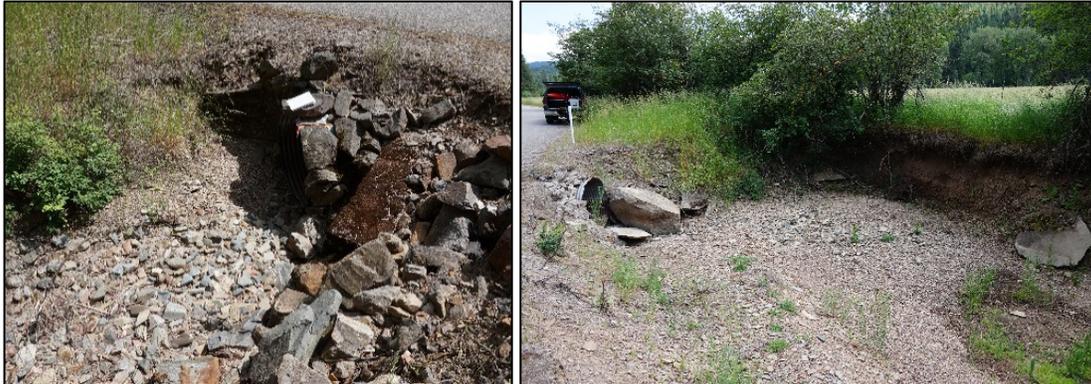
Figure 6-9. RG3_Culvert.

This culvert is located on Rutherford Gulch and is owned and managed by the State of Idaho. The culvert is structurally sound. The inlet and outlet fillslopes are steep and eroding, resulting in sediment delivery to RG3. The culvert skew and alignment result in streambank erosion downstream of the culvert outlet. Aggradation is occurring upstream of the inlet due to inadequate hydraulic capacity (Figure 6-9). Given the lack of hydraulic capacity and high skew angle, plugging is probable and could result in overtopping of the road prism. Replacement is recommended.
