**Forest Practices
Water Quality
Audit 1996**

Prepared by
1996 Forest Practices Audit Team

Idaho Department of Health and Welfare
Division of Environmental Quality
1410 North Hilton Street
Boise, Idaho 83706

February 1997

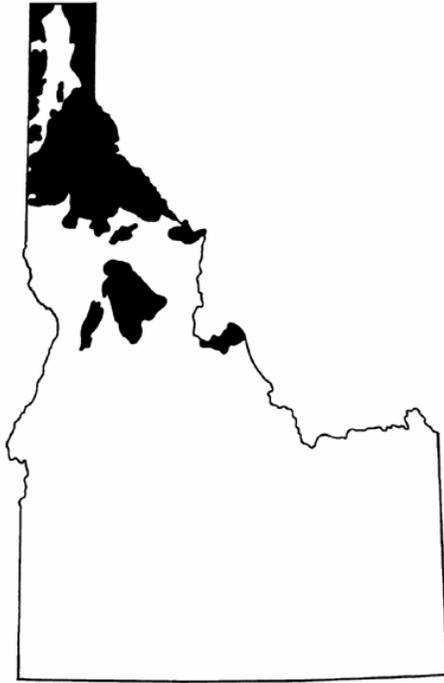
Figure 1. Approximate locations of Belt Supergroup rocks in Idaho.

We recommend the road rule (1996 Rule 040) be modified to account for differences in geologic stability and to make them easier to understand. We also recommend that training should emphasize the need to apply multiple practices on granitic soils. Figure 1 shows approximate locations of the Belt Supergroup (generally stable and good road construction materials), and Figure 2 shows approximate locations of the batholithic granite rocks (generally unstable and poor road construction materials). More detailed descriptions of these rock types are contained in appendix F. As a starting point for discussion, we are suggesting the Rule 040 text modifications contained in appendix G (please note that these suggested changes also address our concerns about road fill compaction and road planning).

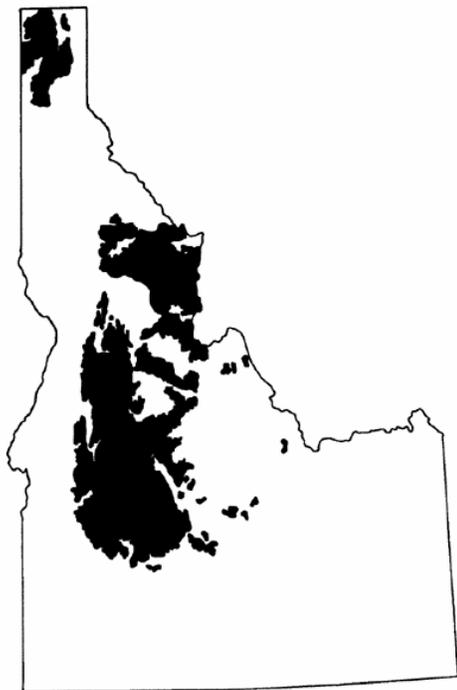
Figure 2. Approximate locations of batholithic granite rocks in Idaho.

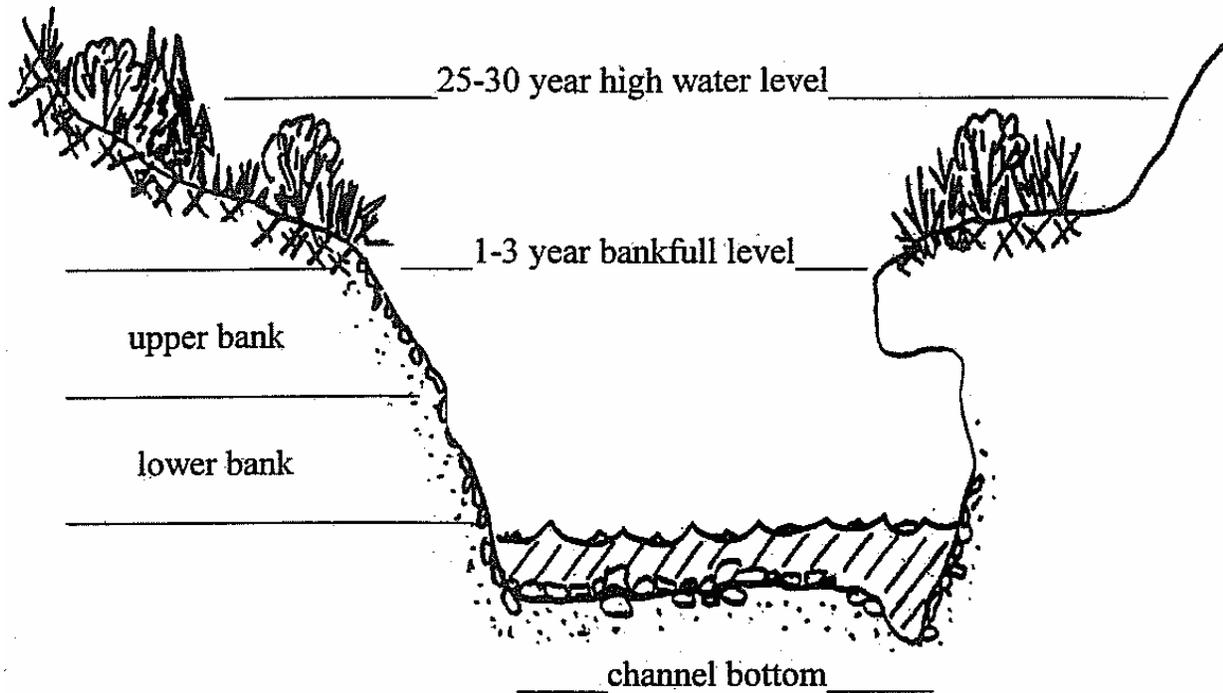
APPENDIX D

DEFINITION OF TERMS AND ILLUSTRATIONS

Upper Bank - That portion of the upper channel to the edge of the 1-3 year bankfull level.
(Typical upper bank descriptions incorporate the area from the break in the general slope of the surrounding land to the 1-3 year bankfull level.)

Lower Bank - The intermittently submerged portion of the channel cross section to the water's edge during summer low flow periods.

Figure 1.	Approximate location of Belt Supergroup rocks in Idaho	25
Figure 2.	Approximate location of batholithic granite rocks in Idaho	25
Appendix D	Illustration of streambank and channel bottom definitions	D-1
