Attachment 22

Past Practice Units

J.0 Corrective Action for Solid Waste Management Units

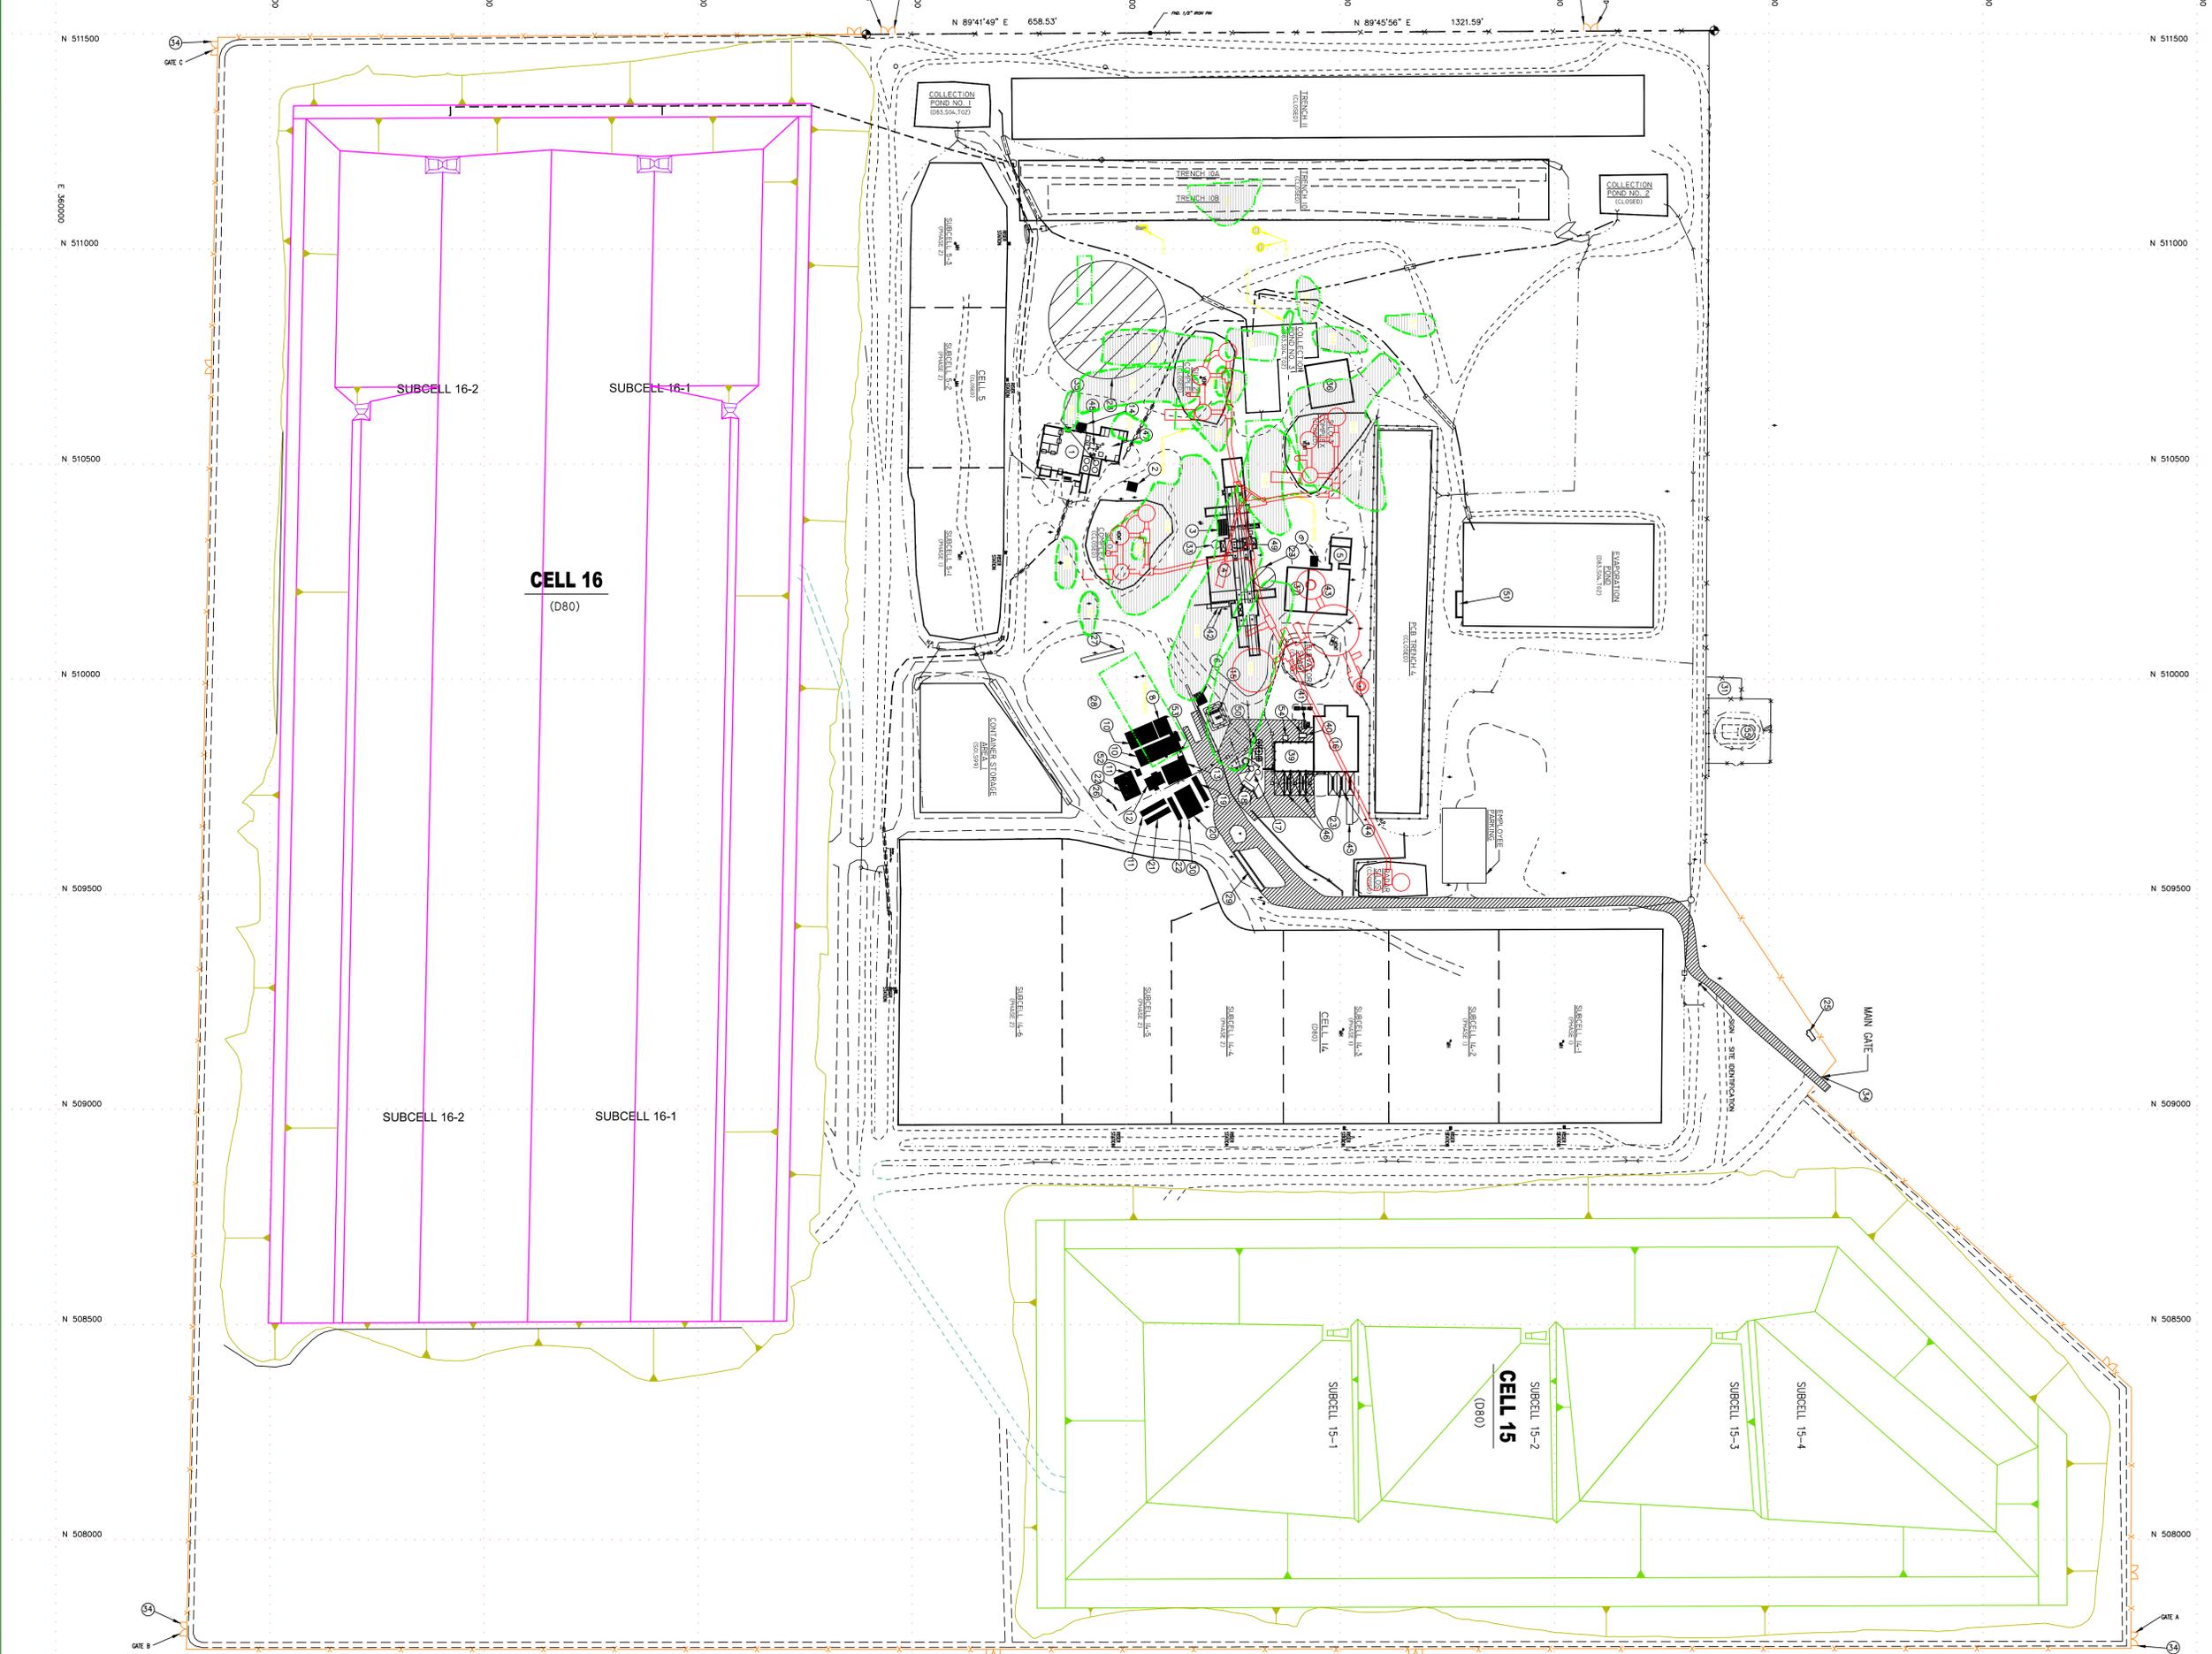
RCRA-regulated and non-regulated SWMUs exist on-site. RCRA-regulated units are defined as those units that received RCRA-regulated waste on or after November 19, 1980. Units that received hazardous waste prior to November 19, 1980, are referred to as pre-RCRA units and are not considered regulated units. Toxic Substance Control Act (TSCA) wastes are also managed on-site. For the purpose, TSCA units are considered non-regulated SWMUs. Available facility records and environmental reports were reviewed to obtain information detailing current and past practices associated with both regulated and non-regulated units. Paragraph J.3 provides a list of these references. The following paragraphs document the types of SWMUs known to exist on-site, including each unit's location, dimensions, materials of construction, details regarding operation, wastes present, and the quantity of wastes involved, if known. Section E provides additional information regarding the types of wastes previously handled on-site. The facility boundary and the location of each SWMU discussed in the following paragraphs are depicted on Drawing Number PRMI-T05a.
